Closure Completion Notification for Closure by Removal

Mitchell Plant

Bottom Ash Pond

Bottom Ash Complex 2024 Annual Dam and Dike Inspection Report

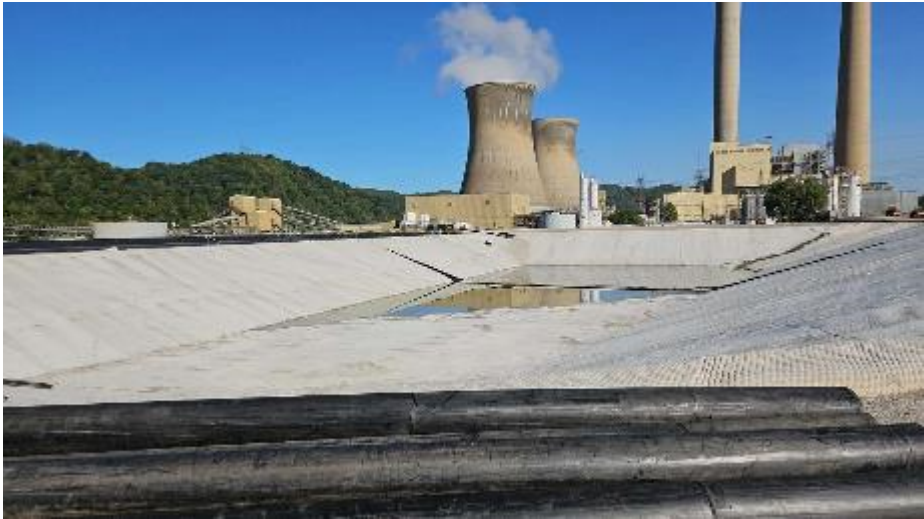
1. The East Bottom Ash Pond was in good condition. The upstream slope Fabriform lining was in good condition as shown in Photograph No. 1. The East Bottom Ash Pond East Crest was in good condition and recently paved with asphalt as shown in Photograph No. 2. The East Bottom Ash Pond downstream slope was also well vegetated on the south end as shown in Photograph No. 3.

PHOTOGRAPH NO: 1	DATE: September 4, 2024 8:27 AM	LATITUDE: 39.82433006	LONGITUDE: -80.81438777
DIRECTION: 230°		SITE LOCATION: MARSHALL COUNTY, WEST VIRGINIA	
DESCRIPTION: East Bottom Ash Pond. Upstream Slope. Note Good Condition of Fabriform Revetment.

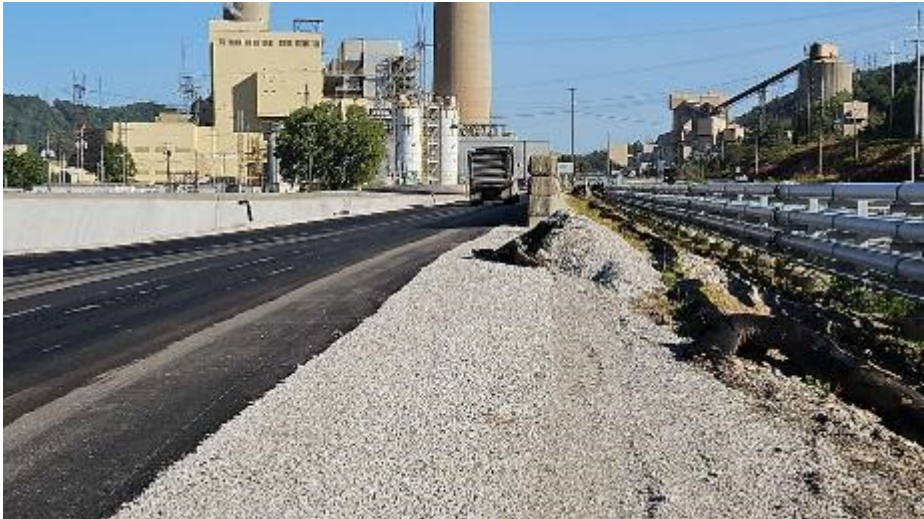
PHOTO BY: GEI CONSULTANTS, INC.			
PHOTOGRAPH NO: 2	DATE: September 4, 2024 8:29 AM	LATITUDE: 39.82432968	LONGITUDE: -80.81412916
DIRECTION: 284°		SITE LOCATION: MARSHALL COUNTY, WEST VIRGINIA	
DESCRIPTION: East Bottom Ash Pond. Downstream Slope. Note Asphalt Surface on Crest of Eastern Dike.

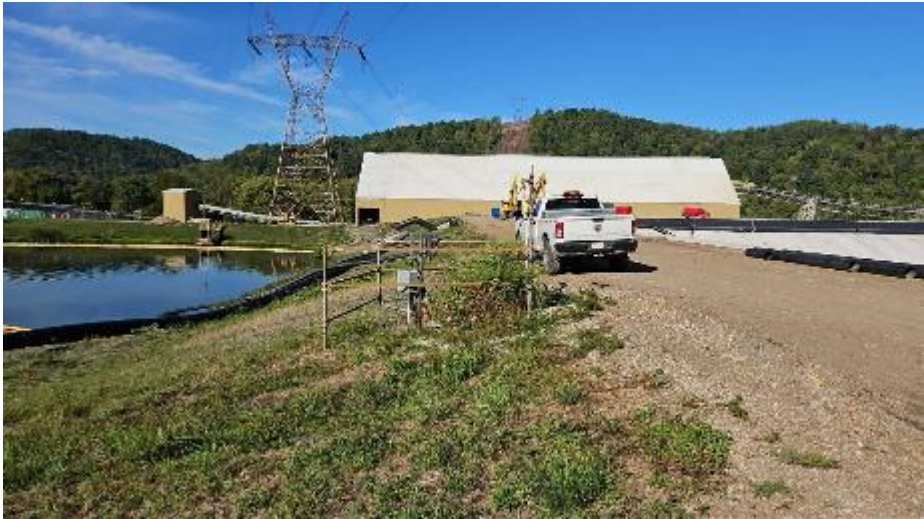
PHOTOGRAPH NO: 3	DATE: September 4, 2024 8:32 AM	LATITUDE: 39.8242526	LONGITUDE: -80.81426778
DIRECTION: 163°		SITE LOCATION: MARSHALL COUNTY, WEST VIRGINIA	
DESCRIPTION: East Bottom Ash Pond. Downstream Slope. General Photo. Note Gravel Surface on Crest of Southern Dike.

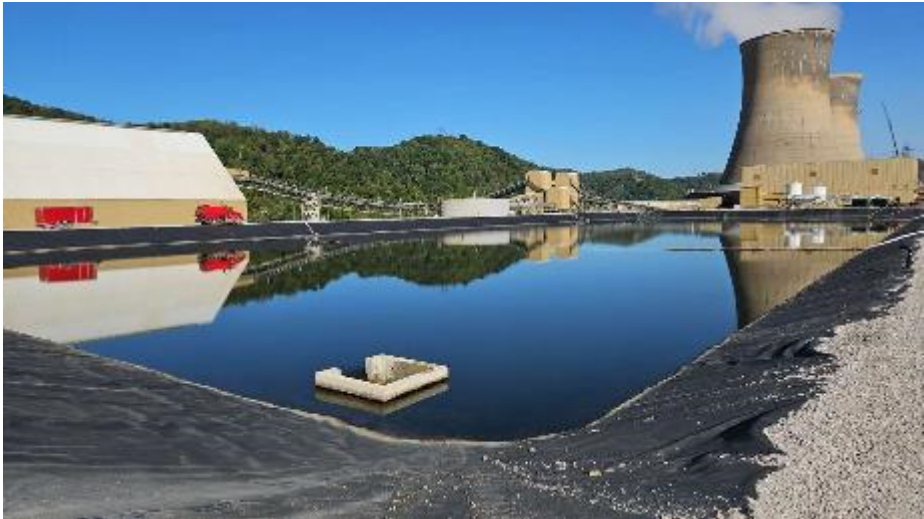
2. The West Bottom Ash Pond was in good condition. The upstream slope geomembrane lining was in good condition as shown in Photograph No. 4. The West Bottom Ash Pond Crest was paved with gravel and in good condition as shown in Photograph No. 5, No. 7, and No. 8. The West Bottom Ash Pond downstream slope was well vegetated but had some areas that should be maintained to 12-inches or less as shown in Photograph No. 5, No. 6, and No. 9. Two railroad ties were identified in the crest that should be removed and regraded as well.

PHOTO BY: GEI CONSULTANTS, INC.			
PHOTOGRAPH NO: 4	DATE: September 4, 2024 8:34 AM	LATITUDE: 39.8241844	LONGITUDE: -80.81510526
DIRECTION: 221°		SITE LOCATION: MARSHALL COUNTY, WEST VIRGINIA	
DESCRIPTION: West Bottom Ash Pond. Upstream Slope. Exposed Liner in good condition.

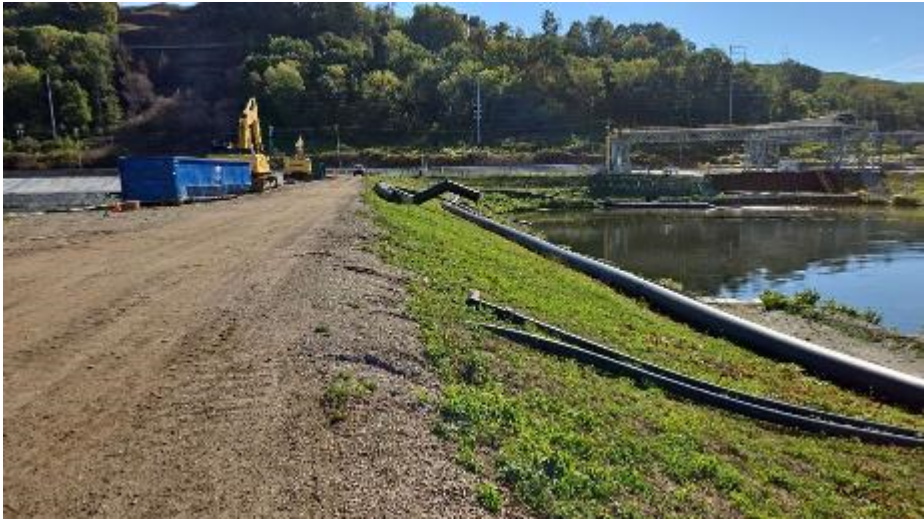
PHOTOGRAPH NO: 5	DATE: September 4, 2024 8:40 AM	LATITUDE: 39.82391542	LONGITUDE: -80.81582125
DIRECTION: 14°	SITE LOCATION: MARSHALL COUNTY, WEST VIRGINIA		
DESCRIPTION: West Bottom Ash Pond. Downstream Slope. General Photo, Typical Conditions.

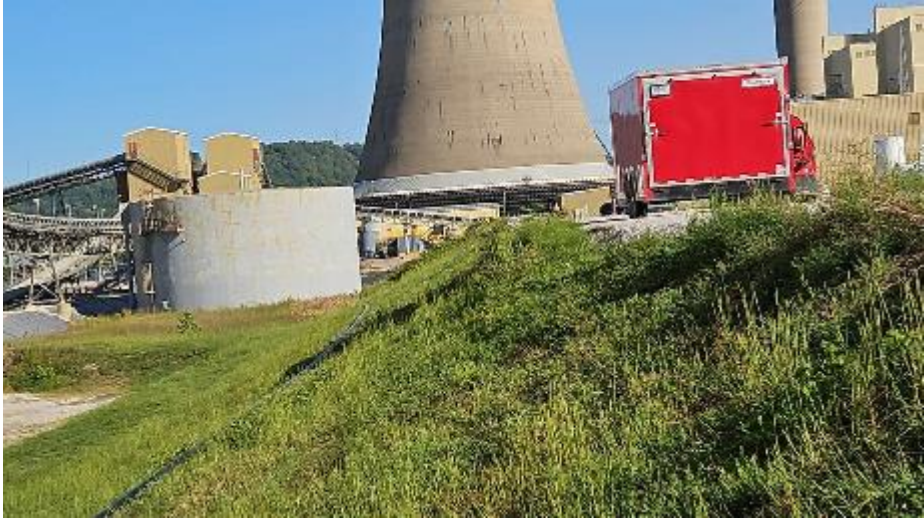
PHOTO BY: GEI CONSULTANTS, INC.			
PHOTOGRAPH NO: 6	DATE: September 4, 2024 8:41 AM	LATITUDE: 39.82399621	LONGITUDE: -80.81615071
DIRECTION: 261°	SITE LOCATION: MARSHALL COUNTY, WEST VIRGINIA		
DESCRIPTION: West Bottom Ash Pond. Downstream Slope. General Photo, Typical Conditions.

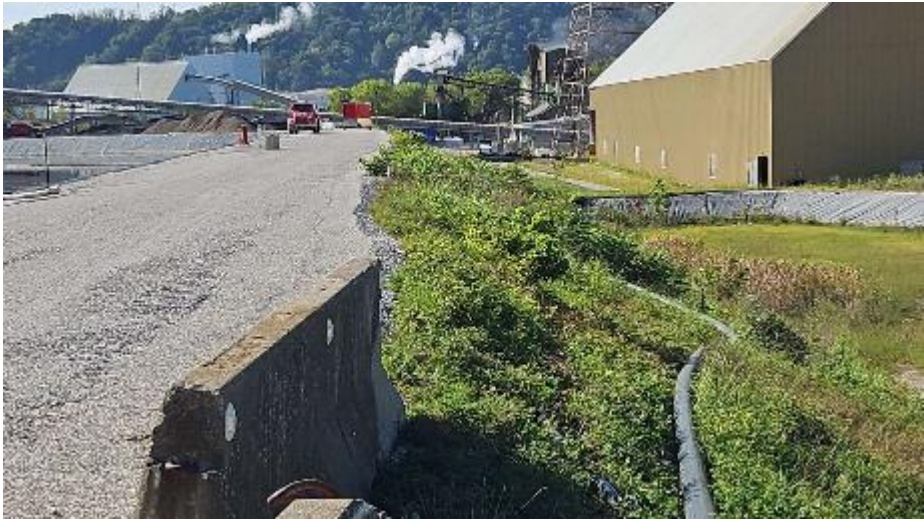
PHOTOGRAPH NO: 7	DATE: September 4, 2024 8:57 AM	LATITUDE: 39.82550773	LONGITUDE: -80.81666012
DIRECTION: 87°		SITE LOCATION: MARSHALL COUNTY, WEST VIRGINIA	
DESCRIPTION: West Bottom Ash Pond. Crest of Dam. Ground Cover, Typical Conditions.

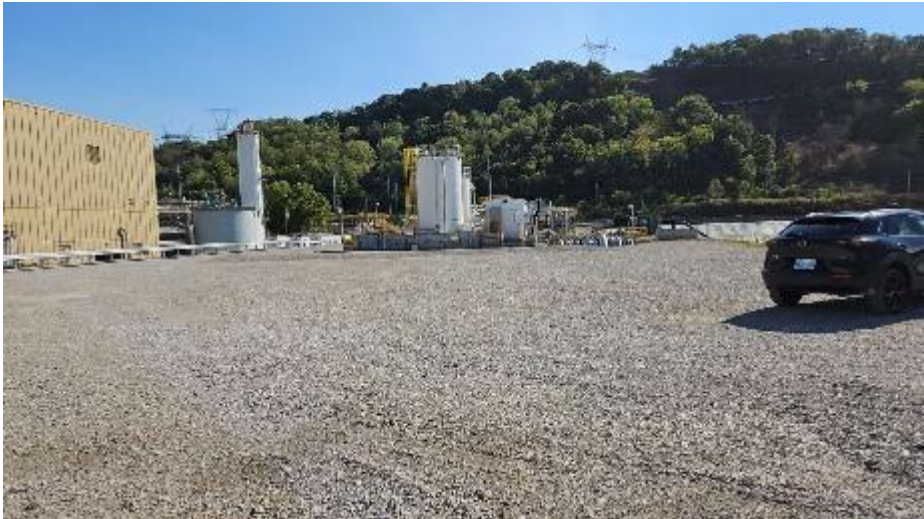
PHOTO BY: GEI CONSULTANTS, INC.			
PHOTOGRAPH NO: 8	DATE: September 4, 2024 8:59 AM	LATITUDE: 39.82565721	LONGITUDE: -80.81668722
DIRECTION: 354°		SITE LOCATION: MARSHALL COUNTY, WEST VIRGINIA	
DESCRIPTION: Crest of Northern Perimeter Dam. Typical Conditions.

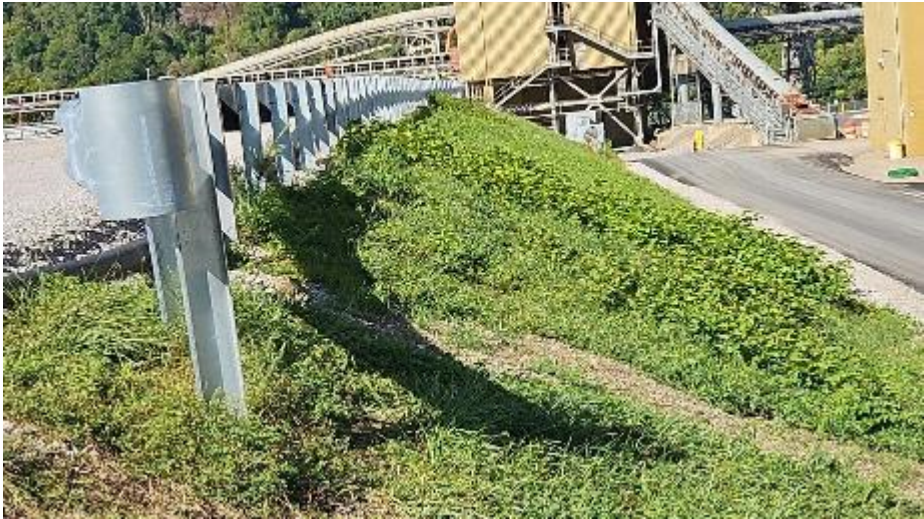
PHOTOGRAPH NO: 9	DATE: September 4, 2024 9:01 AM	LATITUDE: 39.82587134	LONGITUDE: -80.81670748
DIRECTION: 154°	SITE LOCATION: MARSHALL COUNTY, WEST VIRGINIA		
DESCRIPTION: East Bottom Ash Pond. Downstream Slope. General Photo, Typical Conditions.

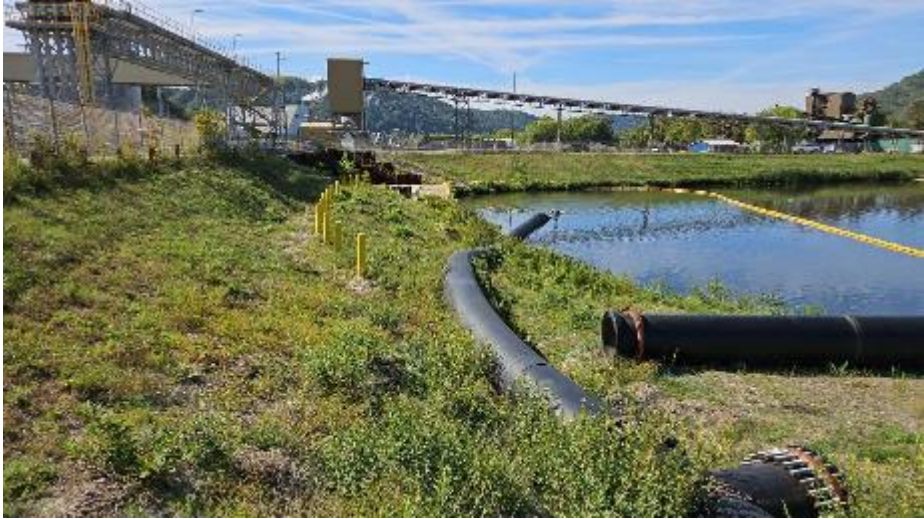
1. The Clear Water Pond was in good condition. The vegetation on the upstream slope was in good condition and maintained to 12-inches or less as shown in Photograph No. 10, No. 12, and No. 13. The Clear Water Pond Crest was paved with gravel and observed in good condition. The Clear Water Pond Outlet/Drainage features were in good condition with no obstructions as shown in Photograph No. 14 and No. 15.

PHOTO BY: GEI CONSULTANTS, INC.			
PHOTOGRAPH NO: 10	DATE: September 4, 2024 9:18 AM	LATITUDE: 39.82416613	LONGITUDE: -80.81427553
DIRECTION: 100°	SITE LOCATION: MARSHALL COUNTY, WEST VIRGINIA		
DESCRIPTION: Clear Water Pond. Upstream Slope. General Photo, Typical Conditions.

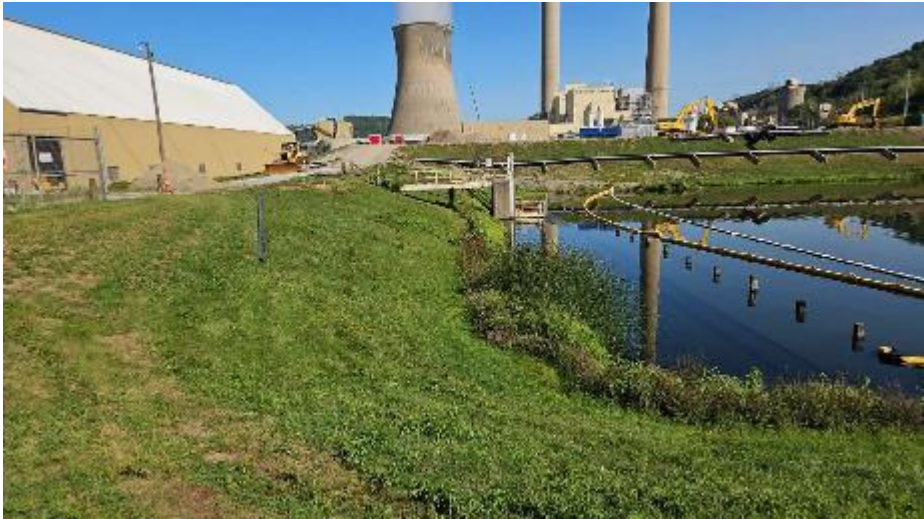
PHOTOGRAPH No: 13	DATE: September 4, 2024 9:35 AM	LATITUDE: 39.823015	LONGITUDE: -80.81549148
DIRECTION: 263°		SITE LOCATION: MARSHALL COUNTY, WEST VIRGINIA	
DESCRIPTION: Clear Water Pond. Upstream Slope. Ground Cover, Typical Conditions.

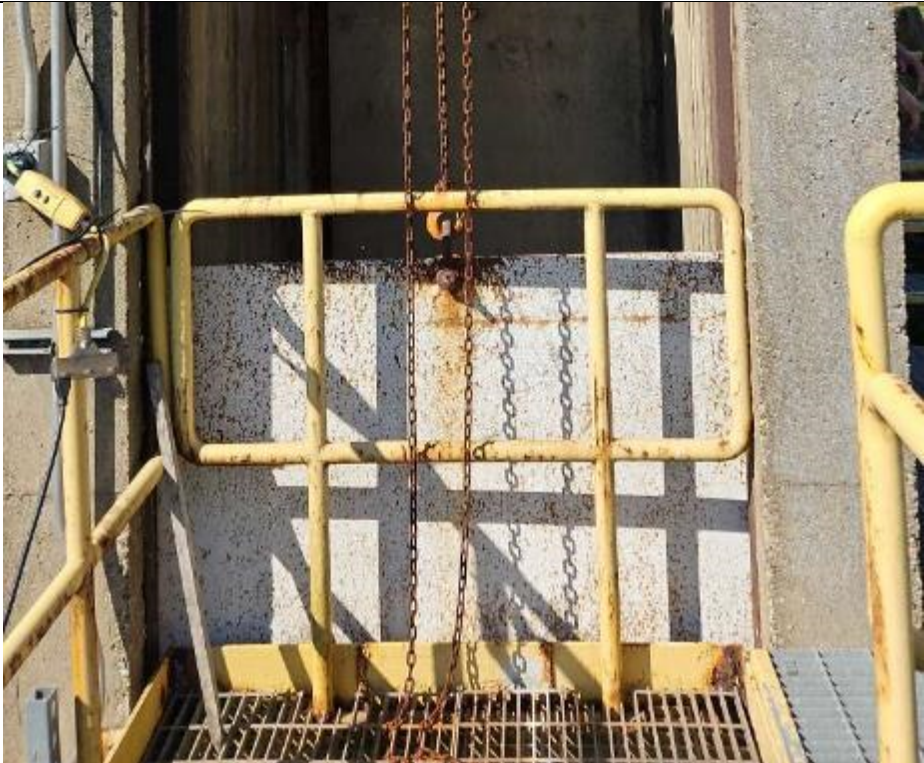
PHOTO BY: GEI CONSULTANTS, INC.			
PHOTOGRAPH No: 14	DATE: September 4, 2024 9:39 AM	LATITUDE: 39.82346205	LONGITUDE: -80.81554678
DIRECTION: 11°		SITE LOCATION: MARSHALL COUNTY, WEST VIRGINIA	
DESCRIPTION: Clear Water Pond. Decant Structure / Control Mechanism. Water Elevation ~ 662.0

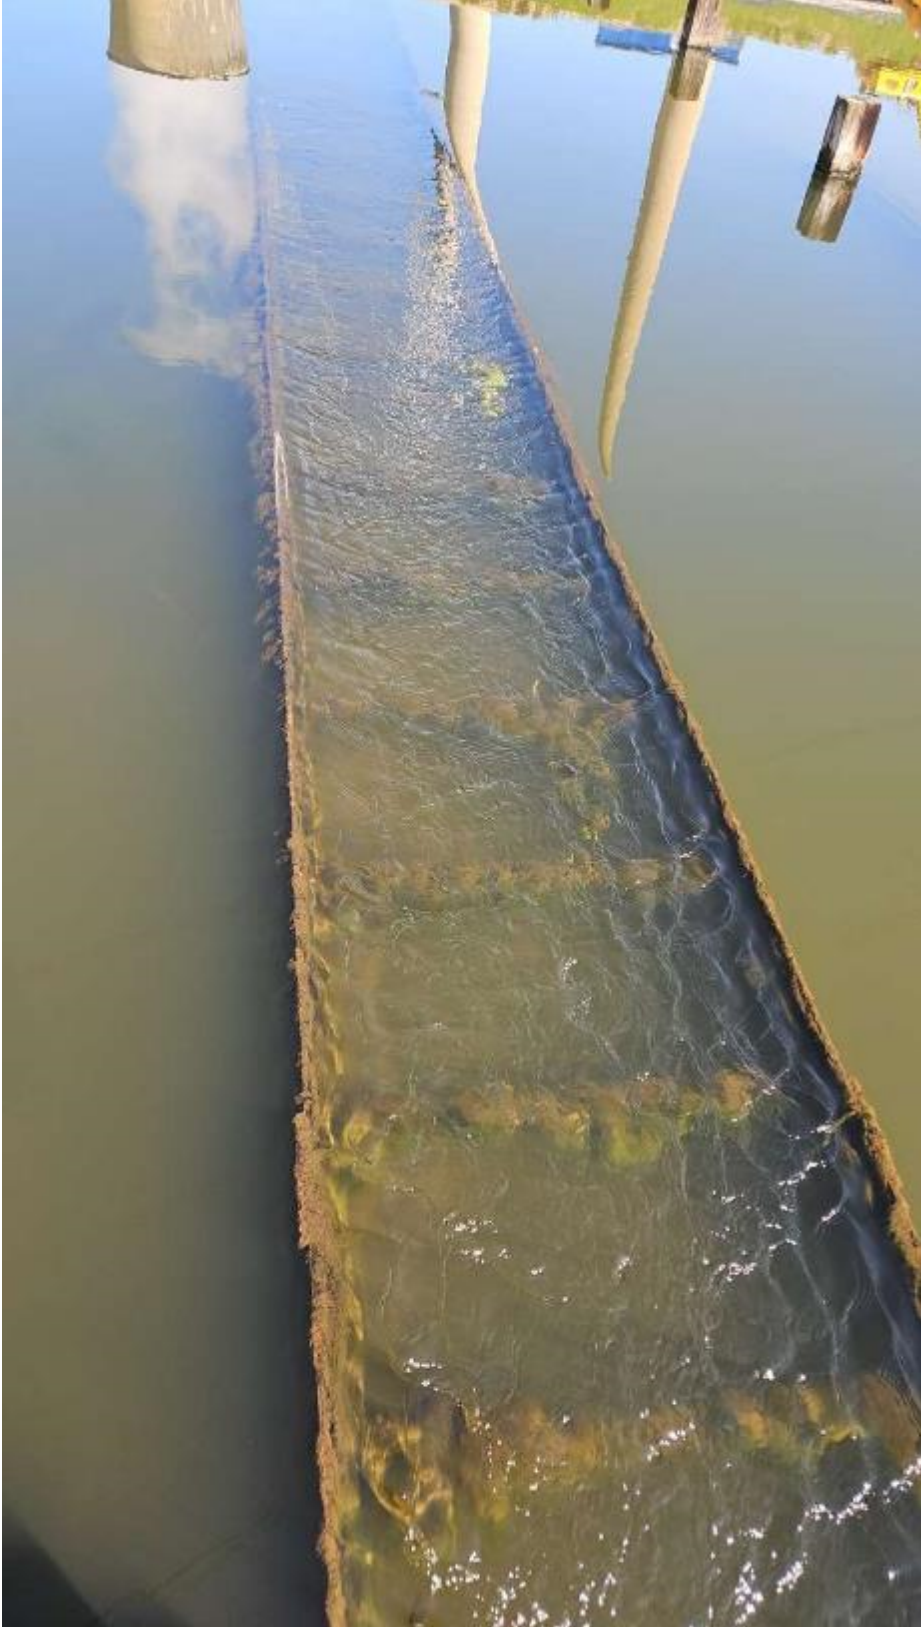
PHOTOGRAPH No: 15	DATE: September 4, 2024 9:42 AM	LATITUDE: 39.82346754	LONGITUDE: -80.81555916
DIRECTION: 30°		SITE LOCATION: MARSHALL COUNTY, WEST VIRGINIA	
DESCRIPTION: Clear Water Pond. Outlet Structure. General Photo. Typical conditions

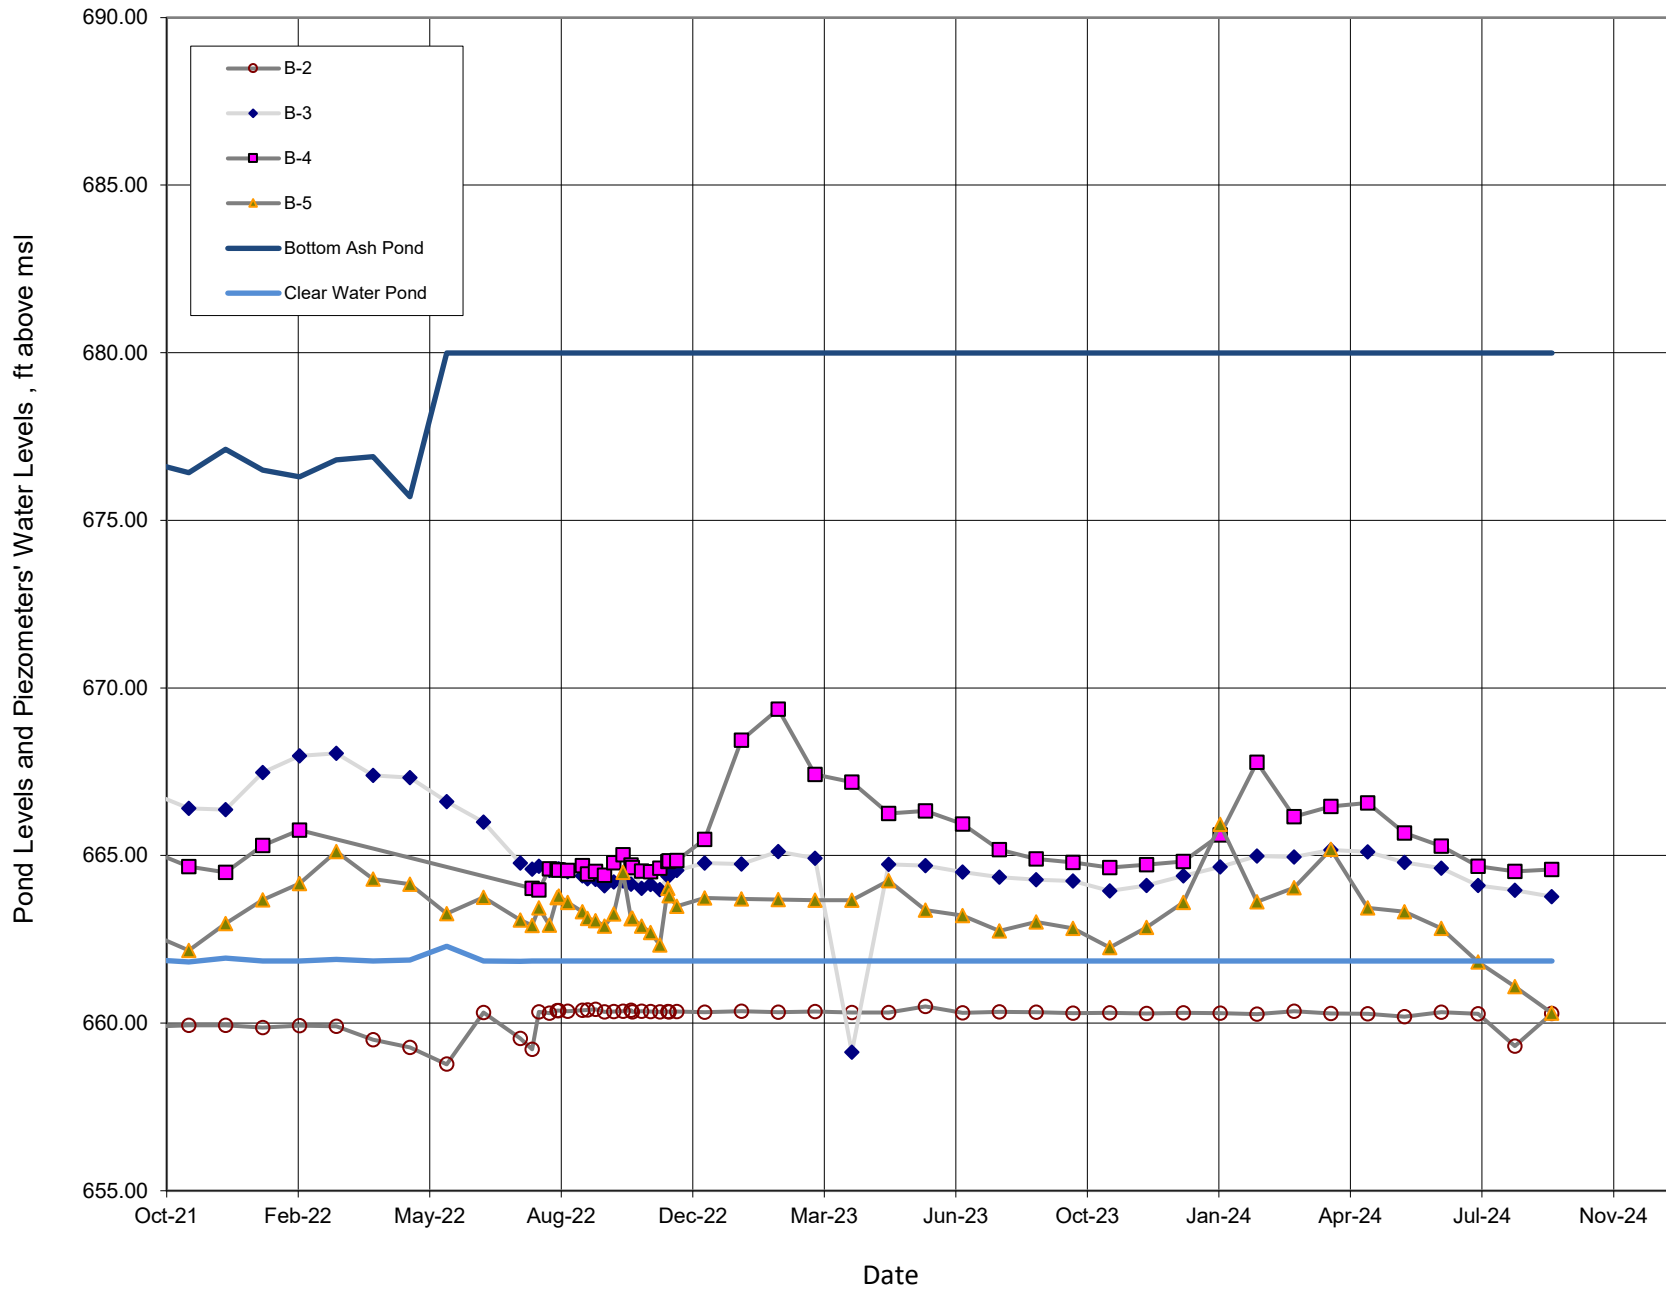
Mitchell Bottom Ash Pond Complex Piezometers & Ponds Level

Four standpipe piezometers exist around the Bottom Ash Complex as shown on Figure 3. Regular readings are recorded for each piezometer at a minimum 30-day interval. The piezometer readings exhibited minor fluctuations month to month during 2024 but were 0.1 to 1.7 feet higher than elevations record in 2023 – which can be attributed to the temporary conditions that were presented as the ponds were being modified. A graph of the piezometer readings is provided in Appendix B – Instrumentation Data.

Piezometer	Max Groundwater Elevation 2023	Max Groundwater Elevation 2024	Difference (feet)
B-2	660.5	660.4	0.1
B-3	665.1	665.2	0.1
B-4	669.4	667.8	1.6
B-5	664.2	665.9	1.7
