Closure Completion Notification for Closure by Removal

Mountaineer Plant

Bottom Ash Pond Complex

AEP Mountaineer Plant Bottom Ash Complex

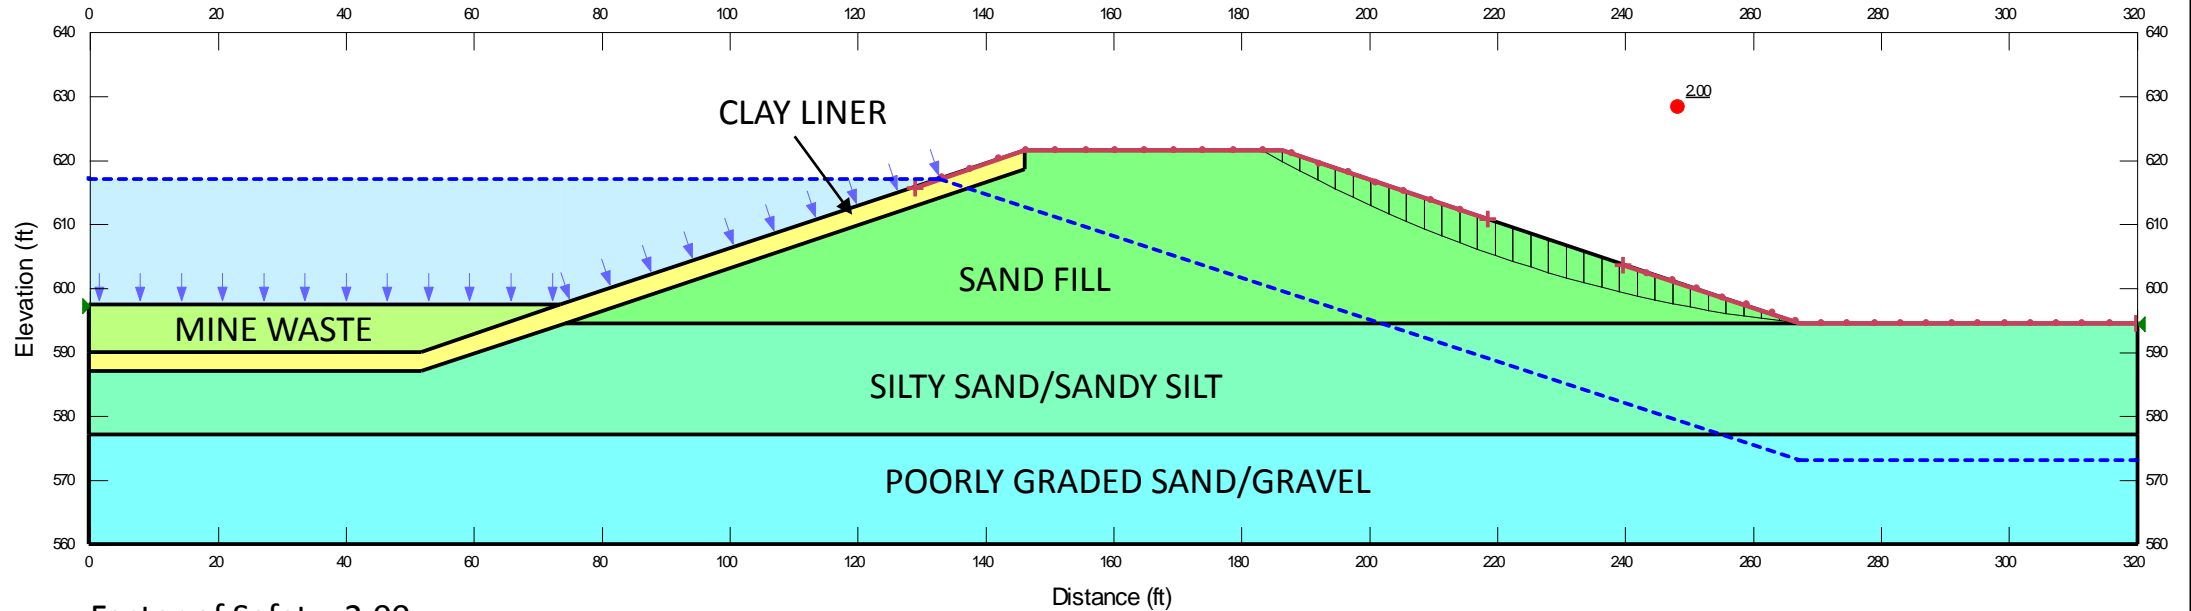
STORAGE POOL: DOWNSTREAM

Factor of Safety: 2.00

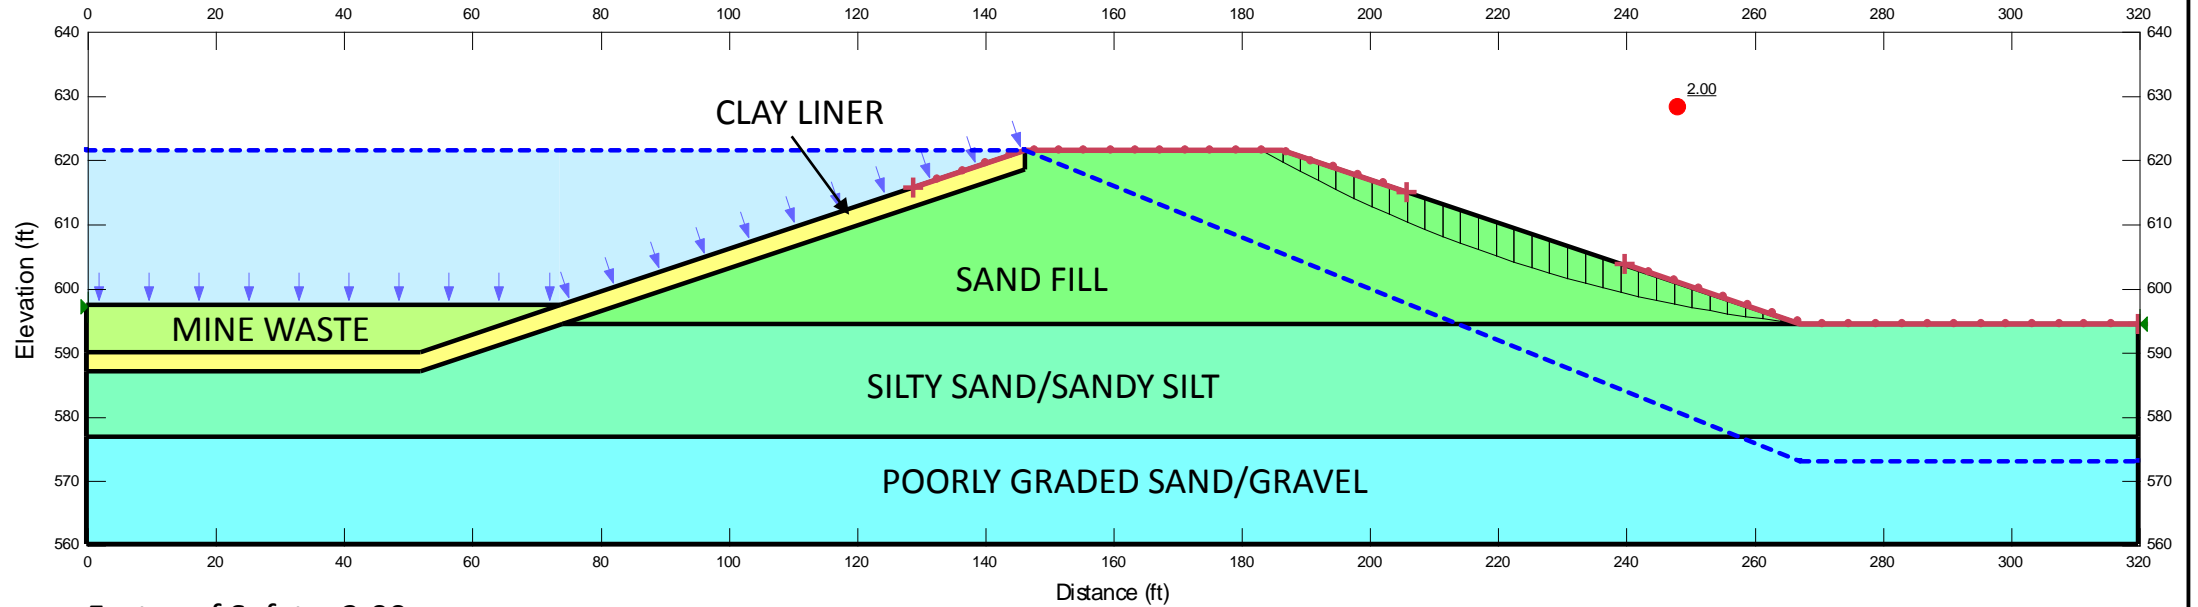
SURCHARGE POOL: DOWNSTREAM

Factor of Safety: 2.00

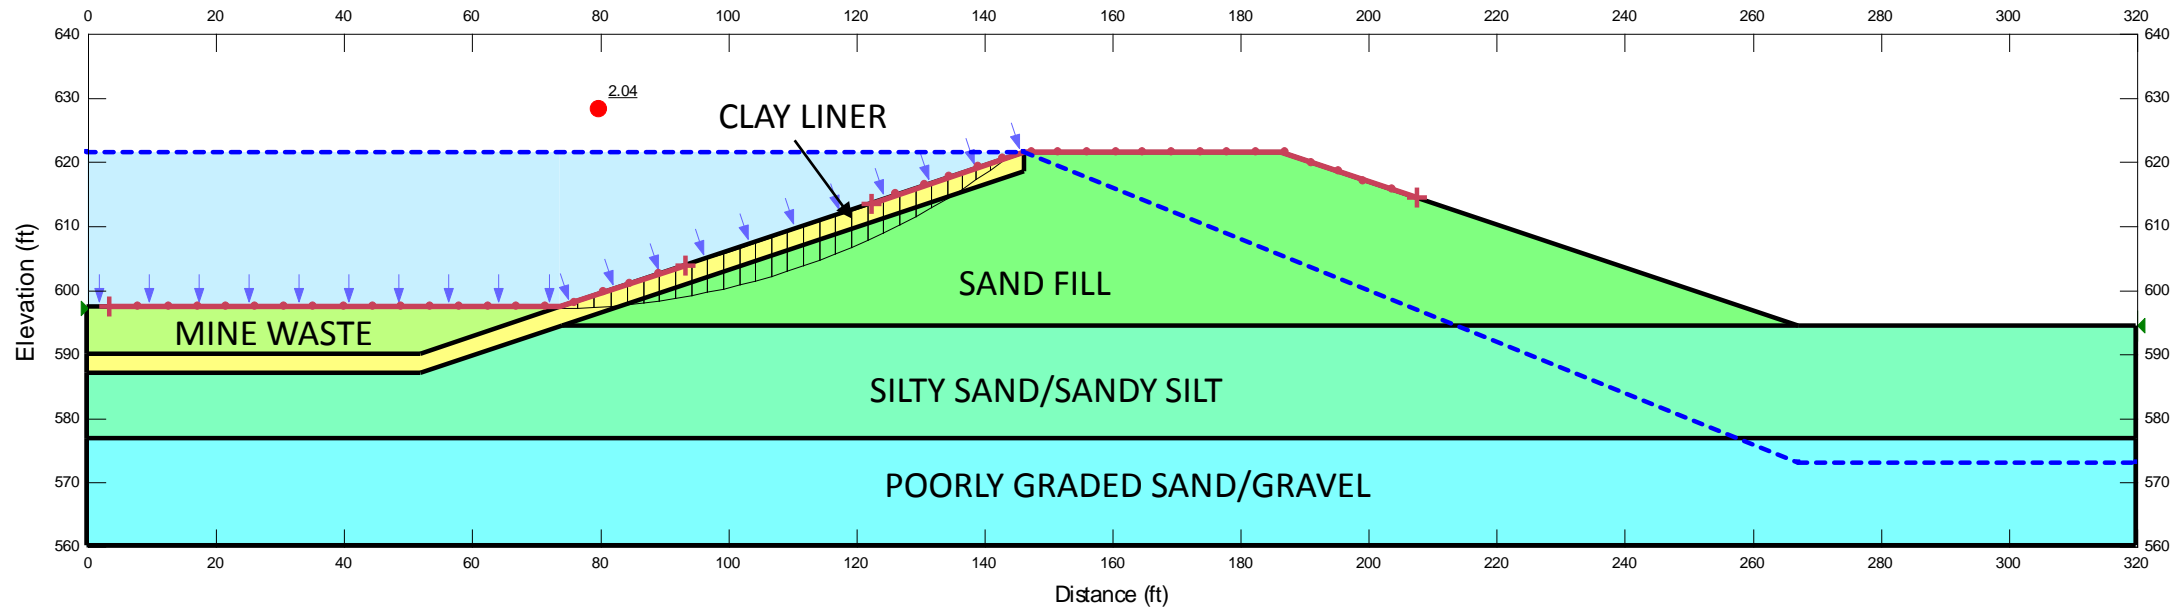
SURCHARGE POOL: UPSTREAM

Factor of Safety: 2.04

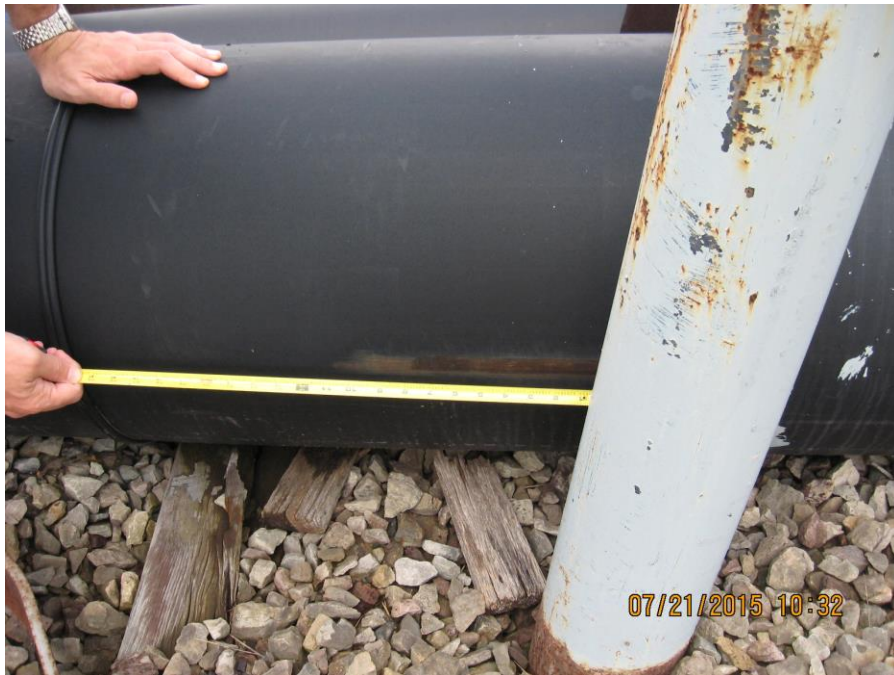
Photo 9: Bottom Ash Ponds: evidence of movement along bottom ash inlet pipes due to thermal expansion.

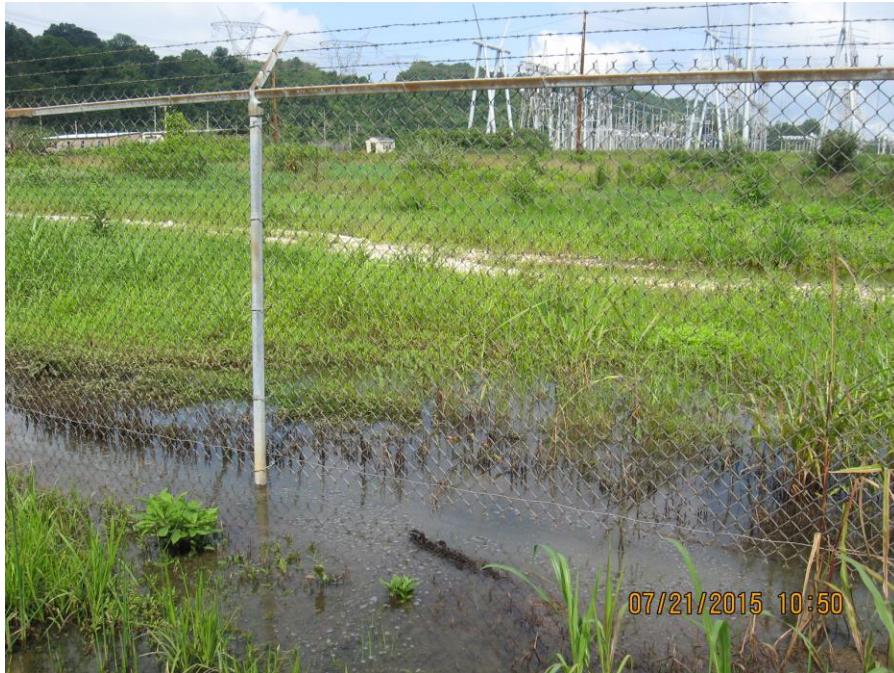
Photo 17: Bottom Ash Ponds, north dike: water near the exterior toe.

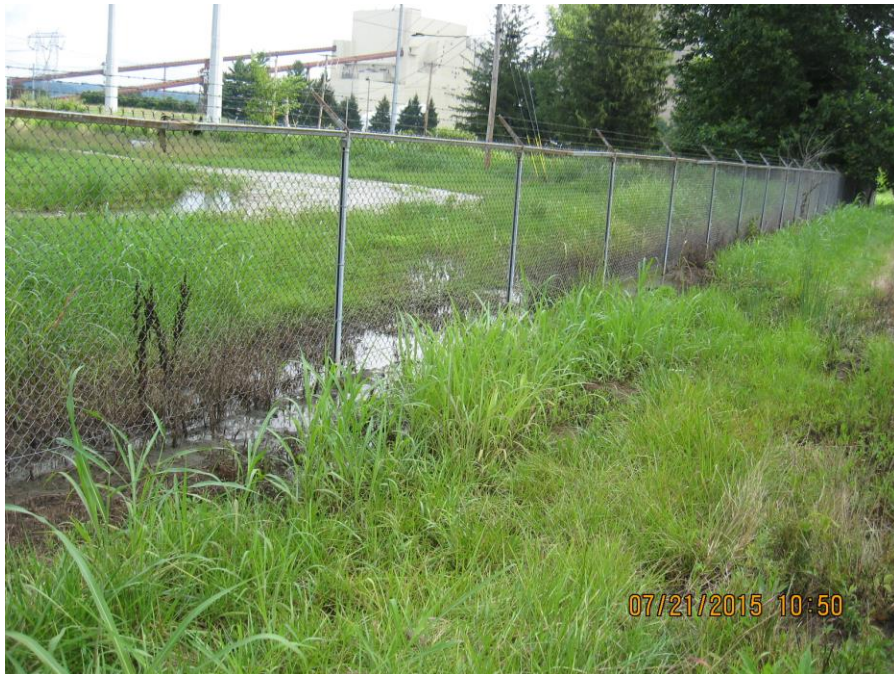
Photo 18: Bottom Ash Ponds, north dike: water near the exterior toe.

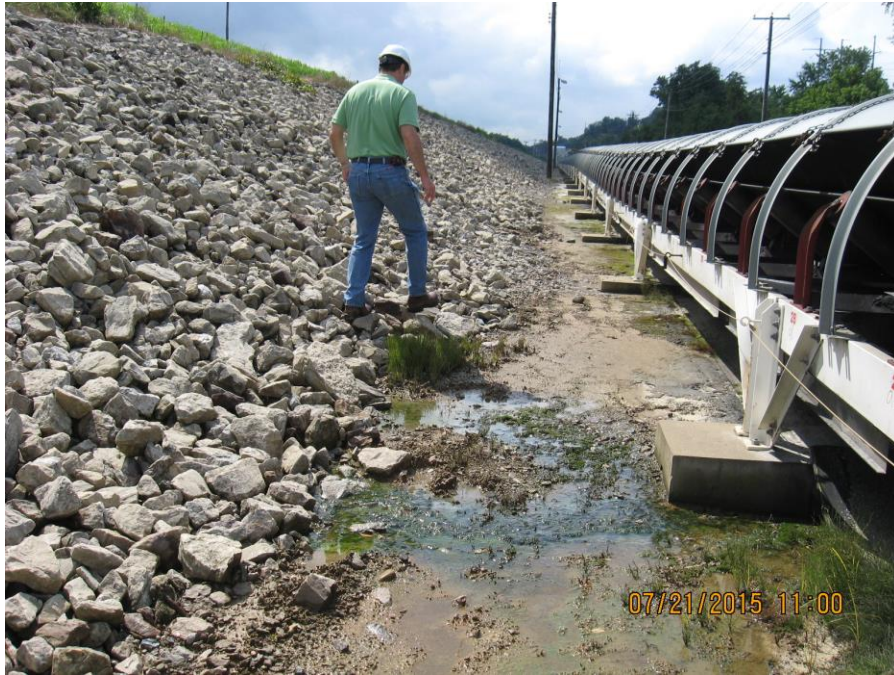
Photo 23: West Bottom Ash Pond, west dike: water near the exterior toe.

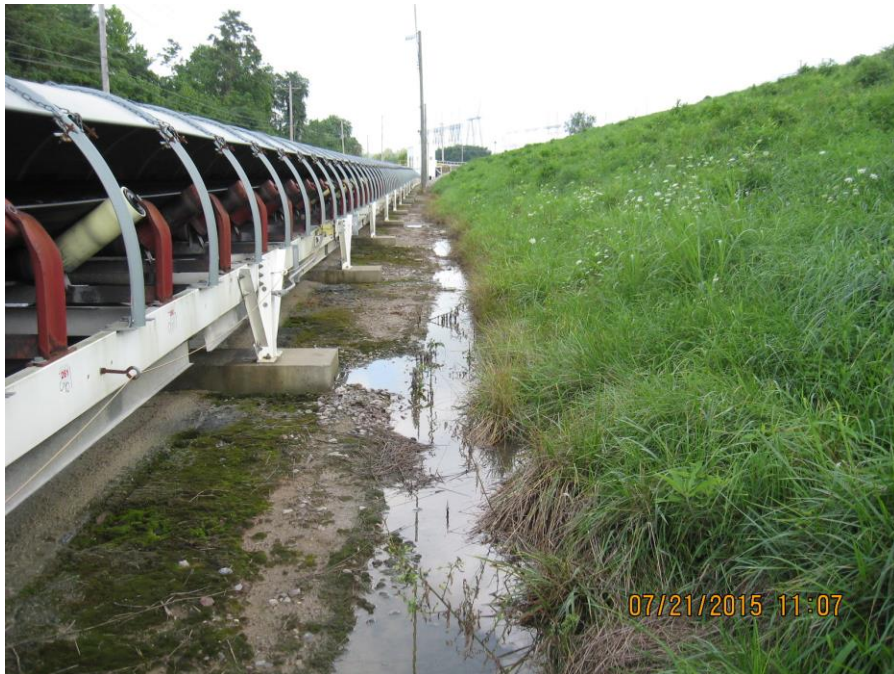
Photo 24: West Bottom Ash Pond, west dike: water near the exterior toe.

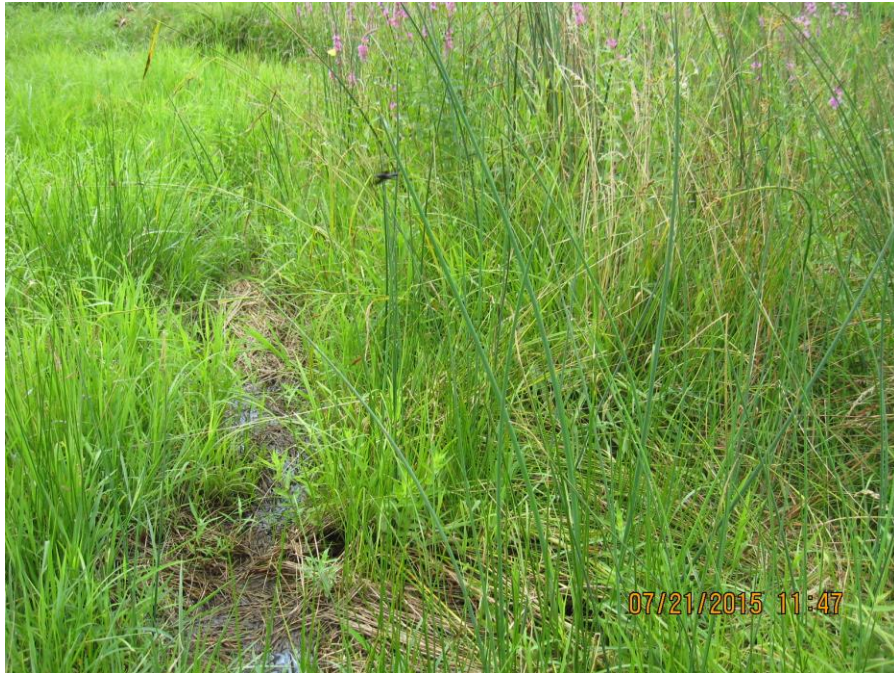
Photo 47: East Wastewater Pond, east dike: water along exterior toe.
