2025 First Annual Dam and Dike Inspection Report

Bottom Ash Pond Complex

**Kanawha River Plant
Appalachian Power Company
Glasgow, Ohio**

August 2025

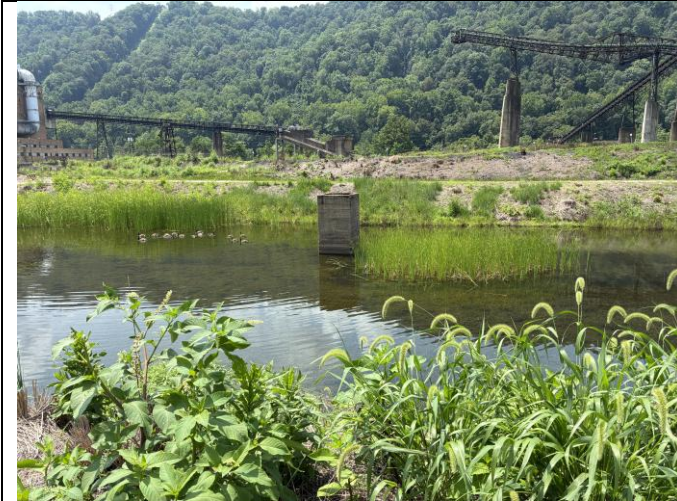
Photograph 1:

North Bottom Ash
Pond – Concrete
Riser to Storm Sewer

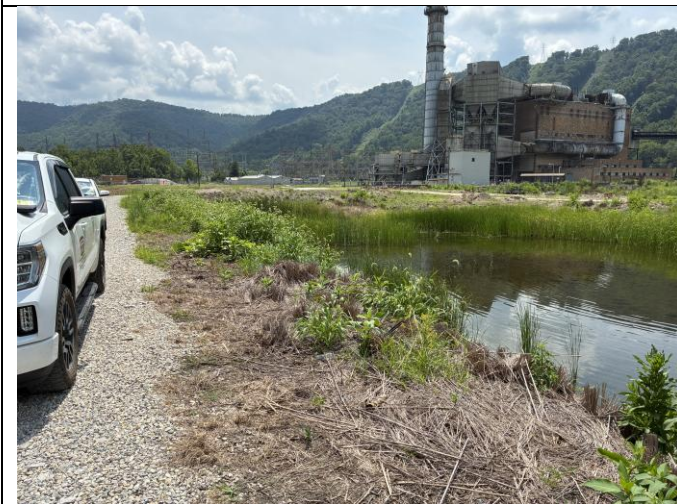
Photograph 2:

North Bottom Ash
Pond – Inlet end
looking towards idle
plant.

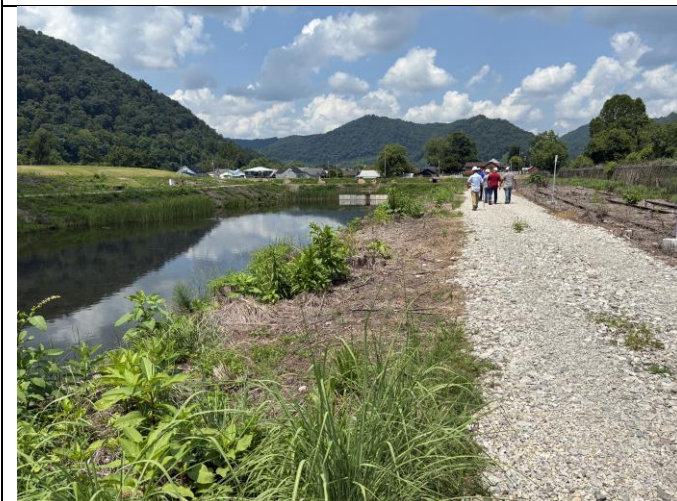
Photograph 3:

North Bottom Ash Pond –
Looking towards outlet
spillway.

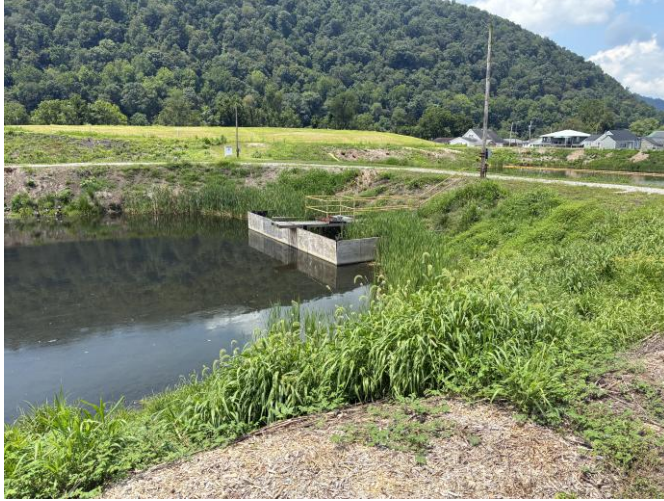
Photograph 4:

North Bottom Ash Pond –
Outlet Spillway.

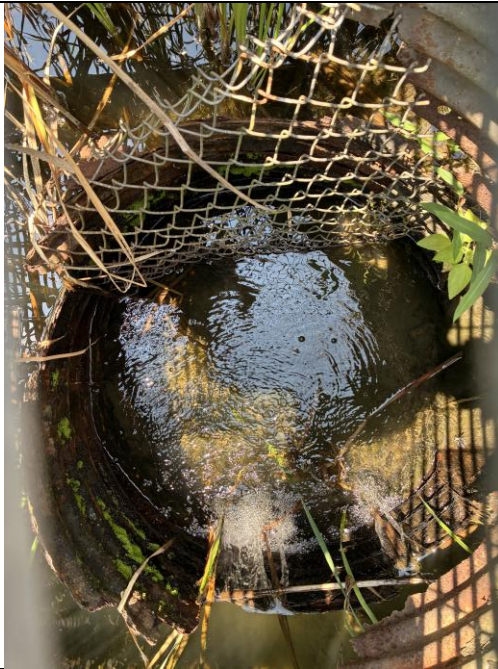
Photograph 5:

North Bottom Ash Pond –
Outlet Spillway Riser.

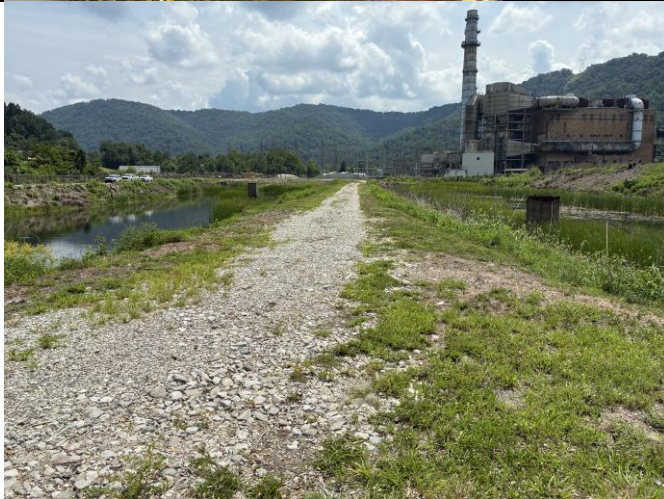
Photograph 6:

North and South Bottom
Ash Pond Splitter Dike.

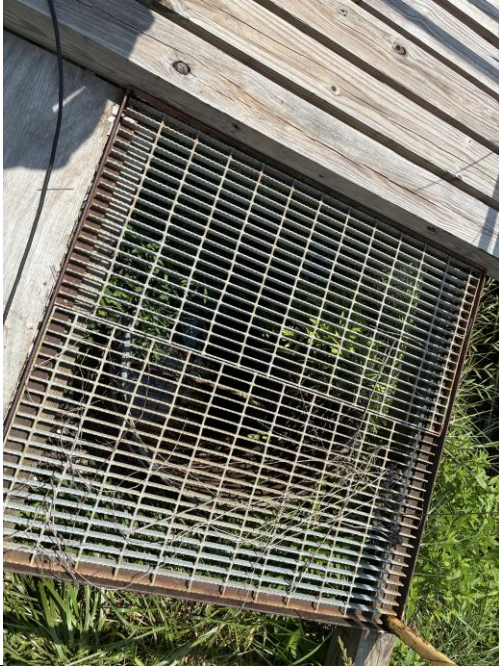
Photograph 7:

South Bottom Ash Pond
Spillway Riser.

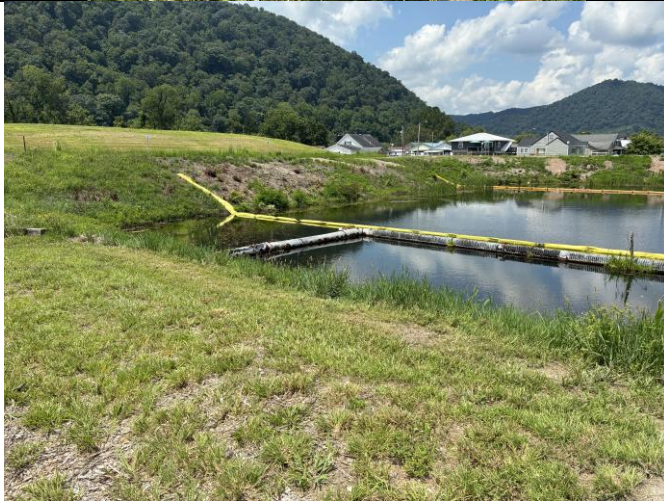
Photograph 8:

Clearwater Pond –
Distribution Weir.

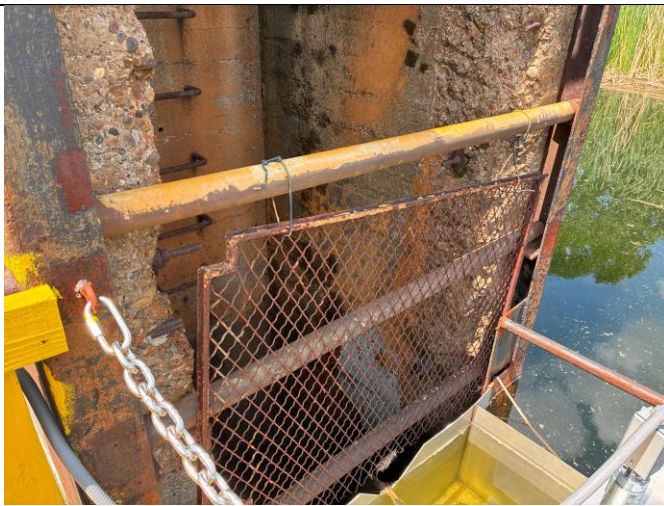
Photograph 9:

3. The primary discharge structure was in good condition. There was some minor concrete deterioration on the face from previous bolting. The discharge is permitted as NPDES Permit No. WV 0001066 Outfall 001.
4. The discharge structure connects to a stormwater pipe that runs under the BAP. It is recommended to have this visually inspected via robotic camera to determine if there are any issues which could affect the BAP.

Clearwater Pond – Outlet
Riser

- 1) Monitor the concrete on the clearwater pond discharge structure for any further deterioration.
- 2) Investigate the stormwater pipes running under the BAP to determine if their condition could impact the BAP.

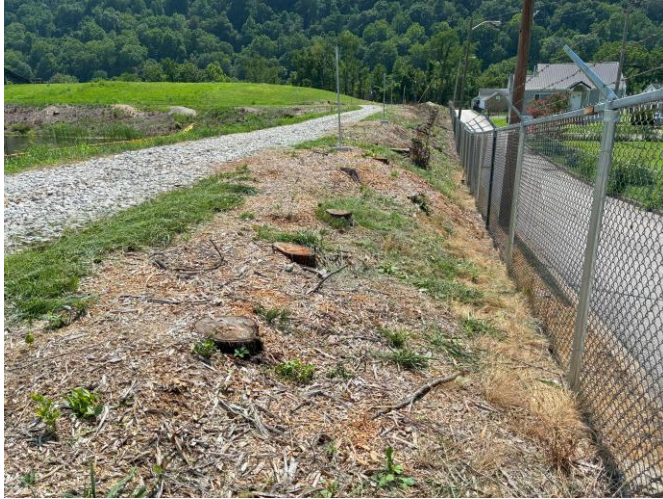
Photograph 10:

1. The interior and exterior slopes showed no signs of distress such as sloughing, bulges or erosion. The interior slopes are growing vegetation that is being regularly maintained. Vegetation is over 6" high, but is scheduled for weed eating in the fall.
2. The western dike had trees removed on the exterior slope, and showed no signs of seepage.

Clearwater Pond - Dike

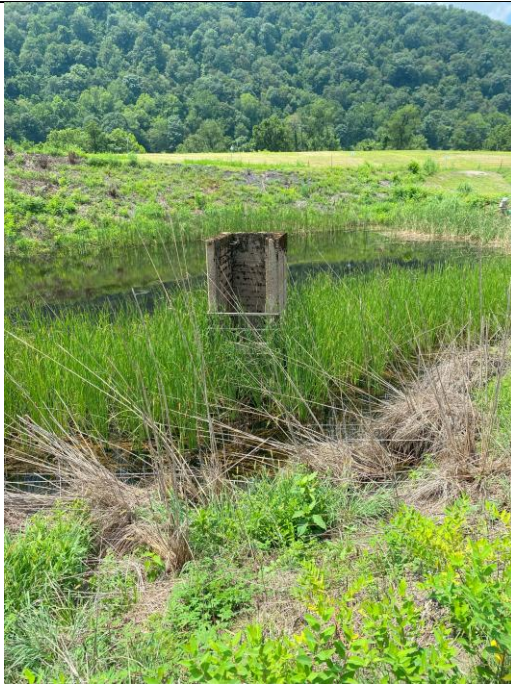
Photograph 11:

South Bottom Ash Pond –
Concrete Riser to Storm
Sewer.
