2025 Annual Landfill Inspection Report

Amos FGD Landfill

John E. Amos Plant
Appalachian Power Company
Putnam County, West Virginia

Inspection Date: November 12, 2025

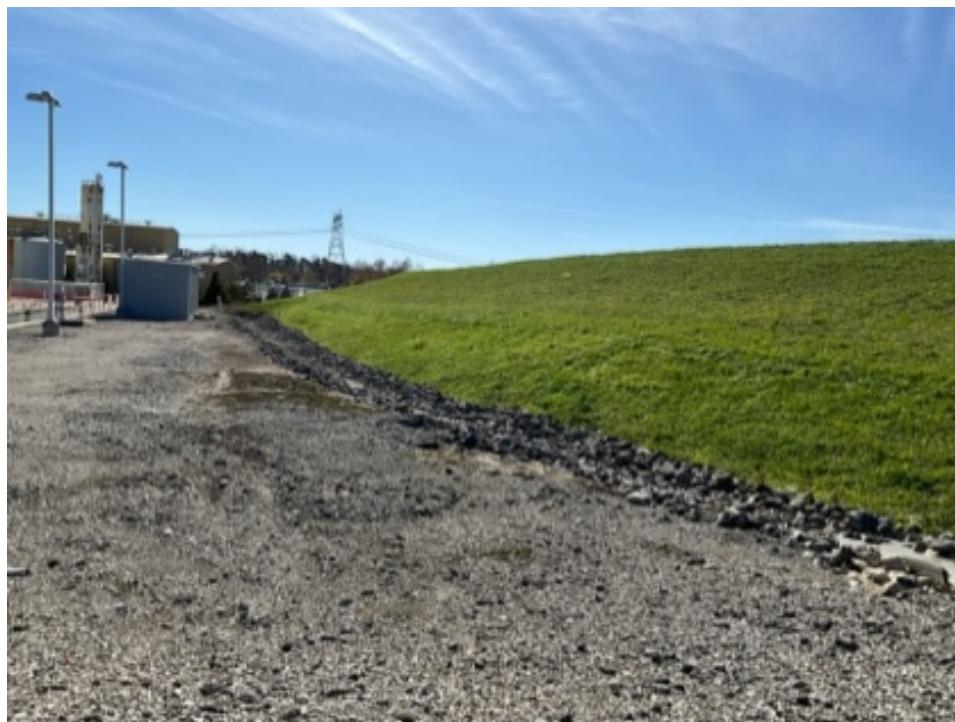
1. The Final Cover Vegetation on the east slope of the South Valley fill area (Sequence 1 & 2) appeared to be in good condition (Photograph #1).
2. The temporary armoring and erosion controls on the Slope Drain (SD-1) on the east slope appeared in fair condition (Photograph #2).

General condition of final cover along toe on east side landfill. Looking south

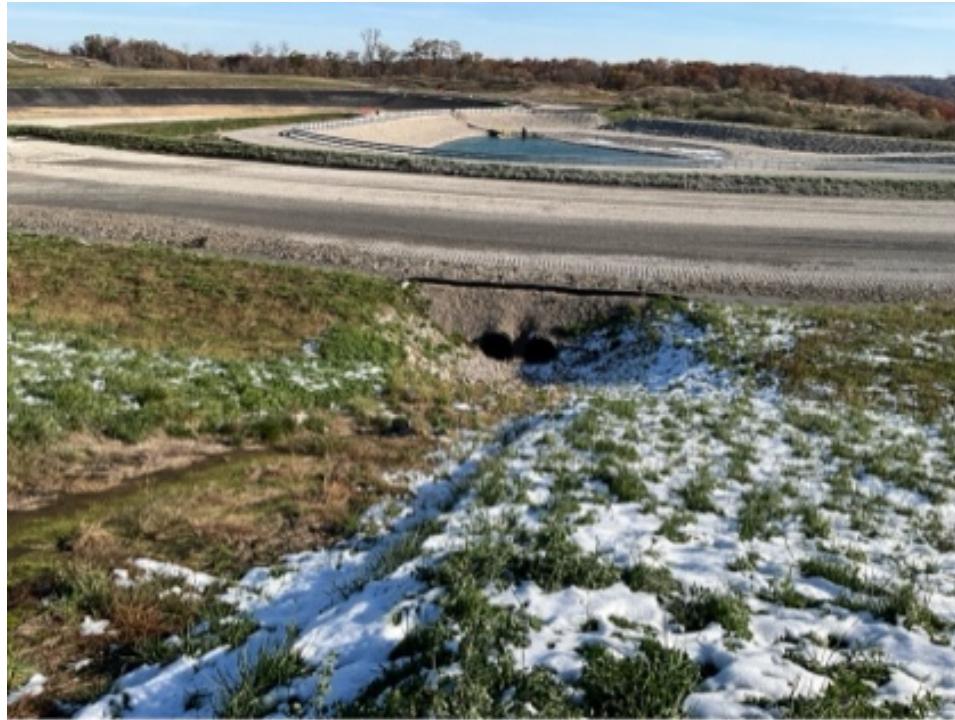
2

General condition slope drain (SD-1) on temporary cover draining to double culverts under haul road.

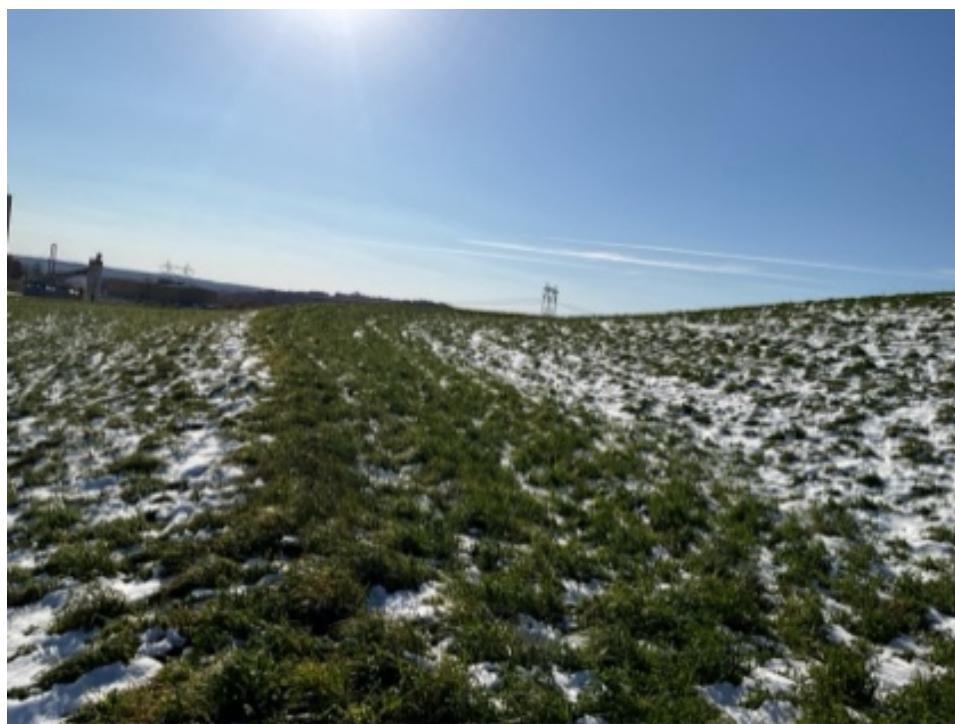
3

3. The temporary cover vegetation on the east slope of the South Valley was visually in good condition (Photograph #3) and areas that were recently seeded had adequate erosion and sediment controls to minimize erosion while vegetation is established (Photograph #4).

General condition of cover soil on bench and slope on east side of landfill looking south

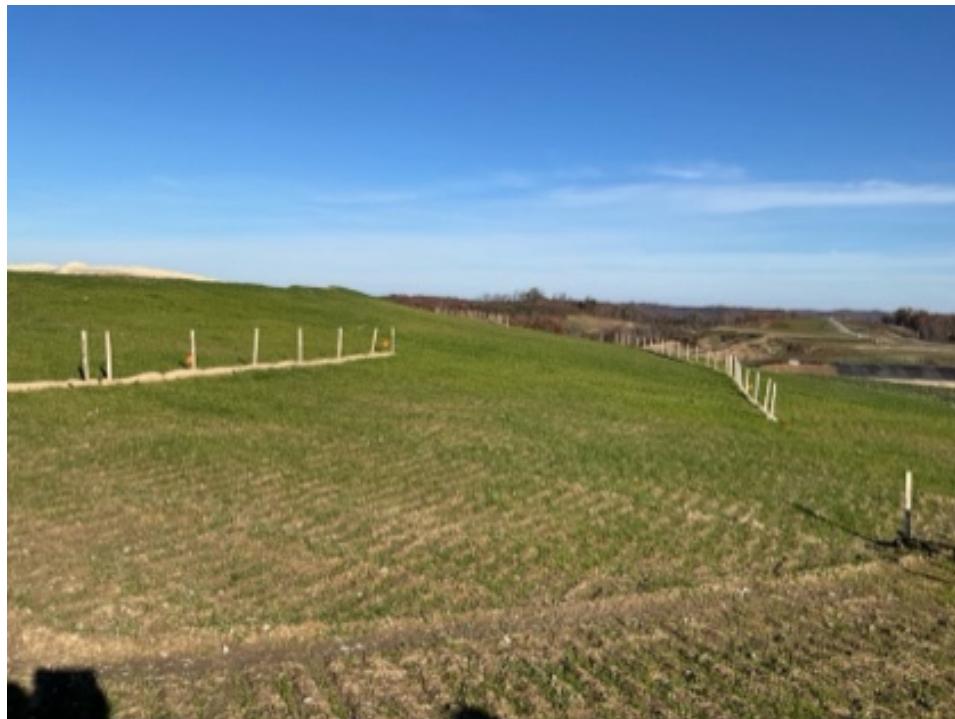
4

General condition of recently seeded temporary cover on east side of landfill looking north

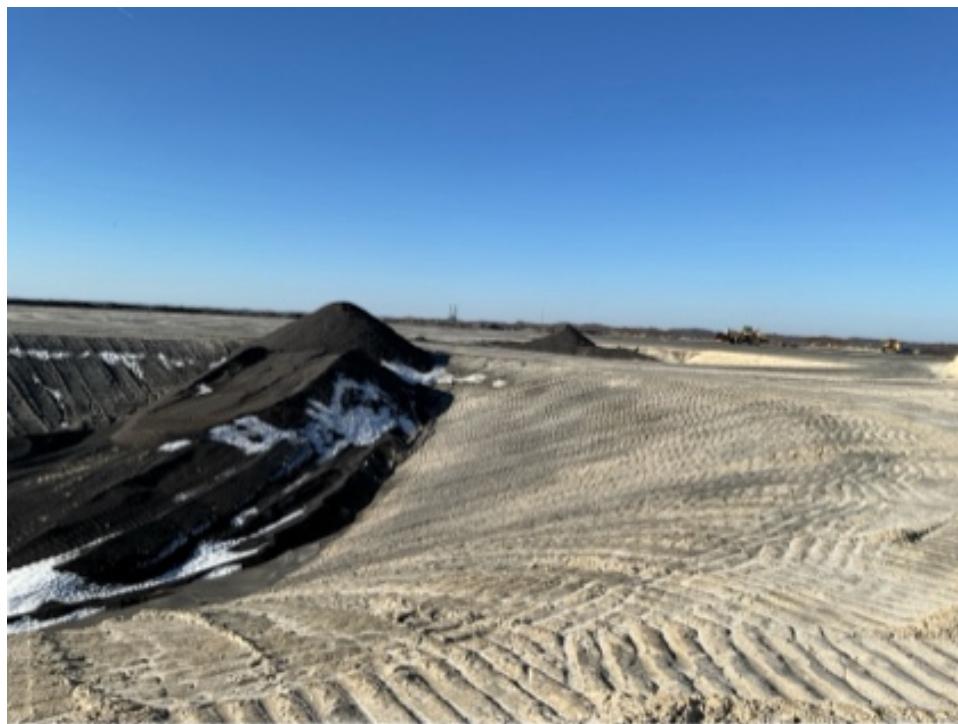
5

4. The active area at the top of the South Valley fill appeared in good condition with the waste well compacted and graded to drain to the Chimney drains which showed no signs of standing water (Photograph #5).

General condition of working face in South Valley area looking west

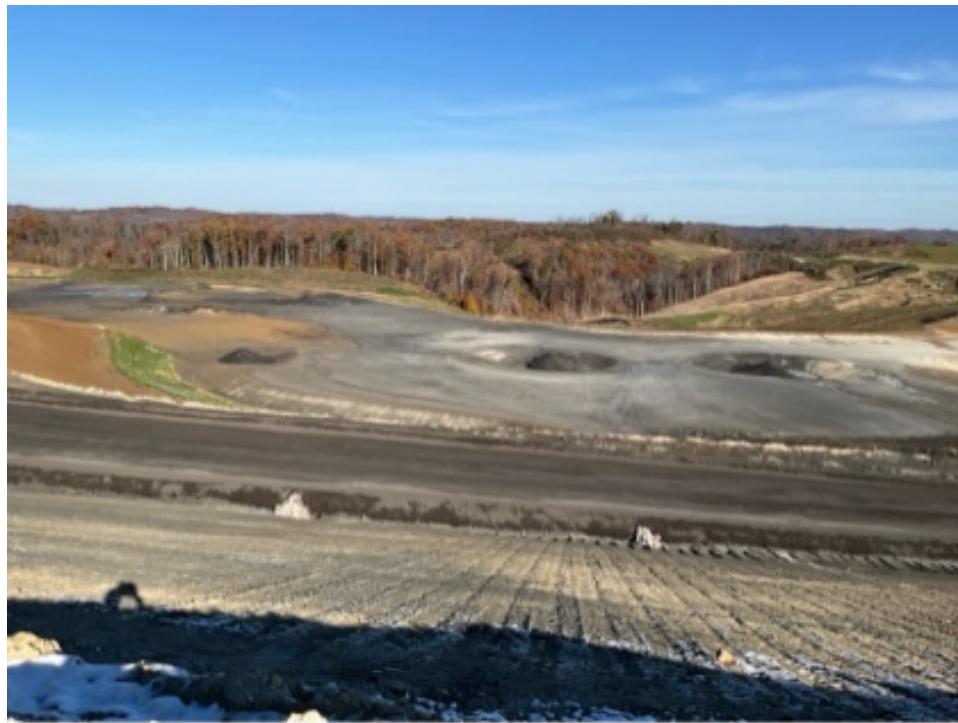
6

5. The interim slope between the South Valley fill (Sequence 1 & 2) and the North Valley fill (Sequence 4) appear to be in good condition with material tracked in to minimize erosion, interim soil cover in place (Photograph #6).

General condition of interim slope from South Valley to Sequence 4 working face. Looking north.

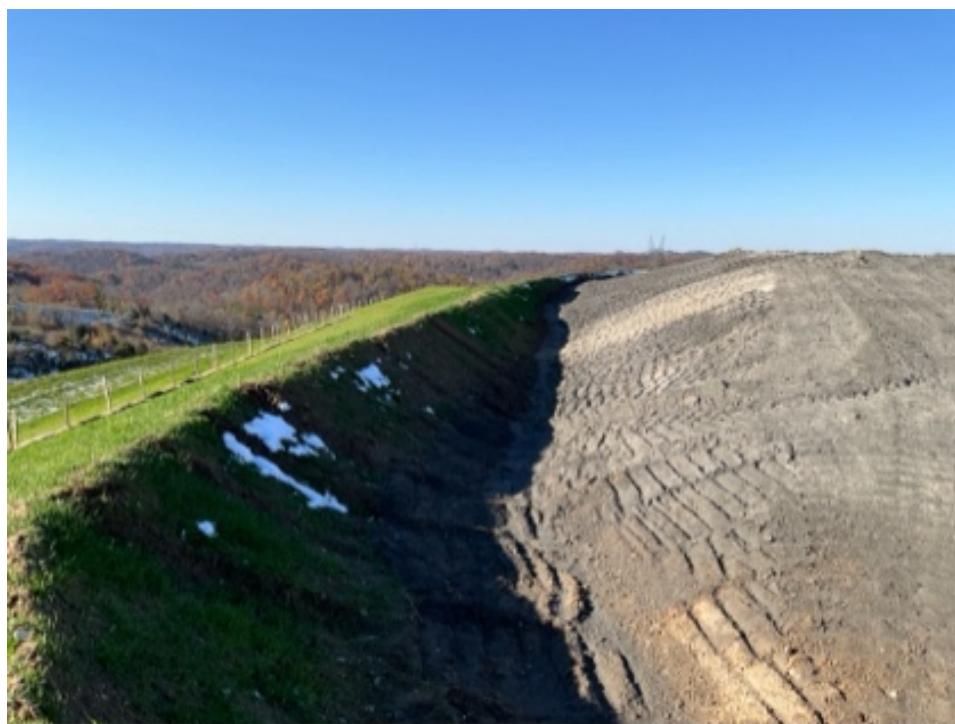
7

6. The transition from the active fill to the temporary cover appeared good condition with the waste surface compacted and tracked in and the temporary cover soil creating drainage channel to convey stormwater (Photograph #7).

General condition of edge of temporary cover with placed CCR forming stormwater control channel

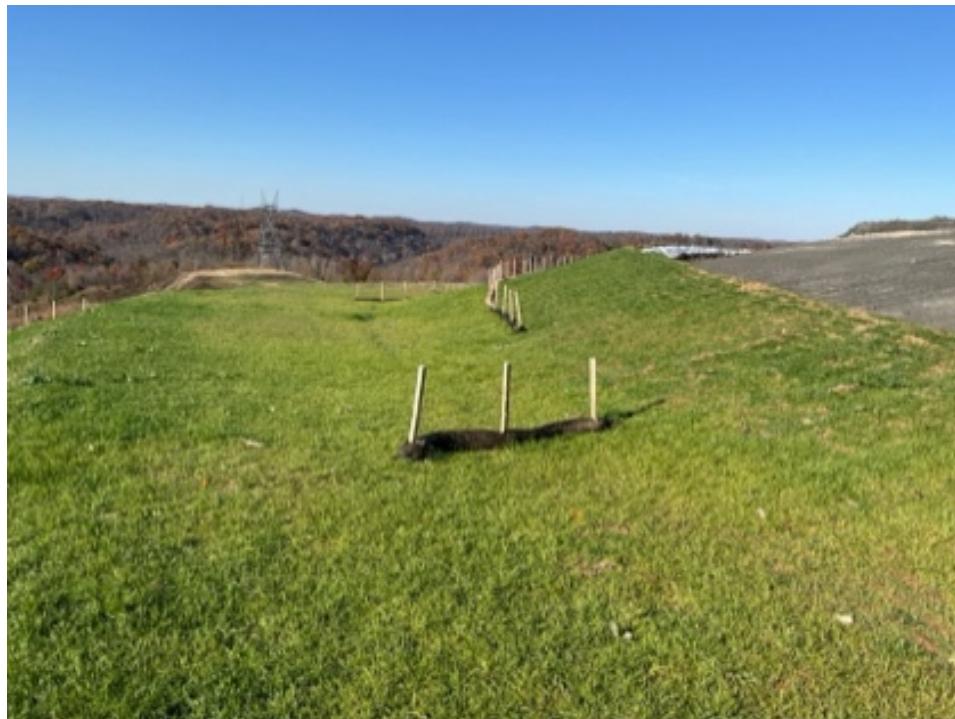
8

7. The erosion and sediment controls to minimize erosion in areas that were recently seeded appeared adequate while vegetation is established for temporary cover on the south slope of the South Valley (Photograph #8).

General condition of bench on temporary cover looking west.

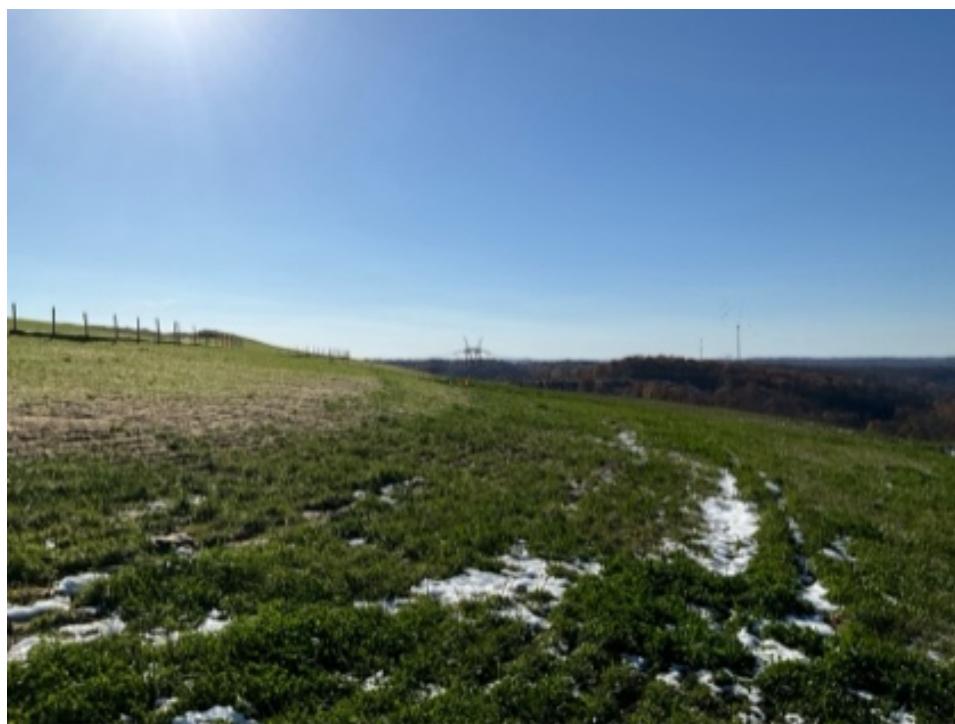
9

8. The vegetative cover on the temporary cover on the west slope of the South Valley appeared in good condition (Photographs #9 & #11).
9. The Slope Drain (SD-3) at the southwest corner of the South Valley has temporary vegetation and armoring for erosion controls were visually in fair condition (Photograph #10).

General condition of temporary cover with established vegetation to the right and recent seeding to the left

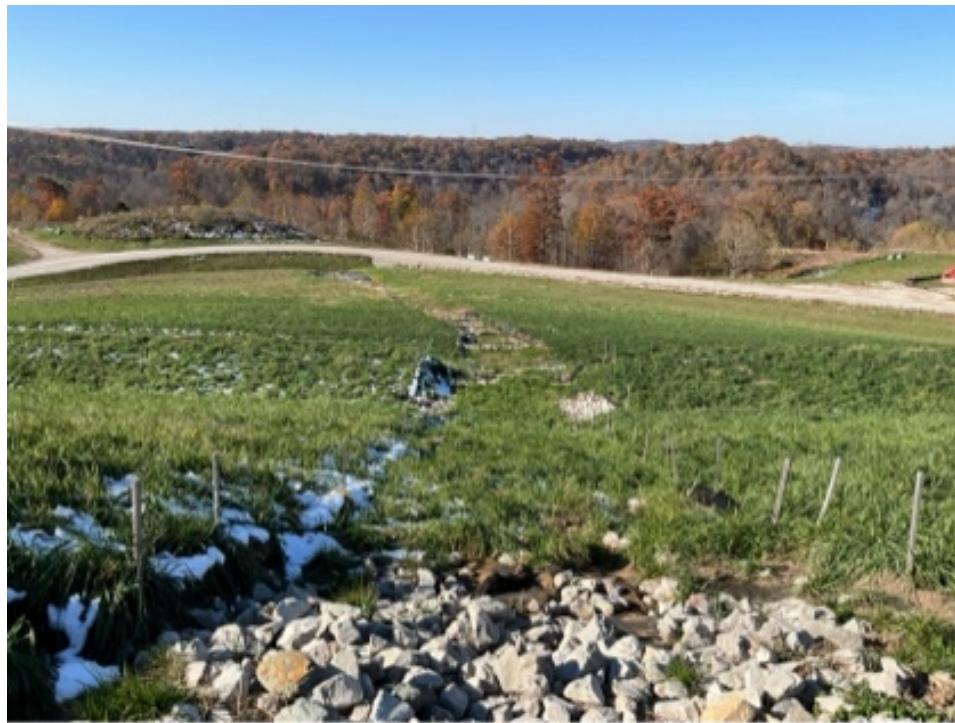
10

General condition slope drain (SD-3) on temporary cover draining west side.

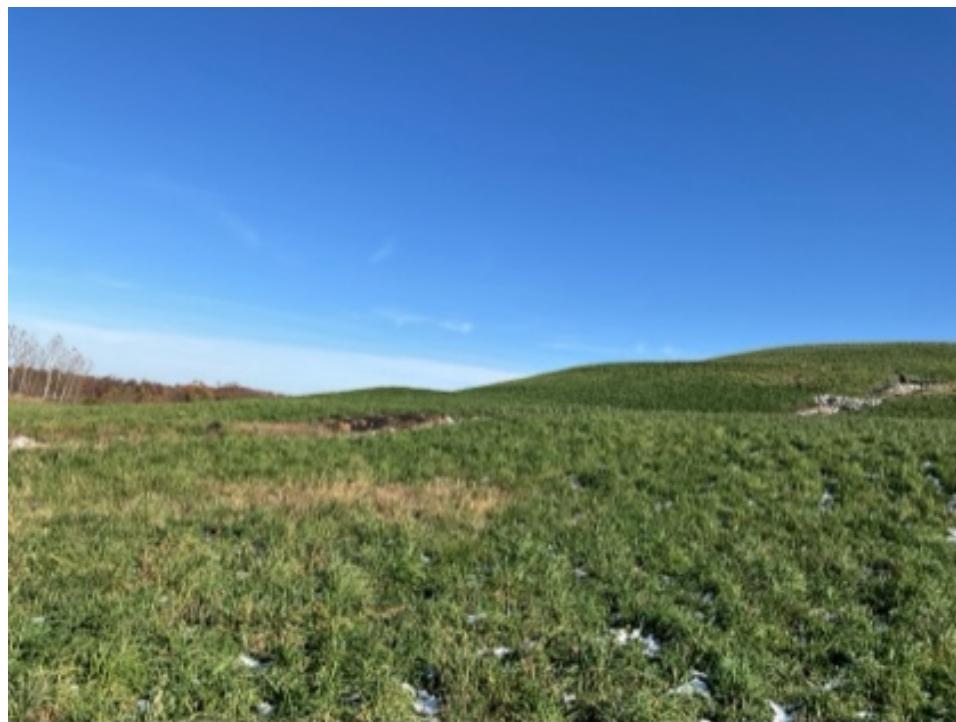
Photo #: 11

General condition of temporary cover soil in South Valley looking north.

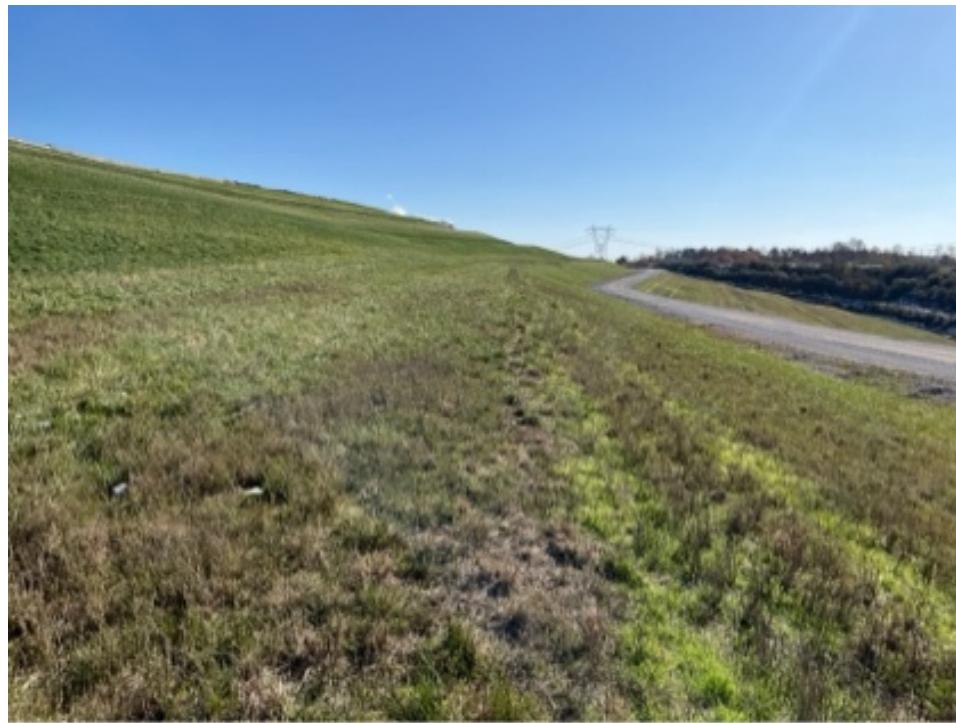
Photo #: 12

10. The vegetation on the final cover above the access road on the south slope appeared in good condition (Photograph #12).
11. The access road along the south slope appeared well graded and maintained as part of the final cover system (Photograph #13).

General condition of vegetation on area with final cover. Looking southeast.

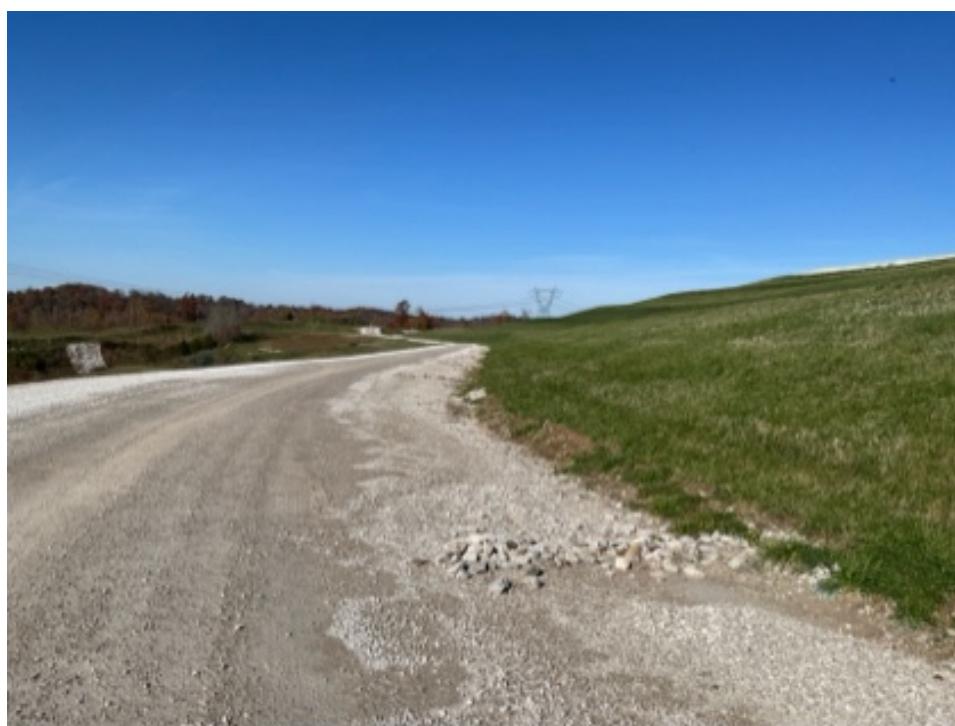
Photo #: 13

Notes: General condition of vegetation and roadway with final cover. Looking northwest.

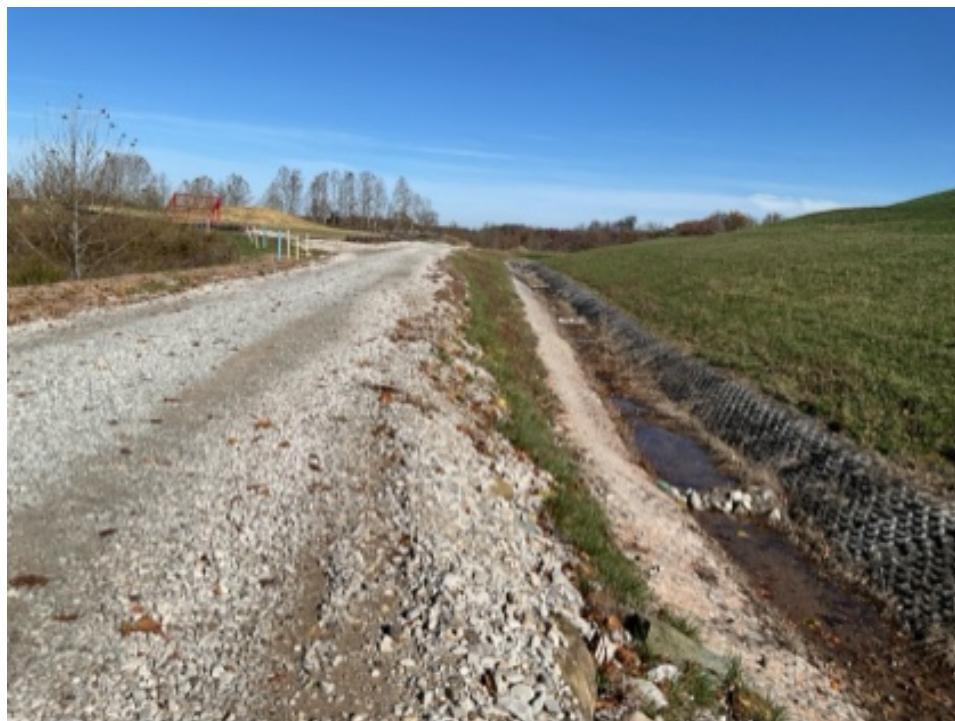
Photo #: 14

12. The access roads and perimeter drainage channels appeared in satisfactory condition (Photograph #14)
13. The final cover in the South Valley (Sequence 3) is well vegetated (Photographs #15 and #18) with the perimeter drainage channels in good condition (Photographs #16 & 17).

Notes: General condition of west access road and drainage channel. Final cover vegetated slope on right. Looking north.

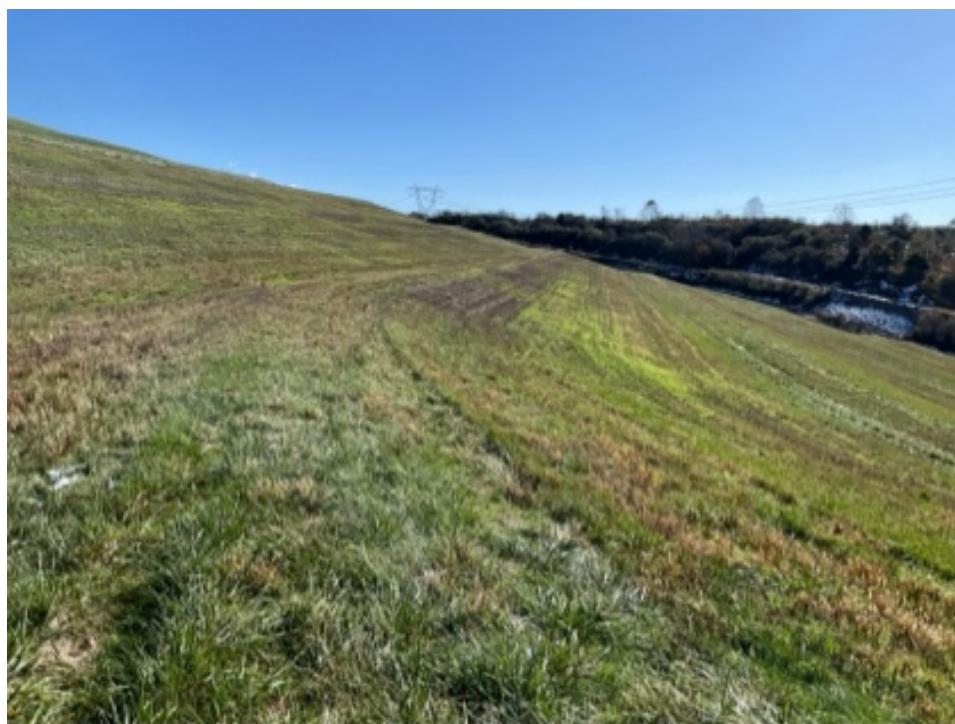
Photo #: 15

Notes: General condition of slope and vegetation of final cover on South Valley Slope.

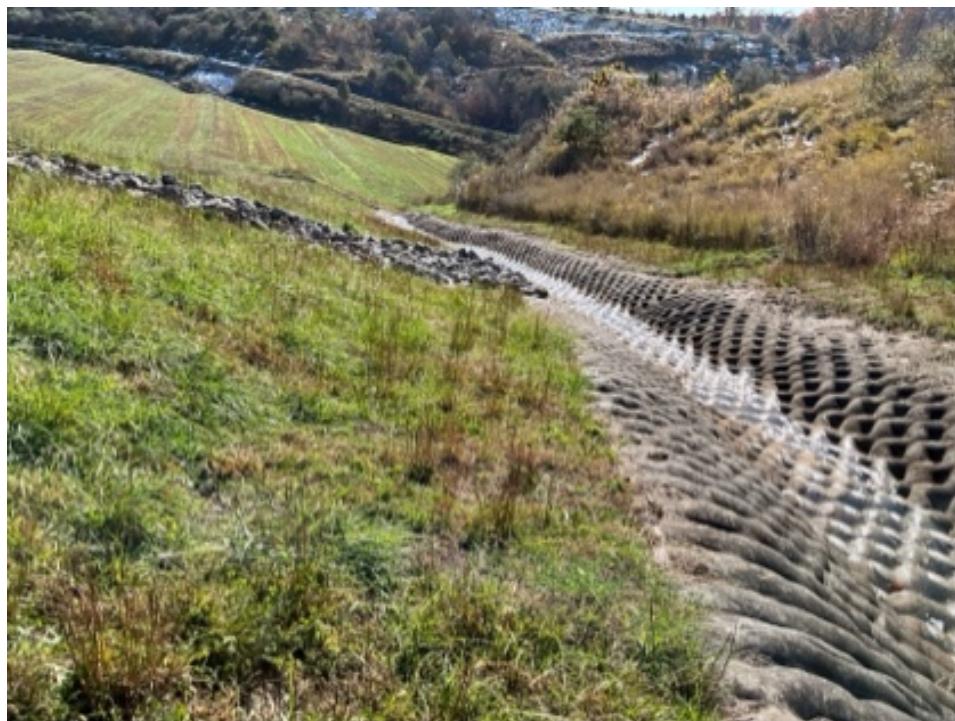
Photo #: 16

Notes: General condition north perimeter drainage channel along final cover looking down slope.

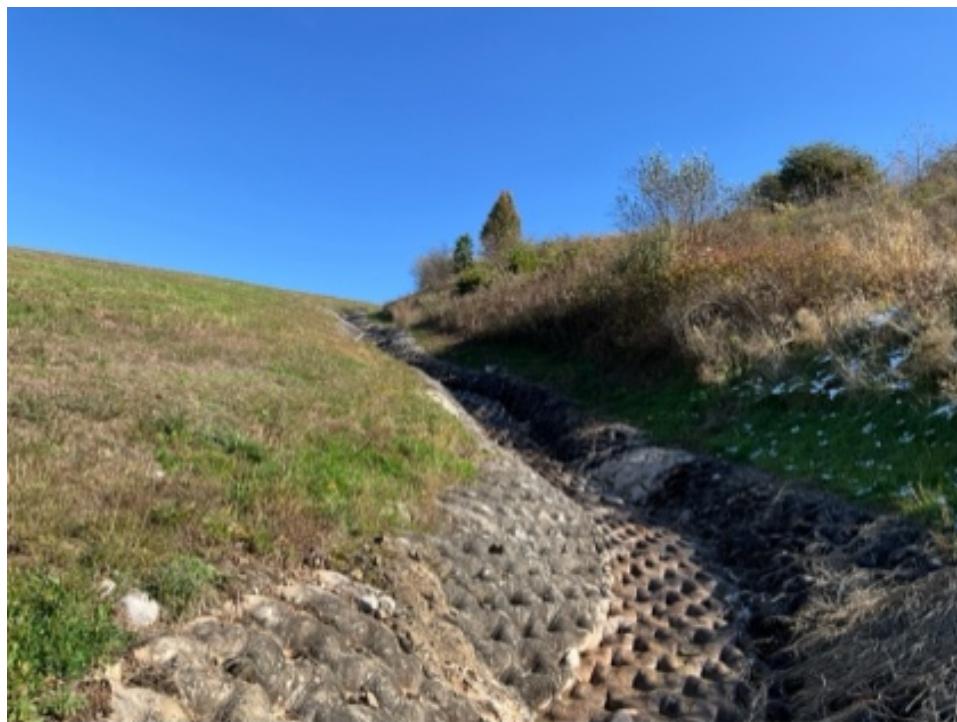
Photo #: 17

Notes: General condition south perimeter drainage channel along final cover looking down slope.

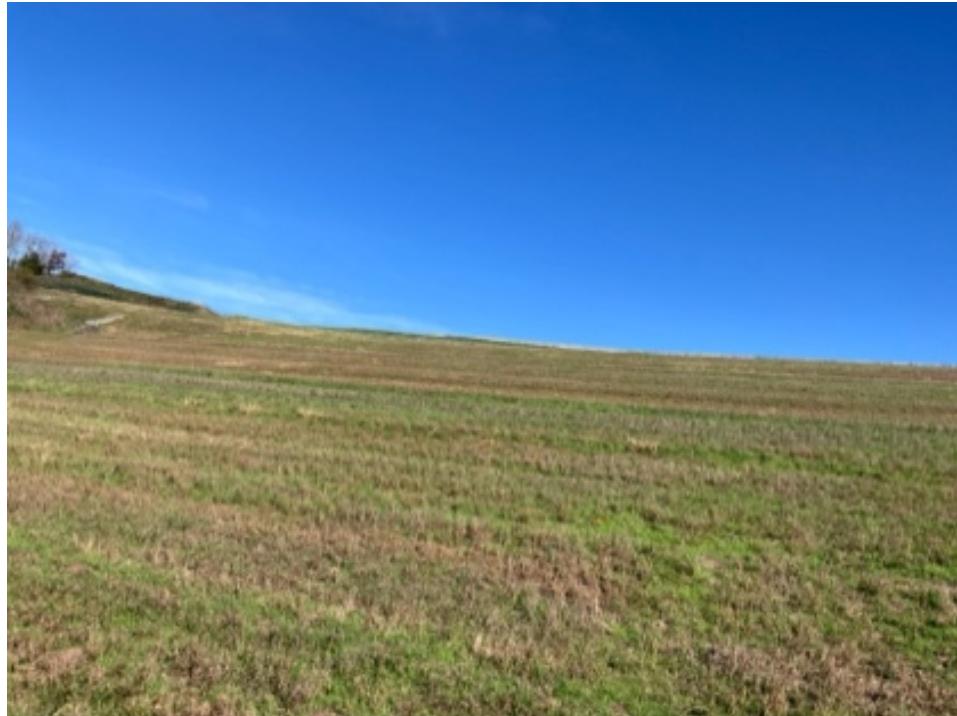
Photo #: 18

Notes: General condition of vegetation on final cover in South Valley Area.

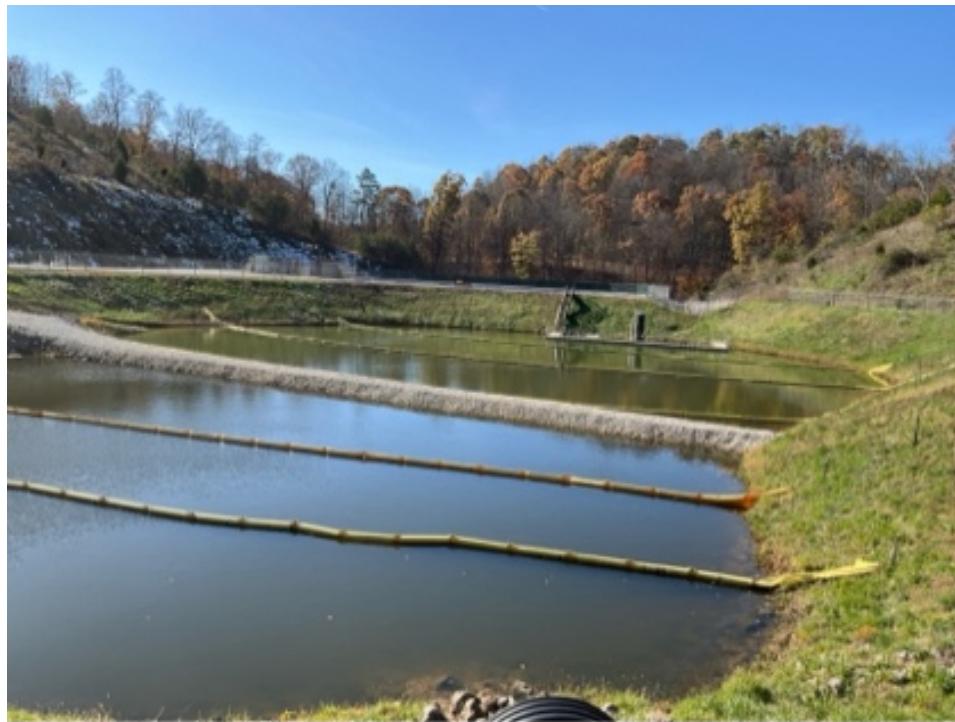
Photo #: 19

14. The South Valley Sedimentation Pond and discharge structure appeared to be in good condition (Photographs #19 & #20).
15. The liner and embankment of the South Valley Leachate Pond appeared to be in good condition (Photographs #21 & #22).

Notes: General condition of the South Valley Sedimentation Pond.

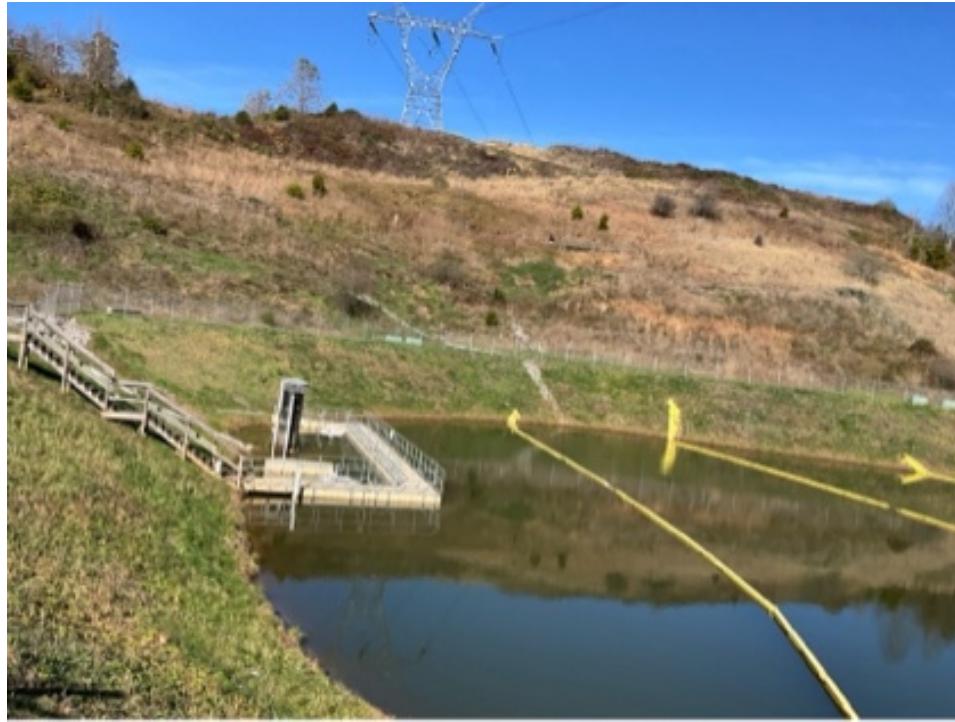
Photo #: 20

Notes: General condition of the South Valley Sedimentation Pond discharge structure.

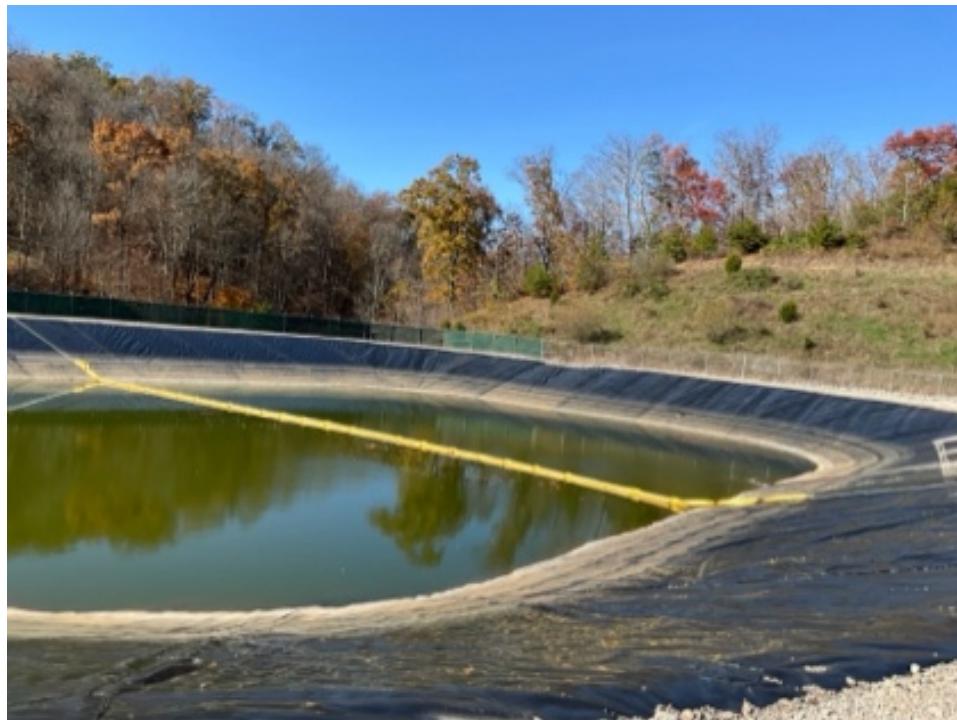
Photo #: 21

Notes: General condition of the South Valley Leachate Pond

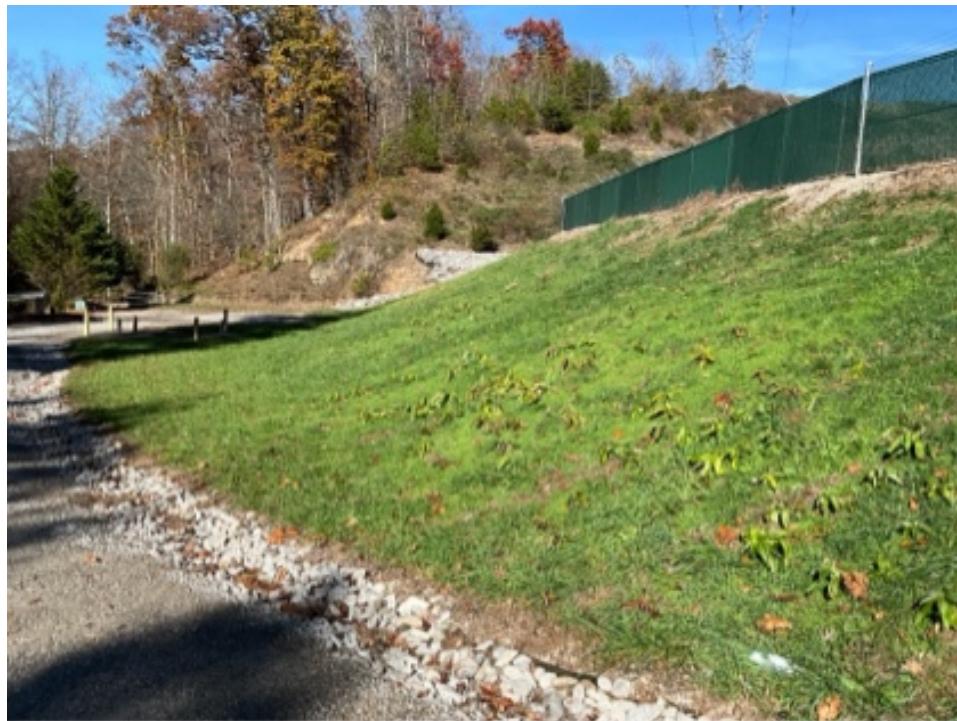
Photo #: 22

Notes: General condition of downstream embankment below the South Valley Leachate Pond.

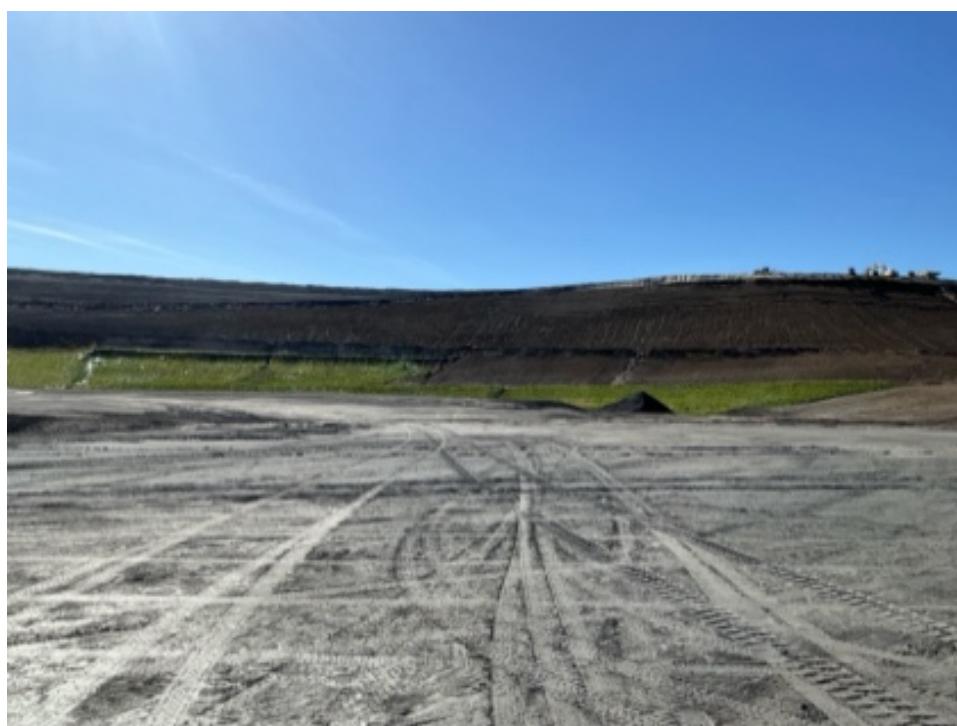
Photo #: 23

16. The Sequence 4 active fill area appeared to be in good condition with material compacted, graded to chimney drains and no signs of standing water (Photograph #23).

Notes: General condition of working face in Sequence 4. South Valley fill in the background.

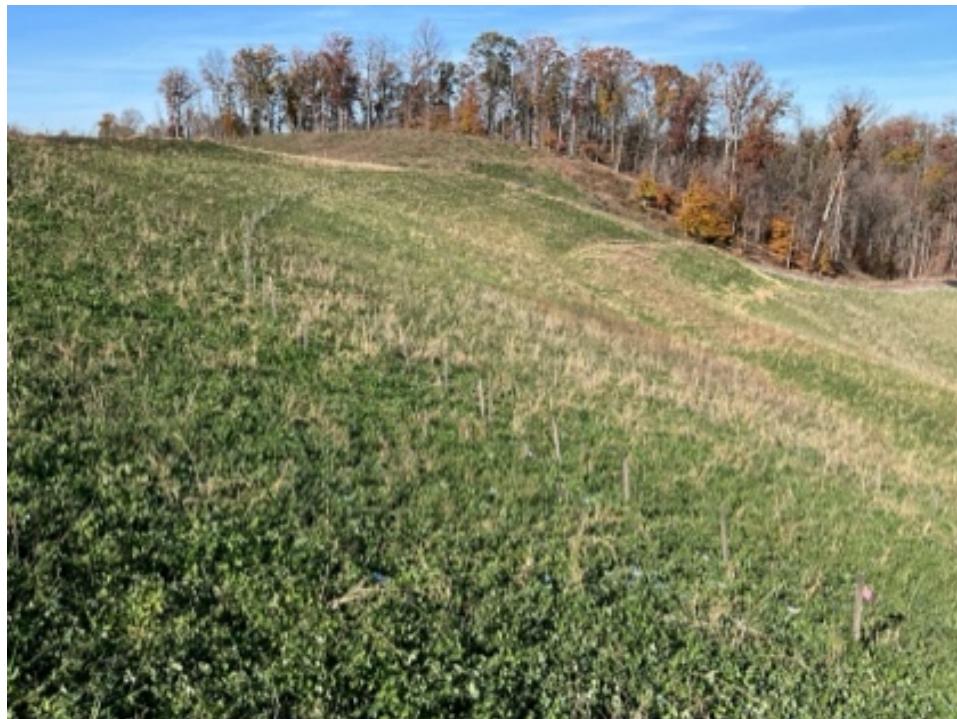
Photo #: 24

17. The interim slope of Sequence 4 with future North Valley expansions appeared well vegetated with no signs of erosion or movement observed (Photograph #24).

Notes: General condition of interim slope of Sequence 4.

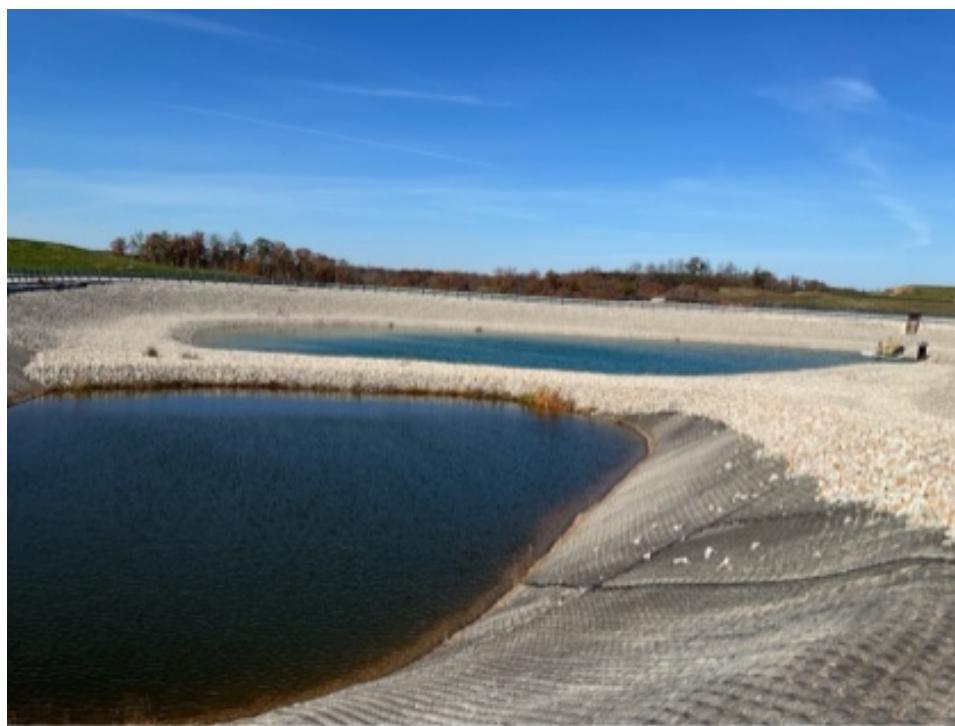
Photo #: 25

18. The Plateau Sedimentation Pond was visually in good condition (Photograph #25)
19. The lower embankment of Sequence 4 appeared well vegetated with no signs of erosion or movement (Photograph #26).

Notes: General condition of Plateau Sediment Pond.

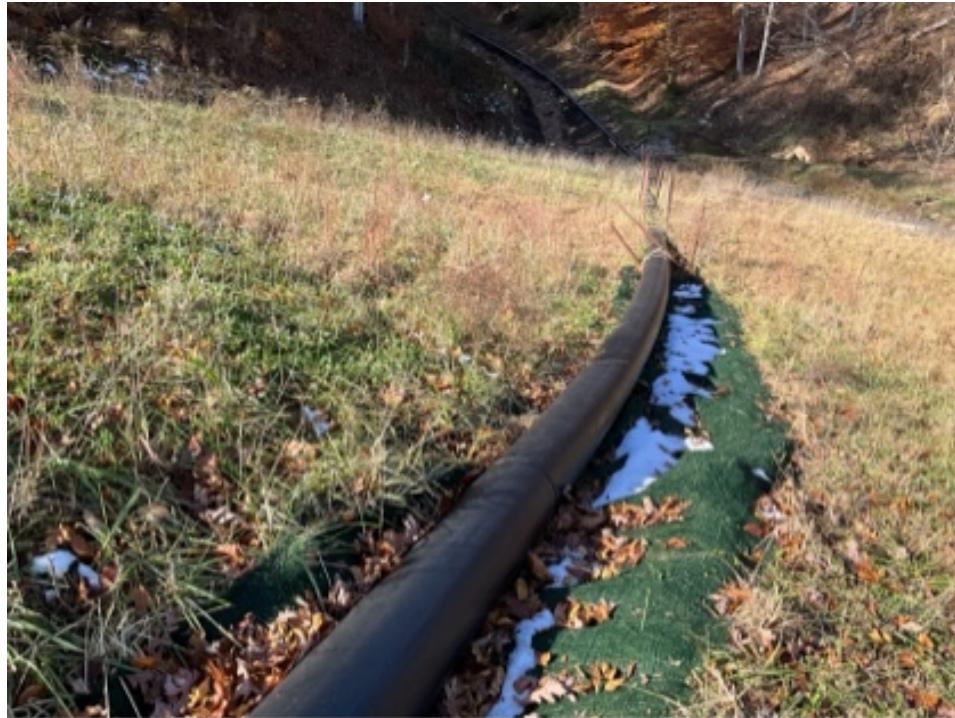
Photo #: 26

Notes: General condition of Sequence 4 embankment slope with leachate line.

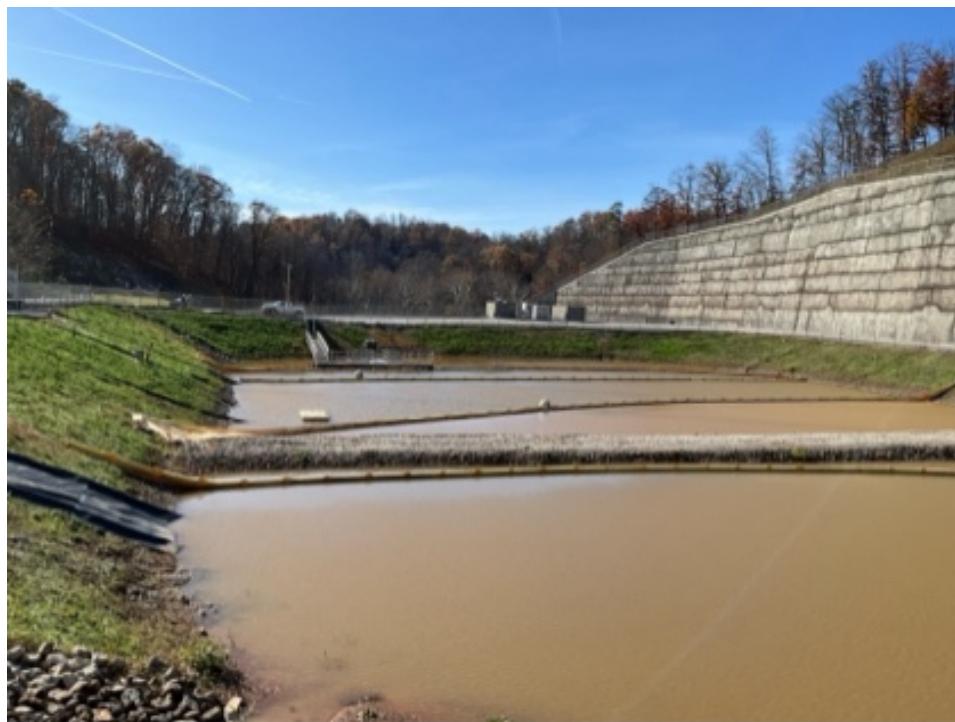
Photo #: 27

20. The visual observation of the North Valley Sediment Pond indicated that it was in good condition (Photographs #27 & 28).
21. The soil nail walls in the North Valley Pond Complex appeared to be in good condition with no signs of weathering or excessive cracks based on a visual observations observed from the ground (Photographs #29 & #30).

Notes: General condition of North Valley Sedimentation Pond.

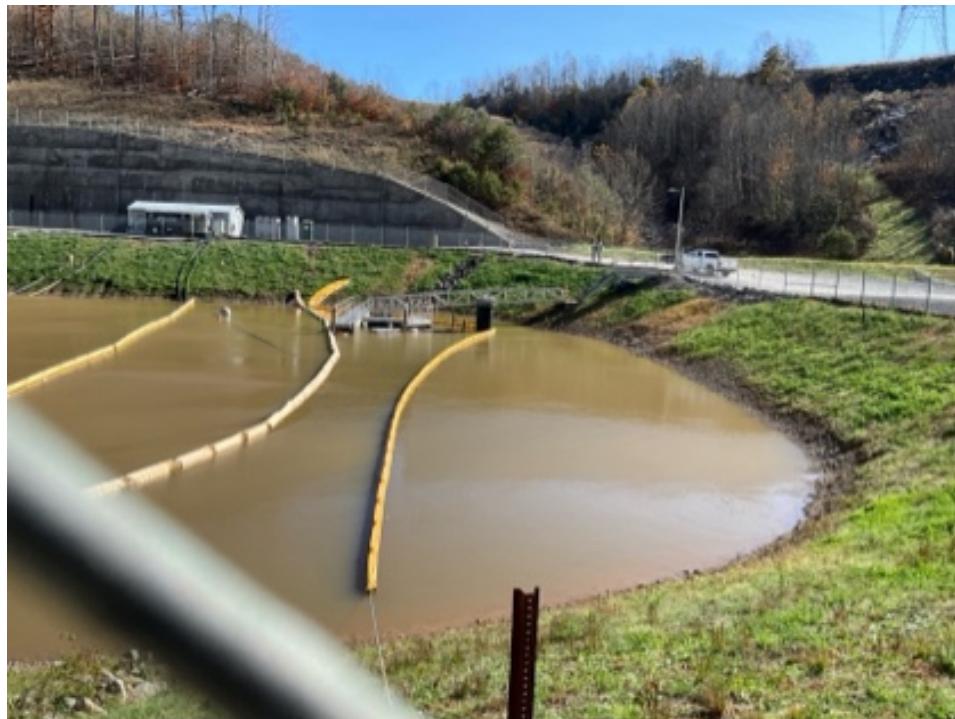
Photo #: 28

Notes: General condition of North Valley Sedimentation Pond discharge structure.

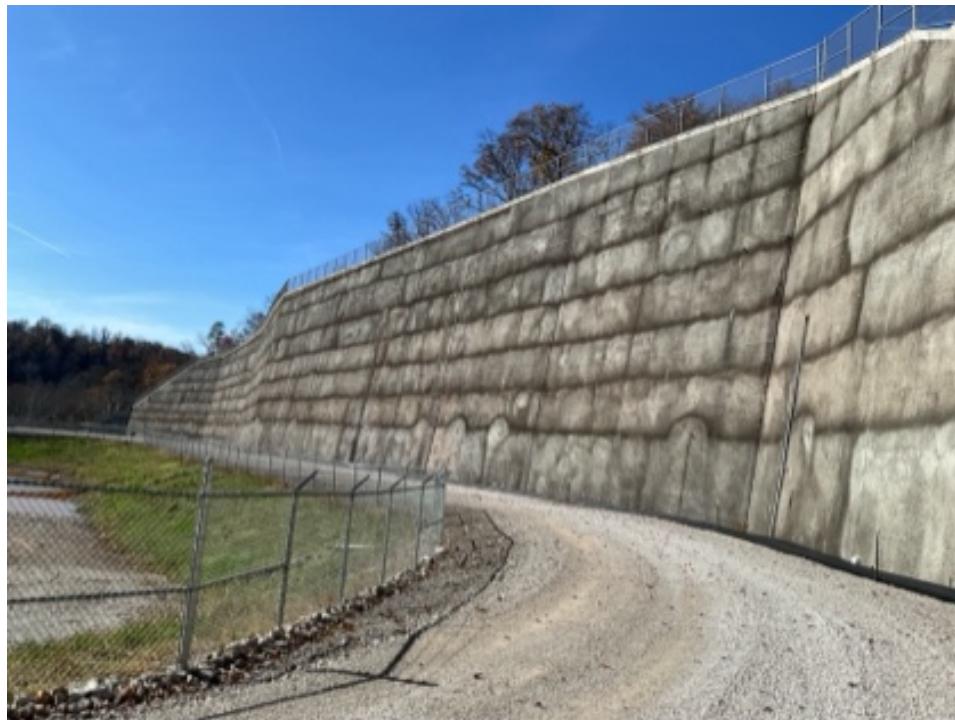
Photo #: 29

General condition of the north soil nail wall at the North Valley Pond Complex.

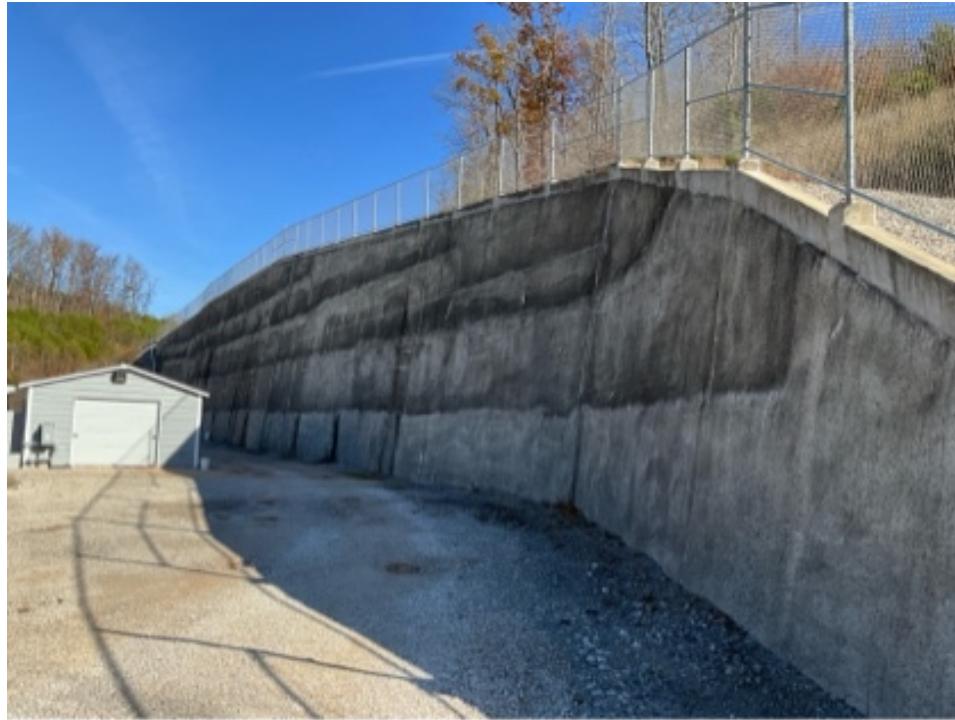
Photo #: 30

General condition of the south soil nail wall at the North Valley Pond Complex.

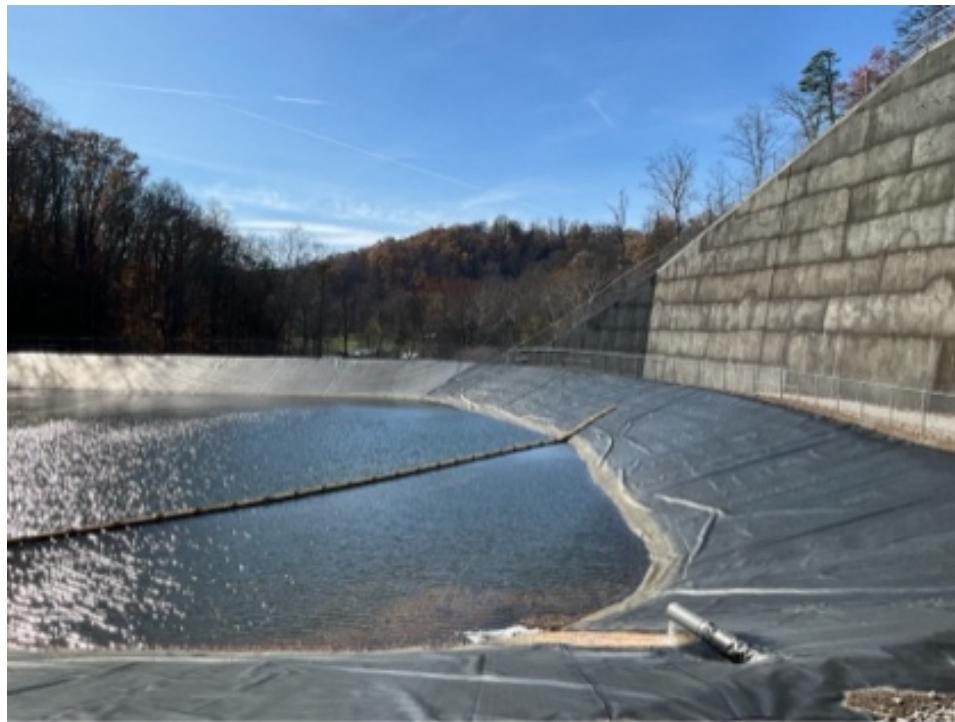
Photo #: 31

22. The North Leachate Pond liner and embankment appeared to be in good condition (Photographs #31 & #32).
23. The stormwater outfalls at both South Valley Pond Complex (Photograph #33) and the North Valley Pond Complex (Photograph #34) appeared in satisfactory condition.

General condition of North Valley Leachate Pond.
