2025 Annual Landfill Inspection Report

Amos FGD Landfill

John E. Amos Plant
Appalachian Power Company
Putnam County, West Virginia

Inspection Date: November 12, 2025

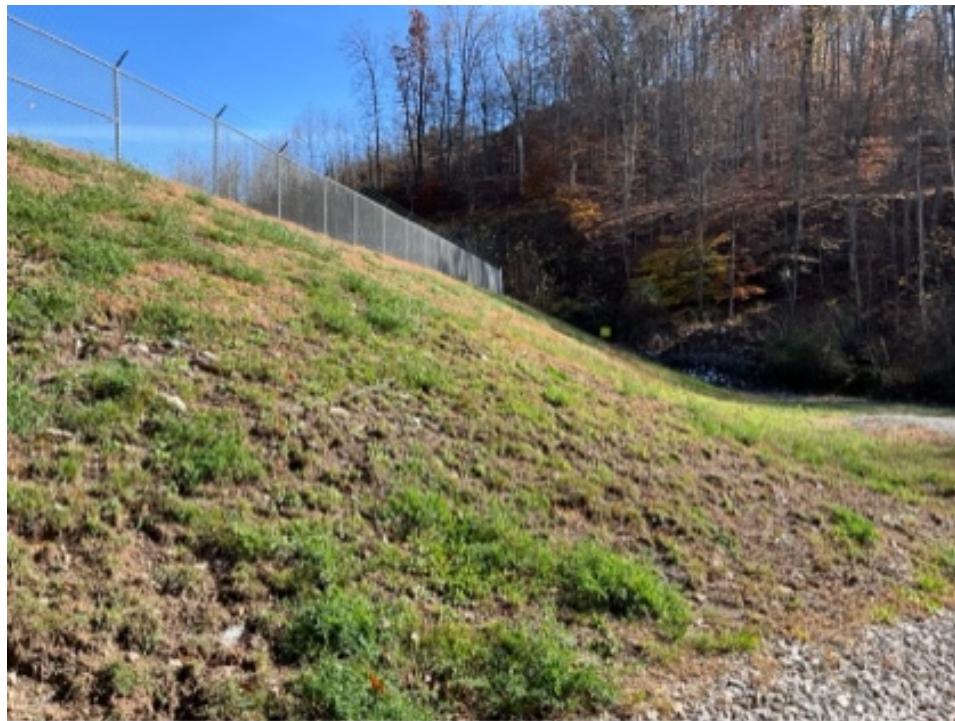
Photo #: 32

22. The North Leachate Pond liner and embankment appeared to be in good condition (Photographs #31 & #32).
23. The stormwater outfalls at both South Valley Pond Complex (Photograph #33) and the North Valley Pond Complex (Photograph #34) appeared in satisfactory condition.

General condition of downstream embankment of the North Valley Leachate Pond.

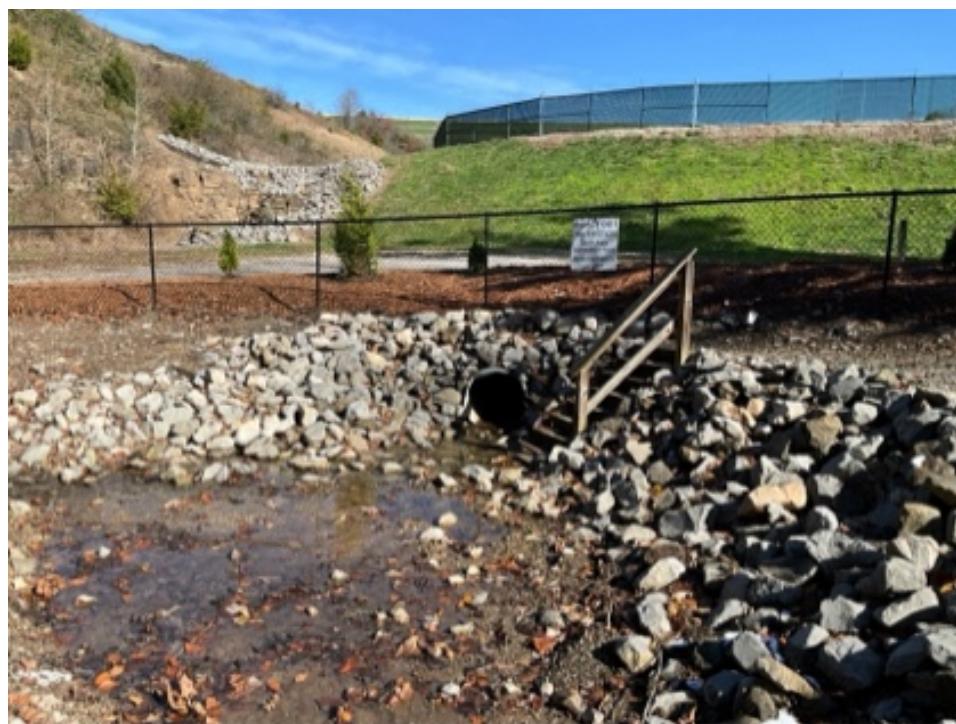
Photo #: 33

General condition of the stormwater outfall at the South Valley Pond Complex.

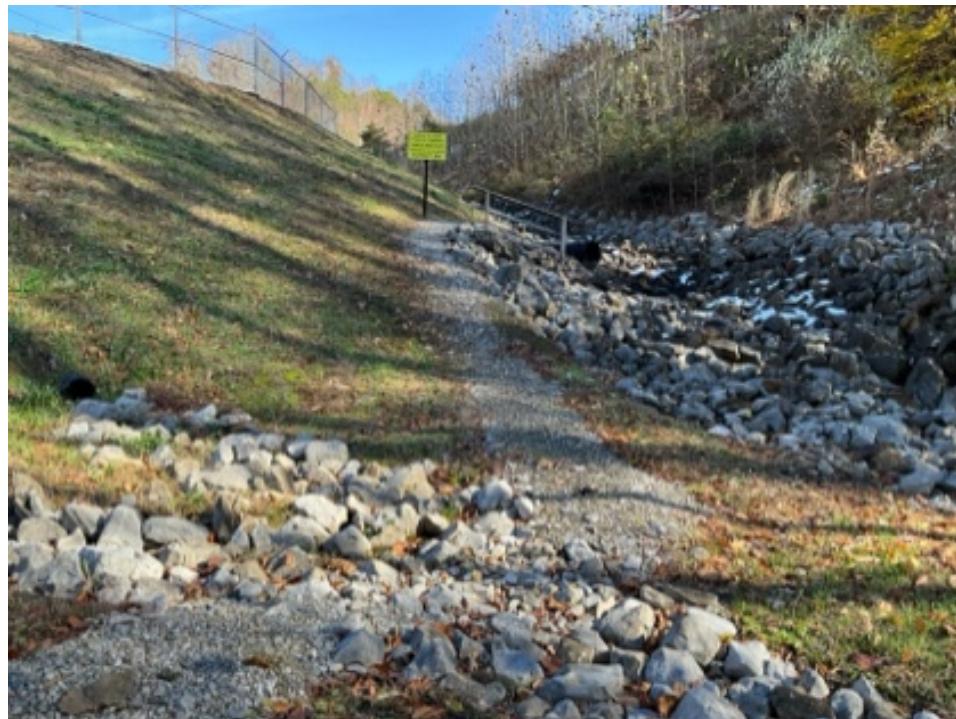
Photo #: 34

General condition of the stormwater outfall at the North Valley Pond Complex.
