2025 Annual Landfill Inspection Report

CCR Landfill

Flint Creek Plant
Southwestern Electric Power Company
Gentry, AR

Document Number: GERS-25-030

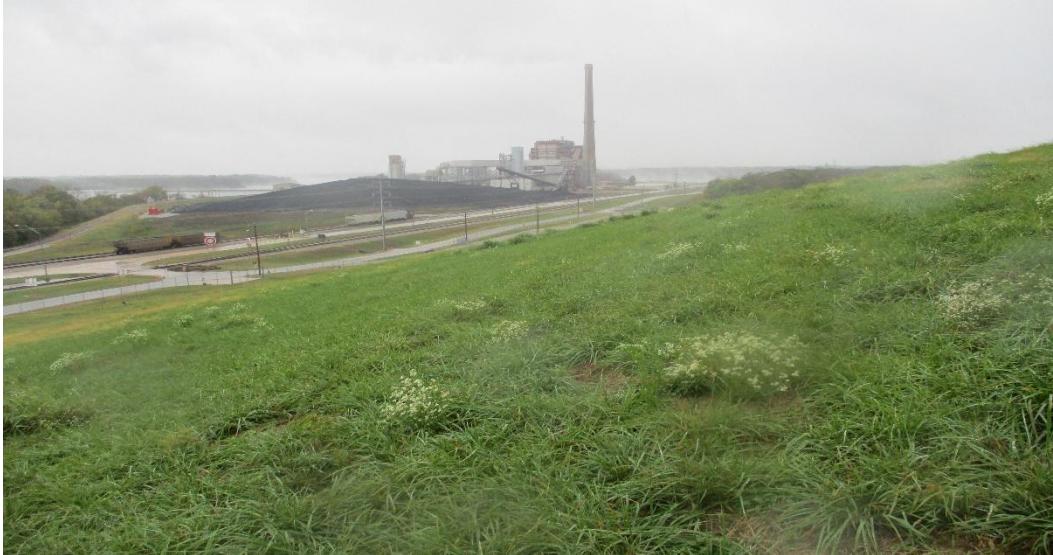
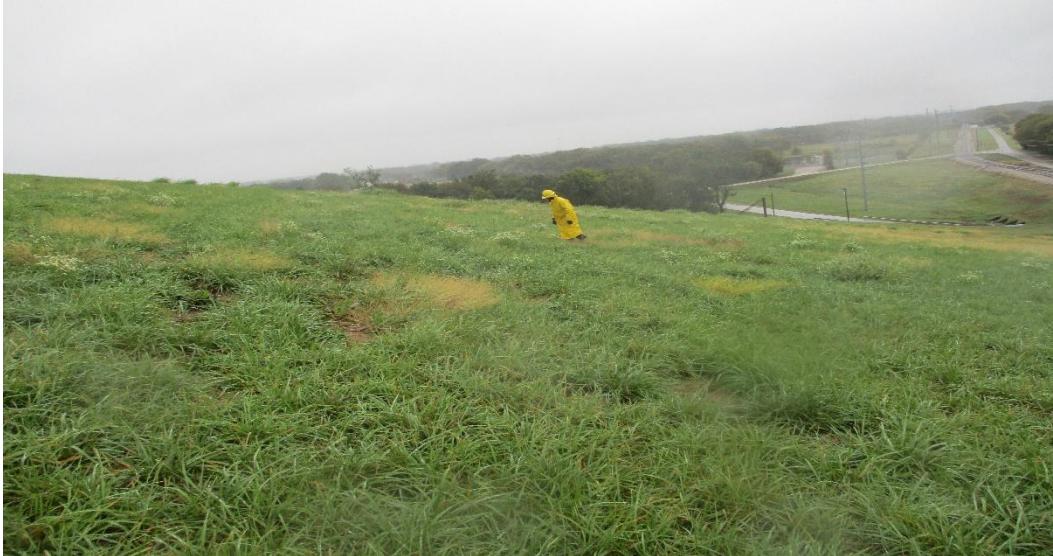
1. The east and west sections of the south slope and the drainage ditch (Photograph Nos. 1 and 2) appeared in good and stable condition with controlled vegetation. The toe ditch appeared to have positive drainage without any signs of standing water. A minor erosion (8 foot in length and 6-inch deep) was encountered mid-way of the south slope.
2. The southeast exterior slope of the landfill is illustrated in Photograph No. 4. The landfill cover slope and vegetation appeared well maintained and in good condition. The fabriform ditch section and the toe ditch were functioning as designed.
3. Photographs No. 5 and 6 illustrate overall condition of the east slope of the landfill and access road. The lower section of the slope downstream of the access road is steeper

<p>Photograph No. 1 The south slope and the toe ditch (looking west).</p>

<p>Photograph No. 2 Overall view of the south slope (looking east).</p>

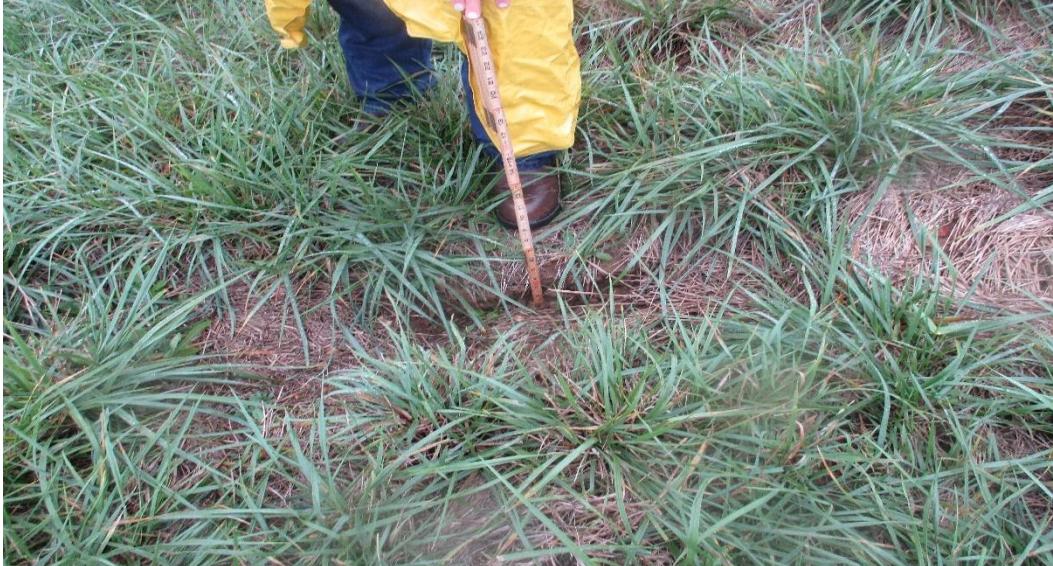
<p>Photograph No. 3 Minor erosion gully.</p>

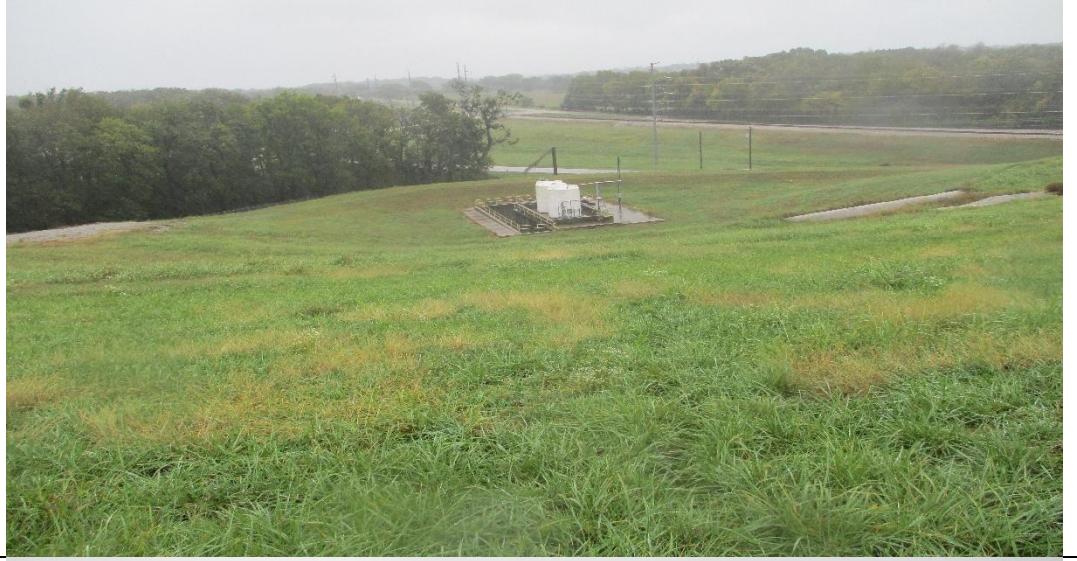
<p>Photograph No. 4</p> <p>Southeast area of the lower slope.</p>

- 1) Excessive grass/vegetation at the east lower slope area should be mowed on a regular basis during the year to facilitate inspections and keep woody vegetation to minimum. Any trees at or around the slopes should be removed. Alternately, remote control mower could be used if manual access is difficult for the operator.
- 2) Minor erosion gully at the south slope of the landfill should be repaired by backfilling and/or regrading.
- 3) CCR waste placement should be properly contained within the landfill areas and contact water should be conveyed via interior temporary ditches and/or piping system as designed.
- 4) The waste grades should be completed in accordance to the design drawings and intermediate cover should be placed thereafter.

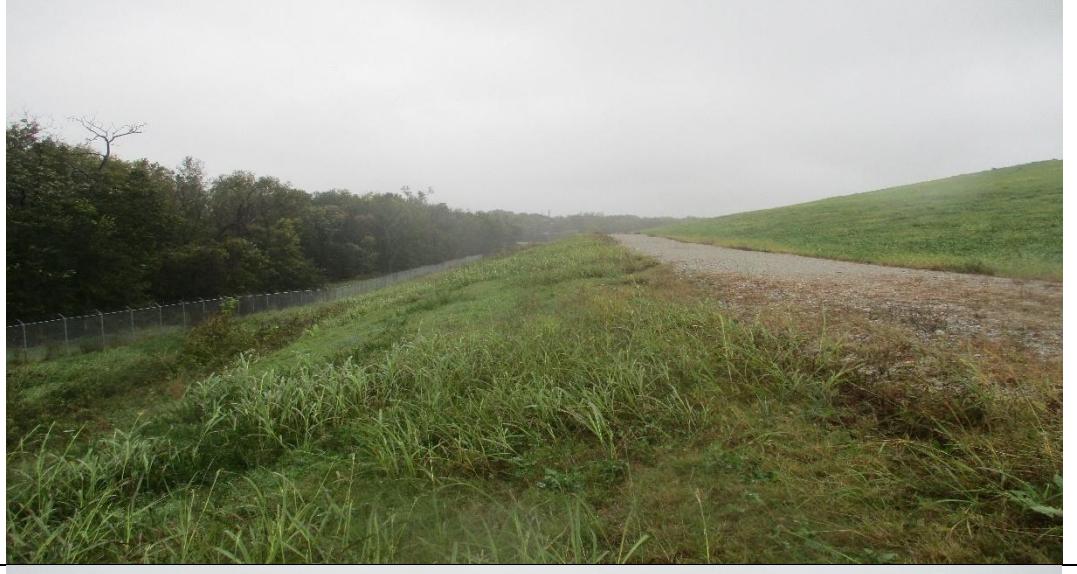
<p>Photograph No. 5</p> <p>East slope of the landfill (looking south).</p>

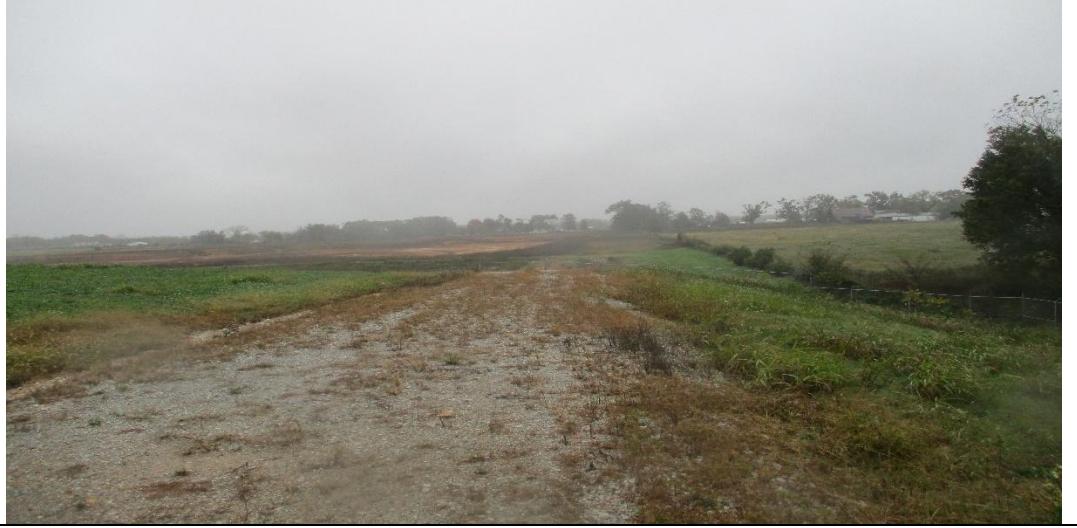
than the upper slope section. The slope appeared to be in good and stable condition. Slightly excessive vegetation was observed along the lower section of the slope.

<p>Photograph No. 6</p> <p>Access road and lower east slope of the landfill (looking north).</p>

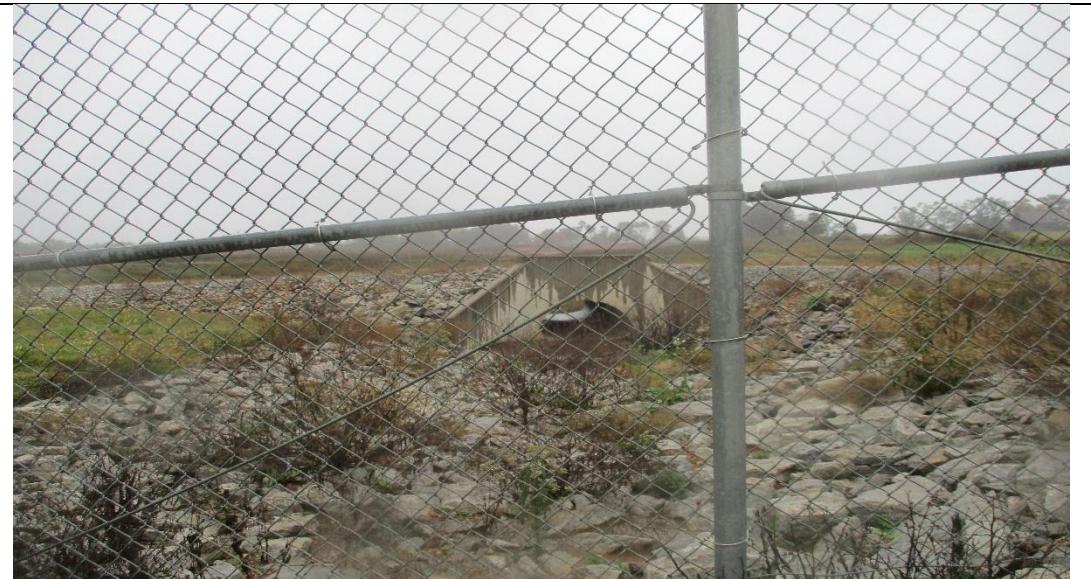
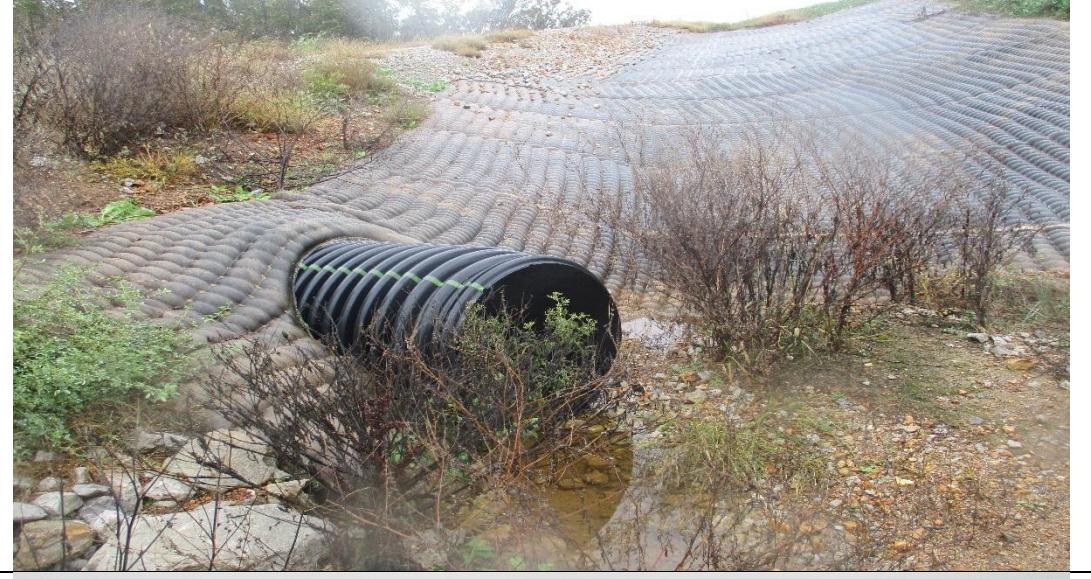
4. Surface runoff drainage ditch and pipe culvert located in the northeast corner of the landfill appeared in functioning condition without any obstruction to flow (Photographs No. 7 and 8). Minor vegetation and small bushes were observed in the ditch area.

<p>Photograph No. 7</p> <p>Offsite drainage channel and pipe culvert located in the northeast corner.</p>

<p>Photograph No. 8</p> <p>Fabriform lined channel in the northeast corner of the landfill.</p>

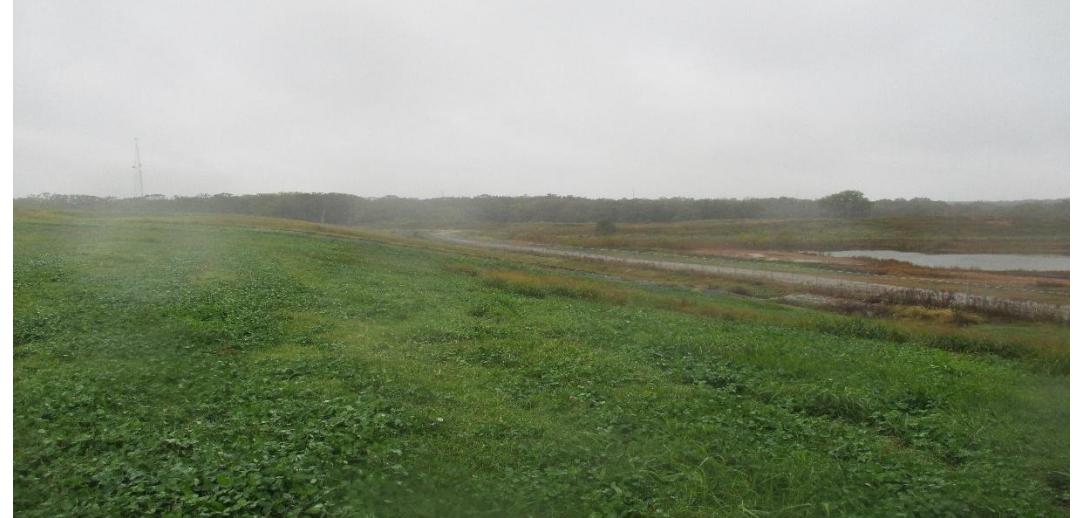
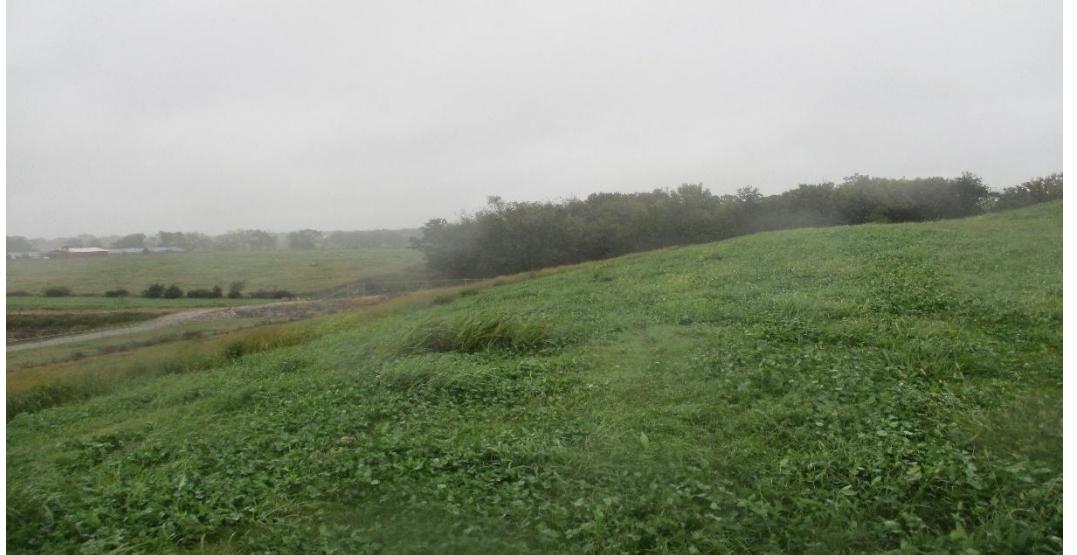
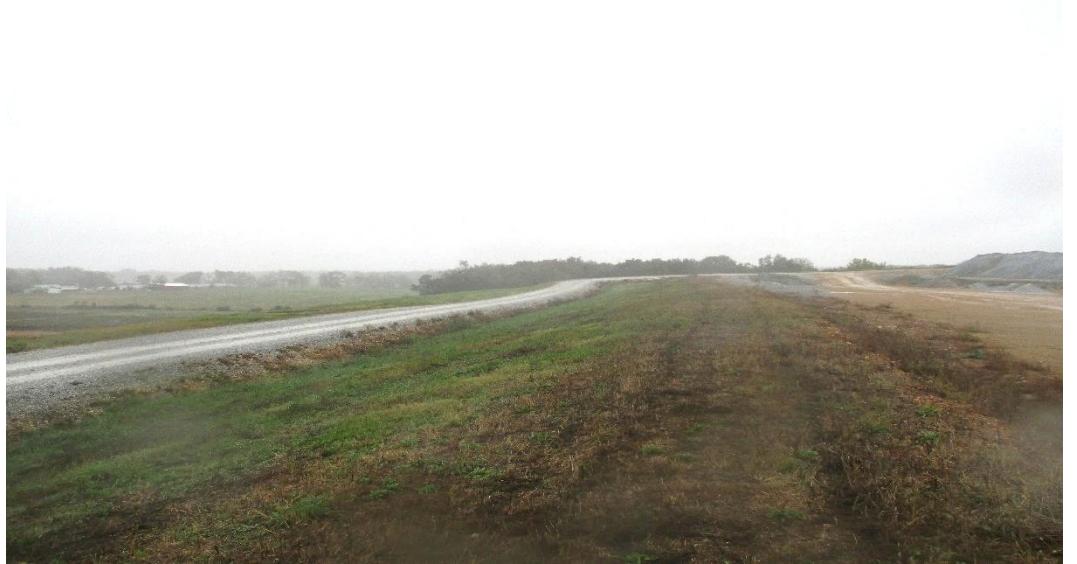
5. Typical condition of the north landfill slope that has final cover is illustrated in Photographs No. 9-11. There were no observed erosion gullies, sloughs, or other signs of settlement. All areas had adequate and good vegetative cover.

<p>Photograph No. 9</p> <p>Typical view of the north slope toe area (looking west).</p>

<p>Photograph No. 10</p> <p>Typical view of the north slope toe area (looking east).</p>

<p>Photograph No. 11</p> <p>North slope upper section.</p>

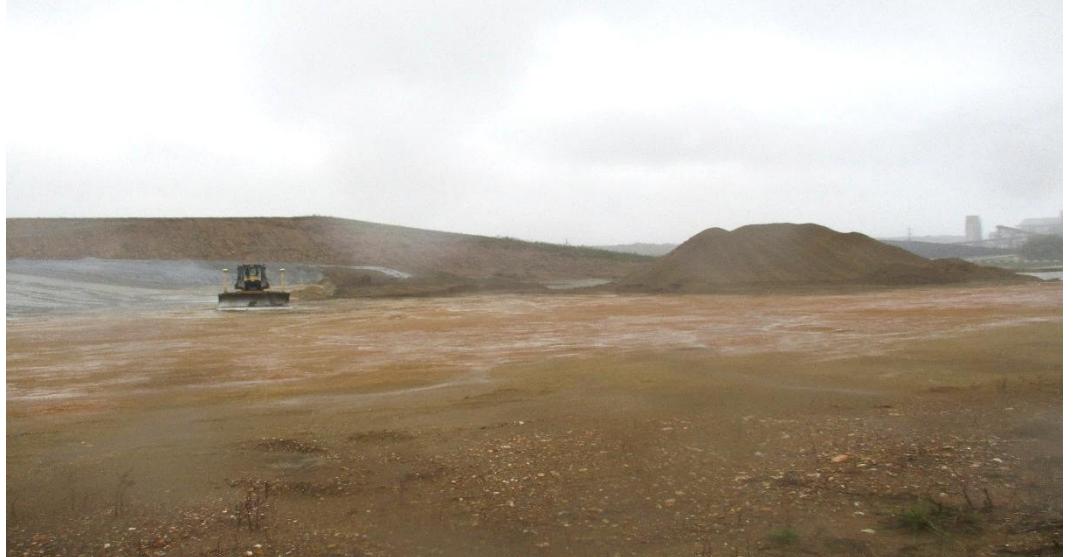
6. The active area of the landfill was in good condition, well graded, without any water ponding, or erosion (Photograph No. 12). Overall the area is well maintained and good contact water control in place.

<p>Photograph No. 12</p> <p>Active area of the landfill.</p>

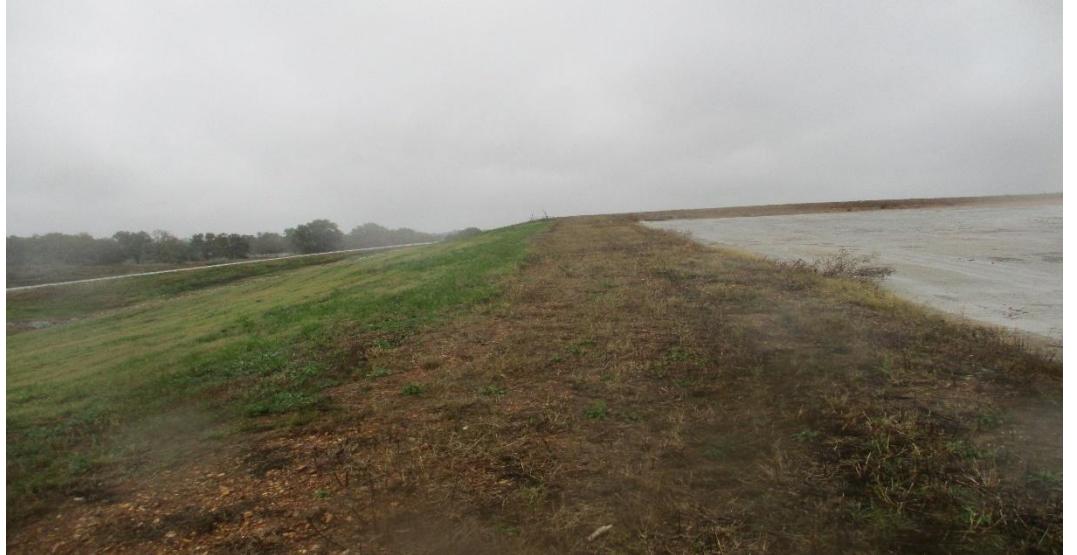
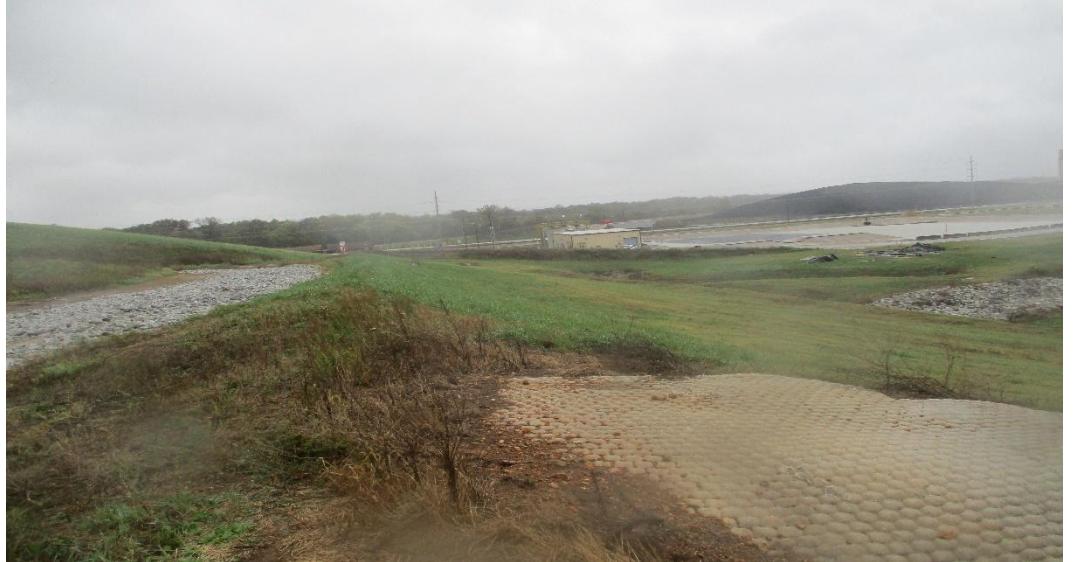
7. Typical condition of the west landfill slope adjacent to Areas 2 and 3 that consists of CCR material (Photographs No. 13 and 14). The landfill cover appeared in good condition and the contact water is directed to the contact water pond. The west slope landfill cover appeared well maintained. The letdown fabriform channel (Photograph No. 15) to the stormwater pond appeared in good functioning condition.

<p>Photograph No. 13</p> <p>West slope of the landfill (looking north).</p>

<p>Photograph No. 14</p> <p>Slightly excessive vegetation at the northeast corner.</p>

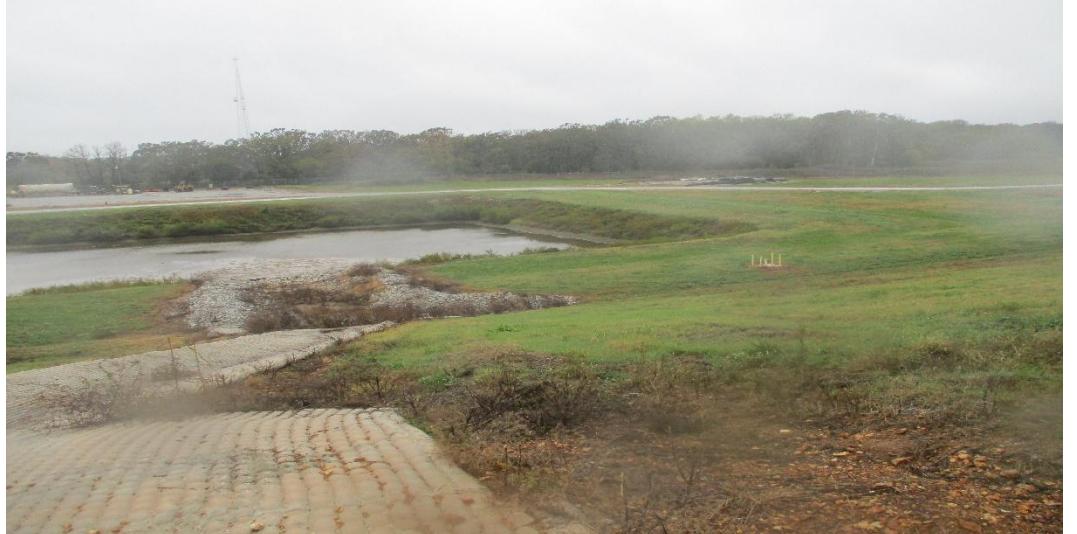
<p>Photograph No. 15</p> <p>Fabriform ditch letdown to the stormwater pond.</p>

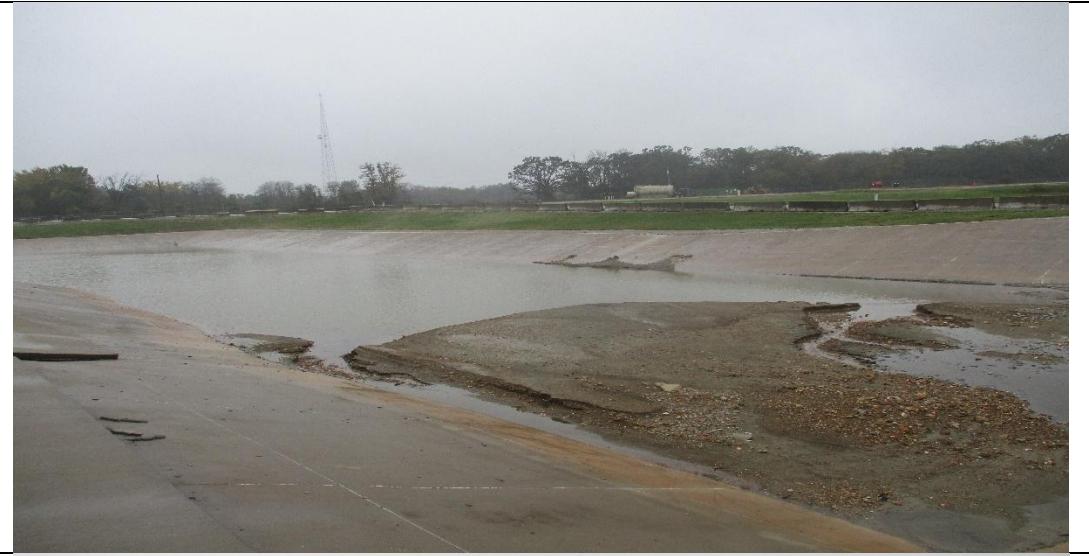
8. The north perimeter contact water channel outlet end is illustrated in Photograph No 16. Water was flowing through the pipe culvert to the contact water pond. It appears that solids were carried from the upstream end of the channel to the contact water pond. The contact water pond dikes appeared in good and stable condition with good concrete cover. The pond appeared functioning as designed.

<p>Photograph No. 16</p> <p>Contact water pond north area.</p>

- 5) The accumulation of ash at the north contact water channel pipe culvert should be removed and control to minimize solid accumulation in the contact water pond.

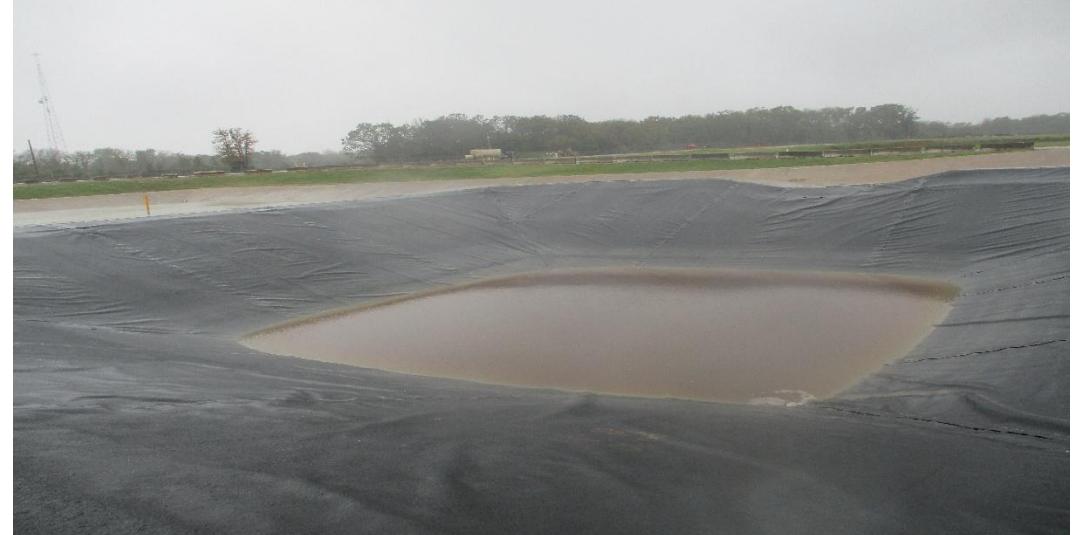
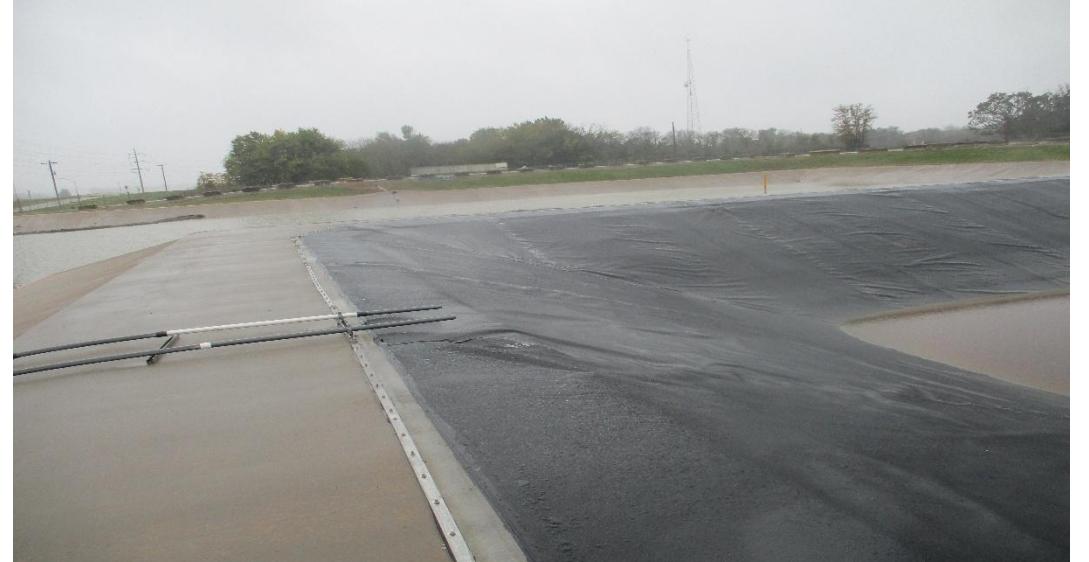
9. Overall view of the leachate pond is shown in Photographs No. 17 and 18. A new protective geosynthetic cover was installed this year over the primary liner of the pond. The protective cover is intact in place properly protecting the primary liner. Leachate pond is functioning as designed after repairs were performed.

<p>Photograph No. 17</p> <p>Overall view of the leachate pond.</p>

<p>Photograph No. 18</p> <p>New protective liner cover.</p>

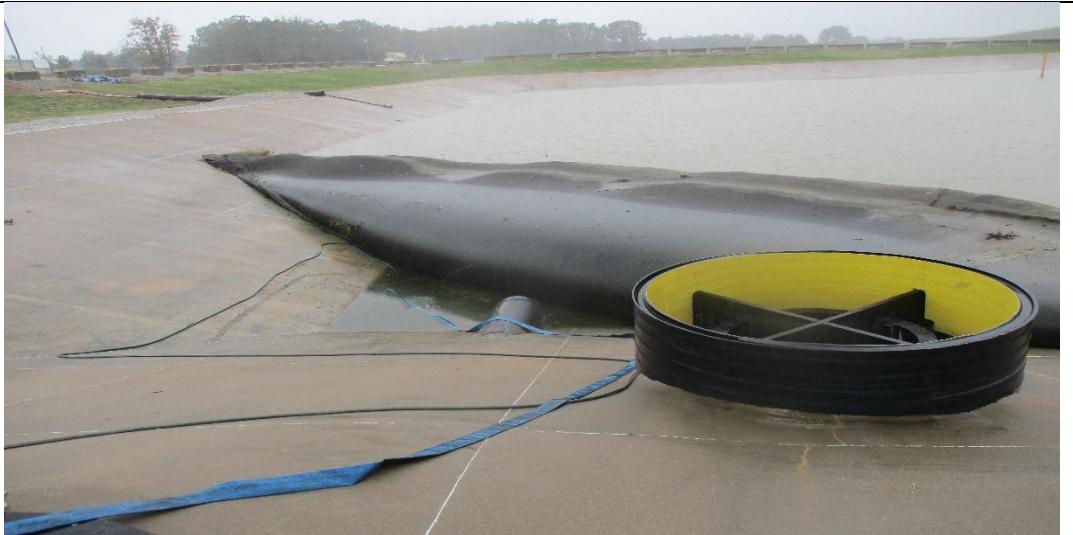
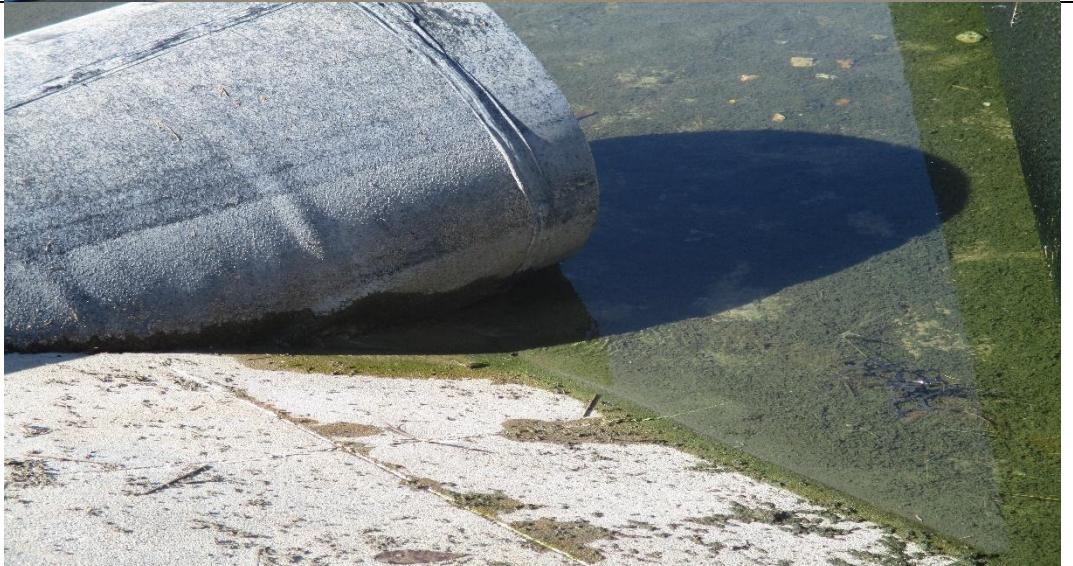
10. A new rock filter berm was reinstalled in the southwest corner of the contact water pond per the design (Photographs No. 19 and 20). Water was observed to be leaking underneath the 24-inch diameter HDPE pipe.

Photograph No. 19 Rock filter berm.

Photograph No. 20 Water dewatering pipe.

1. Monitor the leak under the 24-inch pipe at the southwest corner of the contact water pond.
