2025 Annual Dam and Dike Inspection Report

**Wastewater Pond Dam
(Primary Bottom Ash Pond – CCR Unit)**

**Flint Creek Plant
Southwestern Electric Power Company
Gentry, Arkansas**

Document Number: GERS-25-038

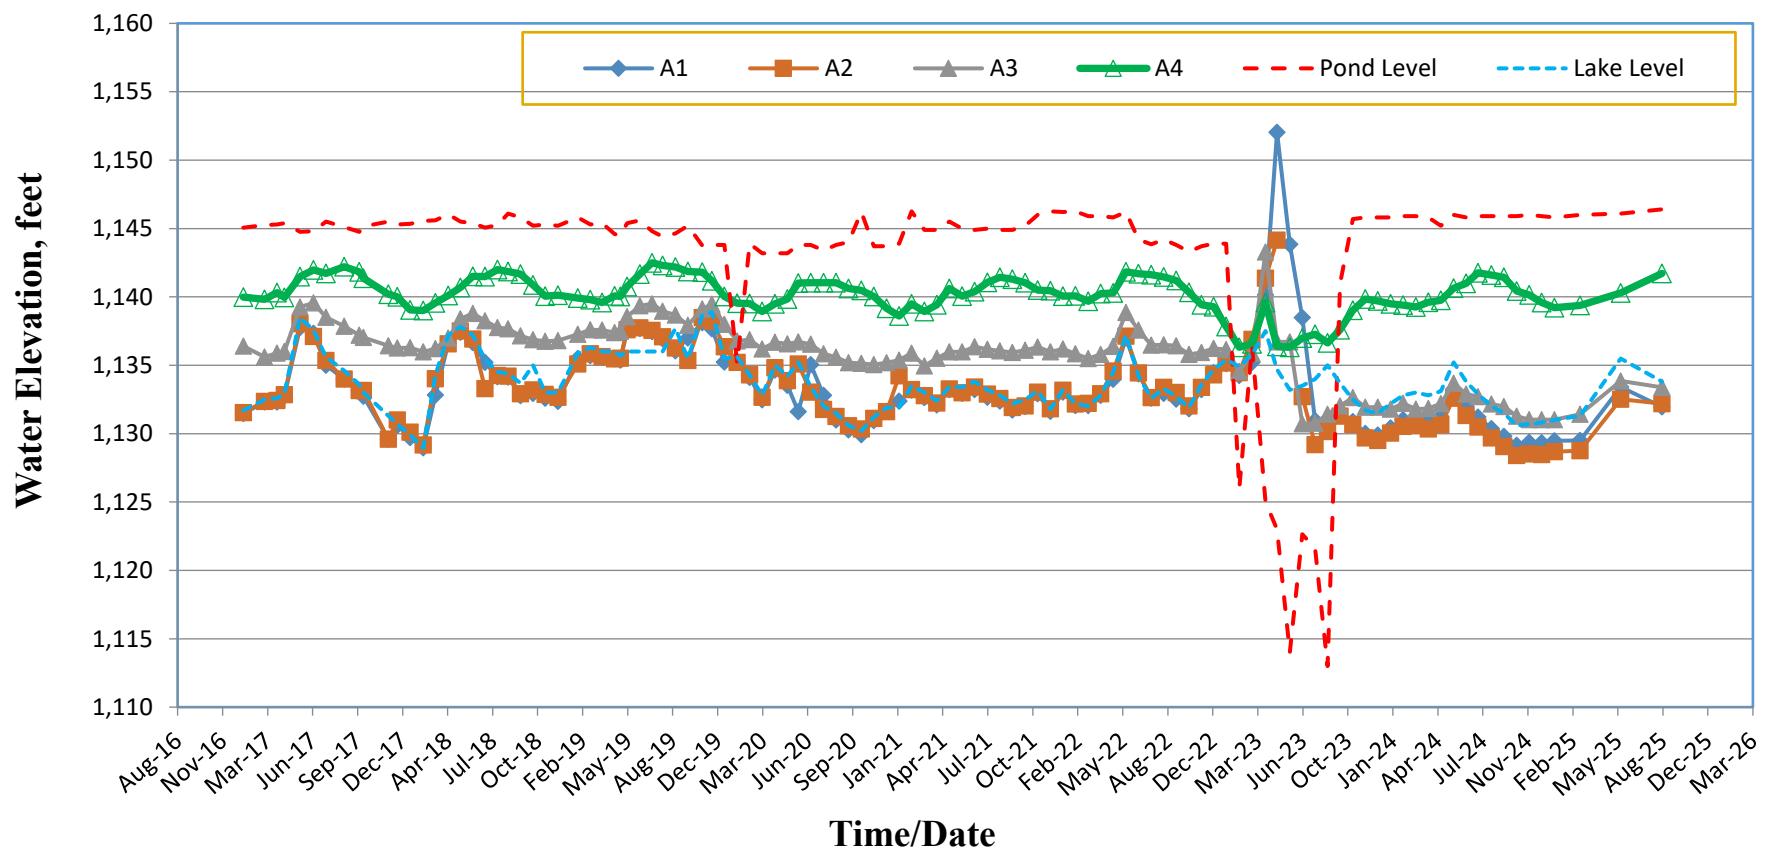
Figure 3 - Wastewater Pond Historical Piezometer Data

There are four piezometers located along the crest of the dam as shown on Figure 2. These are the only instrumentation related to this facility. A review of readings since the last inspection and historical readings (2017-2025) indicate the levels are consistent and respond to the fluctuation of the cooling lake level. The piezometers are more influenced by the

level of the cooling lake than the elevation of the Wastewater Pond. A spike was noticed in Piezometers A1-A3 in April 2023 and A4 in August 2023. Piezometers A1-A3 were damaged by construction equipment and were replaced in June 2023. Typically, the trend in the historical data between the piezometers reading, lake level, and pond levels are consistent. Once the pond resume to its normal operating condition, the piezometer reading shall be checked and compared to its historical readings. Table 1 lists the maximum piezometer reading since the last annual inspection. Figure 3 provides historical data plot of the piezometer readings over the past several years.

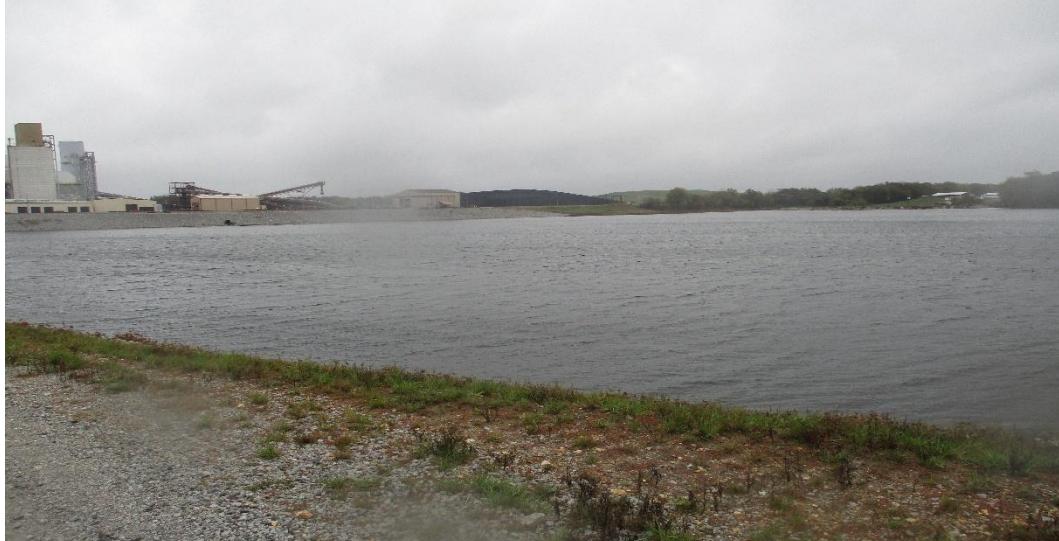
- (i) Overall view of the Wastewater Pond is illustrated in Photograph No. 1. The pond is closed by removal and the CCR materials are placed in the onsite landfill. The pond is converted as a Wastewater Pond and functioning as a repurposed pond.

<p>Photograph No. 1 Overall view of the pond interior.</p>

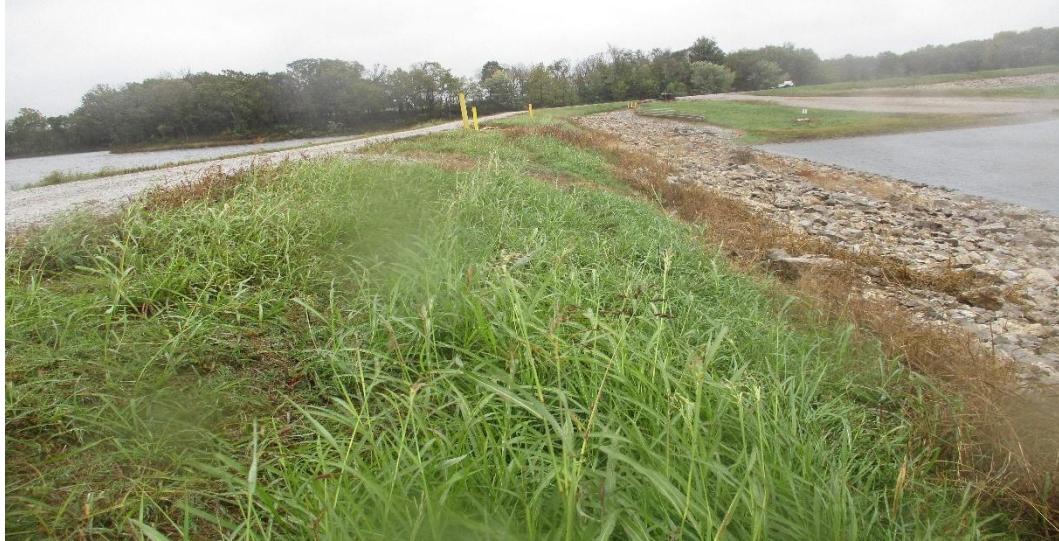
- (ii) Photograph Nos. 2-4 illustrates the condition of the upstream and downstream slopes. New riprap was placed on the upstream slope during the pond closure project. Both slopes of the dam appeared in stable and satisfactory condition without any signs of any distress.

<p>Photograph No. 2 Downstream slope (looking south).</p>

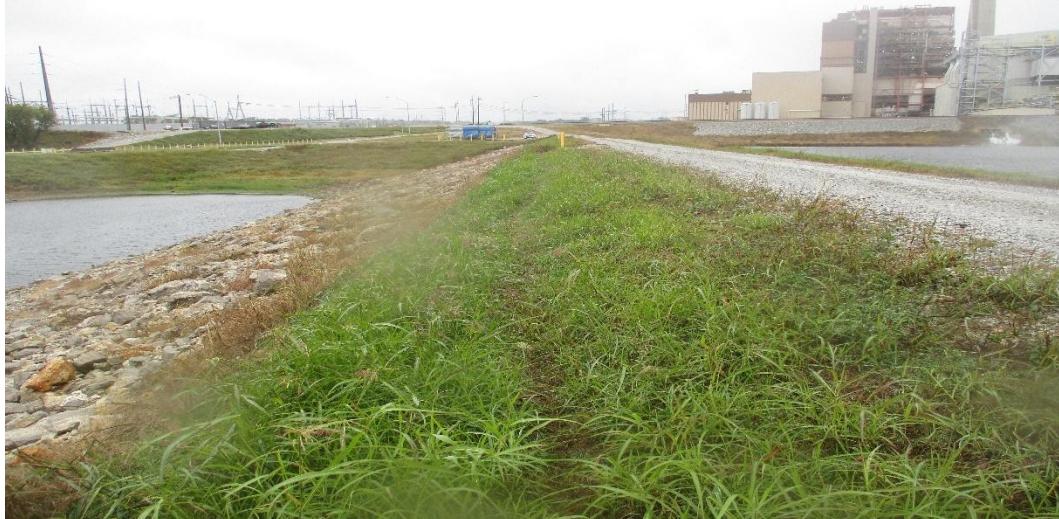
<p>Photograph No. 3 Downstream slope (looking north).</p>

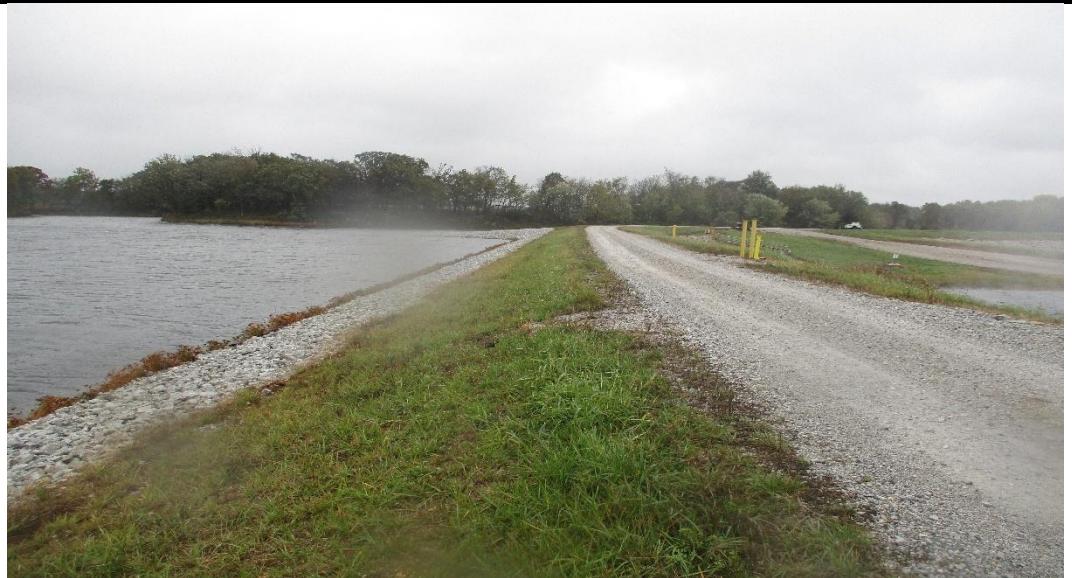
<p>Photograph No. 4</p>

Upstream slope
(looking south).

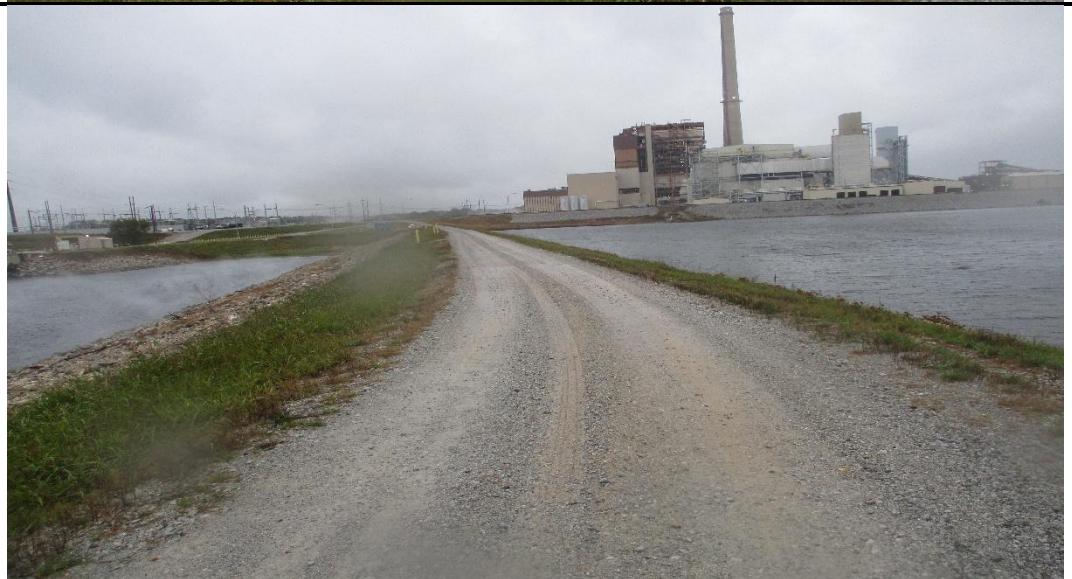
- (iii) Photograph No. 5 illustrates crest of the dam. Crest is also used by vehicular traffic to access the piezometers and operational and maintenance activities. The crest is in good condition with no evidence of misalignment, settlement, or cracking.

Crest of the dam
(looking north).

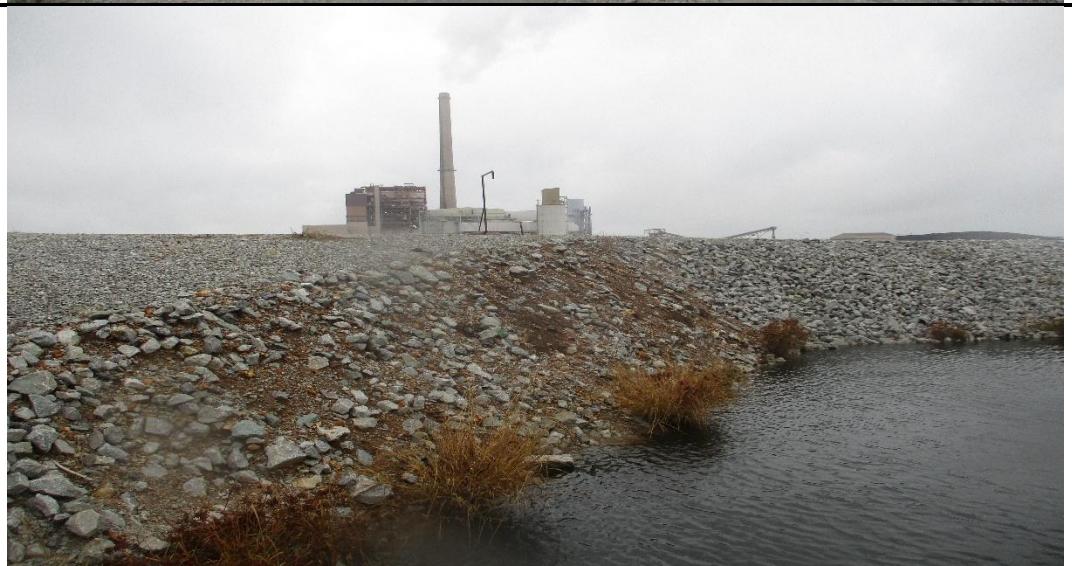
- (iv) Photograph No. 6 illustrates downstream slope section, southeast corner near the overflow structure downstream slope of the dam. The slope is protective with riprap, minor erosion and lack of riprap was noticed.

Southwest corner near
the overflow discharge
structure.

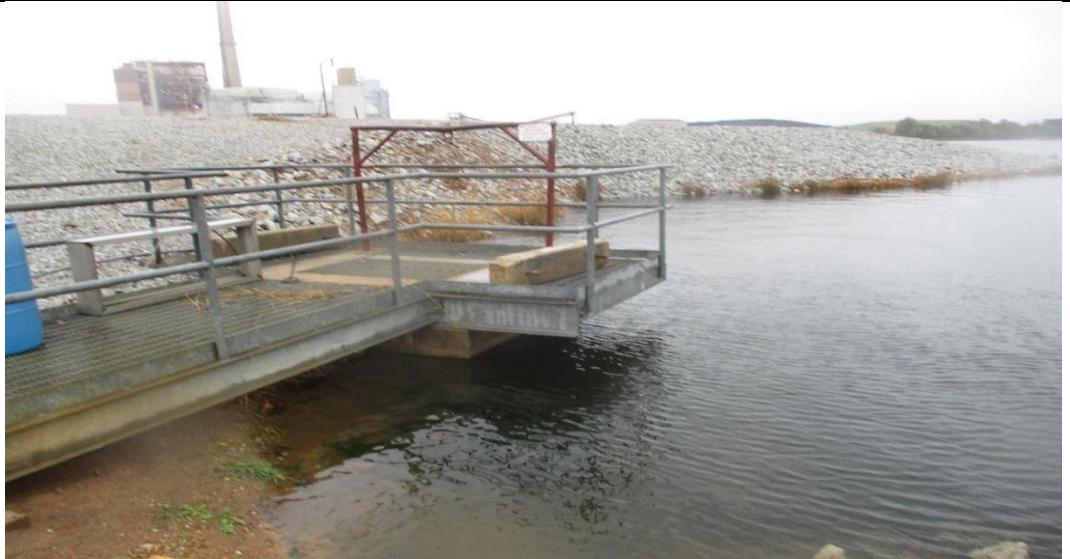
Photograph No. 7

- (v) The principal spillway for the pond is a concrete drop-inlet structure with stop logs used to control the pool elevation. The overflow discharge structure was in generally good and functional condition. The access platform and discharge through the principal spillway was unobstructed (Photograph No. 7).

Overflow discharge structure.

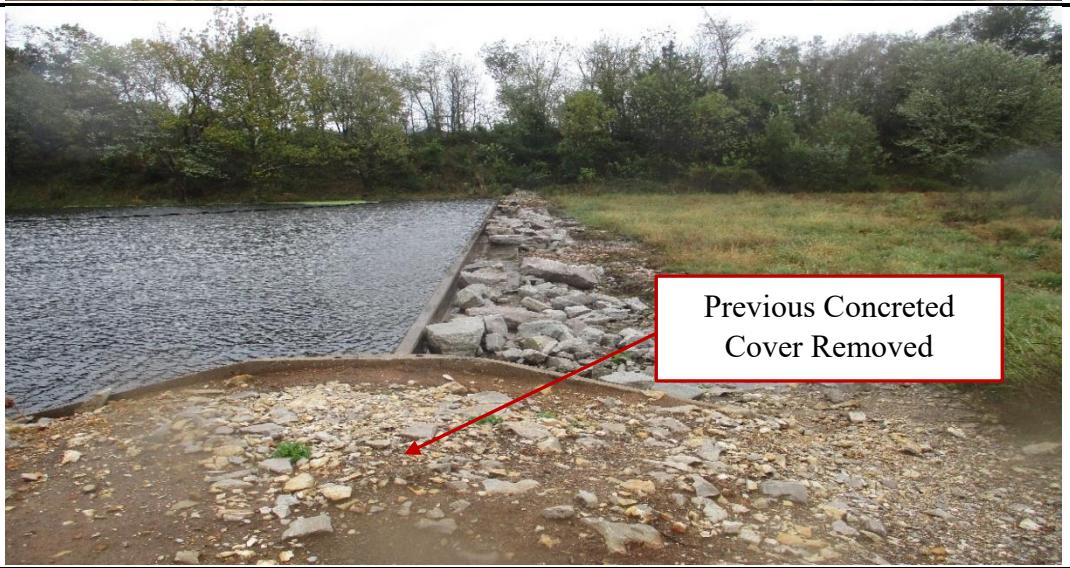
Photograph No. 8

- (vi) The emergency spillway (Photograph No. 8) is an incised channel in natural ground with a concrete weir control section, 1 ft. in height, across the channel width. The spillway was in generally good condition. The spillway appeared to be generally stable. Vegetation control in the natural ground area downstream of the concrete

weir was good. Concrete cover that had hairline cracks was removed from the buttress (north of the spillway).

Emergency spillway concrete sill (looking south).
