2025 Annual Dam and Dike Inspection Report

Wastewater Pond Complex
Formerly named Bottom Ash Pond Complex

Mitchell Plant
Wheeling Power Company & Kentucky Power Company
Marshall County, West Virginia

Document Number: GERS-25-009

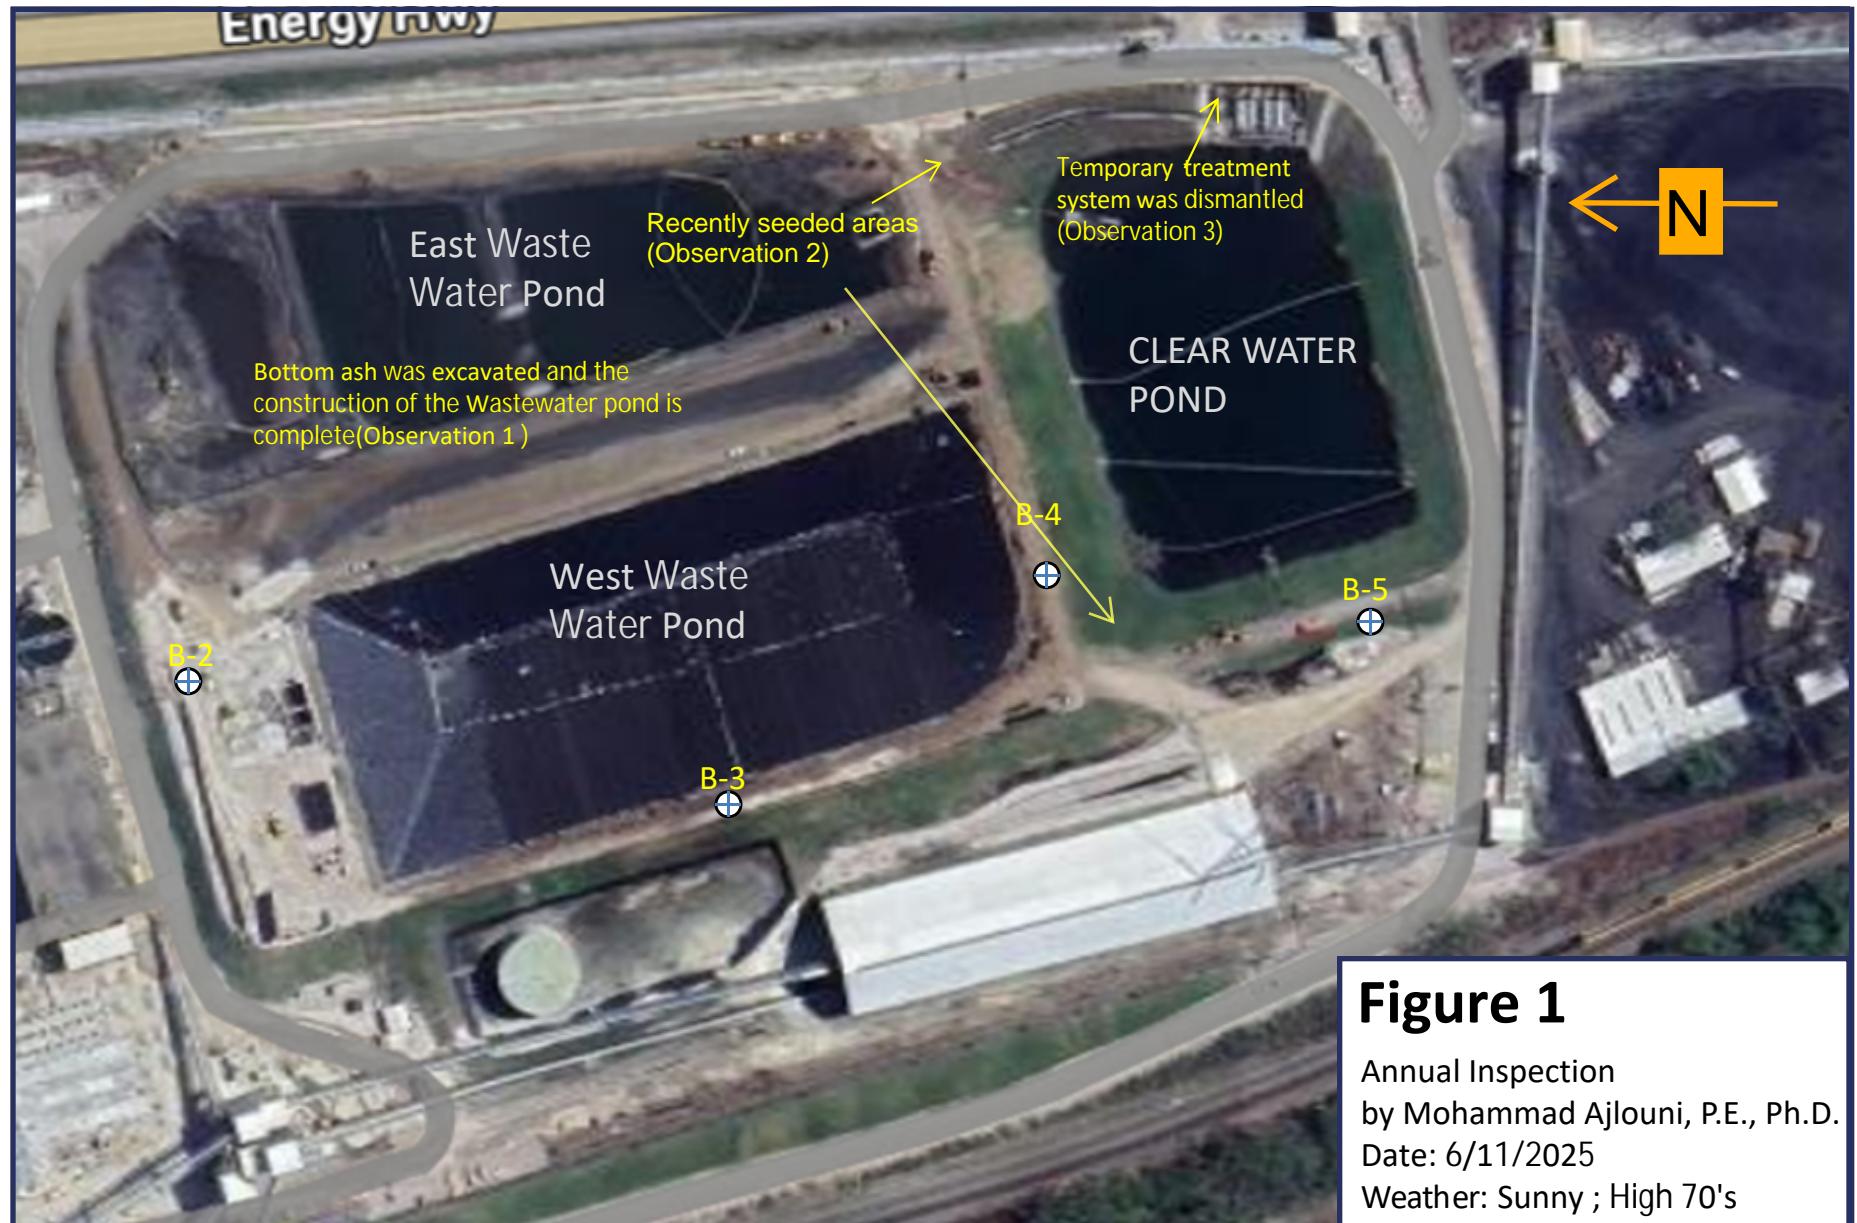
Figure 1

Overall, the facility is in Good condition. The impoundment is functioning as intended with no signs of potential structural weakness or conditions which are disrupting to the safe operation of the impoundment. Inspection photos are included in Attachment A. Additional pictures taken during the inspection are available. A map presenting locations of the inspection observations is included in Figure 1.

The following maintenance items were identified during the visual inspection, see inspection map for locations. Contact GES for specific recommendations regarding repairs:

- Static water levels should continue to be measured on its current frequency for piezometers B-2, B-3, B-4, and B-5.
- The pond pool stages should continue to be recorded on a periodic basis.
- Maintain recently seeded areas downstream embankment slopes for animal burrows.

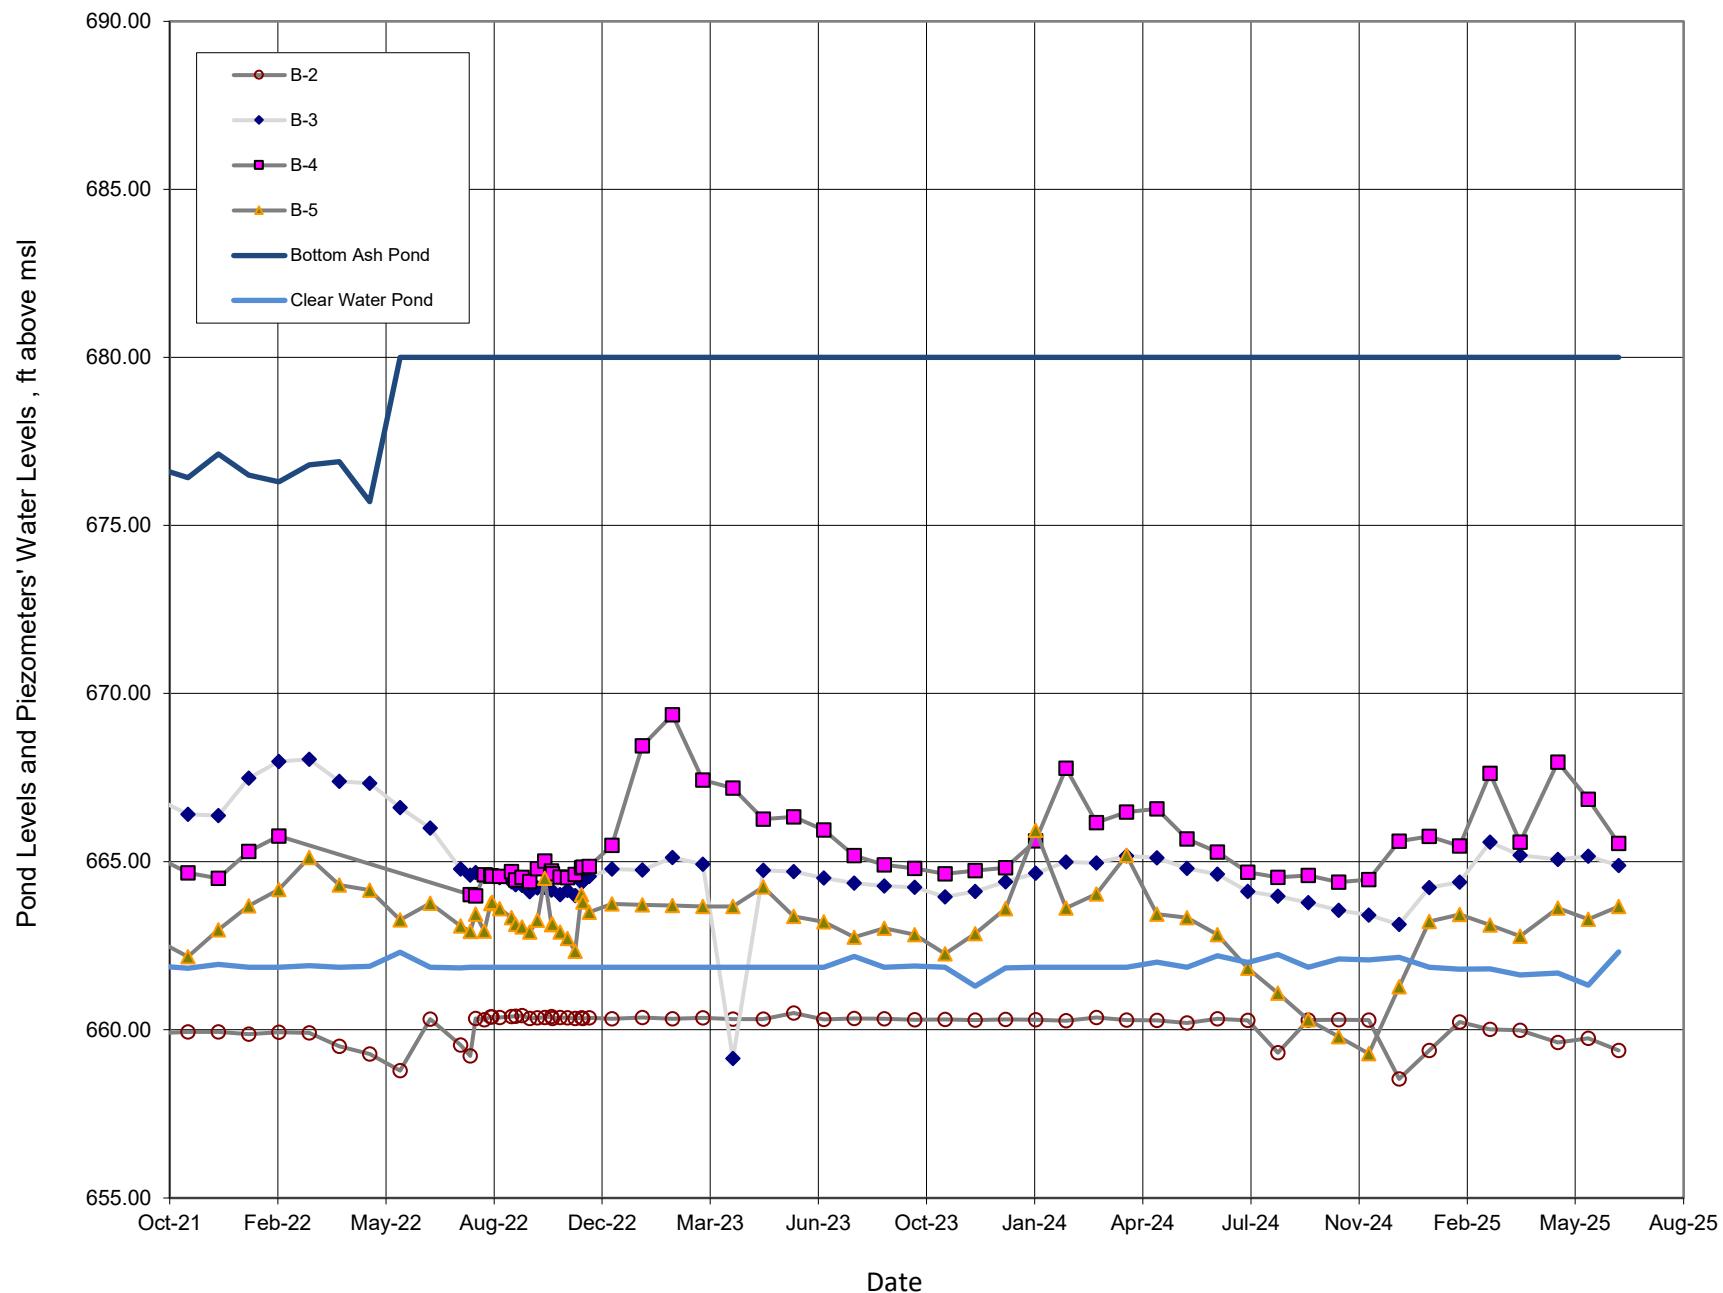
Figure 2 Wastewater Pond Complex Piezometers' & Ponds Level

Figure 2 presents the pond water levels as well as the piezometers water levels. Changes in piezometers levels does not appear to be affected by the WWP level because of the presence of the liner.

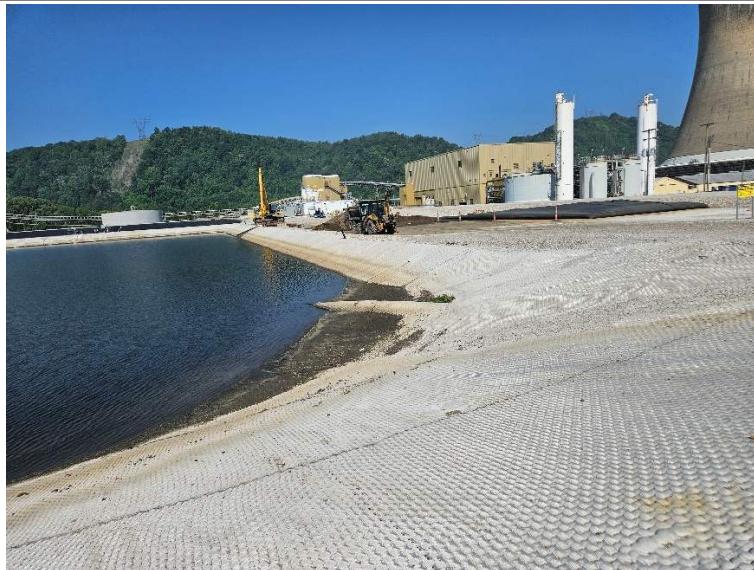
Photo No. 1

East Wastewater Pond. Upstream North Slope. Note Good Condition of Fabriform Revetment.

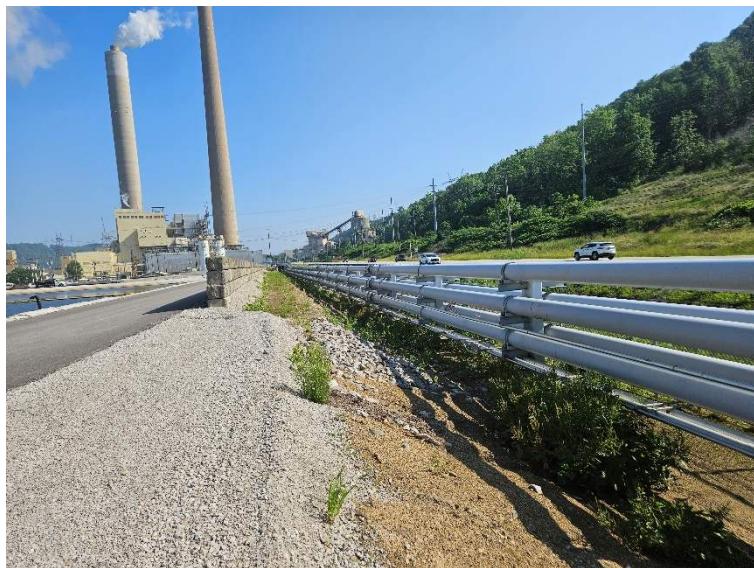
Photo No. 2

East Wastewater Pond. East Downstream Slope Looking North.

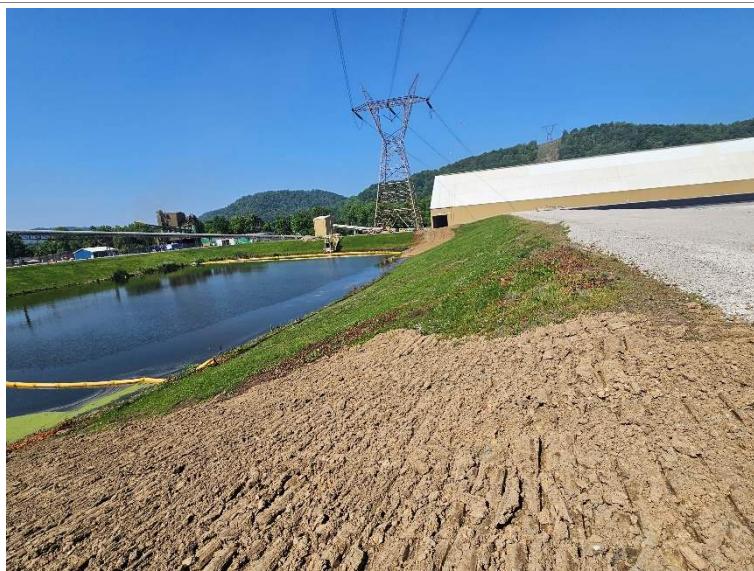
Photo No. 3

East Wastewater Pond. South Downstream Slope Looking West. General Photo.

Note Recently Seeded local area and Gravel Surface on Crest.

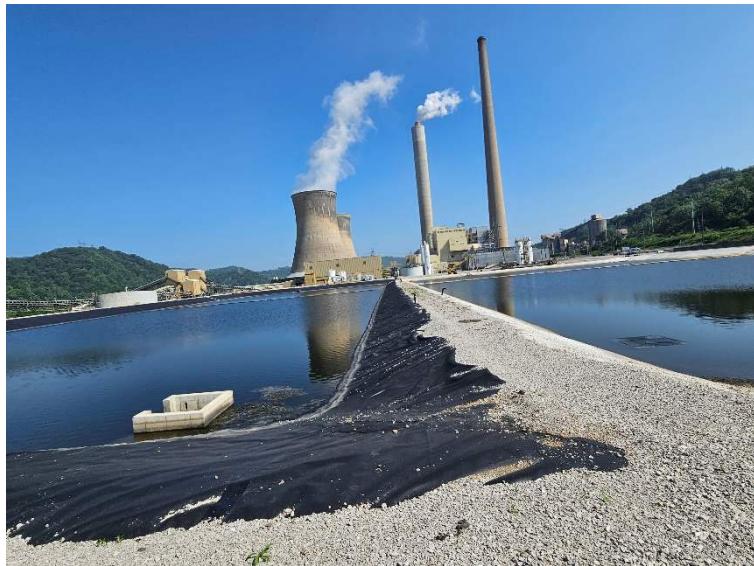
Photo No. 4

West Wastewater Pond. Upstream East Slope looking North. Exposed Liner in good condition

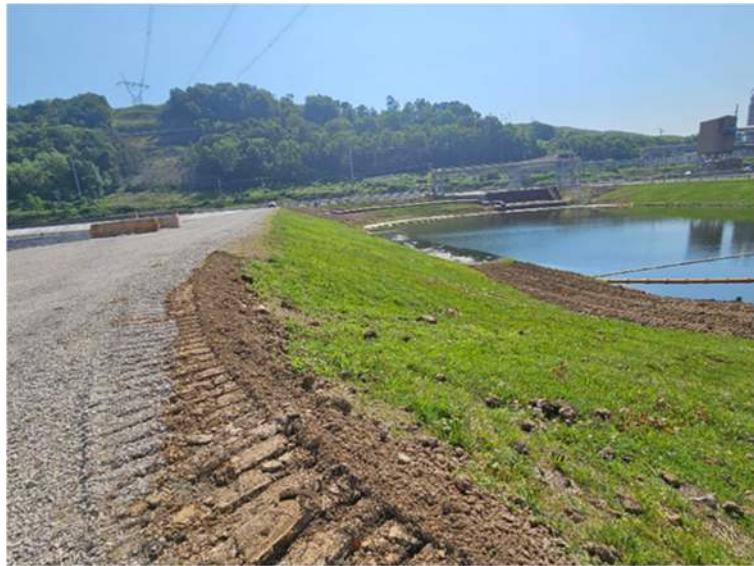
Photo No. 5

West Wastewater Pond. Downstream South Slope. Looking East

General Photo, Typical Conditions.
Note Recently Seeded local area

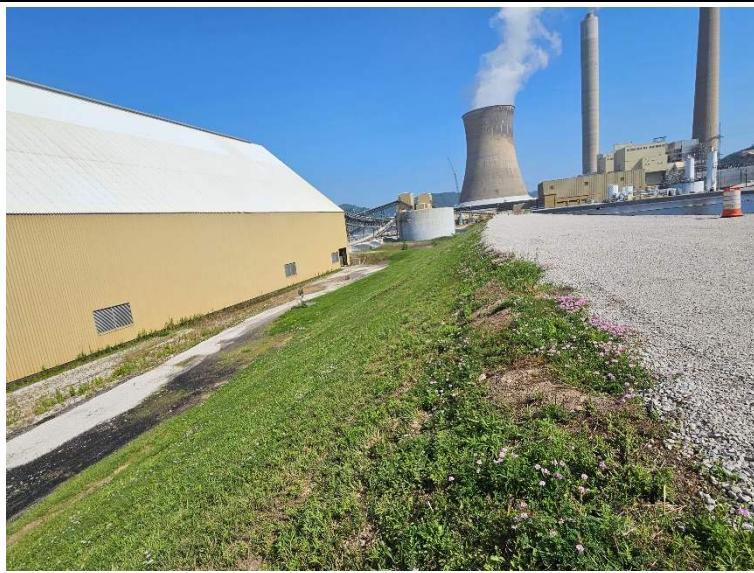
Photo No. 6

West Wastewater Pond. Downstream West Slope. Looking North

General Photo, Typical Conditions.

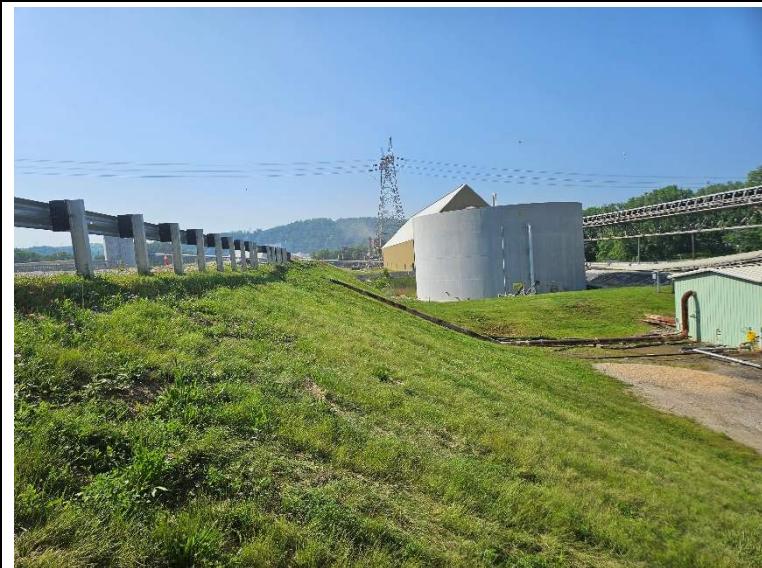
Photo No. 7

West Wastewater Pond. Downstream North Slope. Looking East

Ground Cover, Typical Conditions.

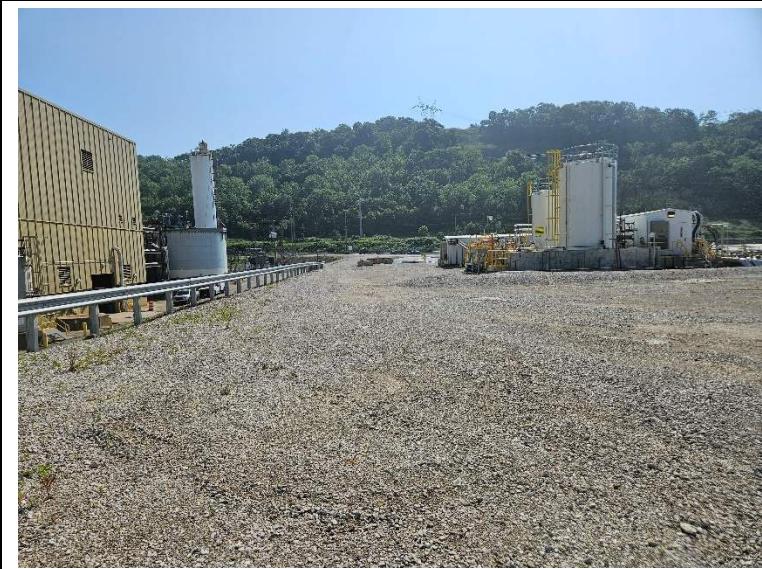
Photo No. 8

Crest of Northern Perimeter Dam. Typical Conditions.

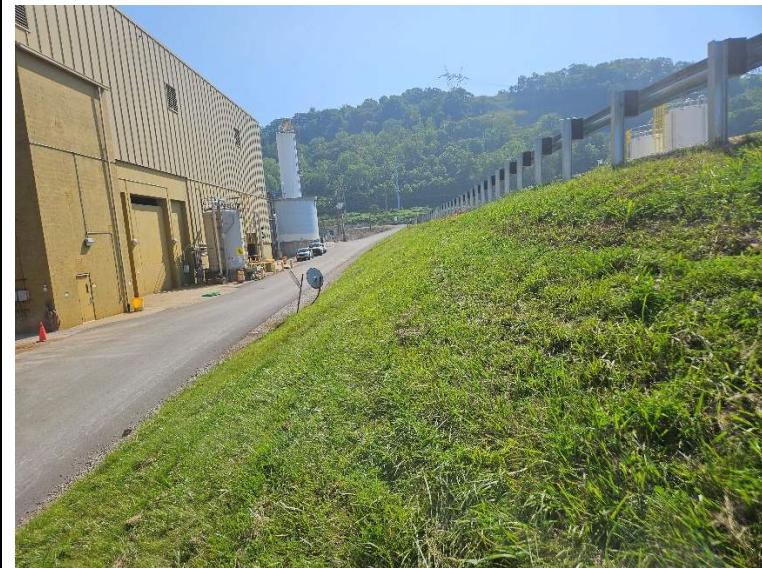
Photo No. 9

Landfill Runoff Collection Pond Dam Adjacent To Toe of Slope Looking East

Overview of Vegetation and General Conditions

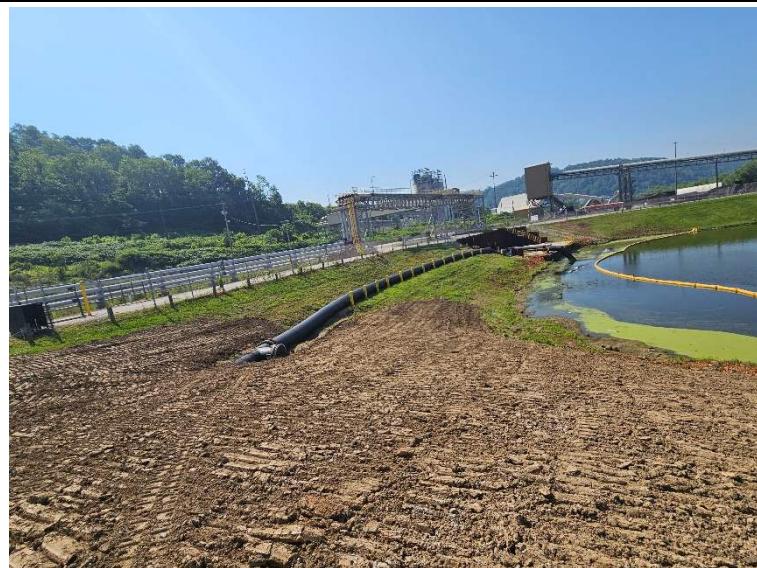
Photo No. 10

1. The Clear Water Pond was in good operating condition during the time of the inspection. Inflows from the West side of WWP enters the CW pond through the newly constructed water conveyance system and the flow appeared to be unobstructed (Photos 10).

Clear Water Pond. Upstream East Slope looking South.

General Photo, Typical Conditions.
Note Recently Seeded local area

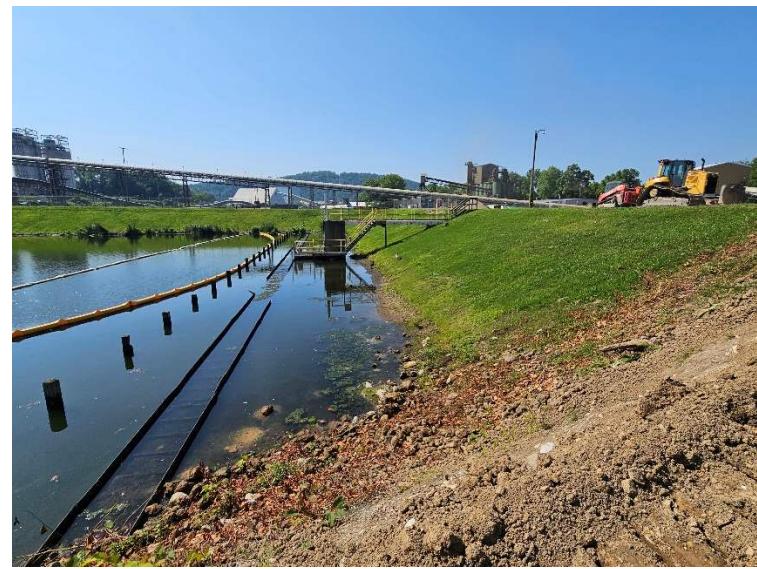
Photo No. 11

Clear Water Pond. Upstream West Slope looking South.

Overview of Vegetation and General Conditions
Note Recently Seeded local area

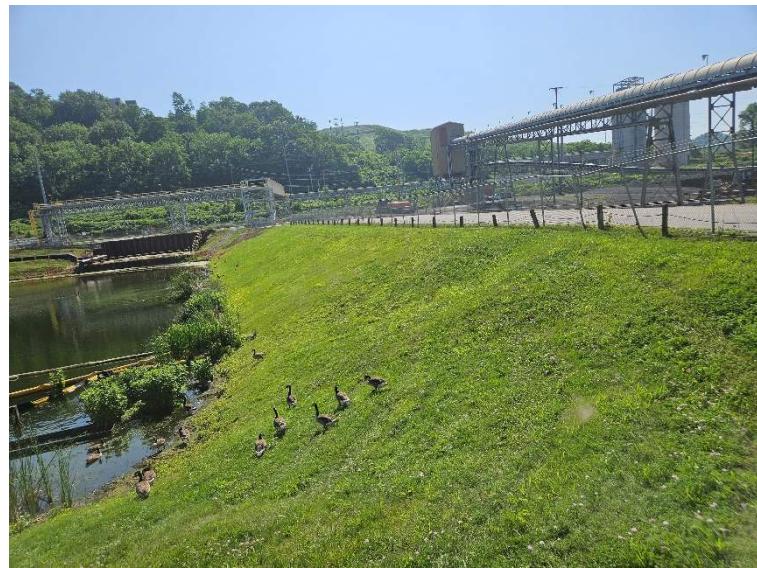
Photo No. 12

Clear Water Pond. Upstream South Slope looking East.

Overview of Vegetation and General Conditions

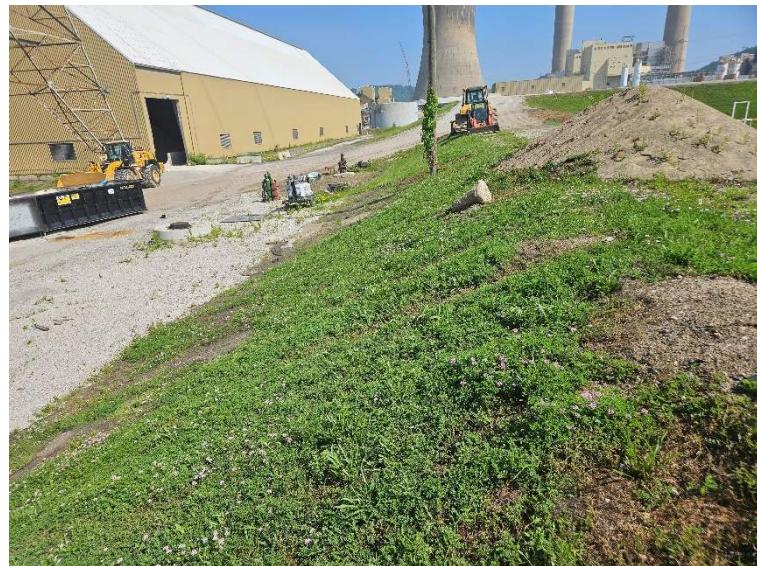
Photo No. 13

Clear Water Pond. Downstream West Slope looking North.

Ground Cover, Typical Conditions.

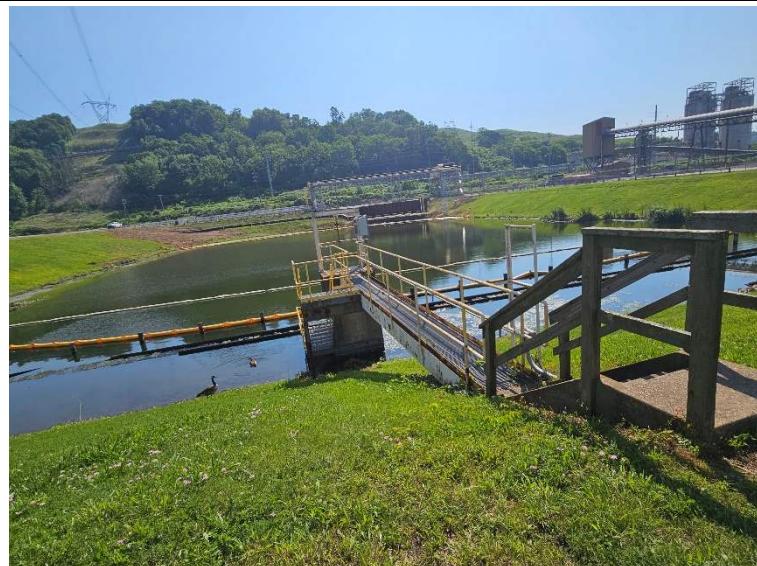
Photo No. 14

Clear Water Pond. Decant Structure / Control Mechanism. Water Elevation ~ 661.4

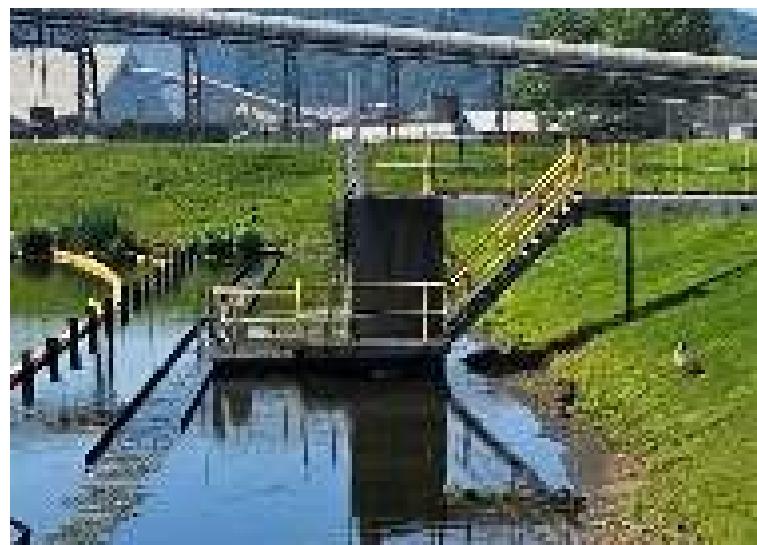
Photo No. 15

7. The visible portions of the concrete discharge structure were in good condition and function properly. The concrete and metal stair structures were in good condition. There was a sediment curtain and boom installed just upstream and it appeared to be in good condition.

Clear Water Pond. Outlet Structure.

General Photo. Typical conditions
