2025 Annual Landfill Inspection Report

**Mitchell Plant
Wheeling Power Company
Moundsville, West Virginia**

August 2025

Document ID: GERS-25-016

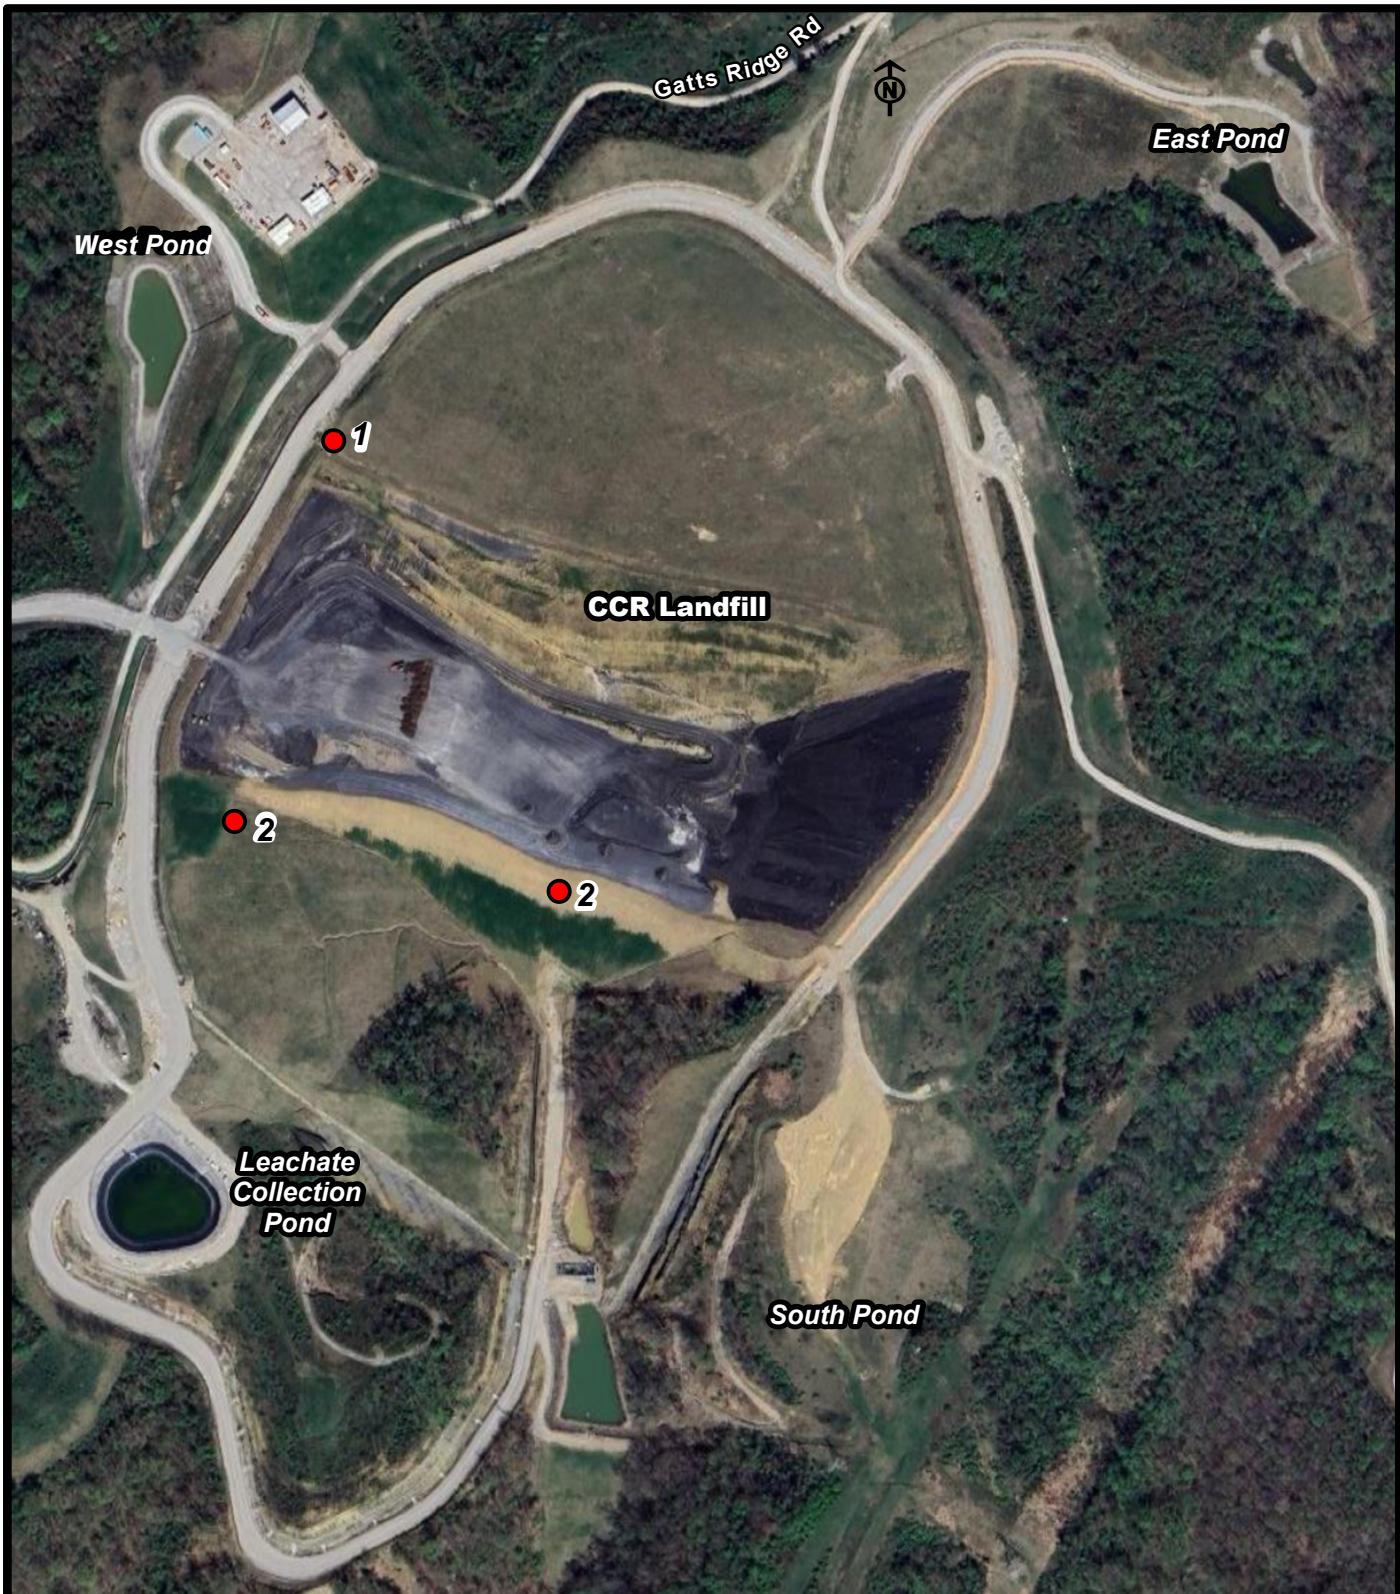
ITEMS TO BE ADDRESSED

The following items were identified during the visual inspection as items to be addressed Figure 3:

1. Item No. 1 – Address minor erosion in the interim cover minor erosion
2. Item No. 2 – Maintain vegetation at the recently raised area of the Clay berm and at the locations of the erosion fixes.

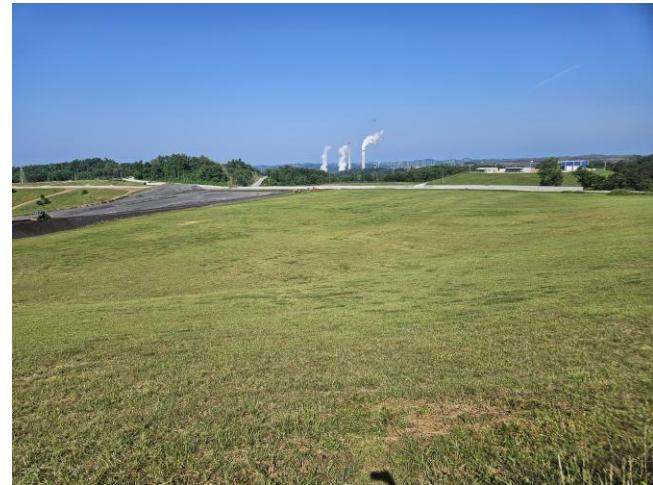
1. The temporary cover on Phase 1 and Phase 2 is satisfactory. The vegetation is maintained to 12-inches or less and there was no ponding water as shown in Photograph 1 and Photograph 2. Minor erosion of the temporary cover, north of Phase 1 as shown in Photograph 1 and Photograph 3.

<p>Photo No. 1</p> <p>Description: General Conditions: temporary soil cover</p> <p>Location: Phase 1</p> <p>Recommendations: N/A.</p>

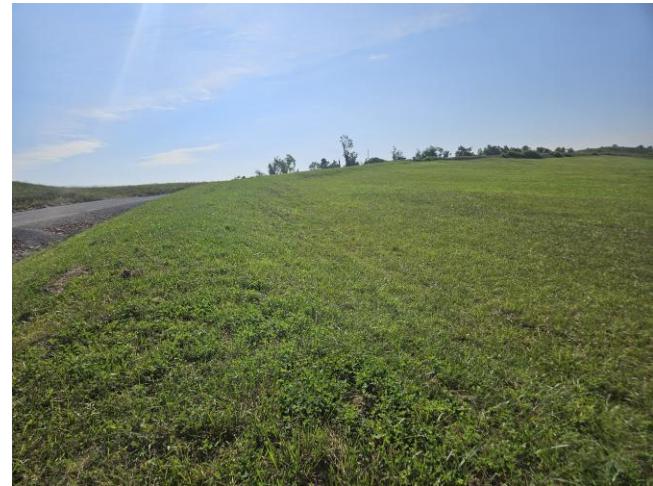
<p>Photo No. 2</p> <p>Description: General Conditions: temporary soil cover</p> <p>Location Phase 2.</p> <p>Recommendations: N/A.</p>

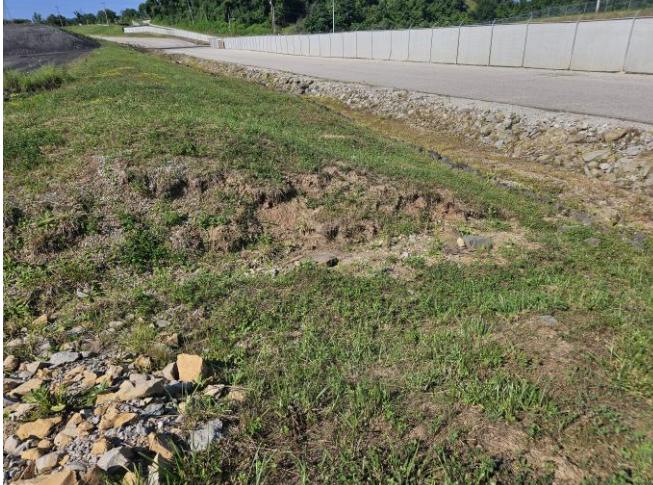
<p>Photo No. 3</p> <p>Description: Interim Cover minor erosion</p> <p>Location: north of phase 1.</p> <p>Recommendations: Address minor erosion before it becomes significant.</p>

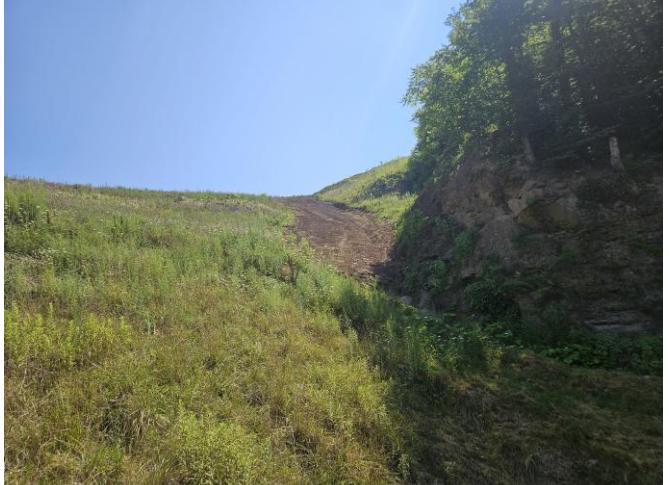
2. The Phase 3 active area is in satisfactory condition. The material is being placed in accordance with fill progression plan and chimney drains were functioning as they were designed as shown in Photographs 4 and 5. The minor erosion observed in last year's inspection in the Phase 3 western and eastern stormwater ditches were ~~fixed~~ as shown in Photograph 6 and Photograph 7.

<p>Photo No. 7</p> <p>Description: Minor erosion observed in last year's inspection was repaired.</p> <p>Location: Mitchell Landfill Phase 3. Eastern Storm Runoff Perimeter Ditch.</p> <p>Recommendations: None.</p>

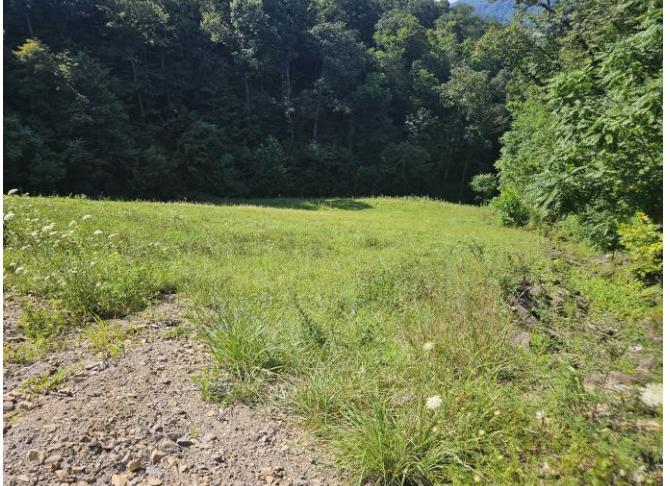
3. The upstream and downstream slopes of the South Pond were in satisfactory condition. The vegetation on the downstream slope was healthy and no erosion was observed as shown in Photograph 8. The upstream slope was covered with riprap and the vegetation was generally maintained to less than 12-inches as shown in Photograph 9. The South Pond outlet structure was in good condition and the trash rack was free of obstructions as shown in Photograph 10.

<p>Photo No. 8</p> <p>Description: Ground Cover, Typical Conditions.</p> <p>Location: South Pond Downstream Slope. Ground Cover, Typical Conditions.</p> <p>Recommendations: None.</p>

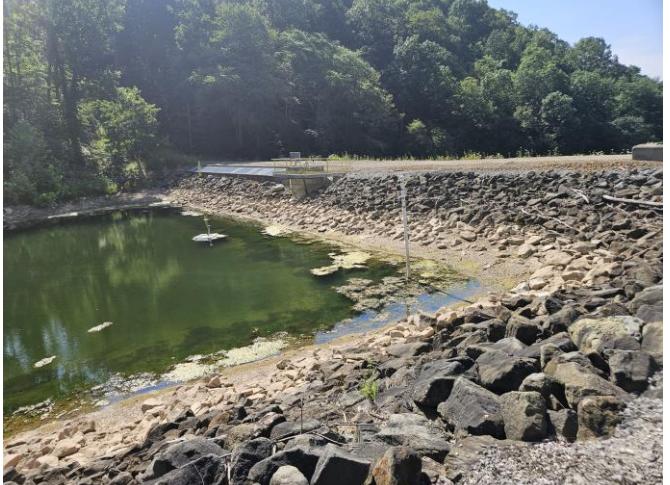
<p>Photo No. 9</p> <p>Description: Typical Conditions.</p> <p>Location: South Pond.</p> <p>Recommendations: None.</p>

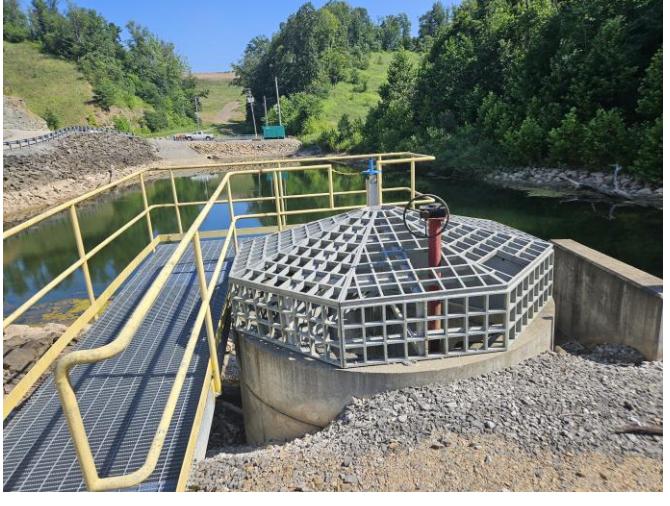
<p>Photo No. 10</p> <p>Description: Decant Structure and Trash Rack working in good condition.</p> <p>Location: South Pond. Decant Structure and Trash Rack working in good condition.</p> <p>Recommendations: None</p>

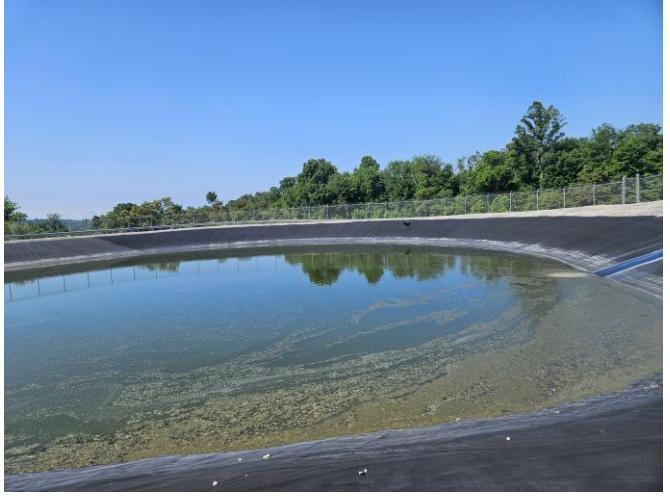
4. The leachate collection pond was in good condition and operating with at least 2-feet of freeboard. No rips or tears were observed in the exposed geomembrane as shown in photographs 11 and 12.

<p>Photo No. 11</p> <p>Description: Exposed geosynthetics in good condition.</p> <p>Location: Leachate Collection Pond. Exposed geosynthetics in good condition.</p> <p>Recommendations: None</p>

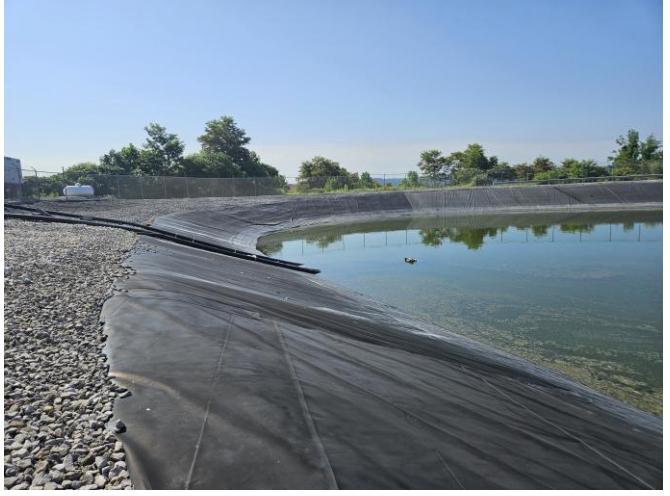
<p>Photo No. 12</p> <p>Description: Exposed geosynthetics in good condition.</p> <p>Location: Leachate Collection Pond. Exposed geosynthetics in good condition.</p> <p>Recommendations: None</p>

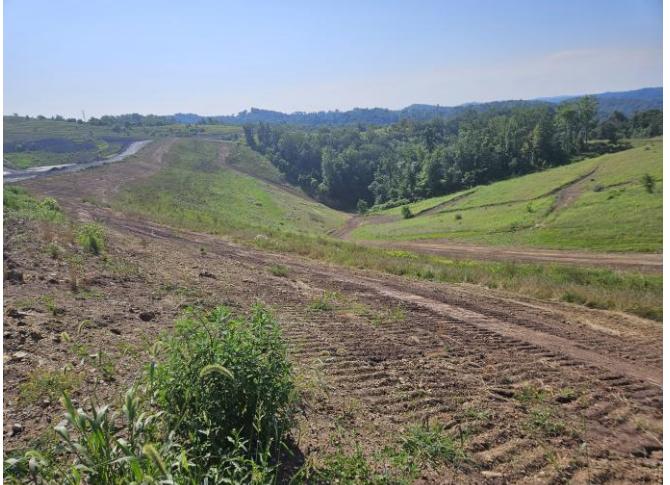
5. At the time of inspection, the clay berm south of Phase 3 was recently mowed with good established grass cover except for the recently raised area and at the locations of the erosion fixes as shown in photograph 13.

<p>Photo No. 13</p> <p>Description: Clay Berm vegetation.</p> <p>Location: Phase 3.</p> <p>Recommendations: maintain vegetation growth for recently raised area and at the locations of the erosion fixes</p>
