# **2025 Annual Landfill Inspection Report**

**Little Broad Run Landfill**

**Mountaineer Plant  
New Haven, West Virginia**

**Date of Inspection:** October 16, 2025

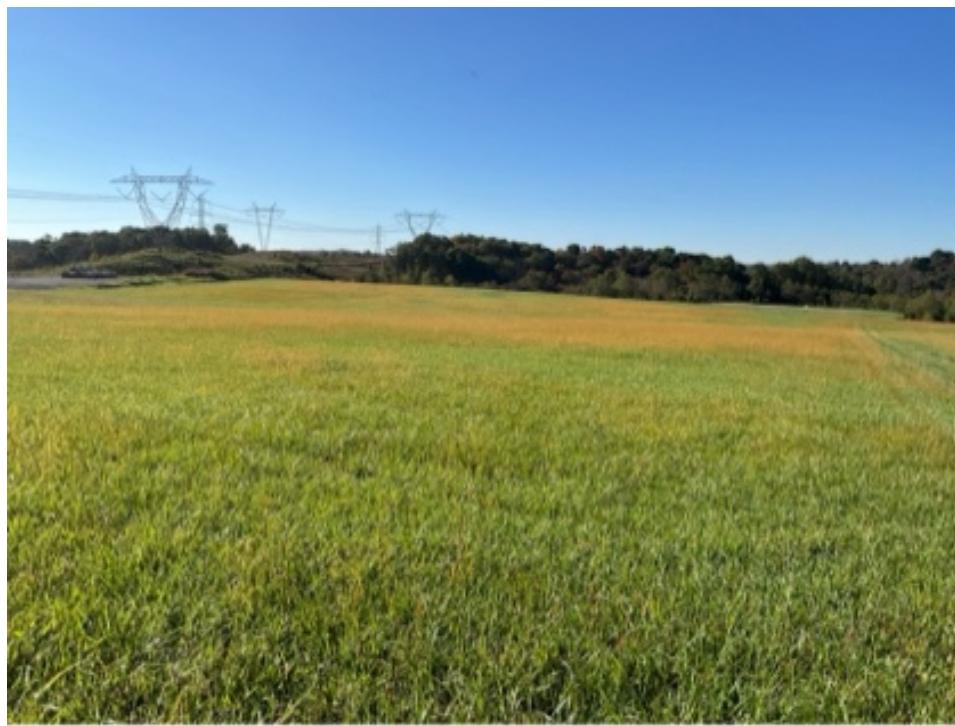
General condition of soil cover over Area 1 looking south

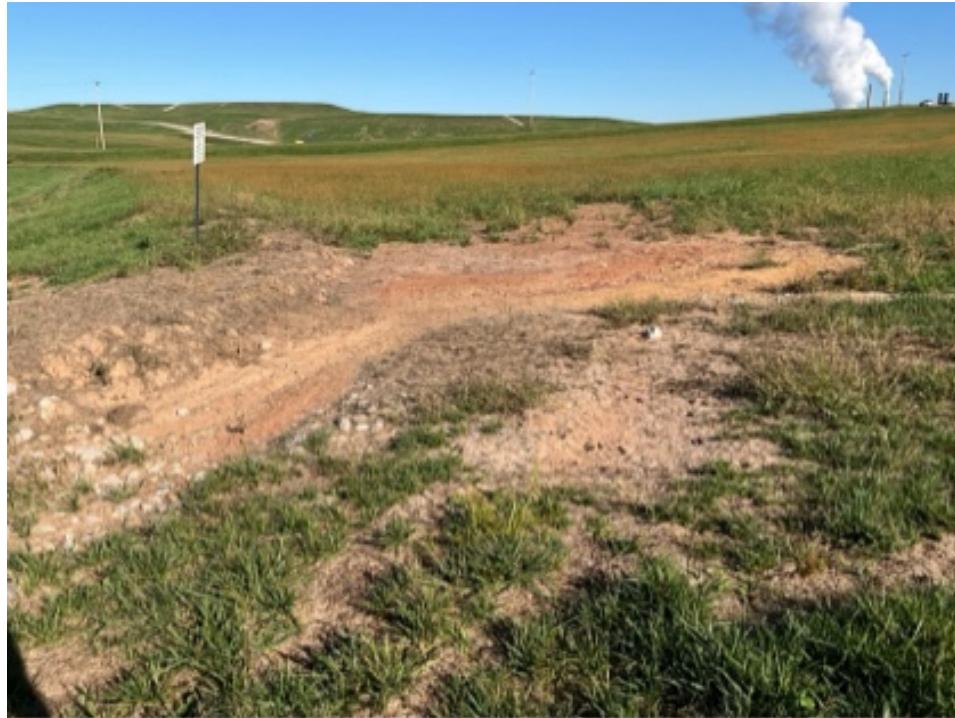
2

1. The soil cover over Landfill Area 1 appeared in satisfactory and with the area with a good stand of vegetation (Photo #1).
2. On the southwest side of Area 1 where the top drainage channels breaks over the ridge needs to be repaired and vegetated or armored (Photo #2)

Vegetation missing from shallow channel on cover at edge of fill where top breaks to slope

1. Repair and reseed the areas on the southwest side of Area 1.
2. Remove cattail growth on the interior slopes of the dikes of the northwest sediment pond.
3. Continue periodic mowing of soil cover areas.

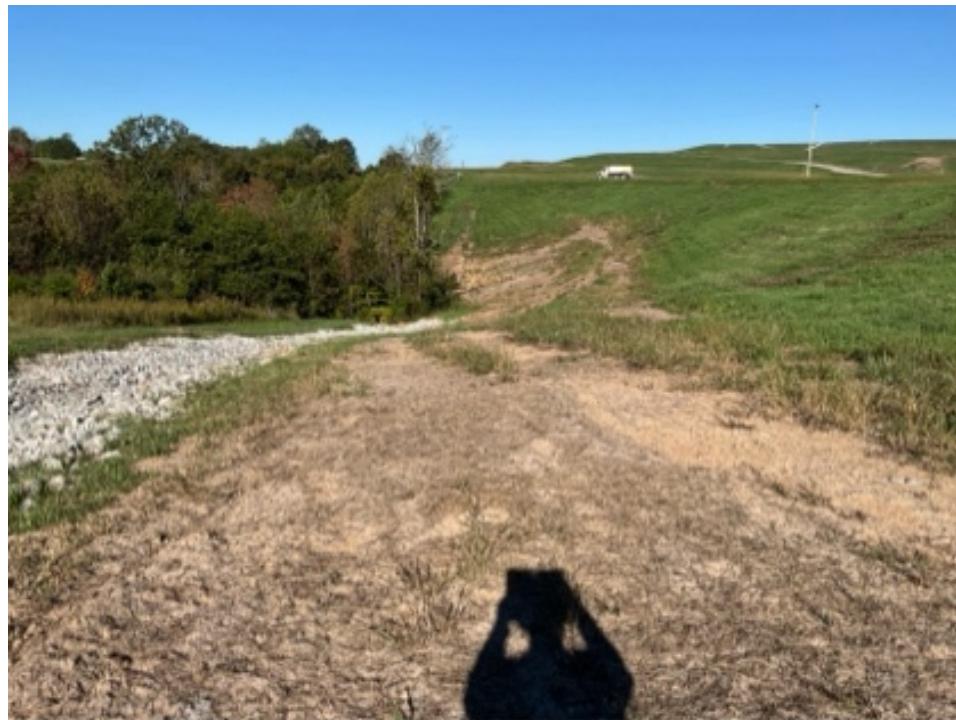
3

General condition of bench and slope along southwest side of Area 1 looking northwest. Vegetation from recent repairs not taken.

3. The bench on the southwest side of Area 1 has been repaired and needs to be reseeded to establish vegetation (Photos #3 & #4).
4. The soil cover and vegetation in Area 2 was satisfactory (Photos #5 & #6) with no signs of erosion or deformation.

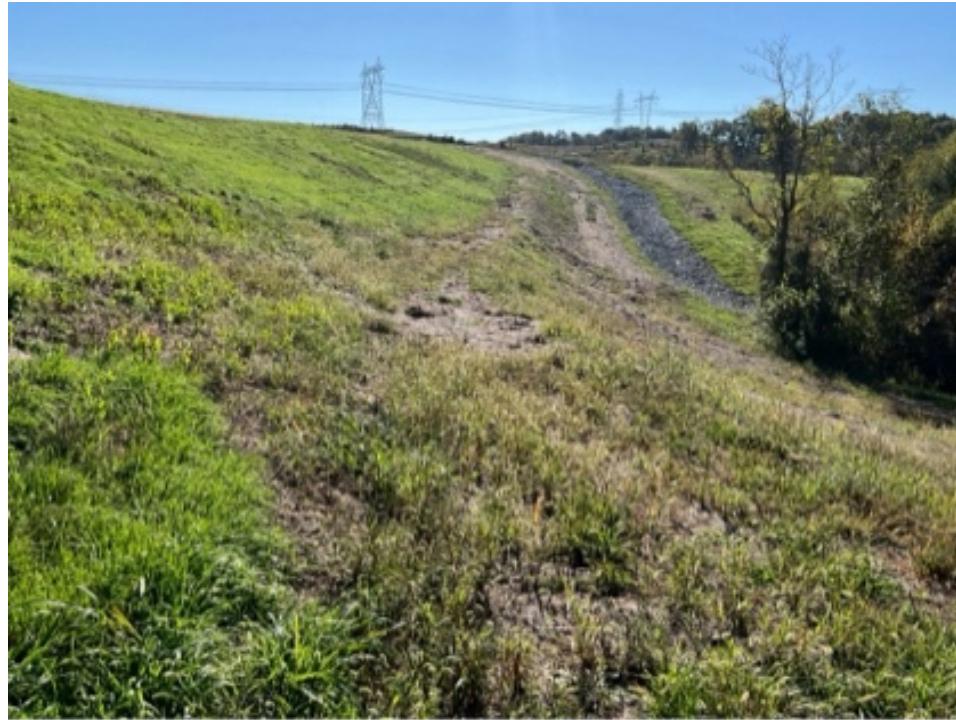
4

General condition of bench and slope along southwest side of Area 1 looking southeast. Vegetation from recent repairs not taken.

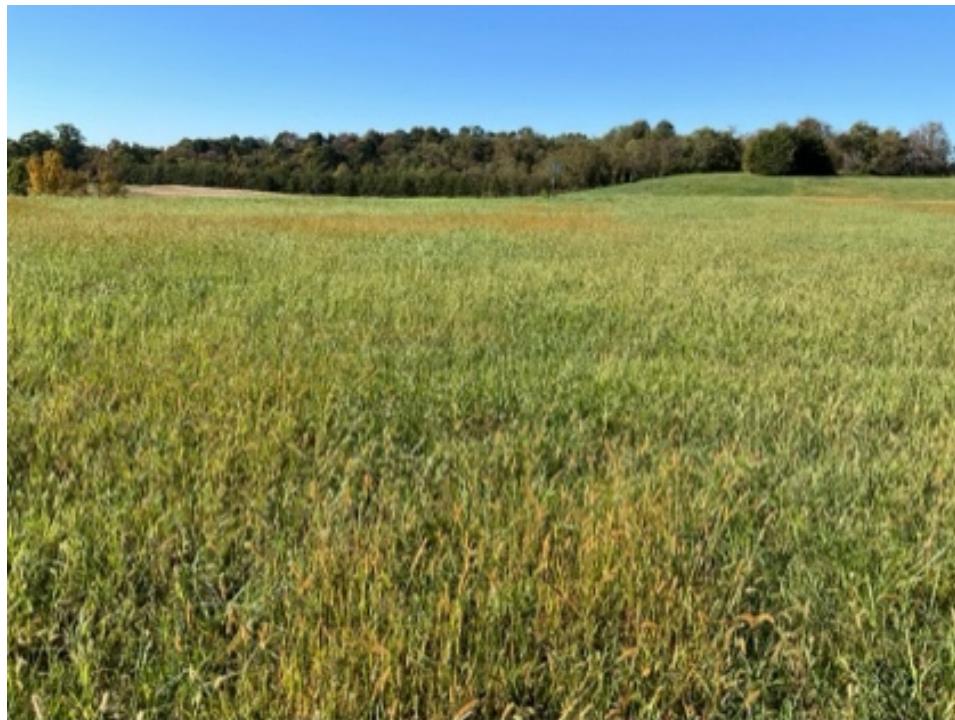
Photo #: 5

Notes: General condition of soil cover over Area 2 looking west

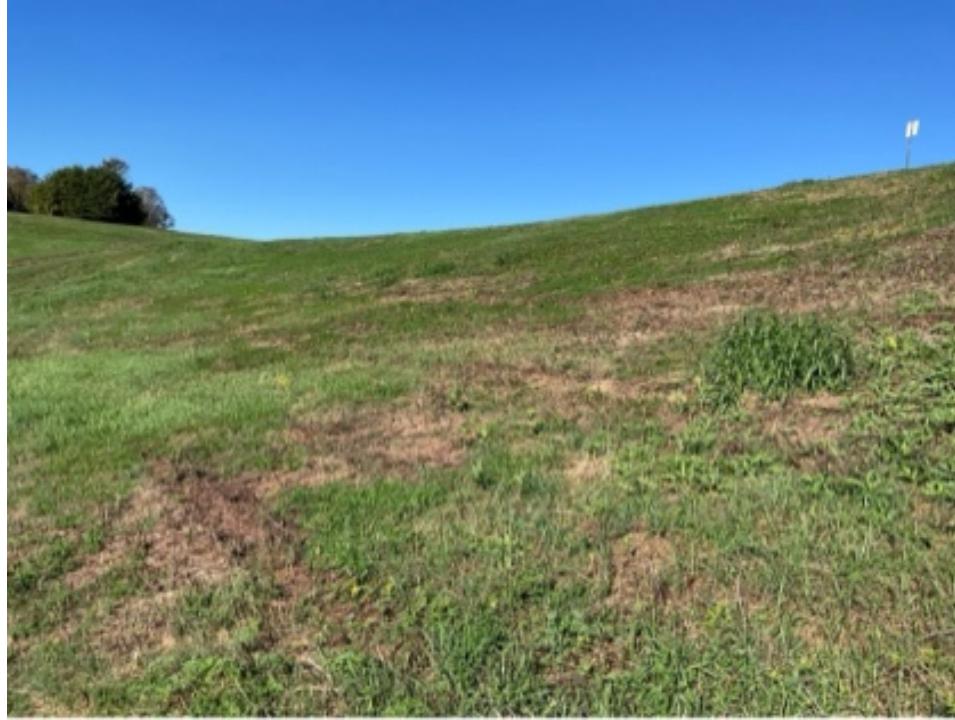
Photo #: 6

Notes: General condition of soil cover on south slope of Area 2

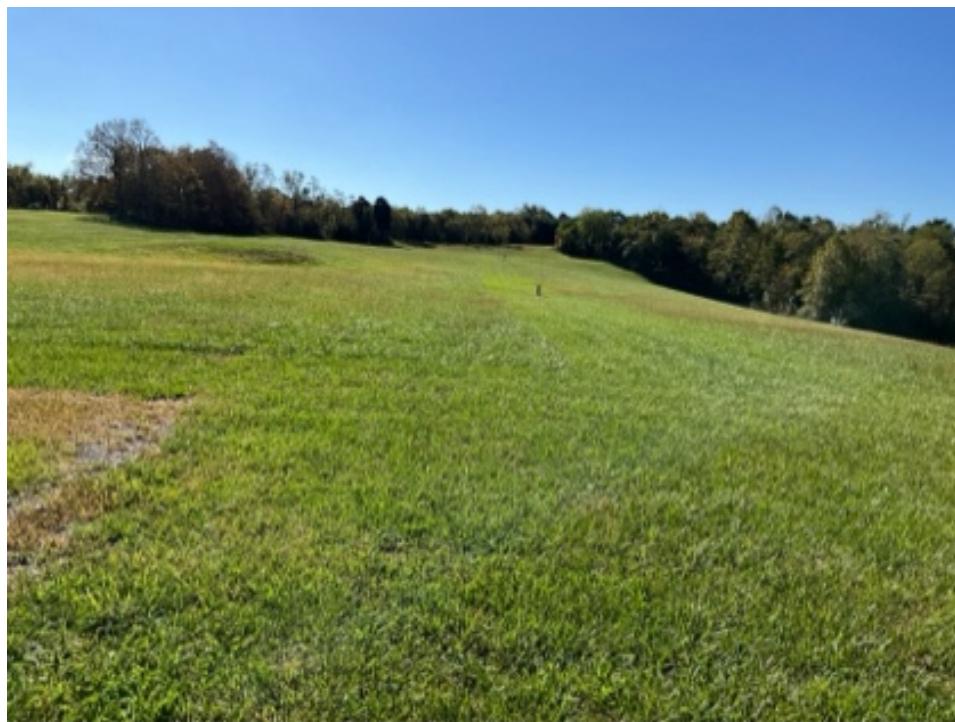
7

General condition of soil cover over Area 3 looking south

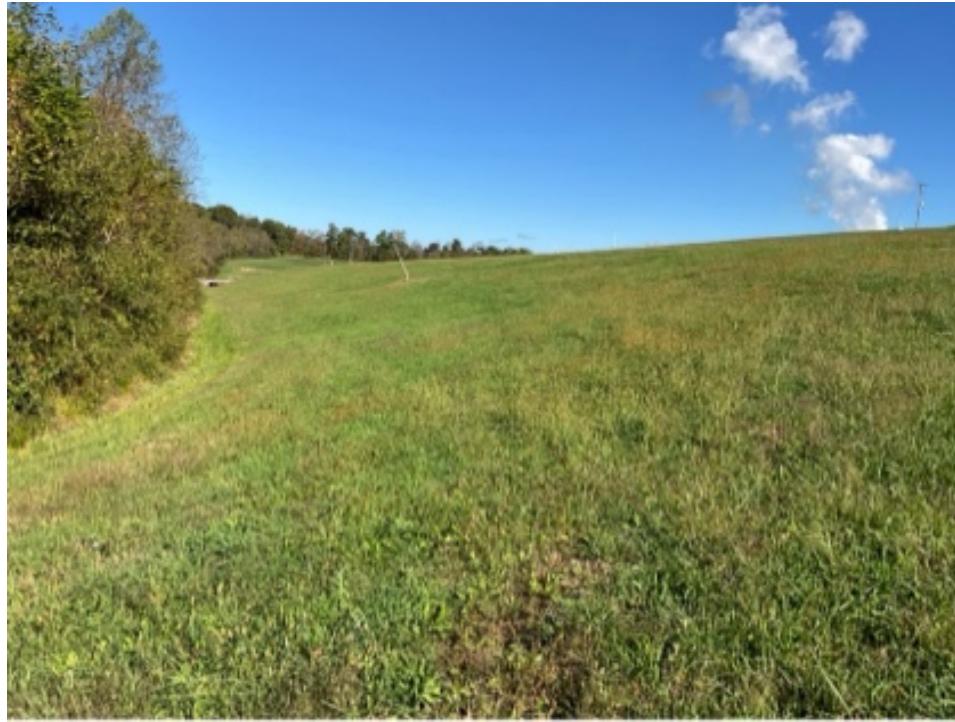
8

General condition of soil cover over Area 3 in area of 2017 slip repair.

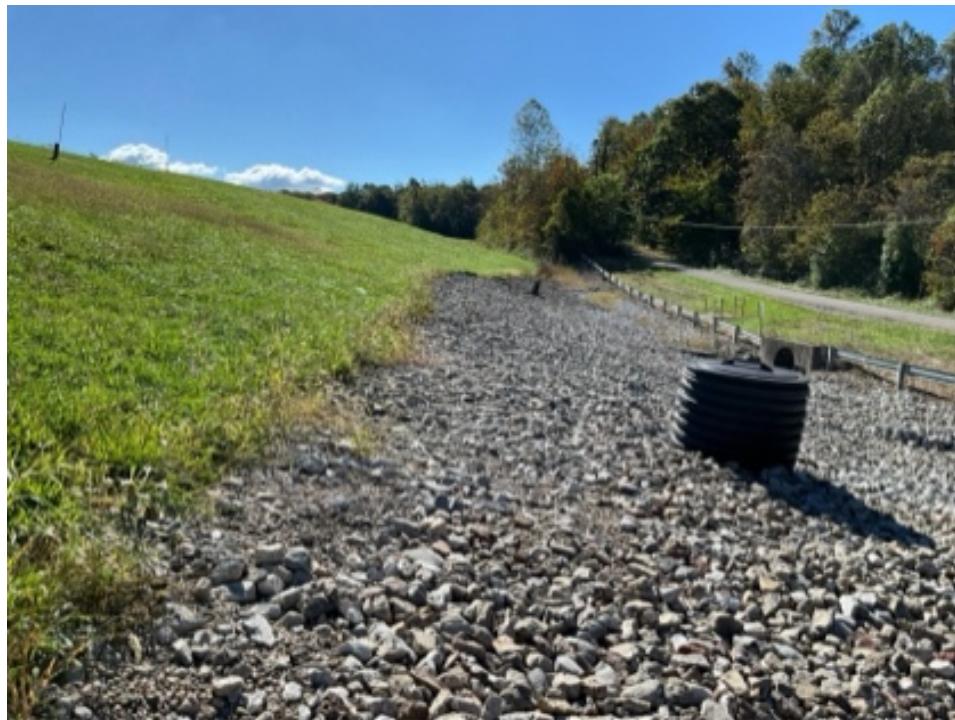
9

General condition of soil cover over Area 3 in area of 2004 slip repair.

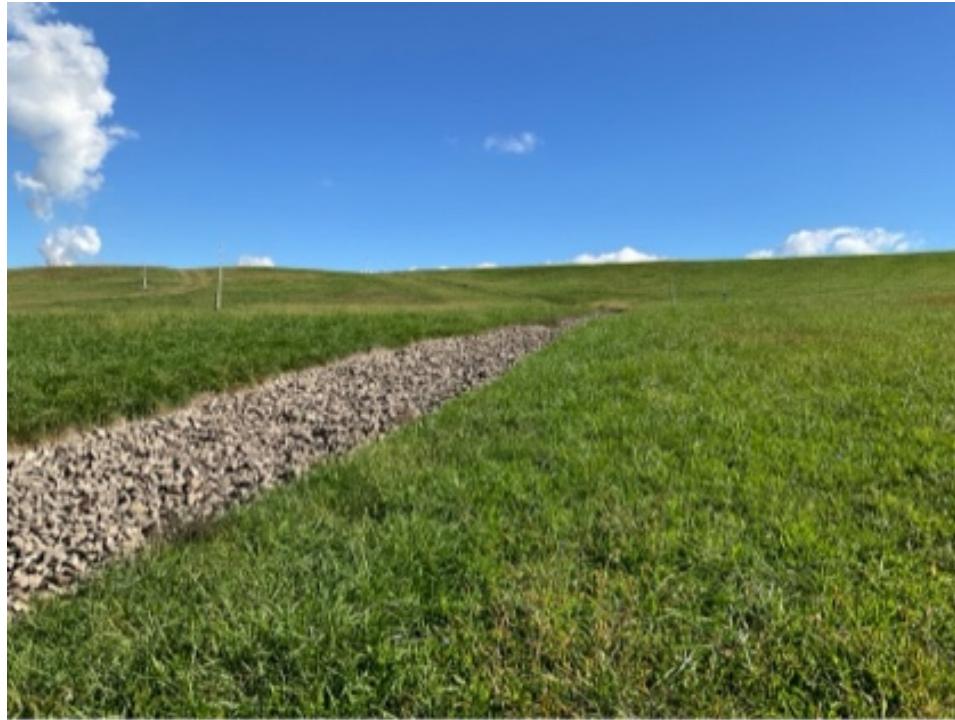
10

General condition of soil cover over Area 3 looking east.

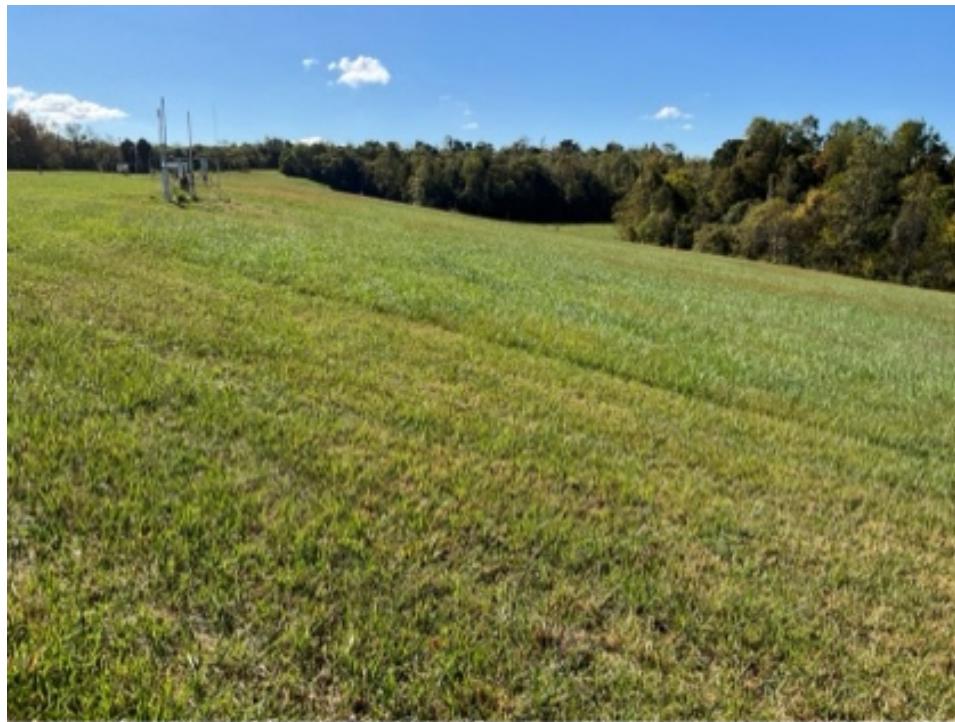
Photo #: 11

Notes: General condition of soil cover over Area 3 looking south

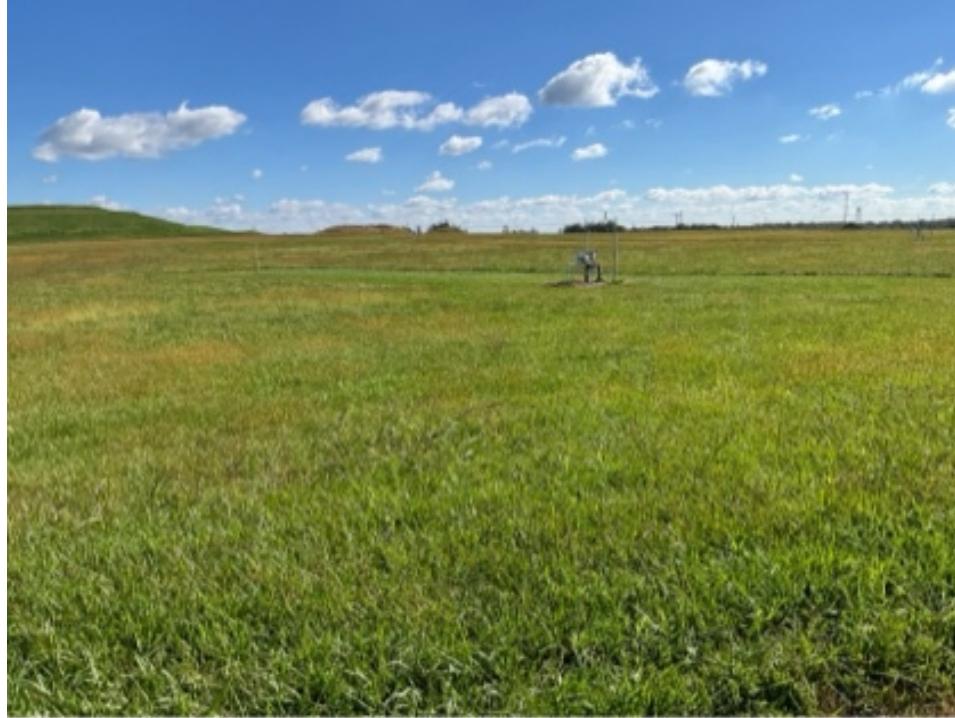
Photo #: 12

Notes: General condition of soil cover over Area 3 looking east

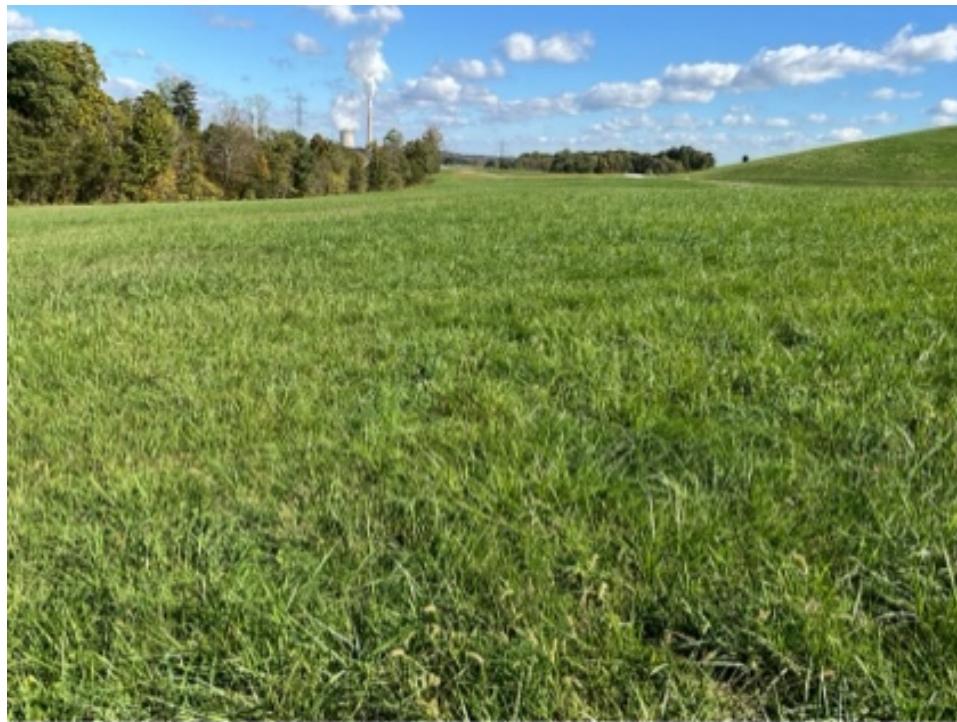
13

General condition of soil cover over Area 4 looking east

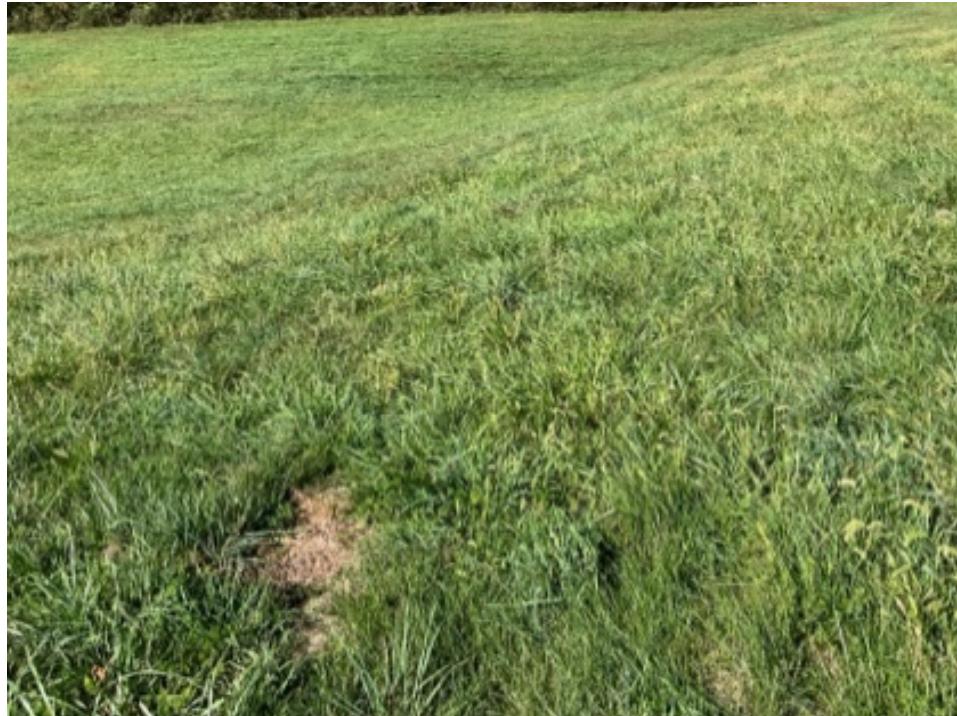
14

General condition of soil cover over Area 4 looking northwest.

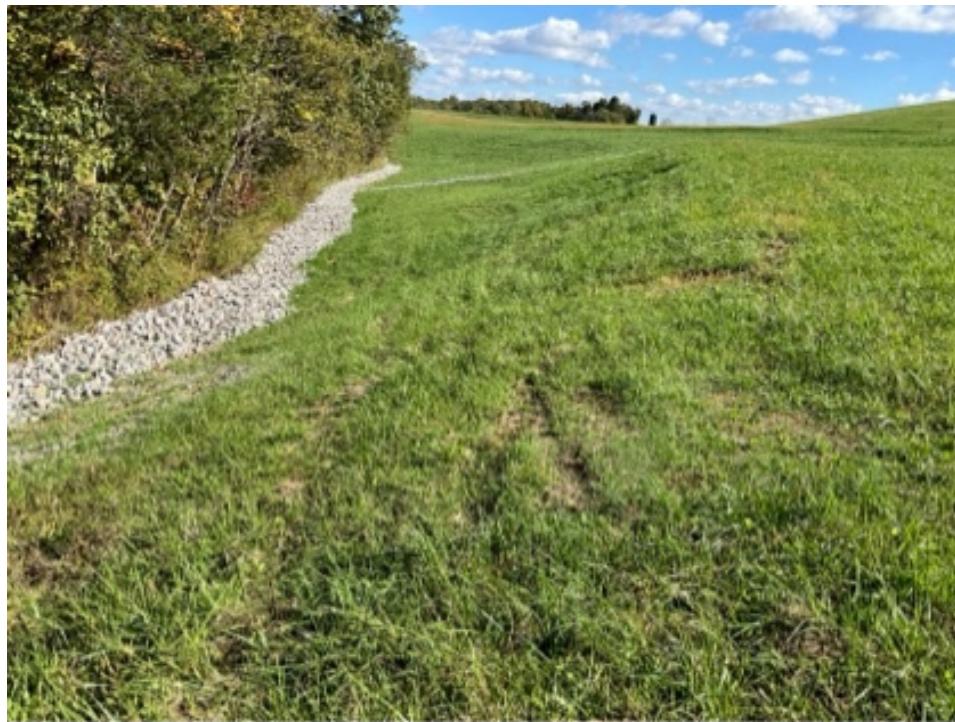
Photo #: 15

Notes: General condition of soil cover over Area 4 looking east along slope

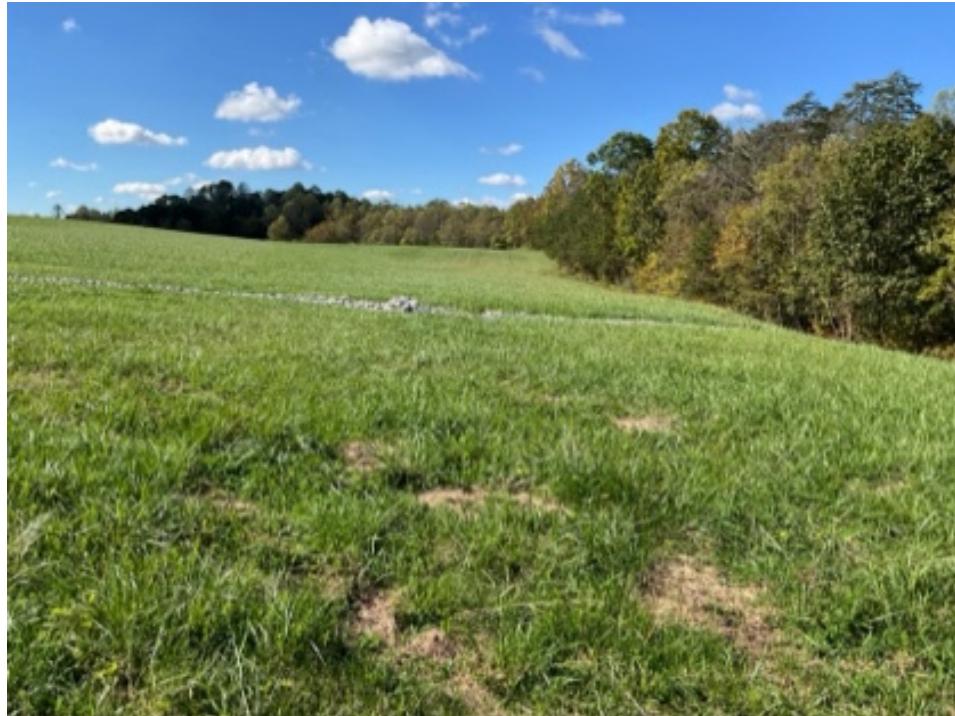
Photo #: 16

Notes: General condition of soil cover over Area 4 looking north

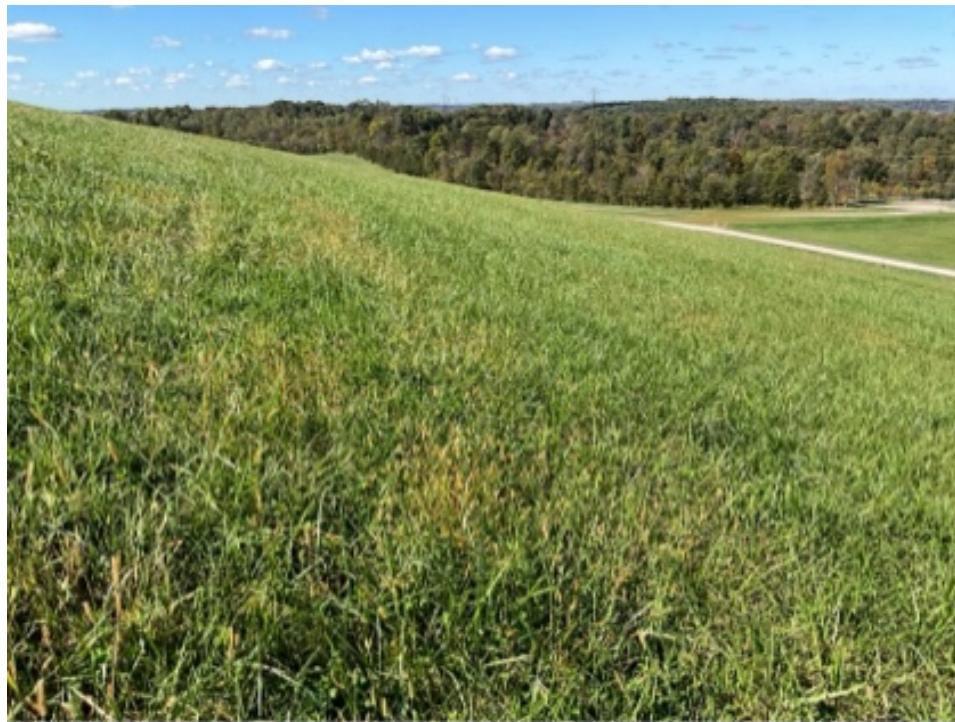
Photo #: 17

Notes: General condition of soil cover over Phase 1 north slope looking west

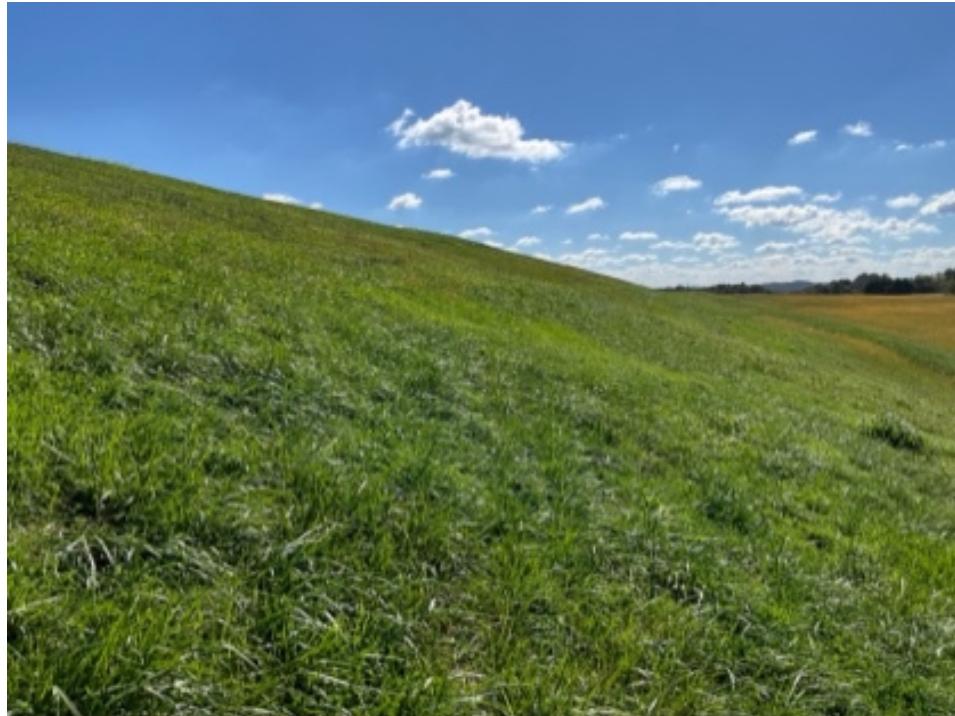
Photo #: 18

Notes: General condition of soil cover over Phase 1 west slope looking south

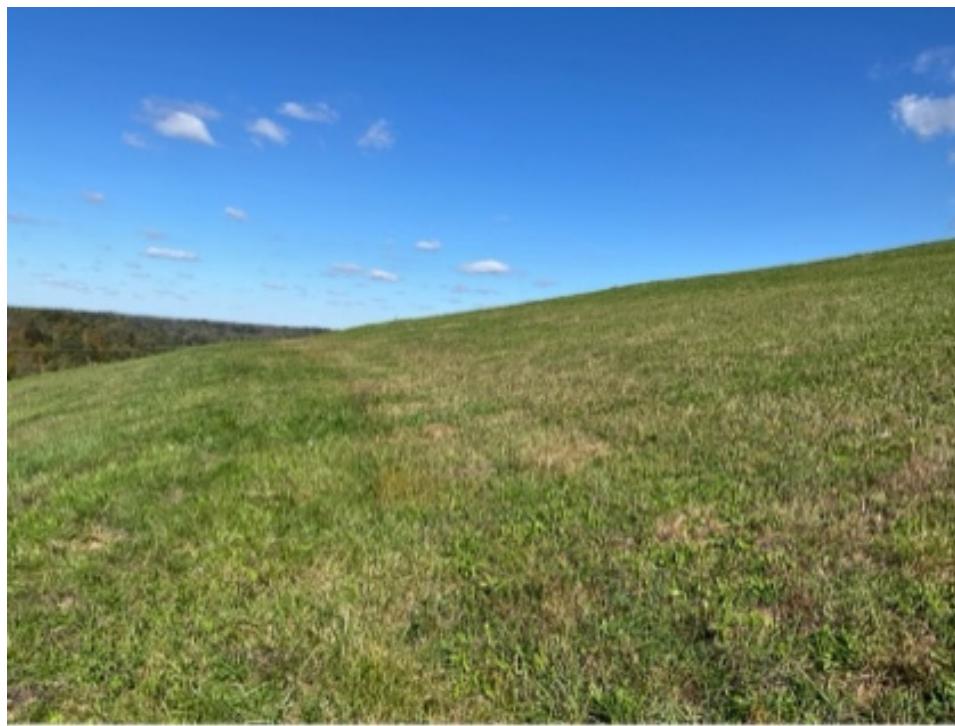
19

General condition of soil cover over Phase 1 west slope looking north

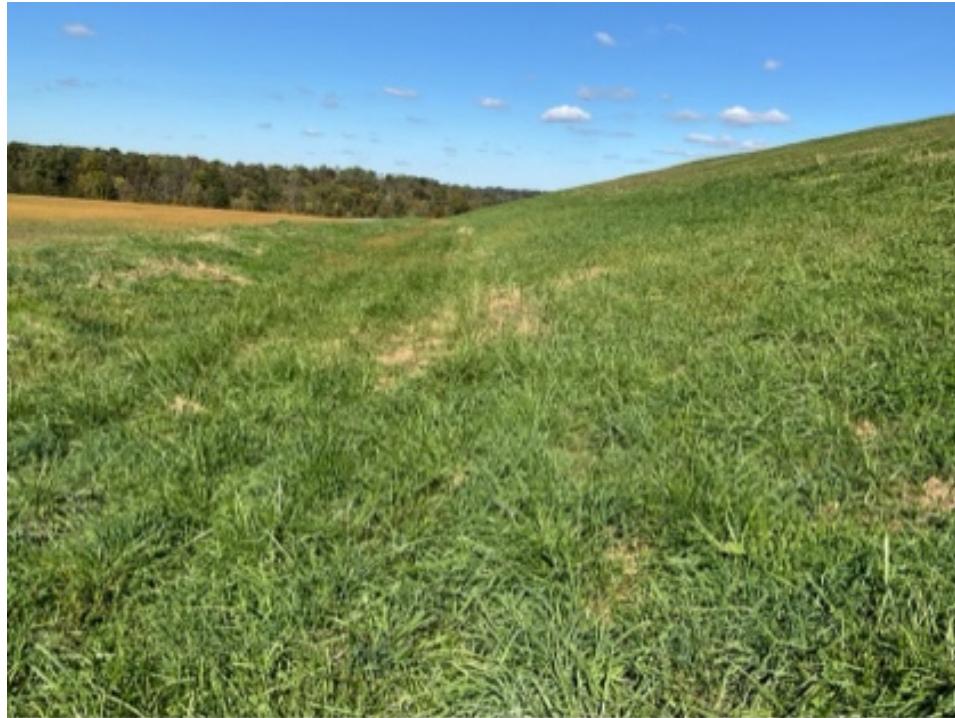
20

General condition of soil cover over Phase 1 west slope looking north

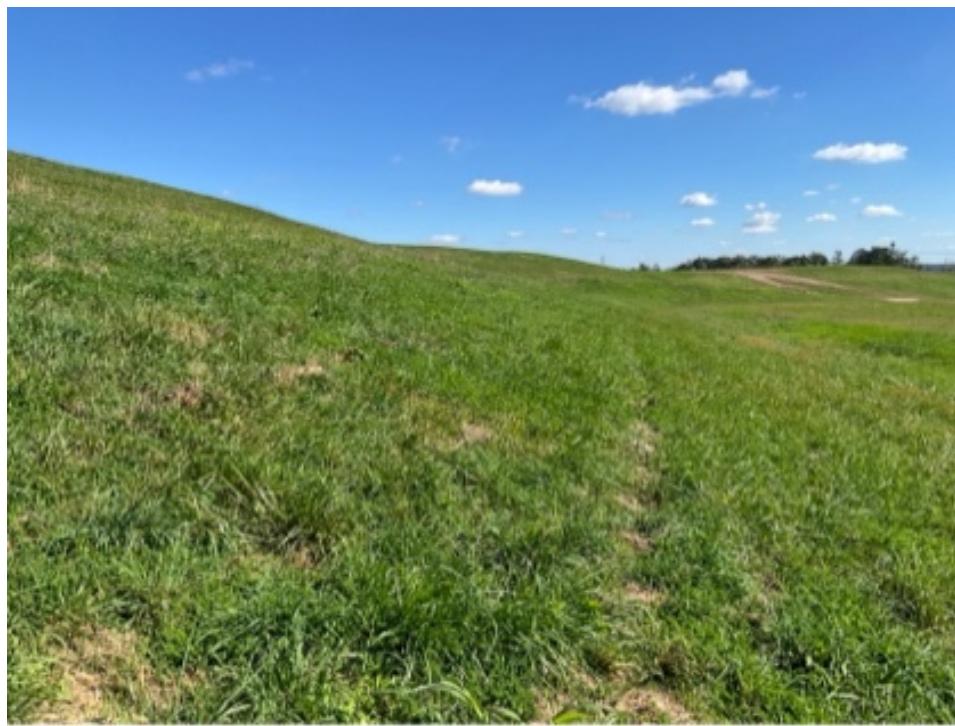
Photo #: 21

Notes: General condition of soil cover over Phase 1 southwest slope looking east

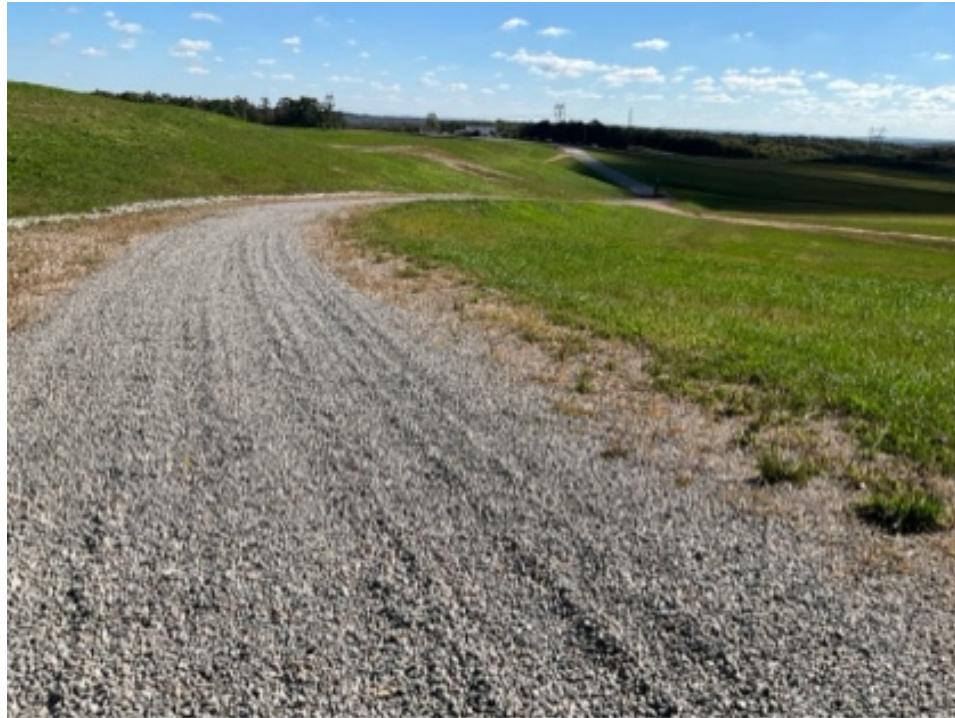
Photo #: 22

Notes: General condition of access road

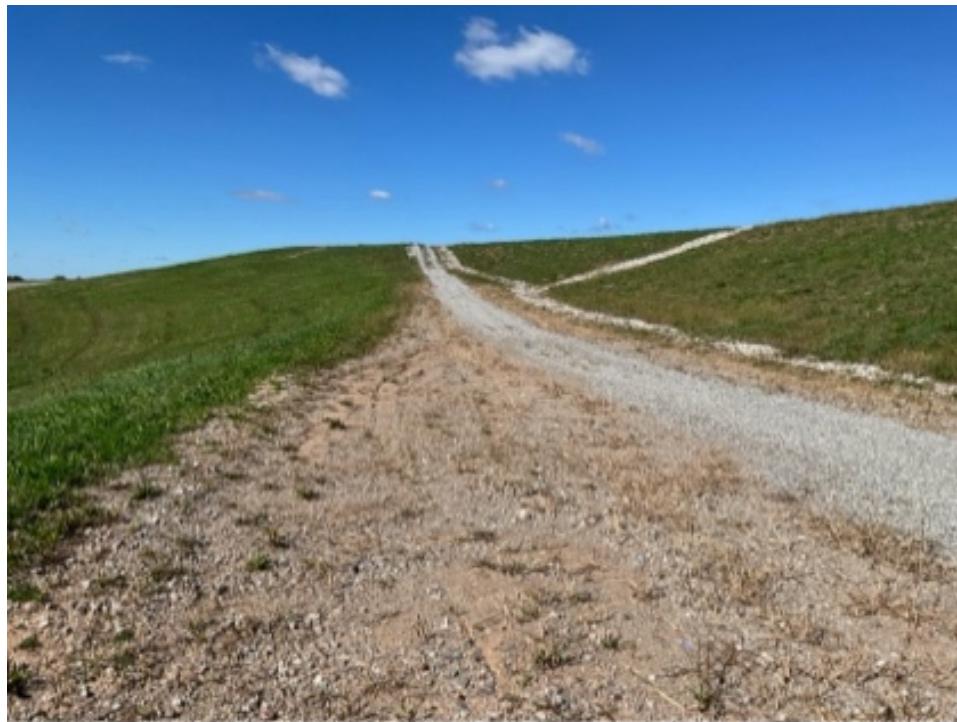
23

General condition of secondary access road

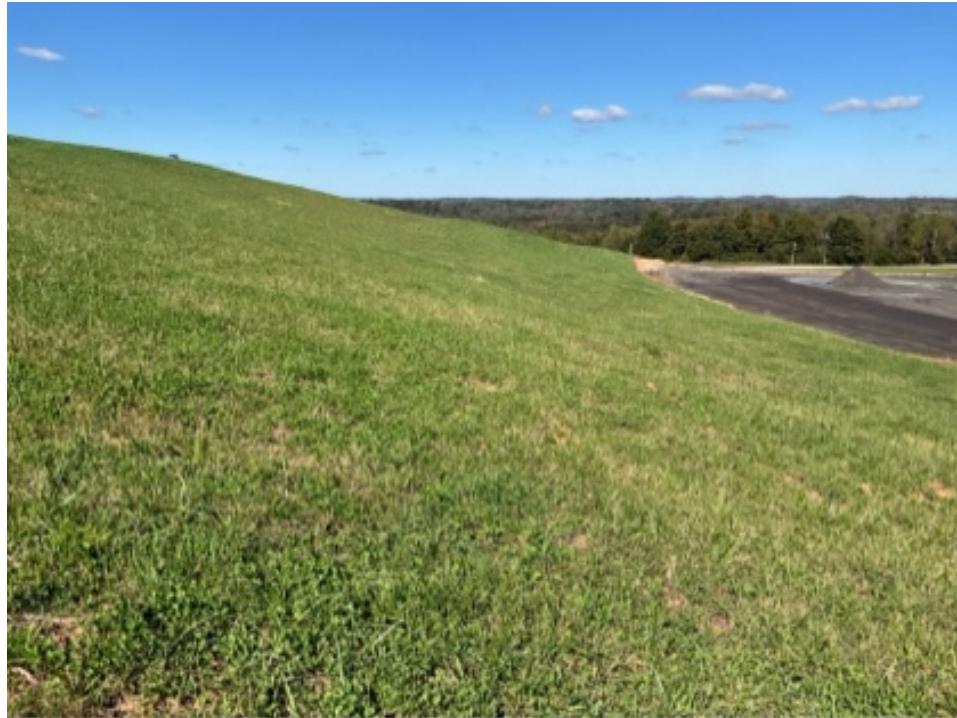
24

General condition of soil cover over Phase 1 east slope looking north

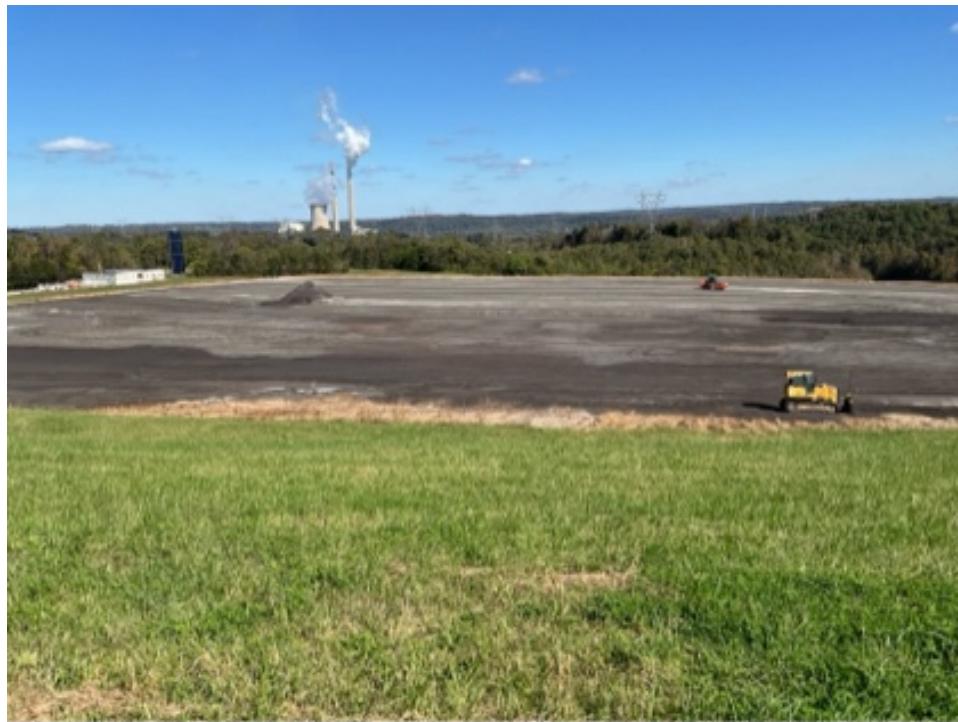
Photo #: 25

Notes: General condition of active working face

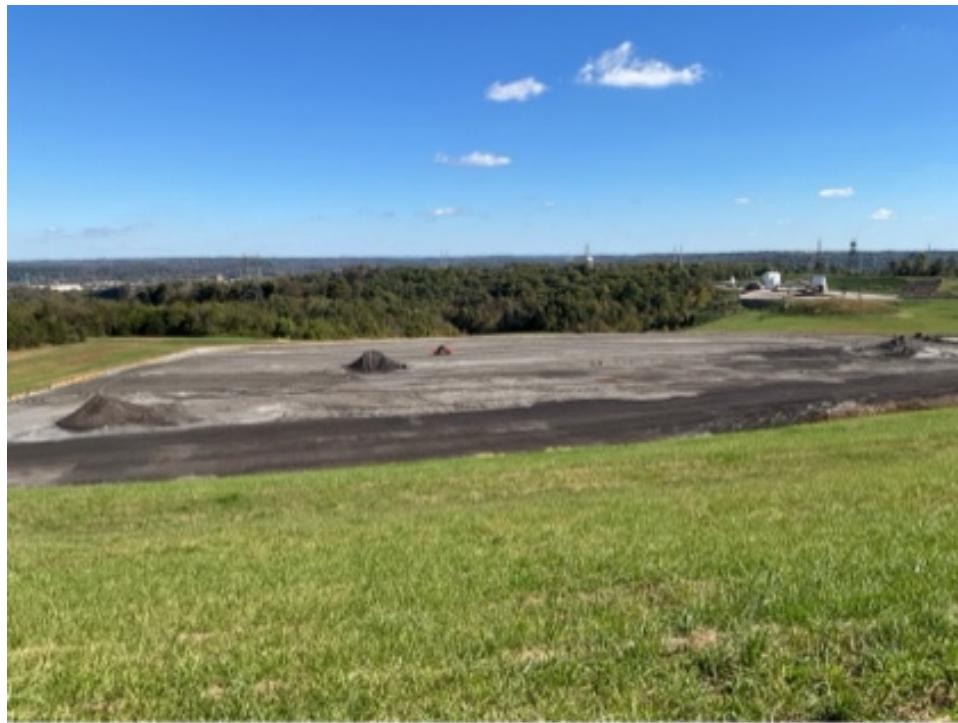
Photo #: 26

Notes: General condition of active working face

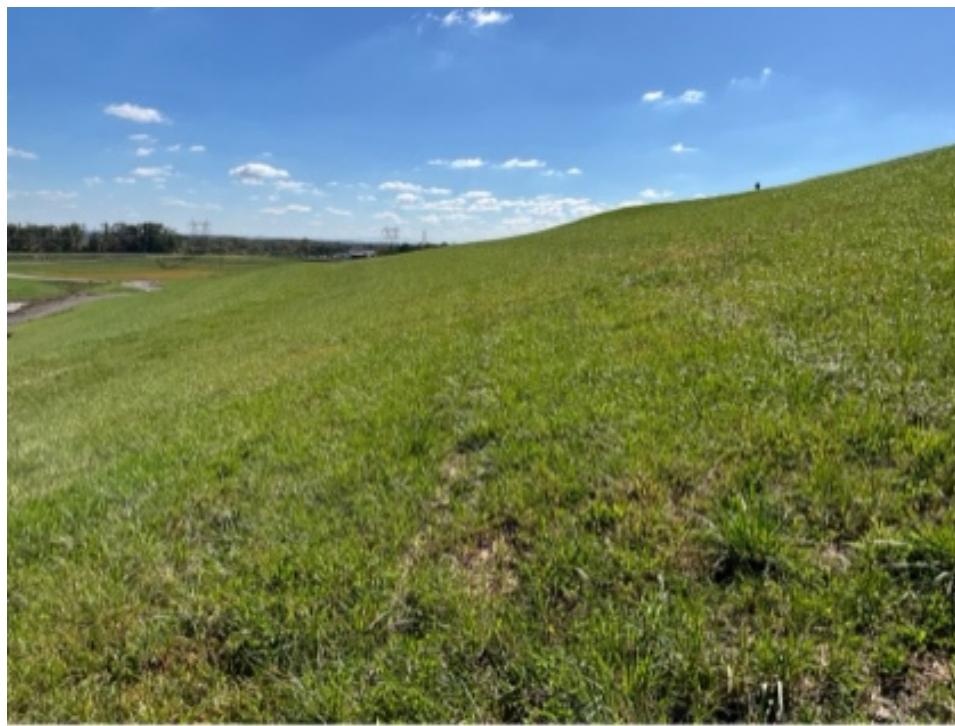
Photo #: 27

Notes: General condition of soil cover over Phase 1 east slope looking south

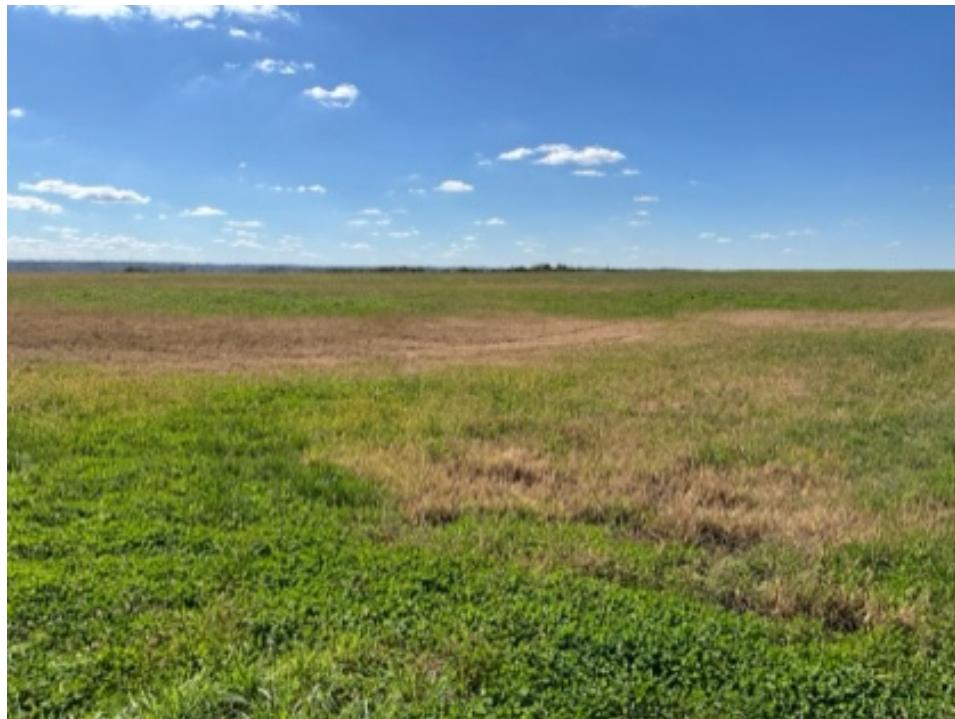
Photo #: 28

General condition of soil cover over Phase 1 top area looking southwest

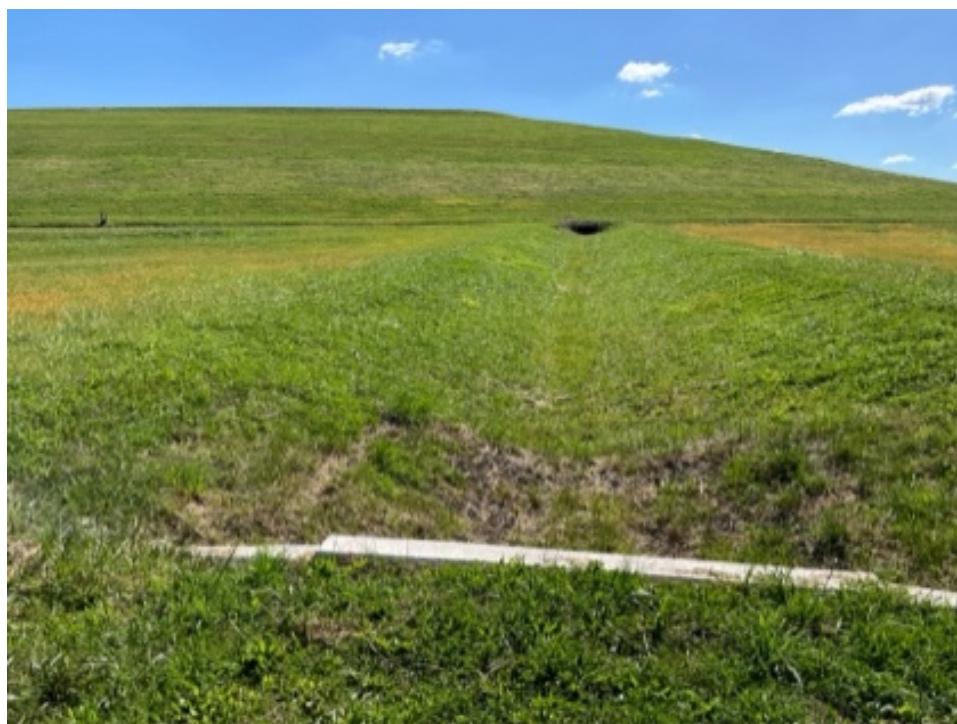
29

General condition of drainage ditch across Area 4 for Vertical Expansion drainage to Northwest Sediment Pond

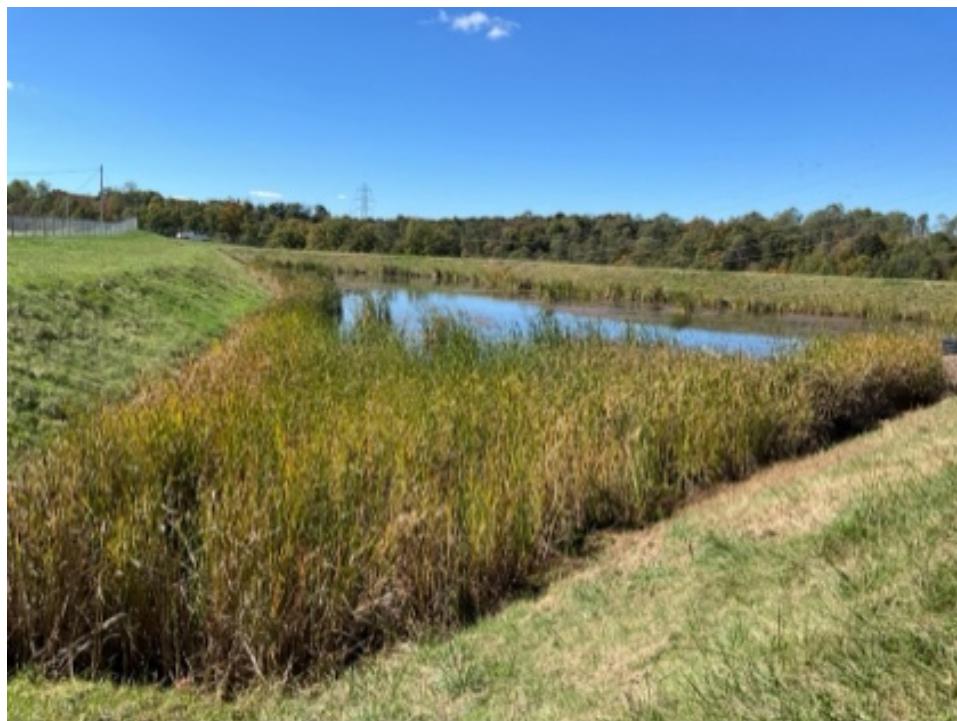
30

11. The Northeast Sediment Pond was generally satisfactory with the need to remove cattails that are growing around the perimeter (Photo #30).
12. The soil cover and vegetation of Area 7 was generally satisfactory (Photo #31) except for the need to repair erosion area on bench (Photo #32).

General condition of Northwest Sediment Pond. Excess vegetation growing in the pond.

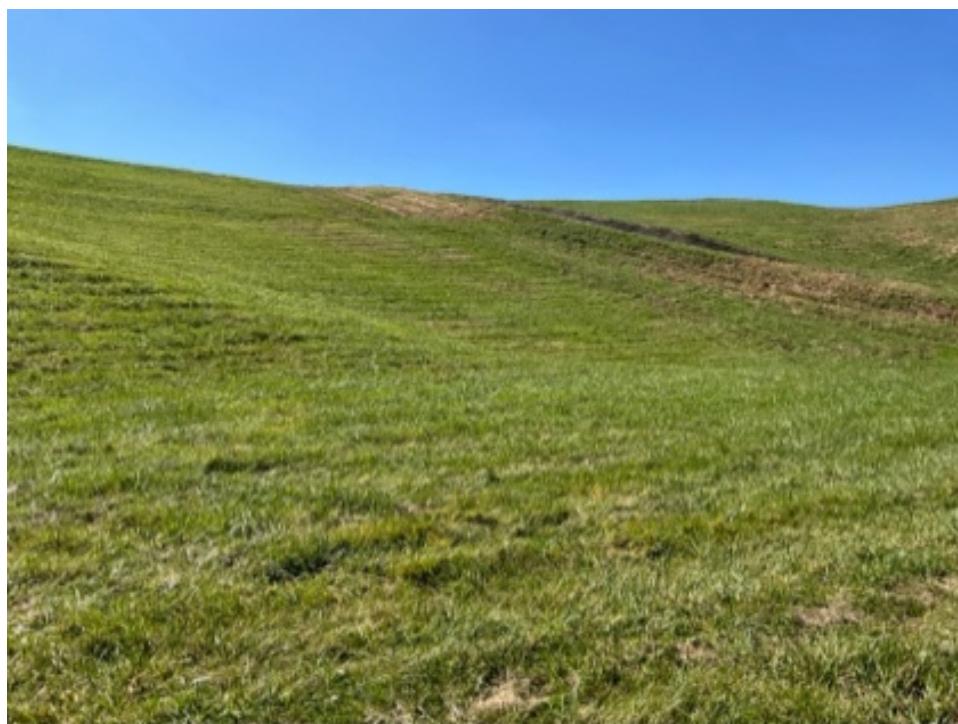
31

General condition of slope where Areas 6&7 come together.

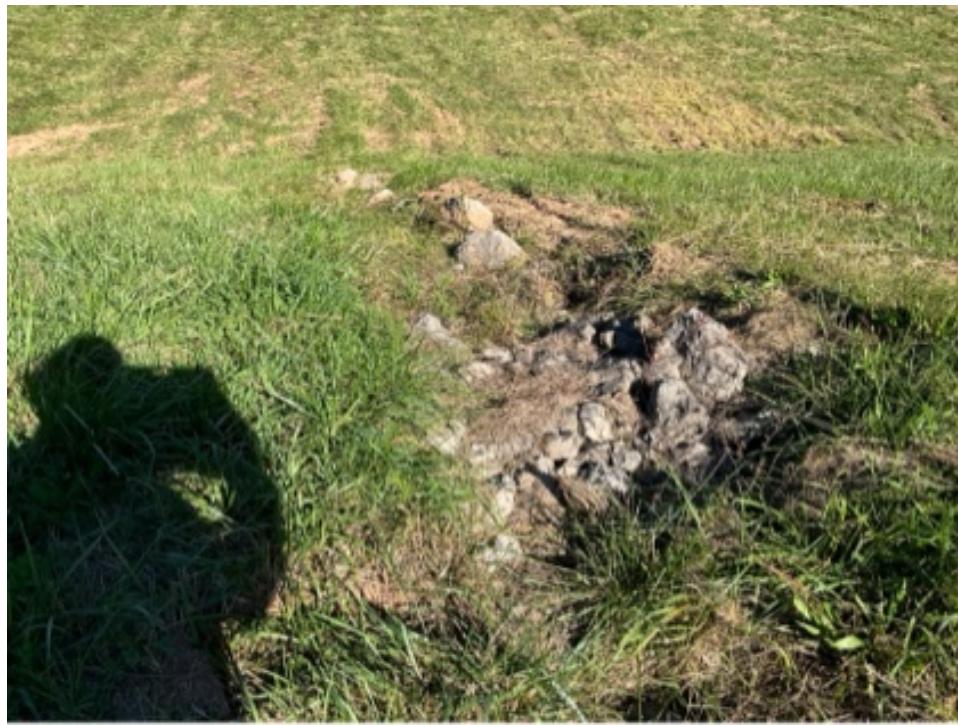
32

Previously repaired erosion on bench in Area 7 that needs reworked.
