# **2025 Annual Landfill Inspection Report**

**Little Broad Run Landfill**

**Mountaineer Plant  
New Haven, West Virginia**

**Date of Inspection:** October 16, 2025

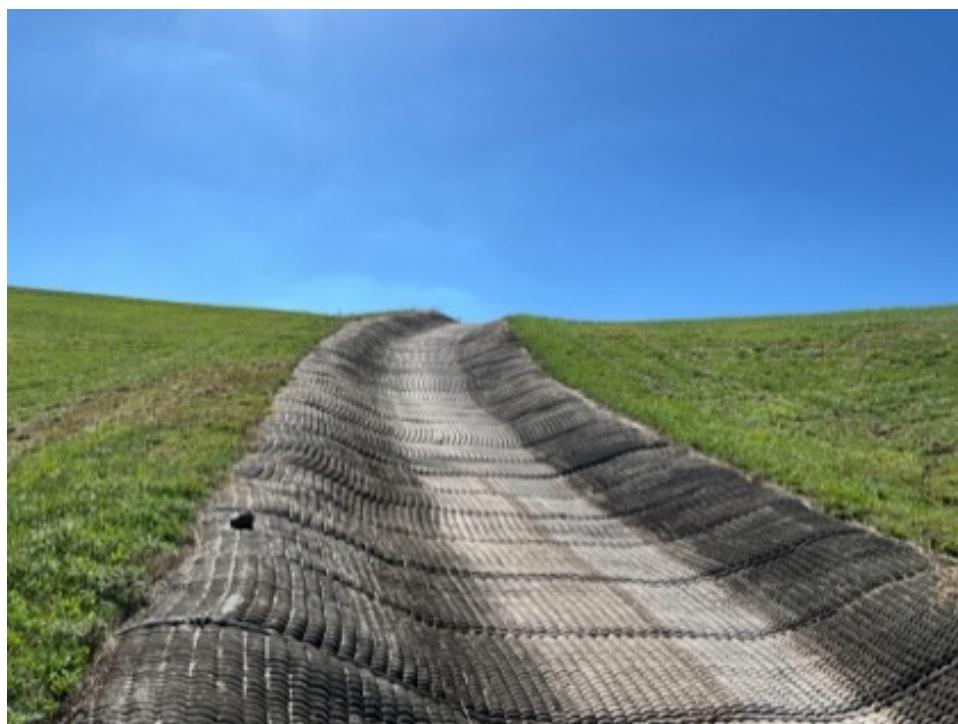
33

General condition of  
fabriform slope drainage  
channel on Area 7 slope

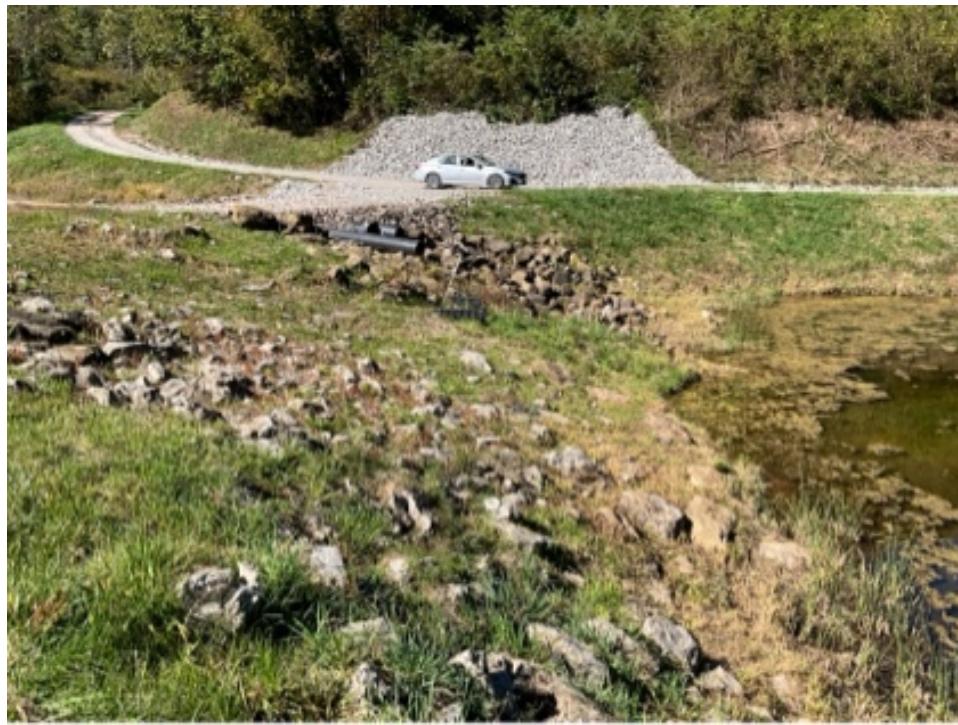
34

General condition of  
stormwater discharge  
into Area 7 Sediment  
Pond from the Landfill.

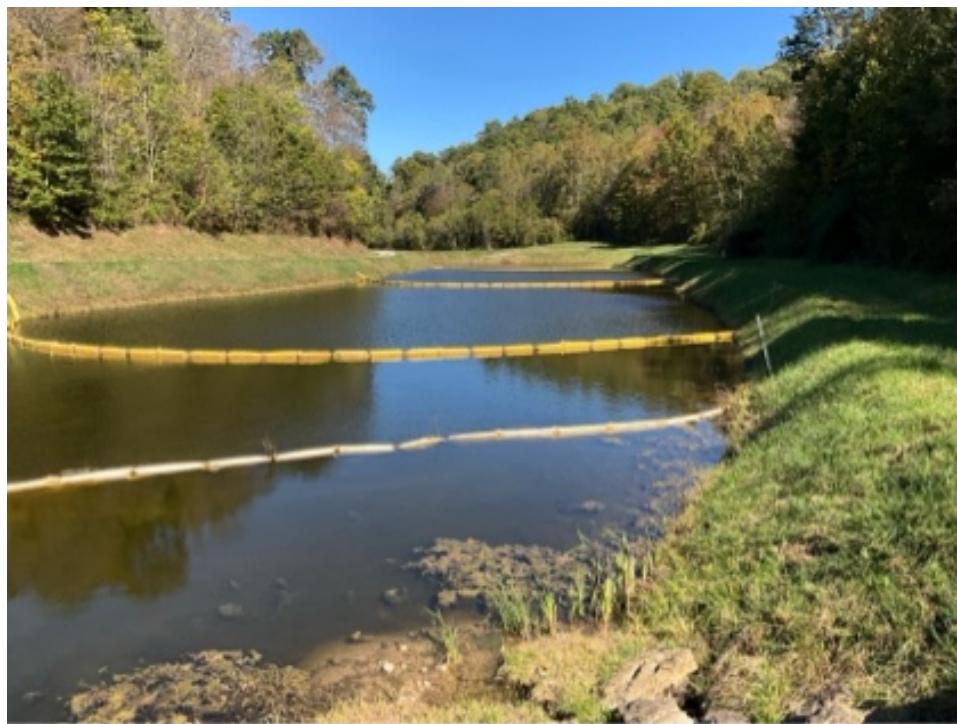
35

General condition of the Area 7 Sediment Pond looking northeast.

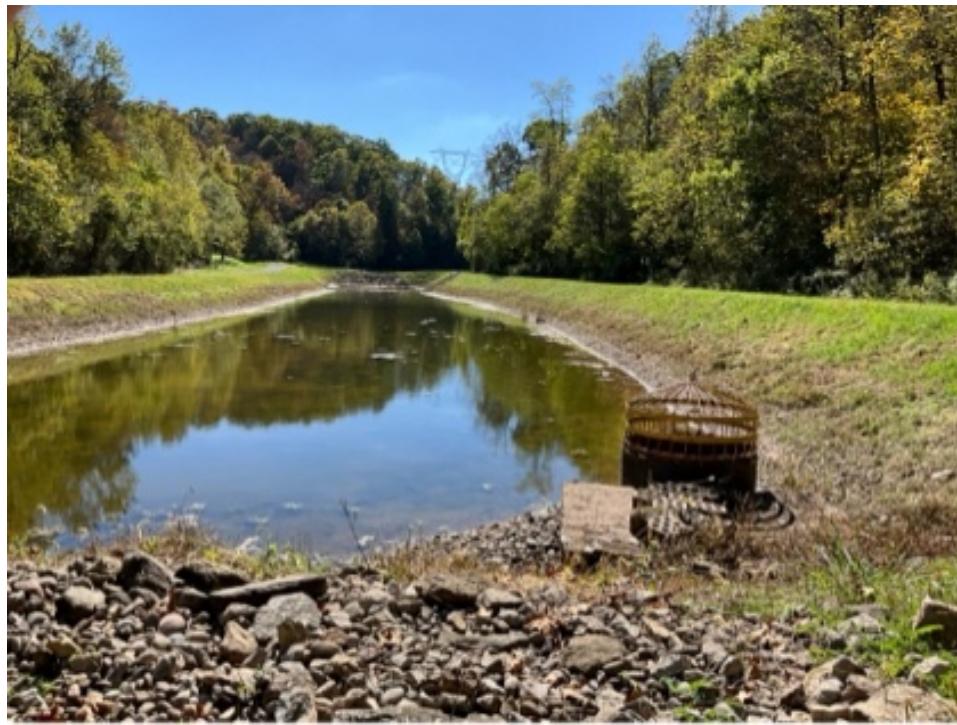
36

General condition of the Area 7 Sediment Pond including the outlet structure looking southwest

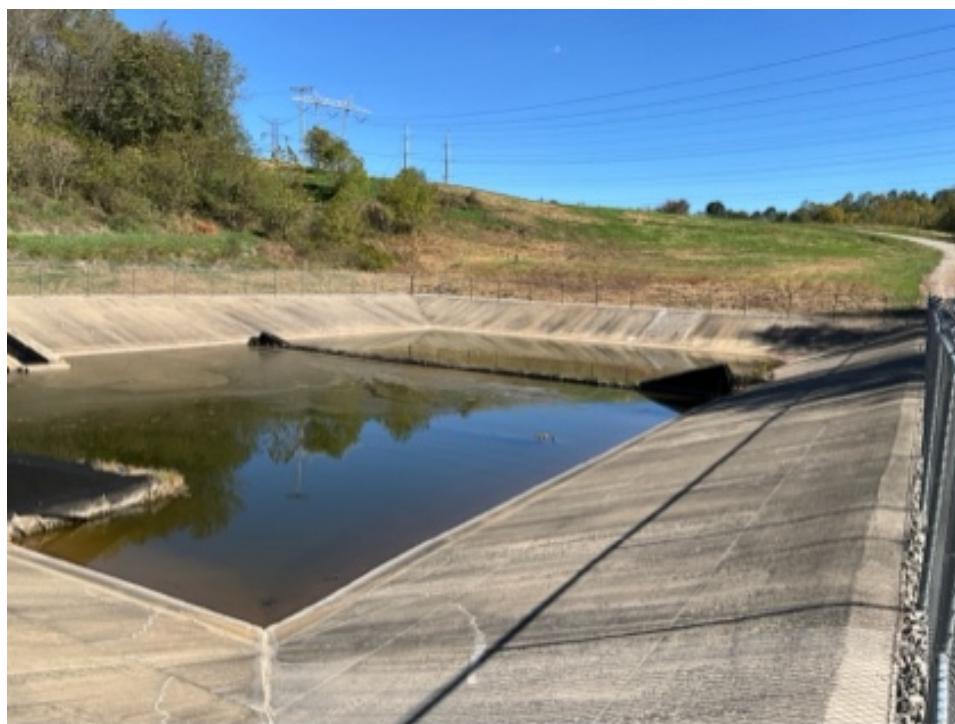
37

General condition of  
Leachate Pond #2

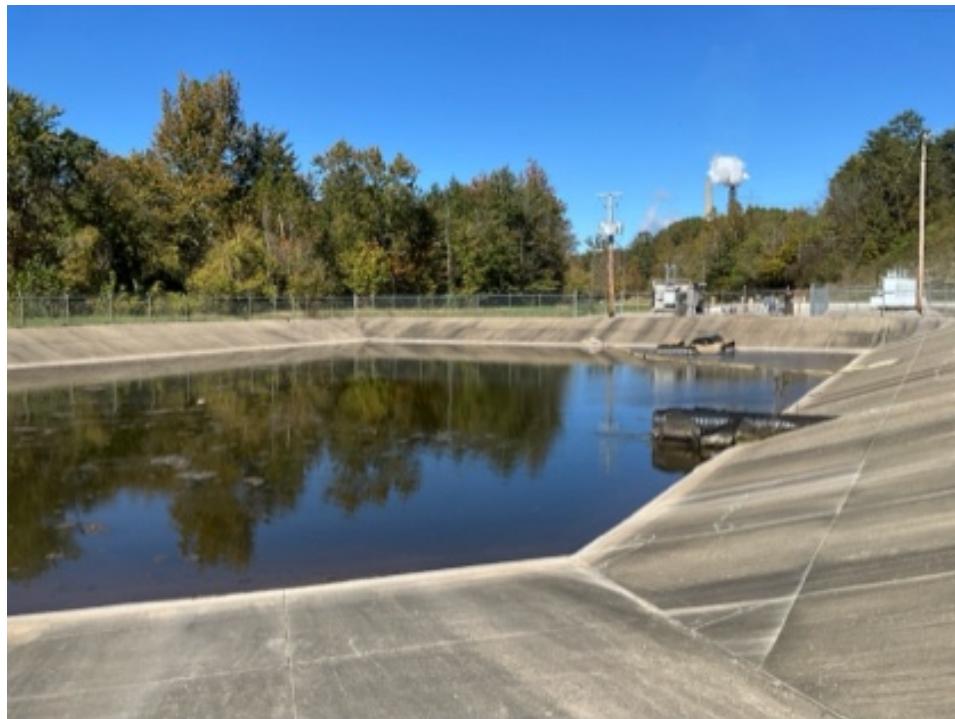
38

General condition of  
Leachate Pond #1

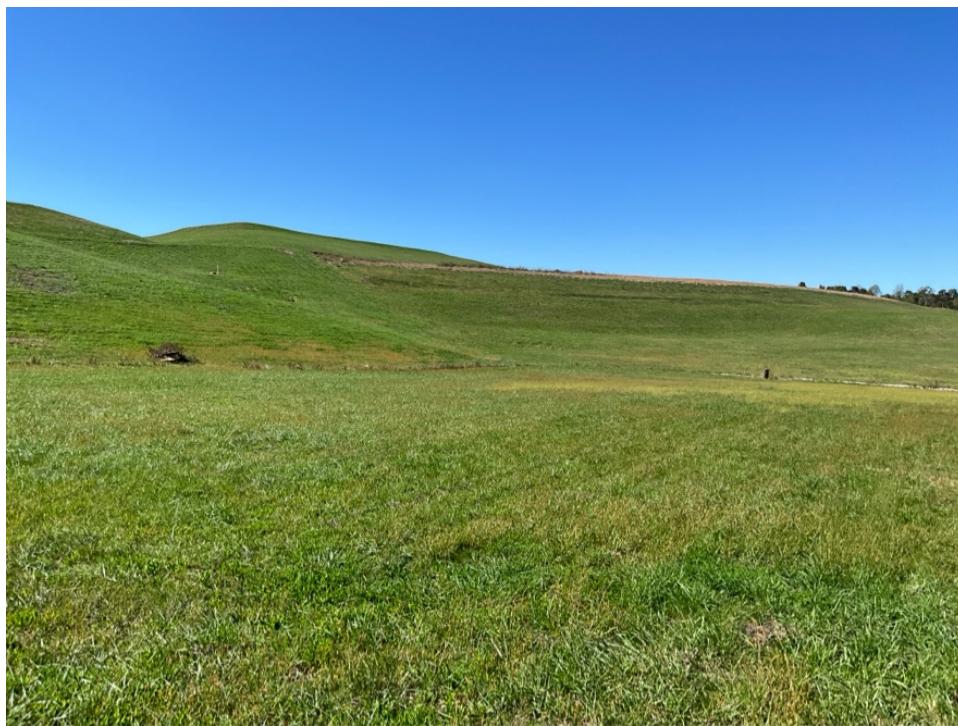
Photo #: 39

Notes: General condition of soil cover over Area 6 looking northwest

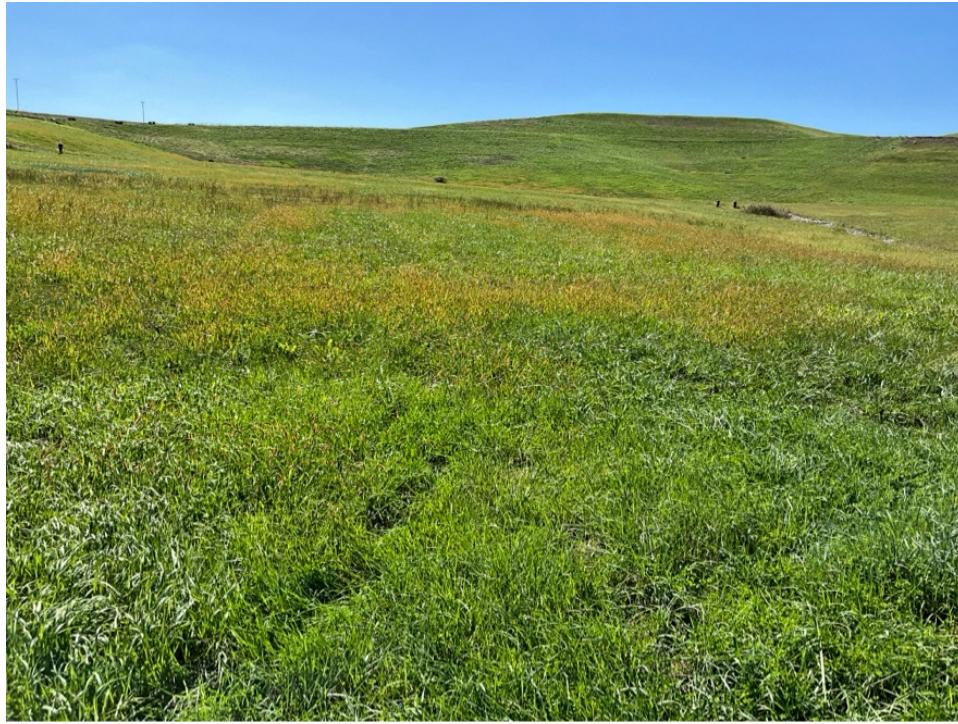
Photo #: 40

Notes: General condition of soil cover over Area 6 looking southwest
