# **2025 Annual Landfill Inspection Report**

**Northeastern Power Plant  
Public Service Company of Oklahoma  
Oologah, OK**

**December 2025**

**Document ID: GERS-25-035**

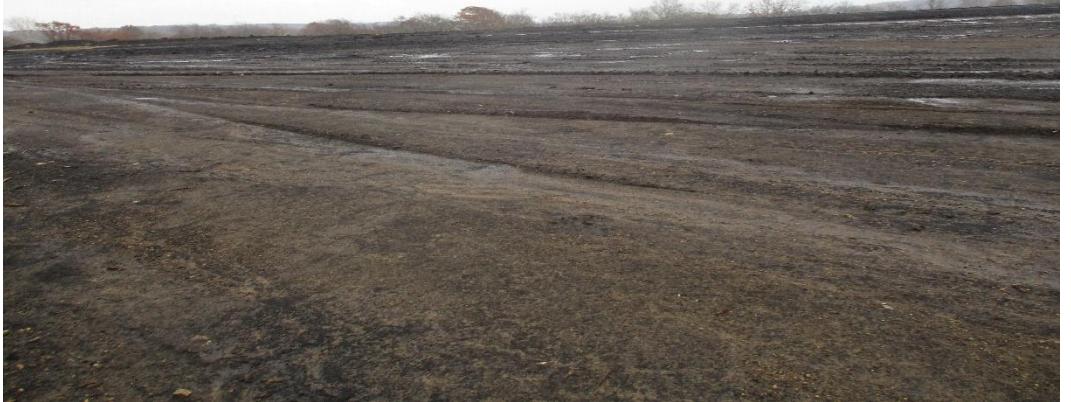
1. Overall view of the west areas of the landfill that previously included designated Cells 3 and 4 (Photograph No. 1). The temporary geomembrane cover and wind defender are removed and CCR materials have been placed. The waste filling areas of the landfill appeared in stable condition with positive drainage and no significant water ponding.

<p>Photograph No. 1</p> <p>Temporary geosynthetic cover removed from the landfill.</p>

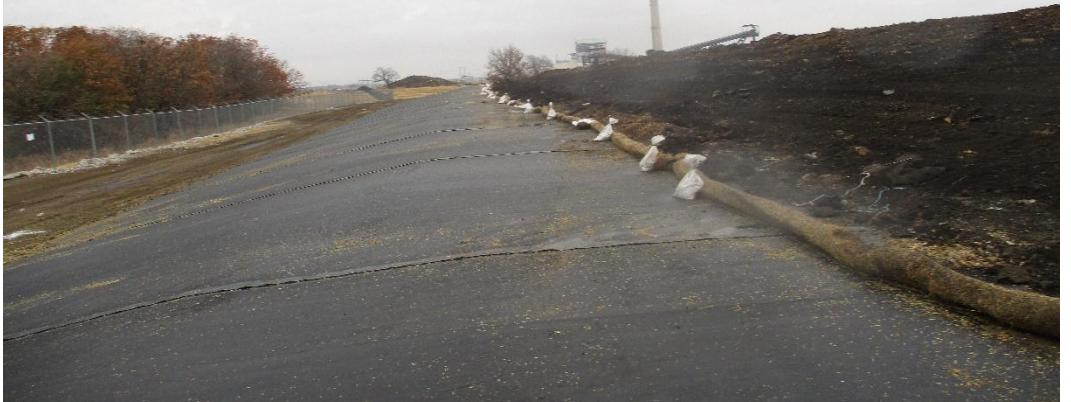
2. The condition of the perimeter berm, protective geomembrane liner, and access road appeared in good condition with no sign of misalignment, settlement, or excessive erosion. The perimeter ditch was functioning as designed and the liner was intact and in good condition (Photographs No. 2-4). Cell 4 area is protected by straw wattle along the perimeter for containment of solid. Cell 3 area was not protected at the perimeter of the landfill.

<p>Photograph No. 2</p> <p>Cell 4 berm, access road, and CCR fill (looking north).</p>

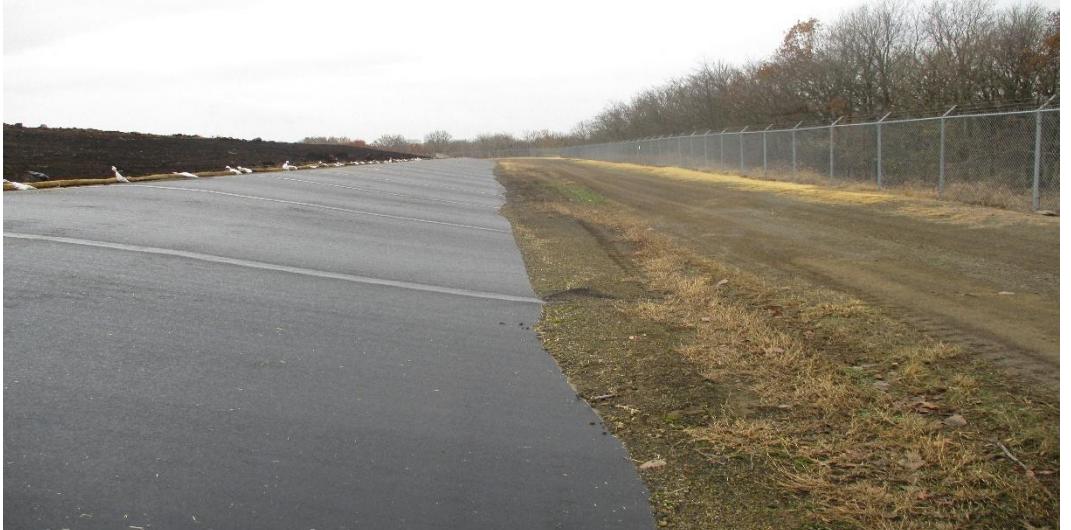
<p>Photograph No. 3</p> <p>Cell 4 berm, access road, and CCR fill (looking south).</p>

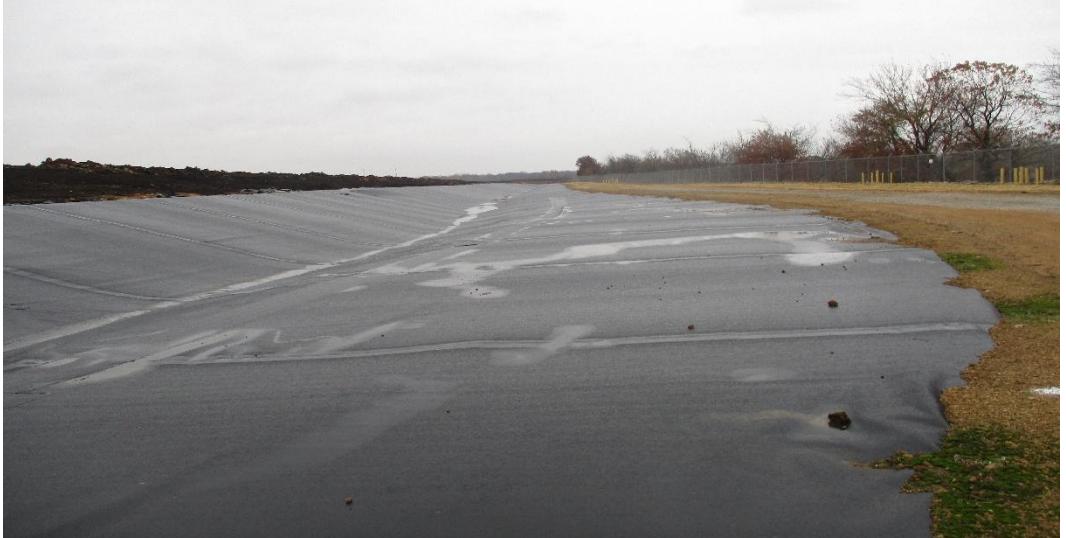
<p>Photograph No. 4</p> <p>Cell 3 perimeter berm and access road (looking northeast).</p>

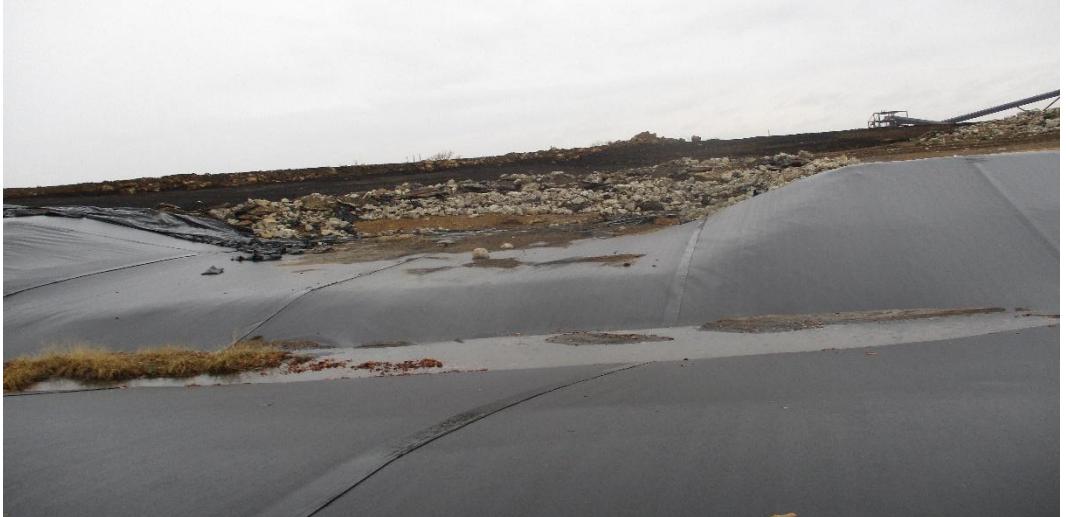
3. A temporary weir is cut into the perimeter berm (Photograph No. 5) for stormwater management appeared to be non-functional due to CCR fill. The CCR fill placement has exceeded beyond the height of the berm.

<p>Photograph No. 5</p> <p>Temporary stormwater control weir.</p>

- 1) Maintain positive grades of the runoff towards the perimeter ditches.
- 2) Adequate measures should be implemented along the perimeter of the landfill to make sure that solids (CCR) are retained within the landfill.
- 3) Temporary cover (e.g. soil or geosynthetic) should be placed on exposed CCR fill to manage contact water within the limits of the waste and/or directed into the contact water ditch, specifically between the landfill and leachate pond and west slope of the landfill.

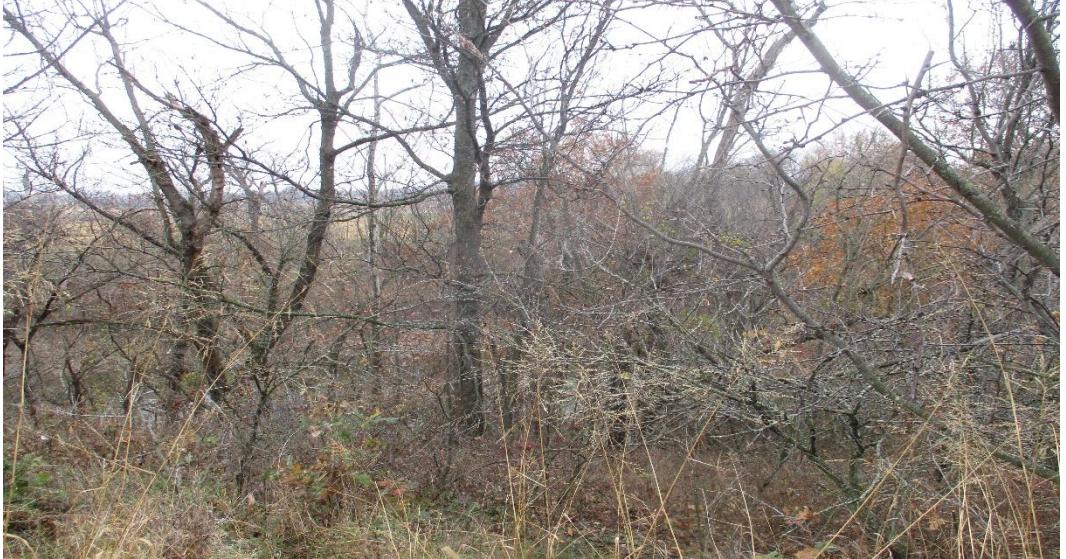
4. The slope adjacent to the river is very steep and was heavily vegetated with mature trees and small bushes (Photograph No. 6). Observation of the slope from the access road indicated overall stable condition.

<p>Photograph No. 6</p> <p>Stability berm adjacent to the river.</p>

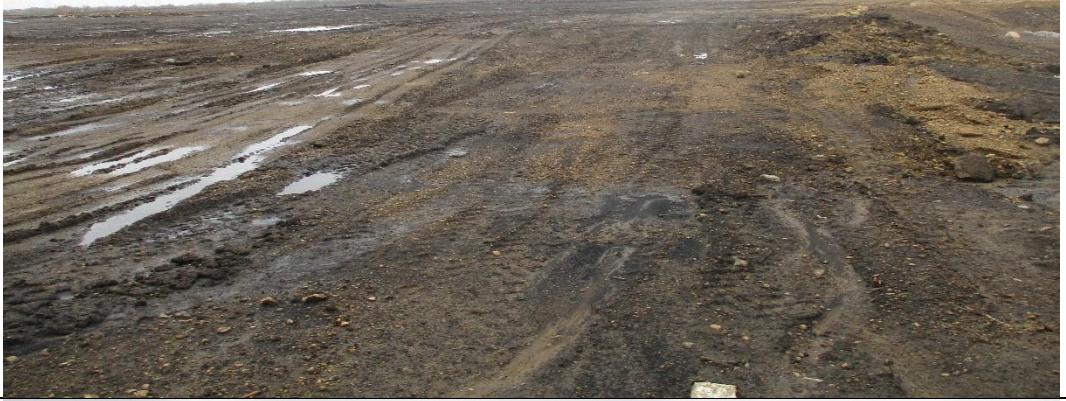
5. The typical condition of landfill Cells 1 and 2 is shown in Photograph No. 7. The surface appeared graded and free of ponding water. Temporary grades are maintained to direct runoff primarily to the perimeter ditch to the north.

<p><b>Photograph No. 7</b> Overall view of landfill Areas 1 and 2.</p>

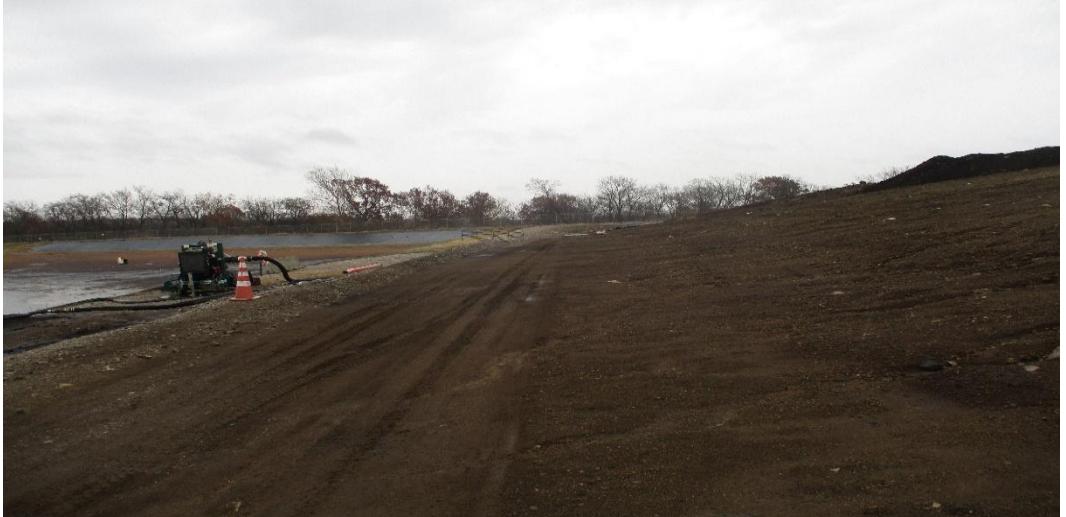
6. The east area (Cell 1 and 2) of the landfill appeared in good condition as shown in Photograph No. 8. CCR material is currently placed in this area. Most of the runoff for the interim condition at present is directed to the perimeter contact water ditch but no containment berm or control was observed between the leachate pond and the landfill.

<p><b>Photograph No. 8</b> East side of landfill area (Cell 1 and 2).</p>

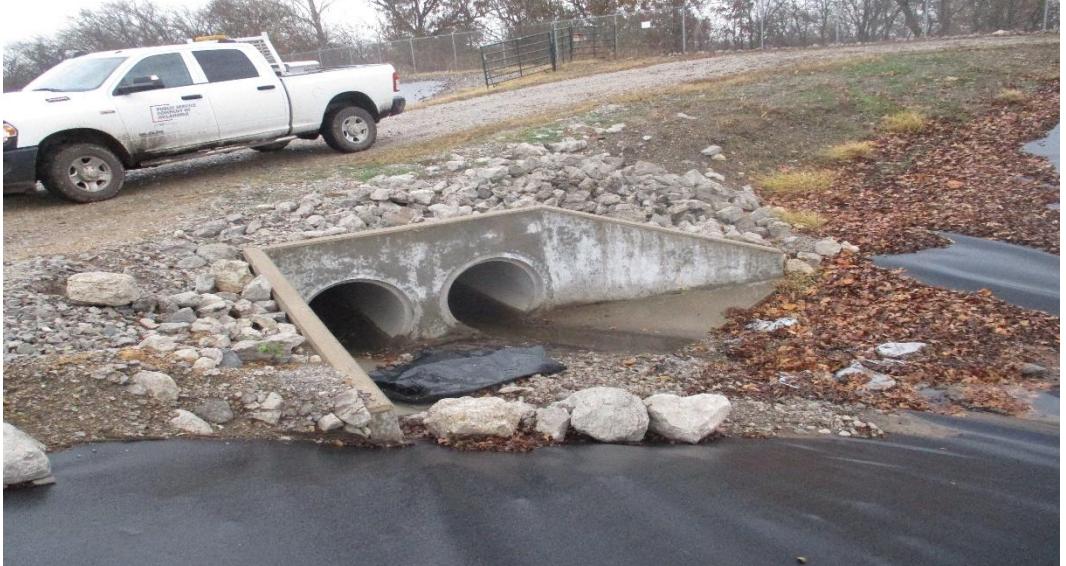
7. The west and south perimeter ditches at the eastern, downstream end of the landfill consists of pipe box culverts (Photographs No. 9-12). These pipe box culverts were structurally sound and clear of any debris and indicated no obstruction to flow or standing water. The drainage structures are functioning as designed.

<p><b>Photograph No. 9</b> South perimeter ditch pipe culvert inlet.</p>

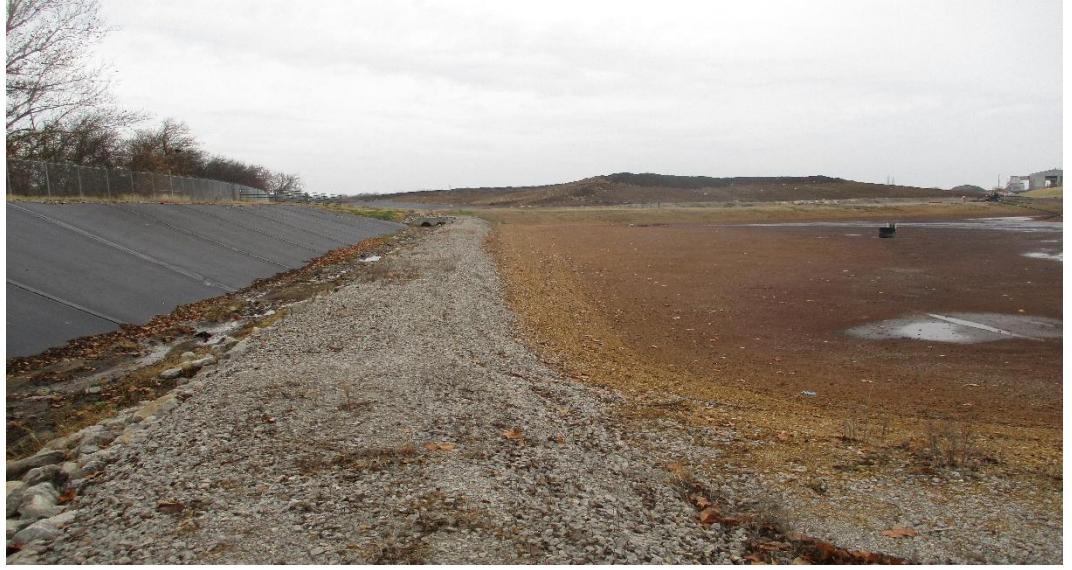
8. Typical condition of the west, north, and south dikes and interior slope of the leachate pond are illustrated in Photographs No. 13-15. Overall, the dikes and interior slopes appeared in good condition without any sign of significant erosion, settlement, or cracks. At the time inspection, the leachate pond indicated very low level of leachate.

<p>Photograph No. 13</p> <p>South contact water ditch.</p>

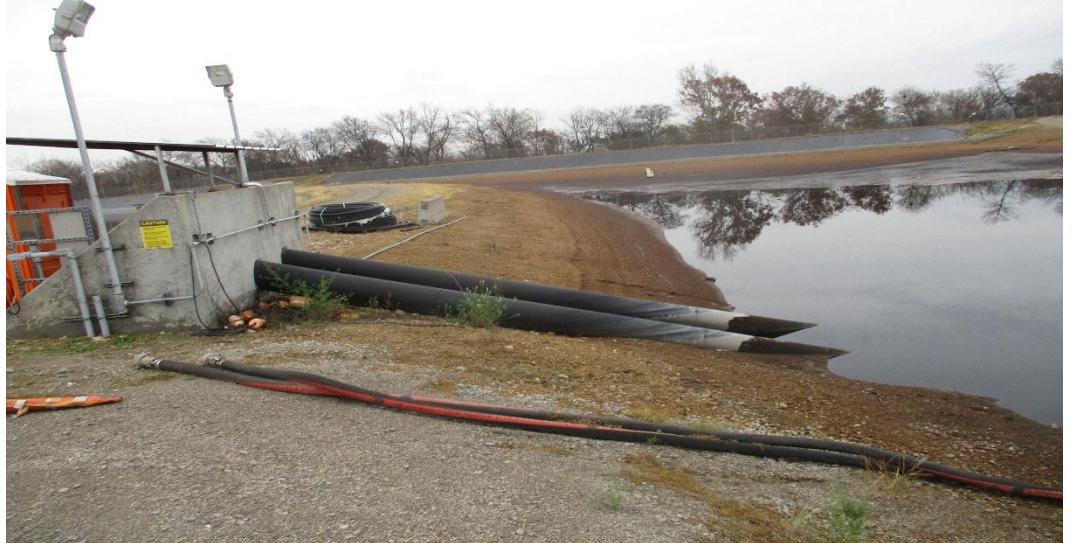
<p>Photograph No. 14</p> <p>Interior slope of the east dike.</p>

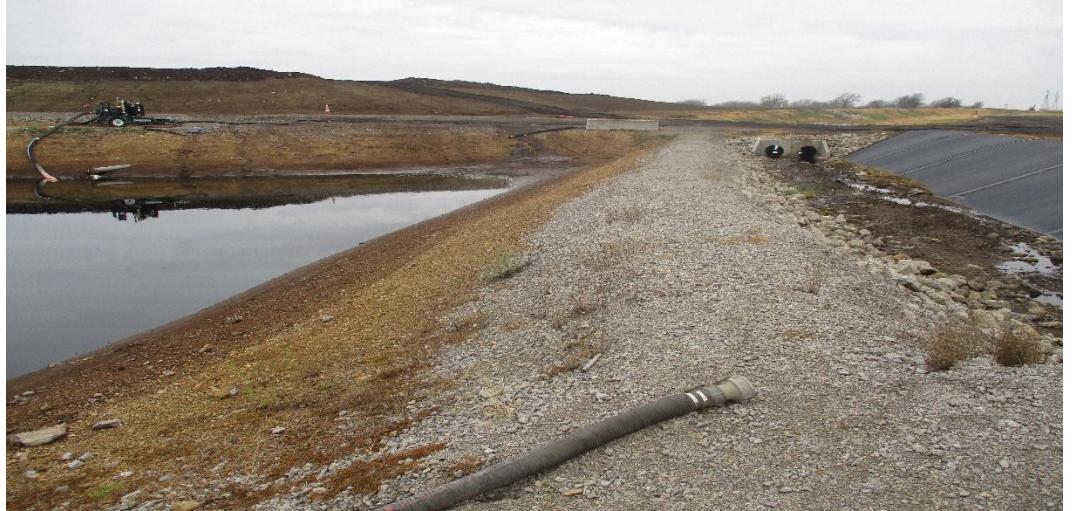
<p>Photograph No. 15</p> <p>North dike and contact water ditch.</p>

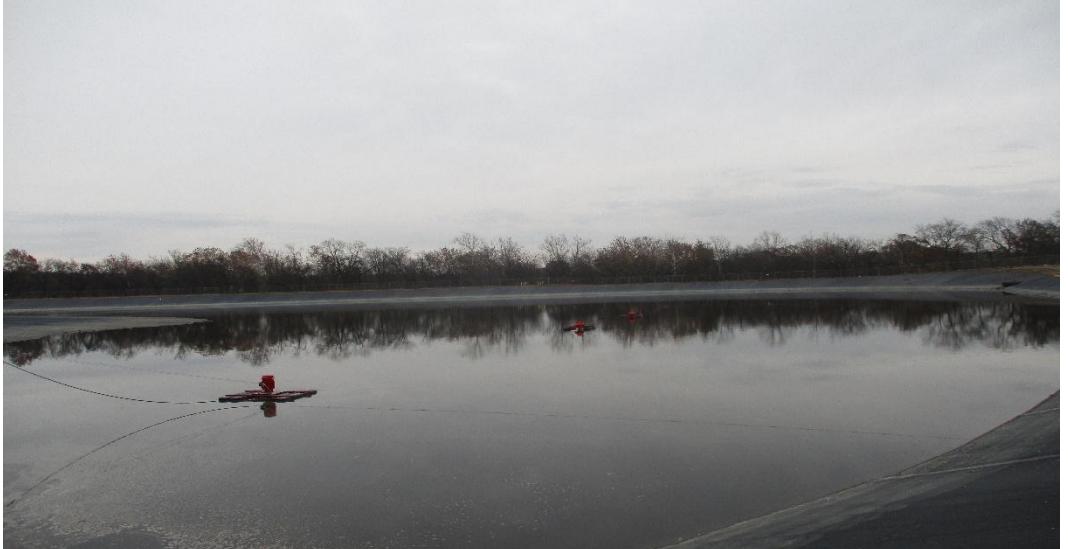
9. The interior of Basin C (contact water pond) is illustrated in Photographs No. 16 and 17. Two sprayers are temporarily installed in the pond to help with contact water management during the closure of the Bottom Ash Pond and Coal-yard. The geosynthetic liner was in place, intact and in good condition without any tears or damage. The crest also used as haul road of the north dike appeared in good and stable condition.

<p>Photograph No. 16</p> <p>Basin C interior illustrating sprayers.</p>

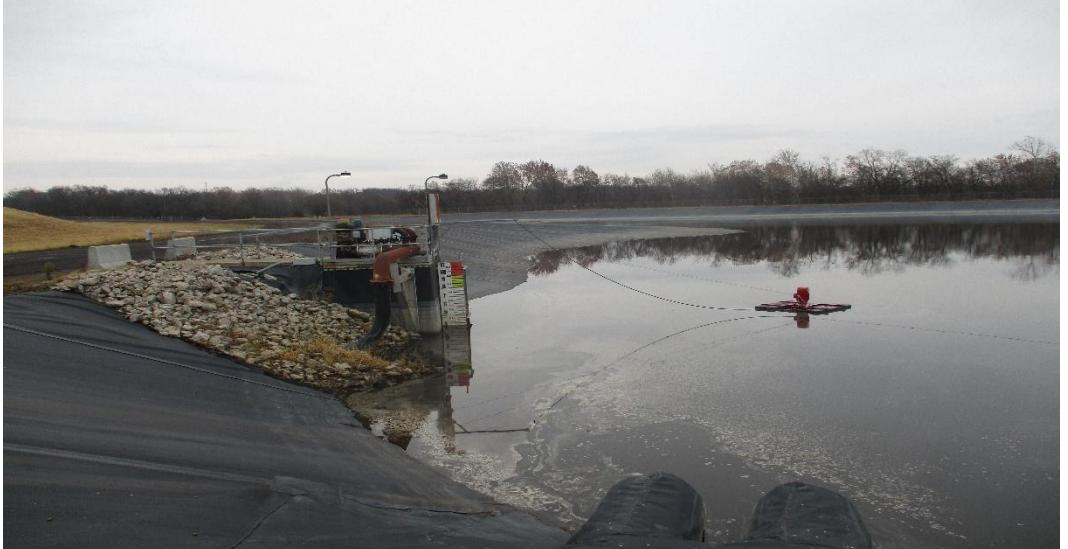
<p>Photograph No. 17</p> <p>Overflow discharge structure (northwest corner),</p>

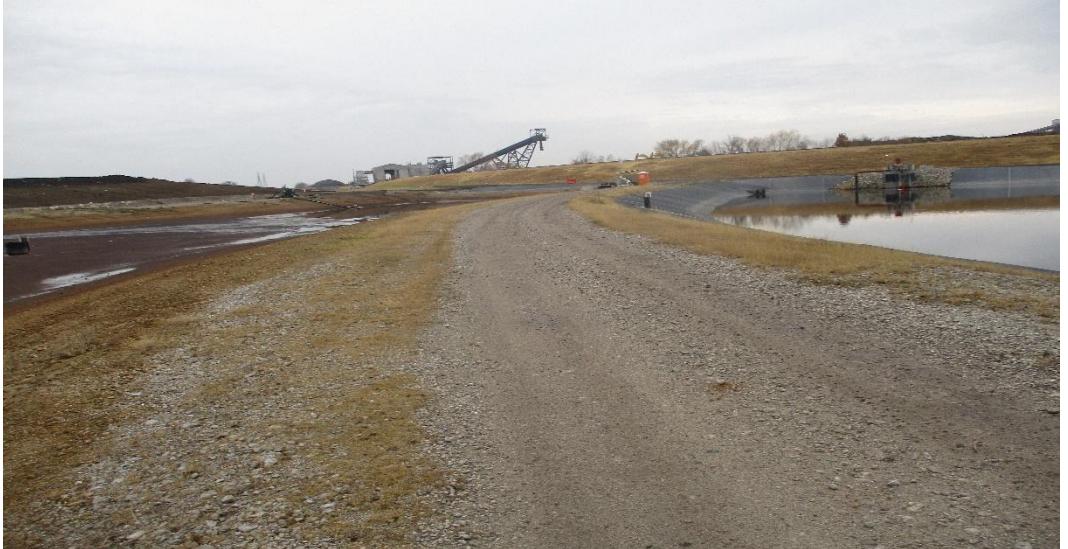
10. The splitter dike between the leachate pond and Basin C is illustrated in Photograph No. 18. The splitter dike appeared in good and stable condition without any settlement or misalignment.

<p>Photograph No. 18</p> <p>Splitter dike between leachate pond and Basin C.</p>
