FGD Stackout Pad Area
2025 Annual Landfill Inspection
Report

H.W. Pirkey Power Plant, Hallsville, Texas

August 30, 2025
Project 2501323
AEP Document ID: GEVR-25-003

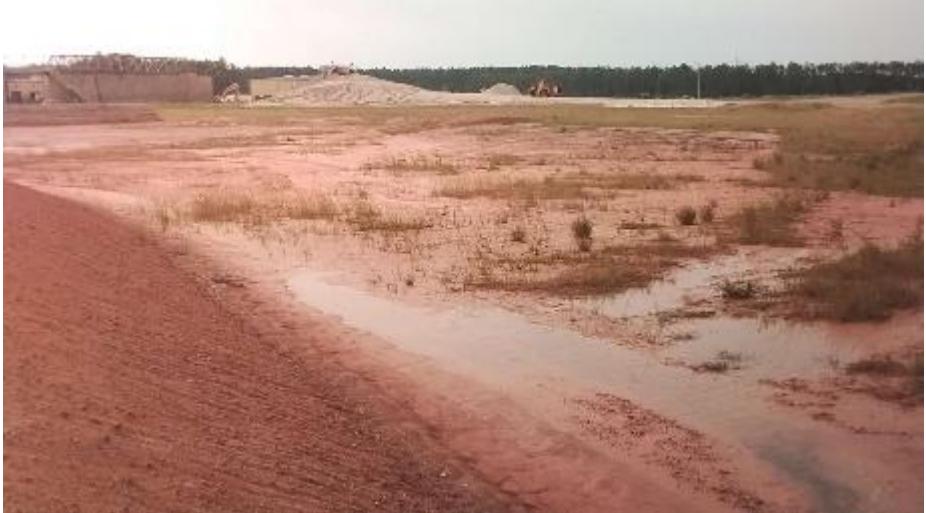
At the time of the inspection the exposed Stackout Pad Area subgrade had small patches of vegetation and some soft/wet areas where silt had accumulated as shown in Photo No. 1.

The upstream slope was in good condition, but minor rills had formed as the slopes were not vegetated as shown in Photo No. 1 and 2. The downstream slope was in good condition with healthy vegetation as shown in Photo No. 3. The gravel perimeter berm / crest appeared to be in good condition as shown in Photo No. 4. The drainage features were clear of obstructions.

PHOTOGRAPH NO: 1	DATE: May 14, 2025 8:54 AM	LATITUDE: 32.46231964	LONGITUDE: -94.4878527
DIRECTION: 44°	SITE LOCATION: HALLSVILLE, TEXAS		
DESCRIPTION: Upstream Slope. General Photo, Typical Conditions.

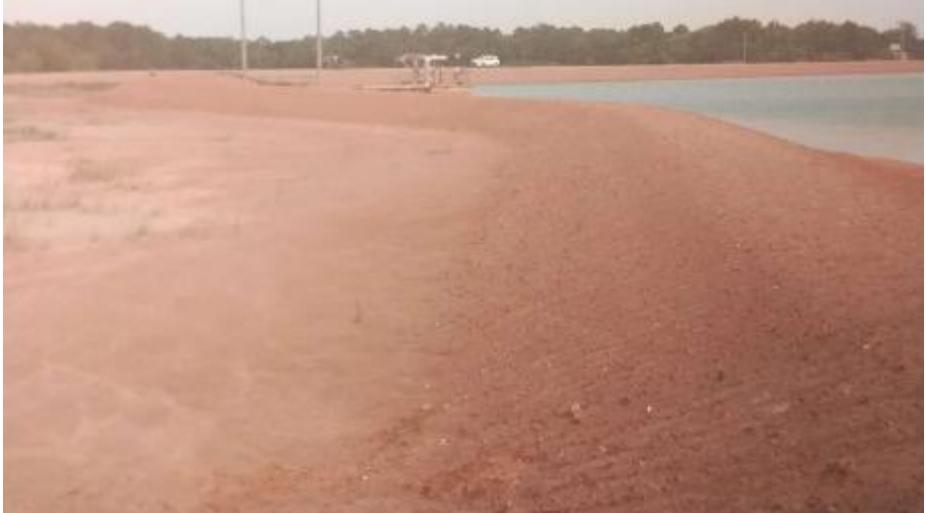
PHOTO BY: GEI CONSULTANTS, INC.			
PHOTOGRAPH NO: 2	DATE: May 14, 2025 9:05 AM	LATITUDE: 32.46189872	LONGITUDE: -94.48653721
DIRECTION: 217°	SITE LOCATION: HALLSVILLE, TEXAS		
DESCRIPTION: Upstream Slope. General Photo, Typical Conditions.

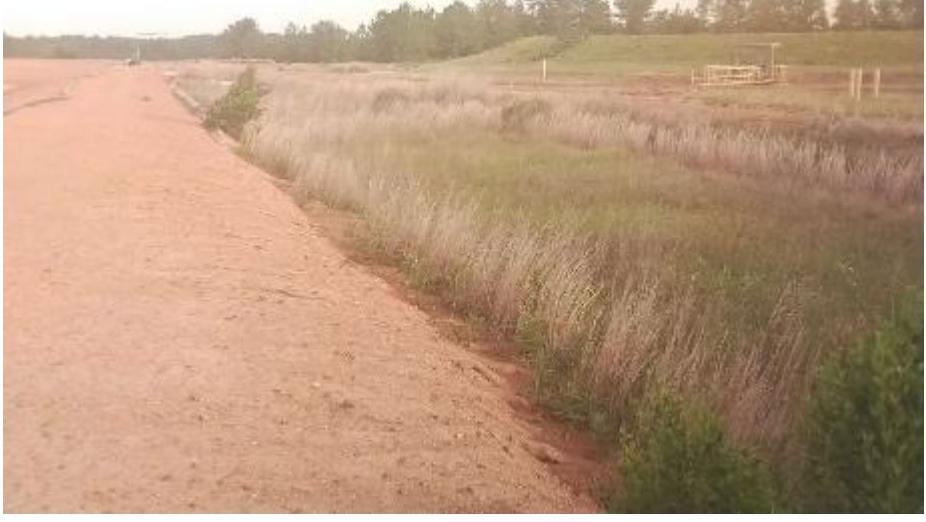
PHOTOGRAPH NO: 3	DATE: May 14, 2025 9:12 AM	LATITUDE: 32.46226834	LONGITUDE: -94.4857971
DIRECTION: 243°	SITE LOCATION: HALLSVILLE, TEXAS		
DESCRIPTION: Downstream Slope. General Photo, Typical Conditions. Vegetation was not recently maintained or mowed due to limited equipment access following recent rain events.

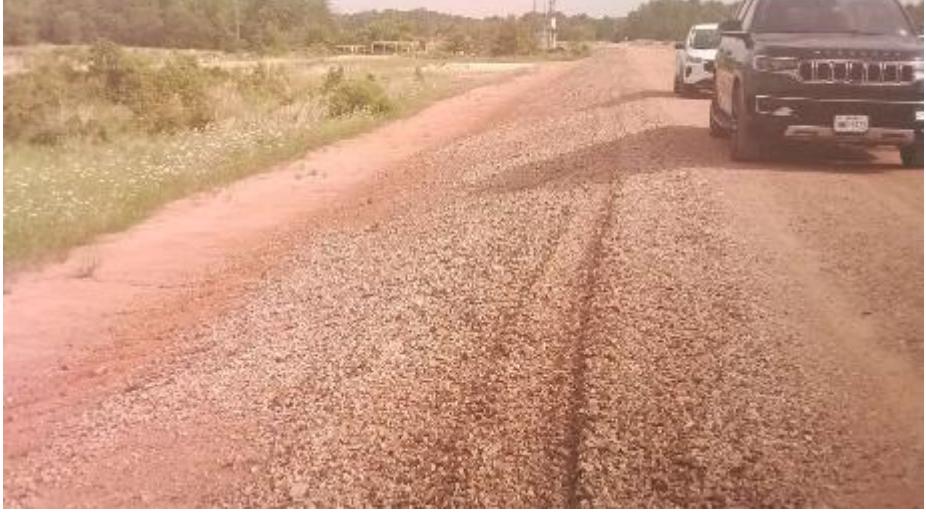
PHOTO BY: GEI CONSULTANTS, INC.			
PHOTOGRAPH NO: 4	DATE: May 14, 2025 9:23 AM	LATITUDE: 32.46250751	LONGITUDE: -94.48798345
DIRECTION: 250°	SITE LOCATION: HALLSVILLE, TEXAS		
DESCRIPTION: Upstream Slope. General Photo, Typical Conditions. Vegetation was not recently maintained or mowed due to limited equipment access following recent rain events.
