Bottom Ash Ponds
2025 Annual Dam and Dike
Inspection Report

H.W. Pirkey Power Plant, Hallsville, Texas

August 30, 2025
Project 2501323
AEP Document ID: GEVR-25-001

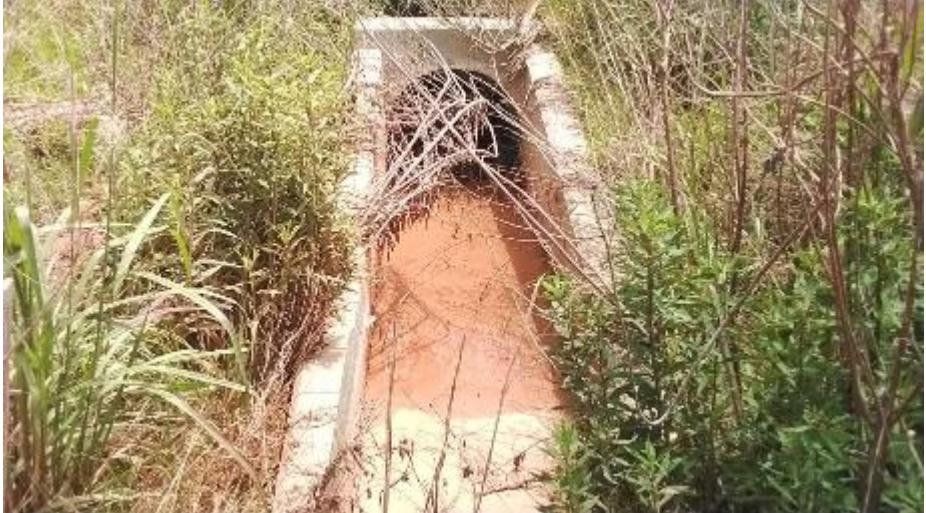
PHOTOGRAPH NO: 1	DATE: May 14, 2025 2:13 PM	LATITUDE: 32.46657161	LONGITUDE: -94.49068523
DIRECTION:	SITE LOCATION: HALLSVILLE, TEXAS		
DESCRIPTION: West Bottom Ash Pond - Drainage Feature, Discharge Culvert. Looking Upstream. General Photo, Typical Conditions.

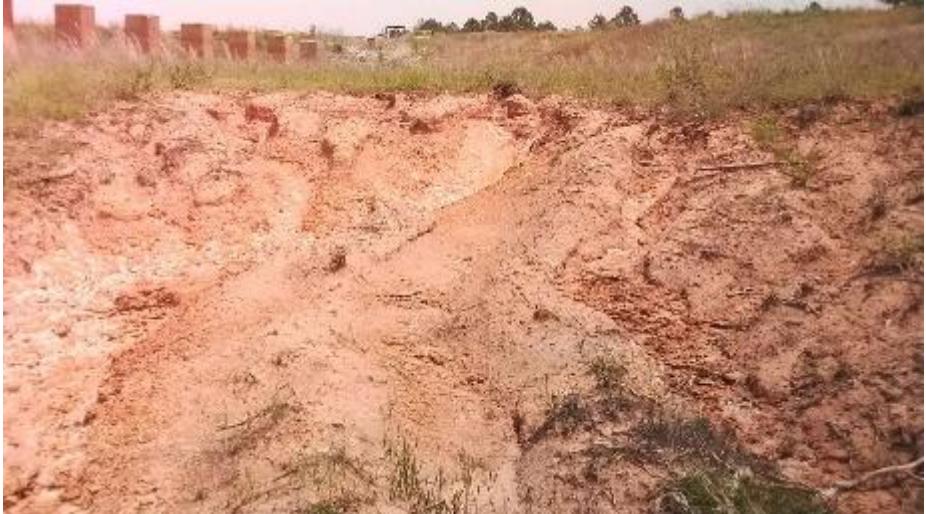
PHOTO BY:			
GEI CONSULTANTS, INC.	PHOTOGRAPH NO: 2	DATE: May 14, 2025 2:10 PM	LATITUDE: 32.46648398
DIRECTION:	SITE LOCATION: HALLSVILLE, TEXAS		
DESCRIPTION: West Bottom Ash Pond - Upstream Slope. Address Major Erosion 3-4 feet-deep.

- The erosion observed in the West Bottom Ash Pond should be addressed by regrading and re-vegetating. Areas of the East Bottom Ash Pond should be monitored for vegetation establishment and reseeded/re-vegetated as needed to limit erosion concerns and future maintenance. Silt should be regularly removed from the rock check dams near the pipe/culvert inlets to maintain its operational functions.

- Item 2 – Address major erosion in the southeast corner of the West Bottom Ash Pond
- Item 5 – Address major erosion in the southwest corner of East Bottom Ash Pond
- Item 6 – Address/remove silt that has accumulated near drainage check dam / pipe inlet at the southwest corner of the East Bottom Ash Pond.

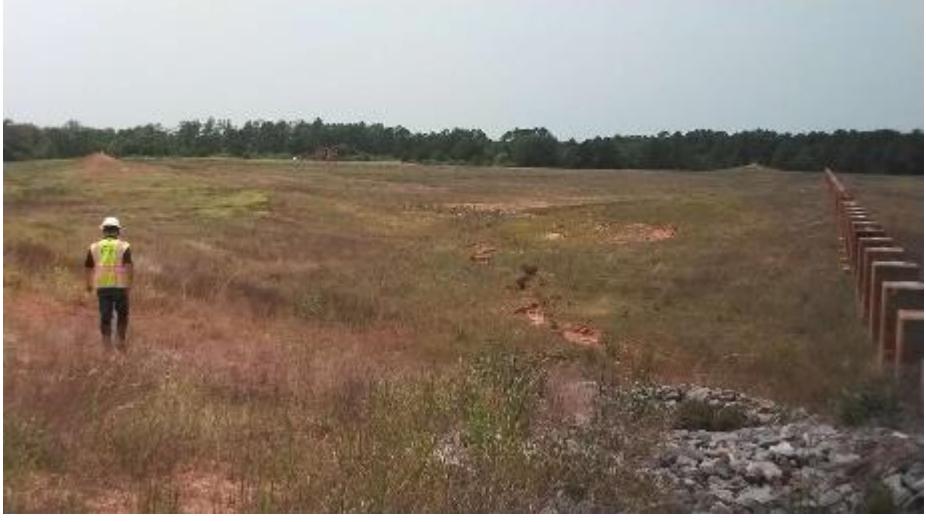
PHOTOGRAPH NO: 3	DATE: May 14, 2025 2:08 PM	LATITUDE: 32.46630389	LONGITUDE: -94.48905269
DIRECTION:	SITE LOCATION: HALLSVILLE, TEXAS		
DESCRIPTION: West Bottom Ash Pond - Upstream Slope. General Photo, Typical Conditions.

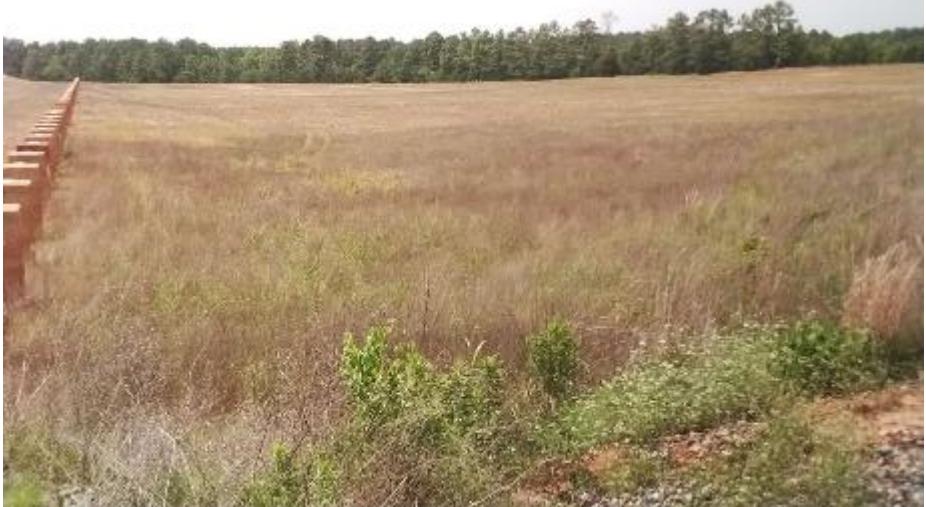
PHOTO BY:			
GEI CONSULTANTS, INC.	PHOTOGRAPH NO: 4	DATE: May 14, 2025 2:07 PM	LATITUDE: 32.46634889
DIRECTION:	SITE LOCATION: HALLSVILLE, TEXAS		
DESCRIPTION: West Bottom Ash Pond - Upstream Slope. General Photo, Typical Conditions. Vegetation was not recently maintained or mowed due to limited equipment access following recent rain events.

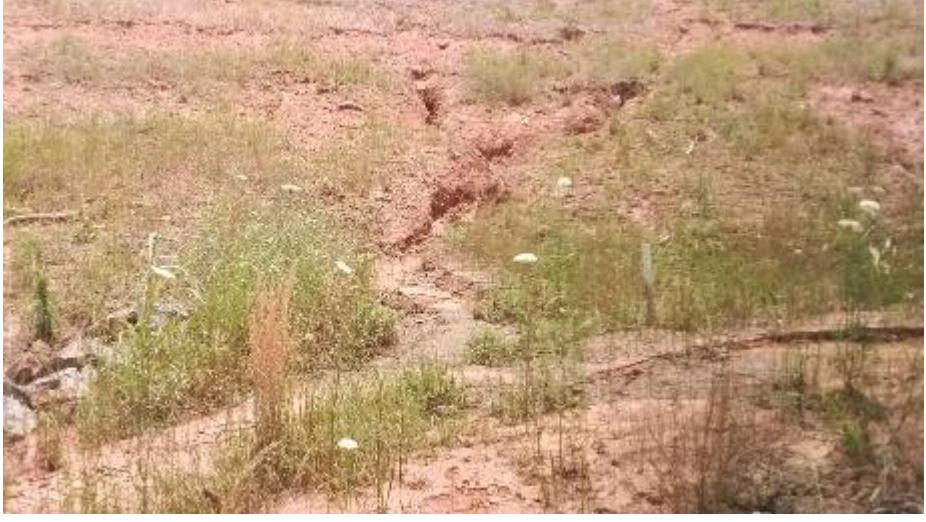
PHOTOGRAPH NO: 5	DATE: May 14, 2025 2:04 PM	LATITUDE: 32.46634771	LONGITUDE: -94.48838302
DIRECTION:	SITE LOCATION: HALLSVILLE, TEXAS		
DESCRIPTION: East Bottom Ash Pond - Upstream Slope. Address Major Erosion. Vegetation was not recently maintained or mowed due to limited equipment access following recent rain events.

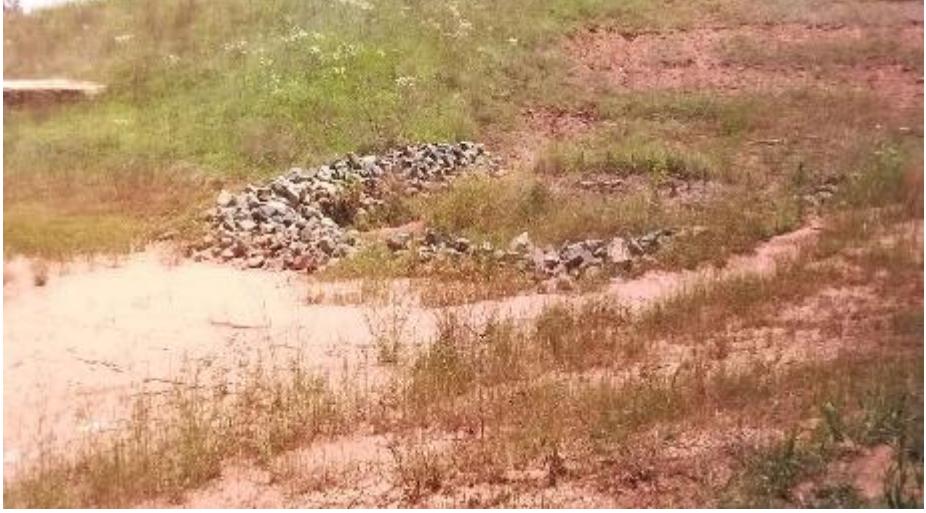
PHOTO BY:			
GEI CONSULTANTS, INC.			
PHOTOGRAPH NO: 6	DATE: May 14, 2025 2:03 PM	LATITUDE: 32.46644103	LONGITUDE: -94.48830827
DIRECTION:	SITE LOCATION: HALLSVILLE, TEXAS		
DESCRIPTION: East Bottom Ash Pond - Drainage Feature, Pipe Inlet. Address silt buildup and maintain vegetation to 12-inches or less.

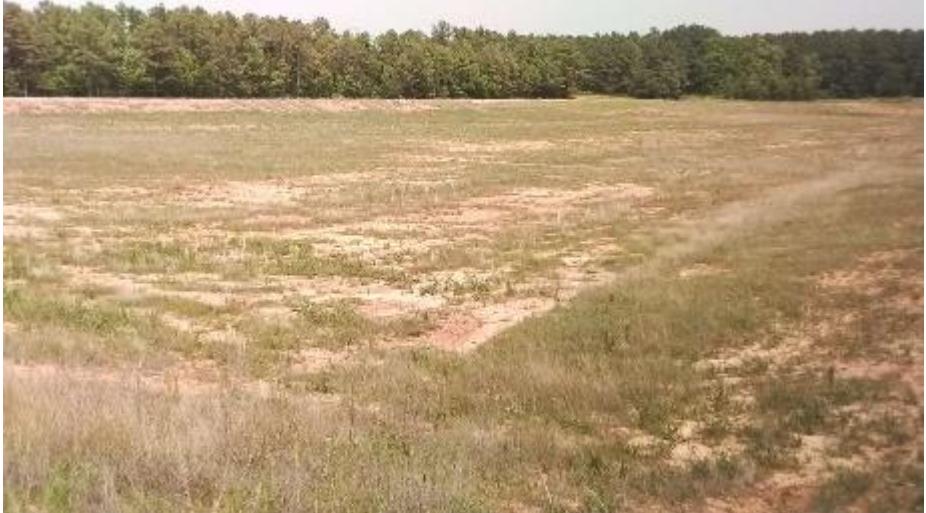
PHOTOGRAPH NO: 7	DATE: May 14, 2025 2:00 PM	LATITUDE: 32.4663186	LONGITUDE: -94.48873888
DIRECTION:	SITE LOCATION: HALLSVILLE, TEXAS		
DESCRIPTION: East Bottom Ash Pond - Upstream Slope. General Photo, Typical Conditions.

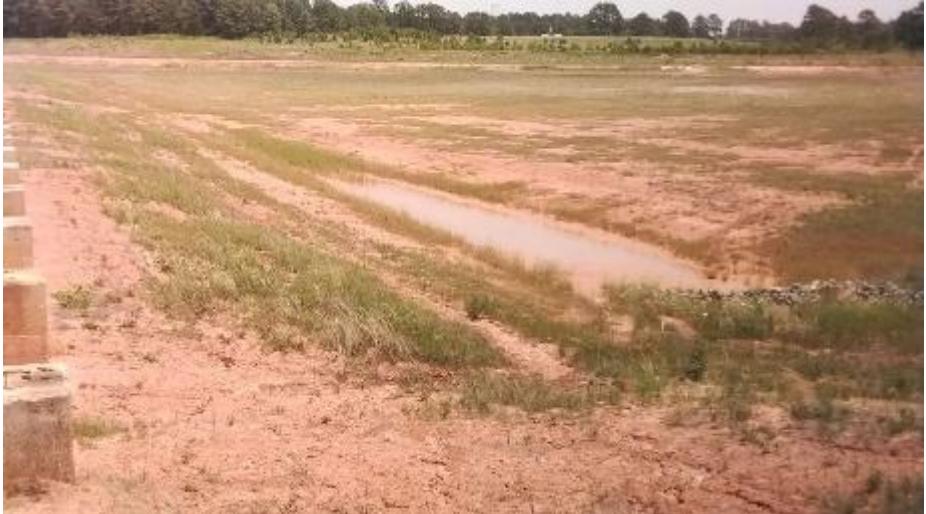
PHOTO BY:			
GEI CONSULTANTS, INC.	PHOTOGRAPH NO: 8	DATE: May 14, 2025 1:59 PM	LATITUDE: 32.46630686
DIRECTION:	SITE LOCATION: HALLSVILLE, TEXAS		
DESCRIPTION: East Bottom Ash Pond - Upstream Slope, Typical Conditions.
