2025 Rockport Landfill Annual Inspection Report

**Rockport Plant
Indiana Michigan Power Company
Rockport, Indiana**

October 2025

Document ID: GERS-25-018

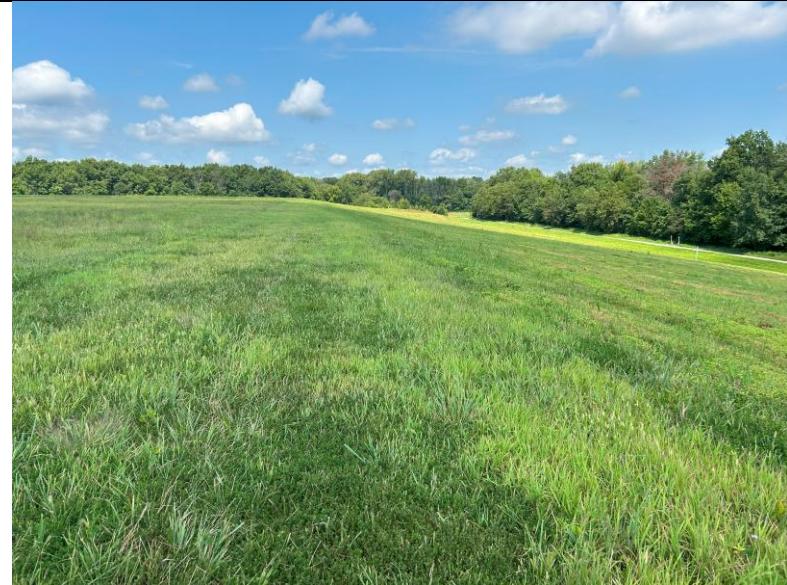
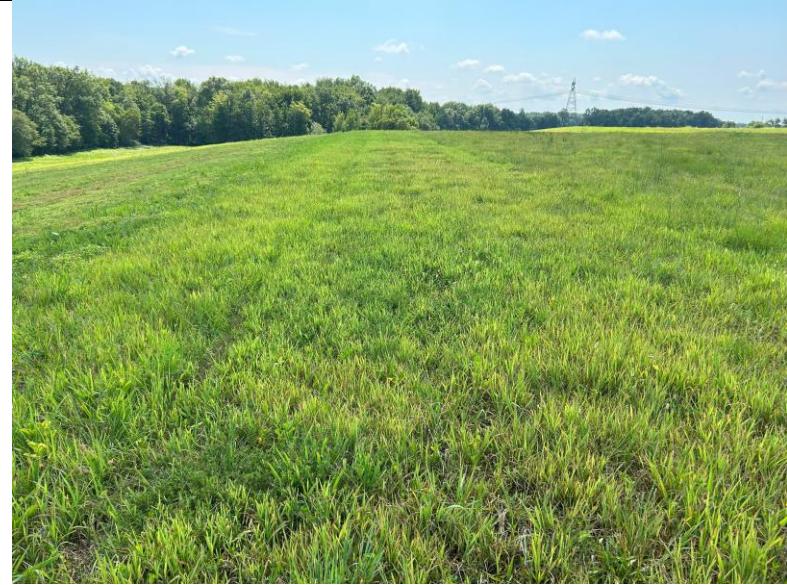
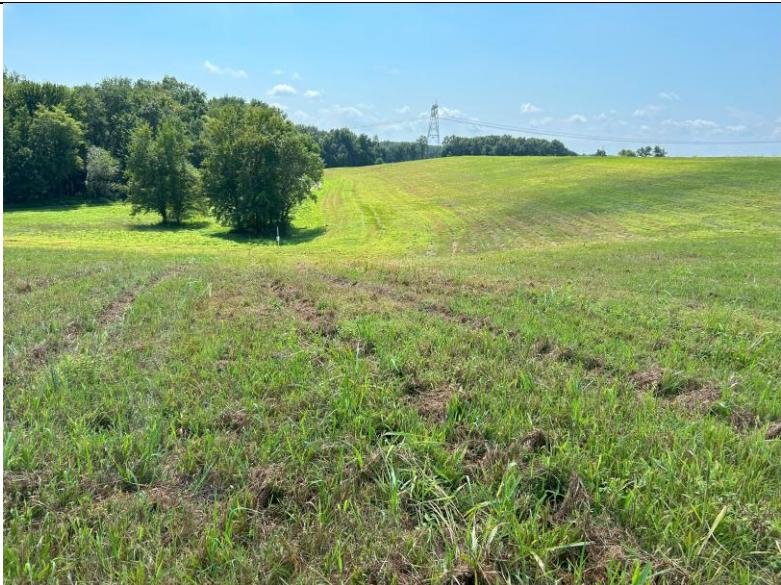
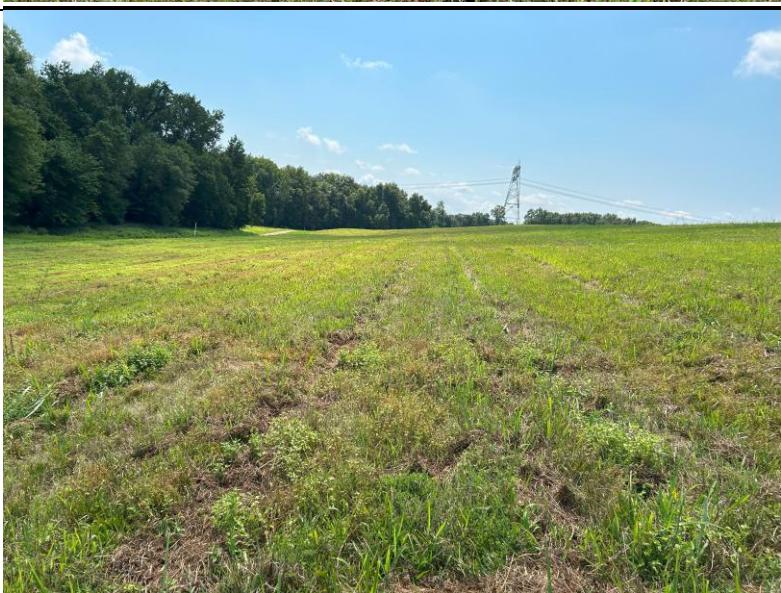
1. The Closed Landfill (Type II Liner) was in good condition. The vegetative cover was well established, controlled with mowing, and in good condition with no apparent signs of erosion or

seepage (Photographs 1, 2, 3 and 4).

View of the Northeastern portion of the Closed Landfill area, located east of Control Point #1501.

View of the northeastern portion of the closed landfill area, situated east of Control Points #1501 and #1085.

View of the northeastern portion of the closed landfill area, situated east of Control Points #1084 and #1085.

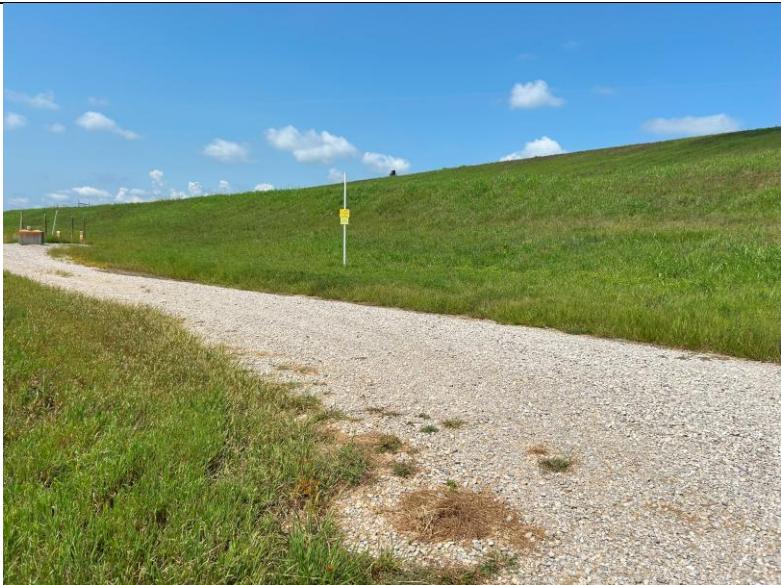
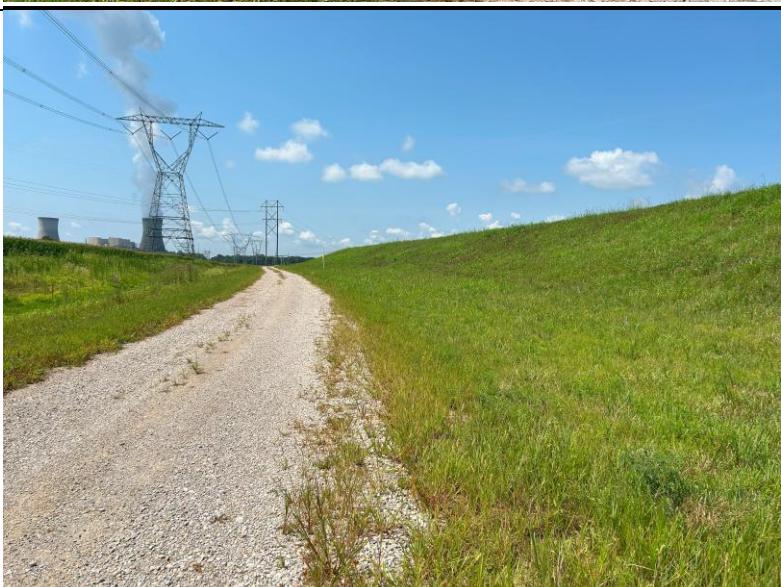
1. Cells 1A, 1B, 2 and 3 were generally in good condition. The vegetative cover was well established and controlled with mowing (Photographs 5 and 6).
2. Stormwater features (riprap down-chutes and culverts) were unobstructed (Photographs 7 and 8).

View of the Southern portion of the Closed Landfill area, located Southwest of Control Point #1084.

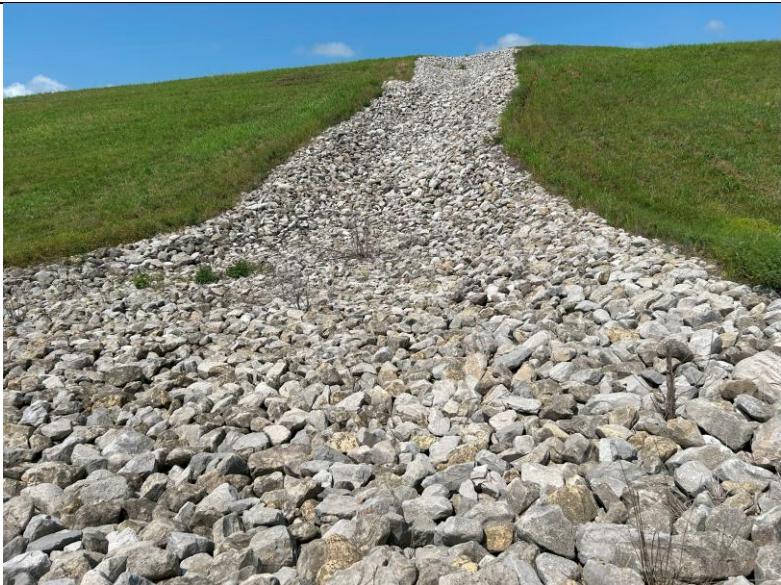
Photograph 7:

View of the Rip Rap Spillway located southwest of Control Points #1084.

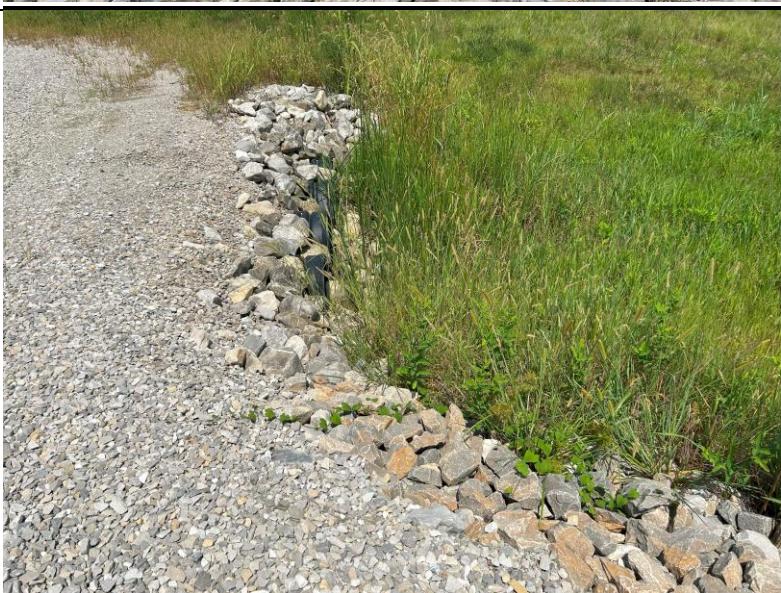
Photograph 8:

View of HDPE (High-Density Polyethylene) pipes installed along the landfill perimeter for efficient stormwater drainage.

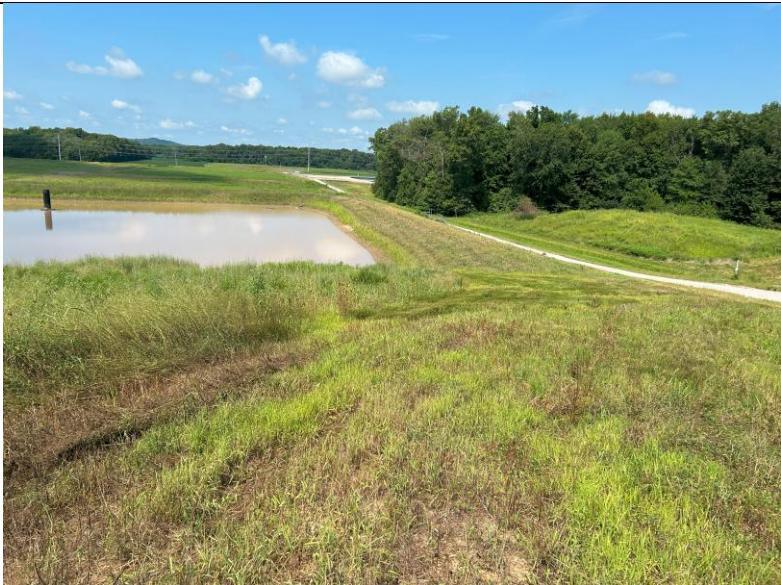
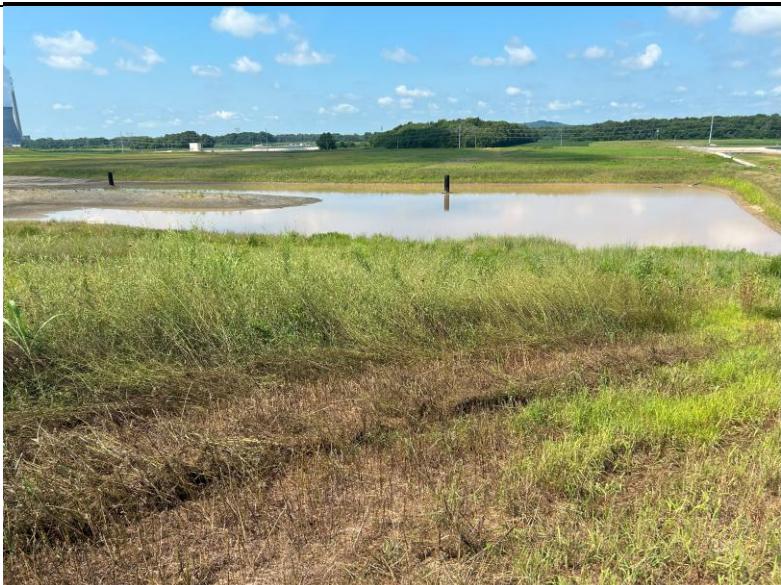
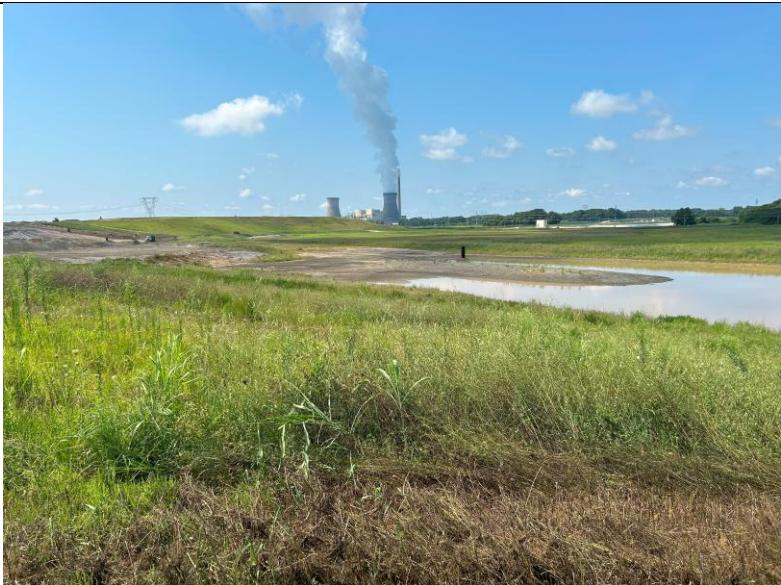
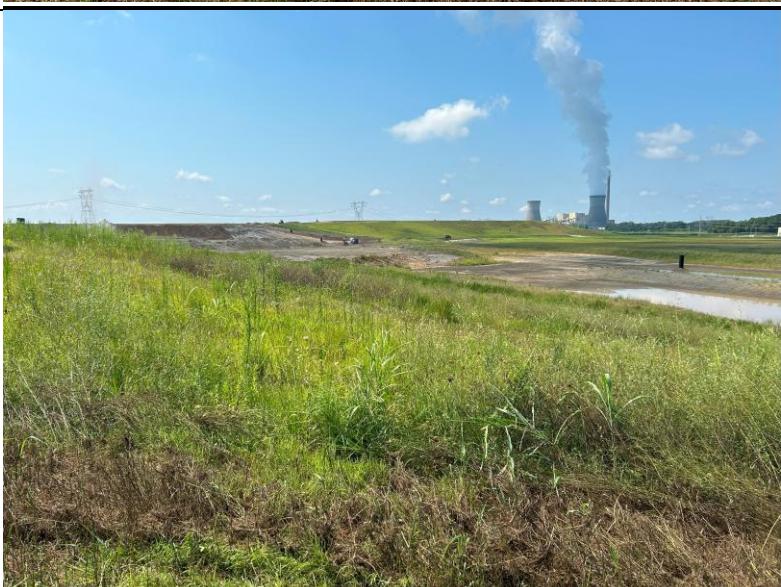
1. A significant amount of surface water was observed standing in the east portion of Cell 4A, indicating that the leachate collection system may not be effectively draining contact water in accordance with specifications for that section of the active landfill area (Photographs 9, 10, 11 and 12).
2. External pumps were installed and utilized to transfer contact water from Phase 2 to the North Leachate Pond (Photographs 13 and 14).
3. Unloading and disposal of soils and waste materials were observed within the Phase 2 areas (Photographs 15 and 16).

1. The significant amount of surface water observed standing in the east portion of Cell 4A within the active landfill area.

The view depicts standing contact water and the chimney drain located south of Manholes #10 and #11 within Phase 2 North. This contact water must be continuously and properly monitored, and regularly pumped out to the North Pond Complex.

The view depicts standing contact water and the chimney drain located south of Manholes #10 and #11 within Phase 2 North. This contact water must be continuously and properly monitored and regularly pumped out to the North Pond Complex.

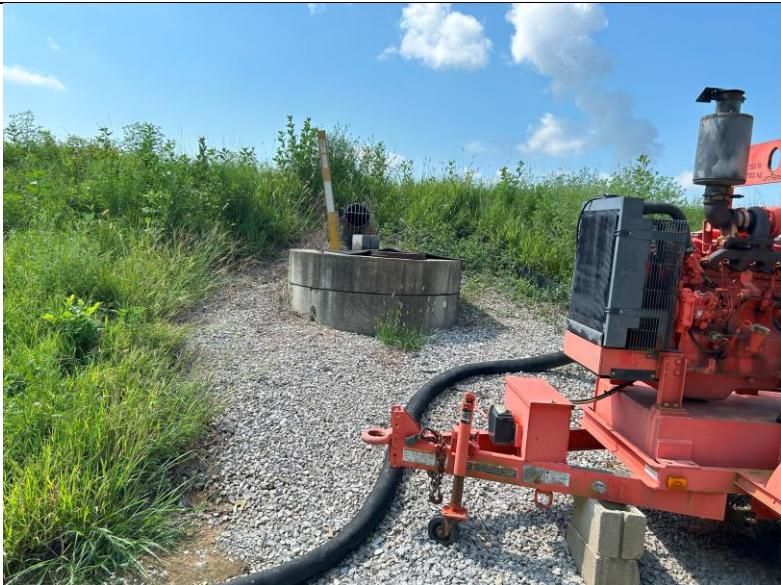
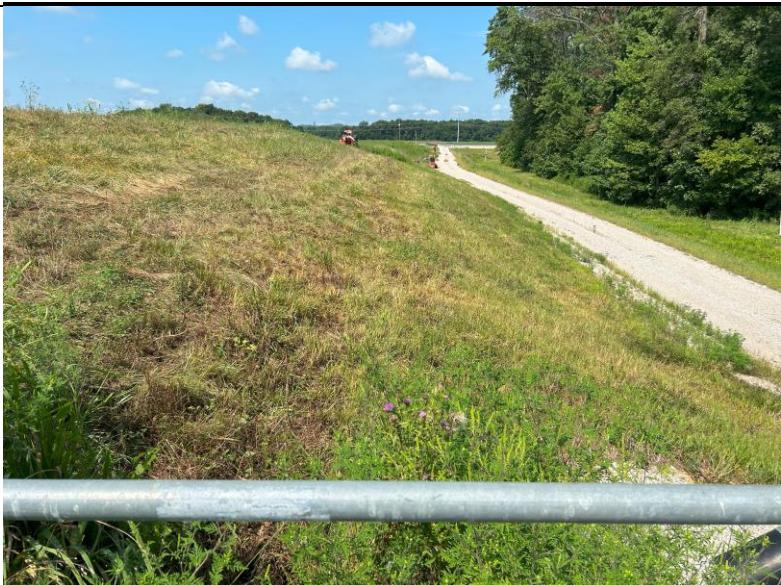
View showing external pumps installed and in use to transfer contact water from Phase 2 to the North Leachate Pond.

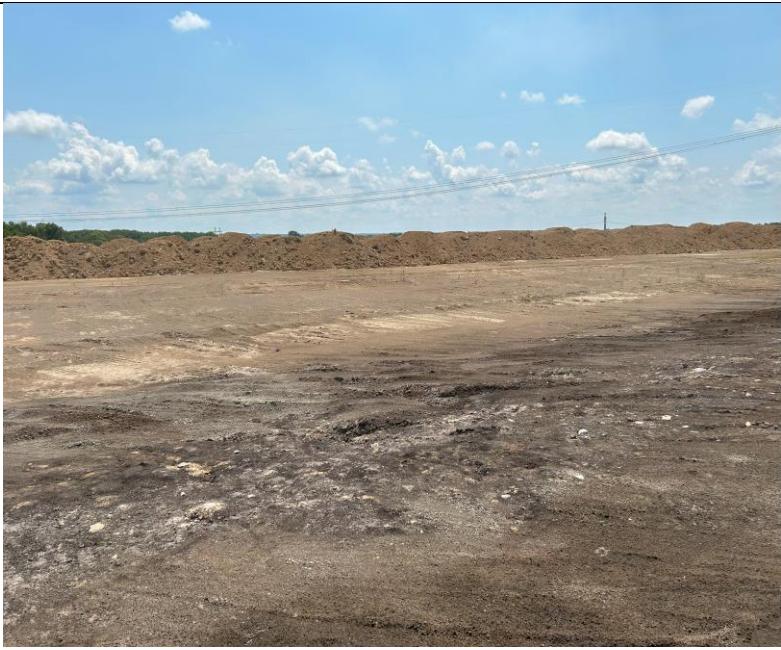
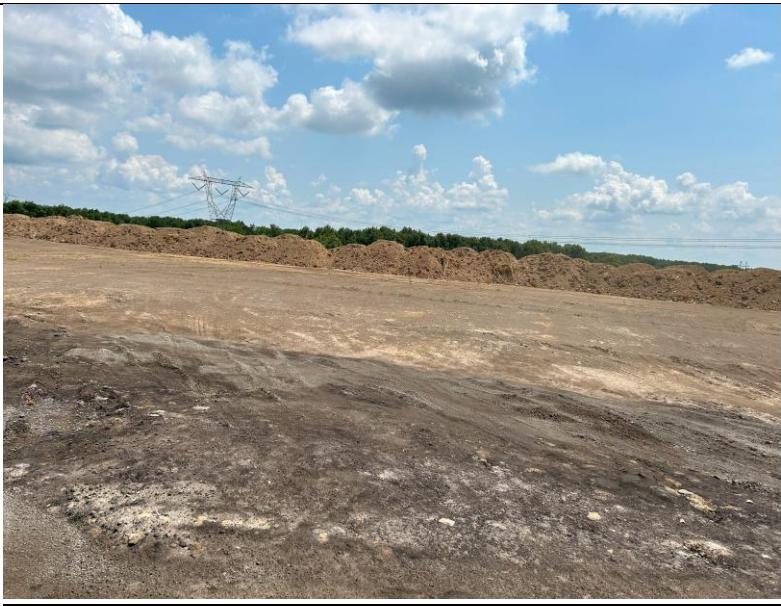
View showing the unloading and disposal of soils and waste materials within the Phase 2 area.

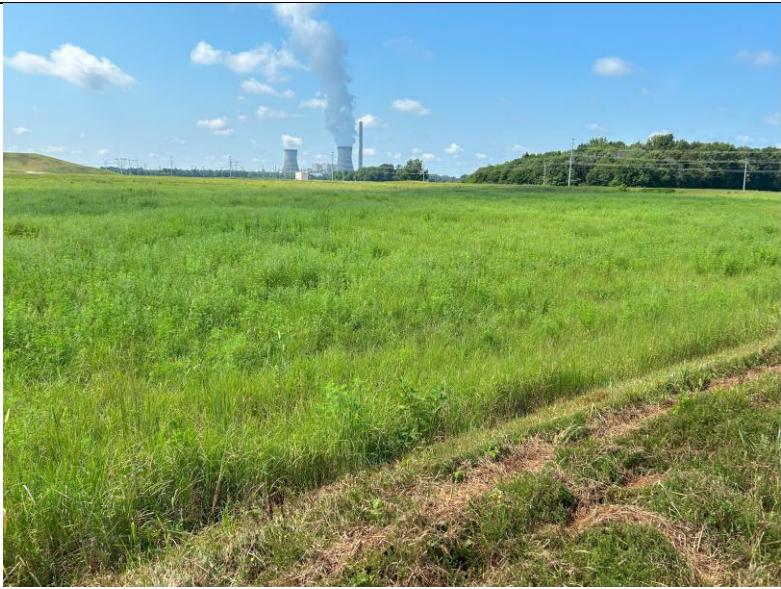
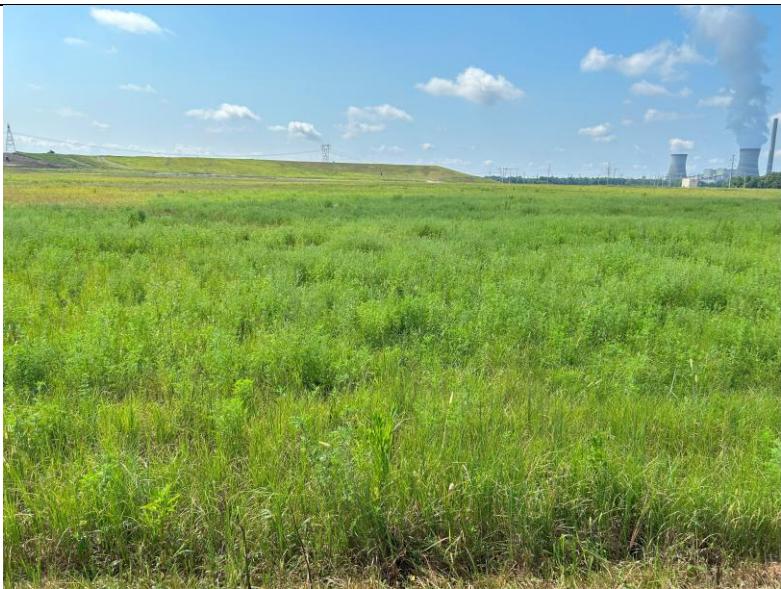
1. The inactive landfill cells 4B, 6, and 7 were in good condition. The vegetative cover was well established and in good condition with no apparent signs of erosion or seepage (Photographs 17 and 18).

View of the Inactive landfill cells 4B, 6, and 7 were observed to be in good condition, with well-established vegetative cover and no visible signs of erosion or seepage.

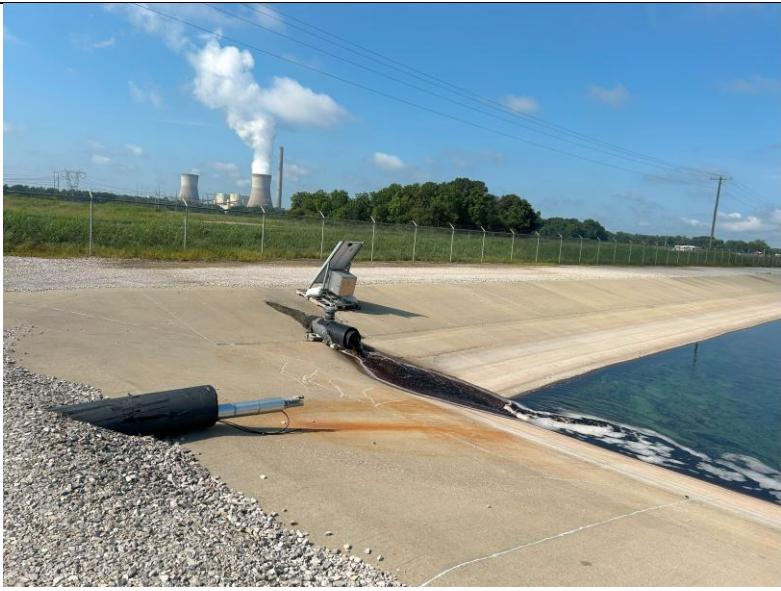
Photograph 19:

1. The Concrete Basin within the West Pond Complex was observed to be in good condition, with only a few minor longitudinal and transverse hairline cracks observed. Additionally, the leachate influent line was flowing at the time of inspection (Photograph 19).

Photograph showing the flow of the leachate influent line into the Concrete Basin at the West Leachate Pond Complex.

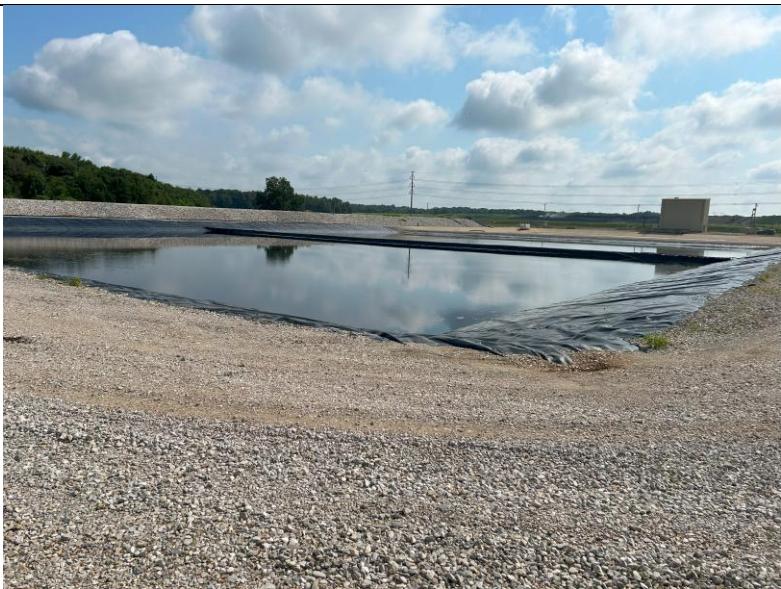
Photograph 20:

2. The LLDPE-lined West Pond within the West Pond Complex was observed to be in good condition, with no visible signs of liner degradation or damage (Photograph 20).

Overview of the LLDPE-lined West Pond located within the West Pond Complex.

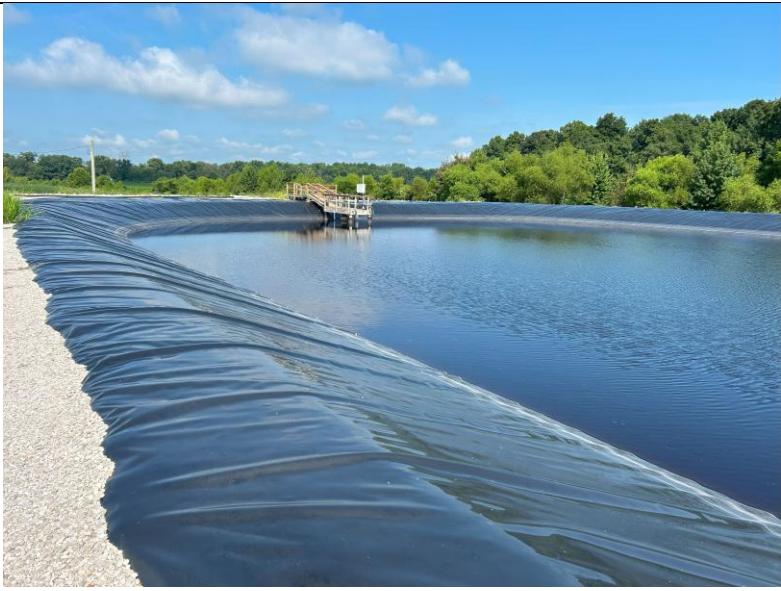
Photograph 21:

3. The LLDPE-lined 002 Outfall Pond within the West Pond Complex was observed to be in good condition, with no visible signs of liner degradation or damage (Photograph 21).

View of the discharge structure located within the LLDPE-lined 002 Outfall Pond, part of the West Pond Complex.

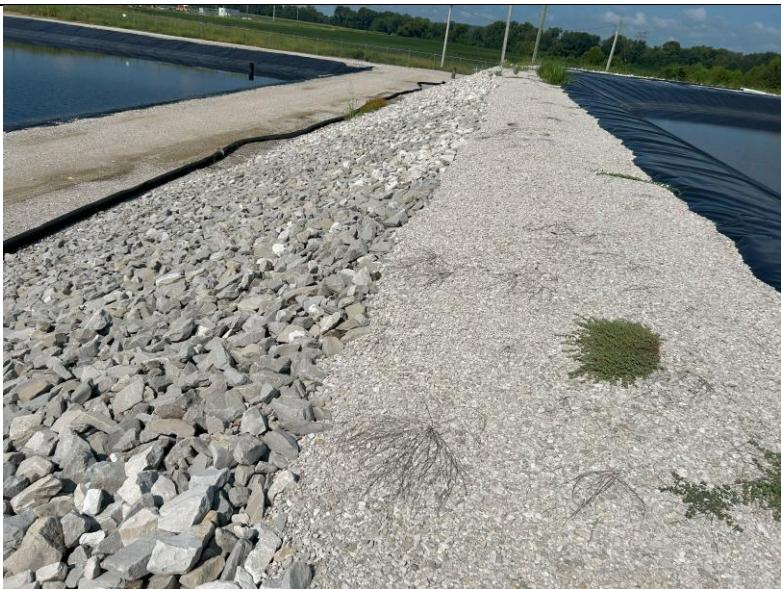
Photograph 22:

4. The riprap on the exterior slopes of the LLDPE-lined 002 Outfall Pond within the West Pond Complex appeared to be in good condition (Photograph 22).

View of the riprap on the exterior slopes of LLDPE-lined 002 Outfall Pond within the West Pond Complex appeared to be in good condition.

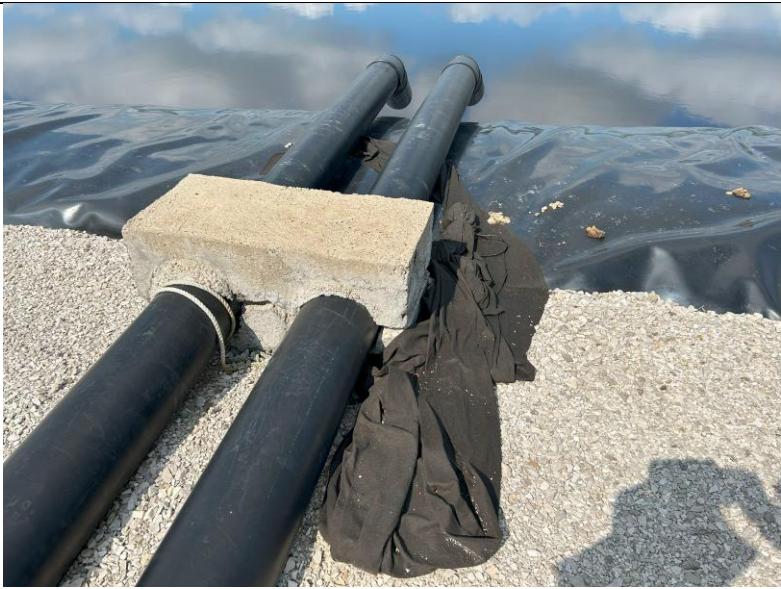
Photograph 23:

5. Few minor cracks were noted in the above-grade concrete thrust blocks connected to the eastern influent lines. (Photograph 23).
6. The safety fence surrounding the leachate West Pond Complex was in good condition (Photograph 24).

View of a crack observed in the exposed thrust block on the east side of the LLDPE-lined 002 Outfall Pond, within the West Pond Complex.

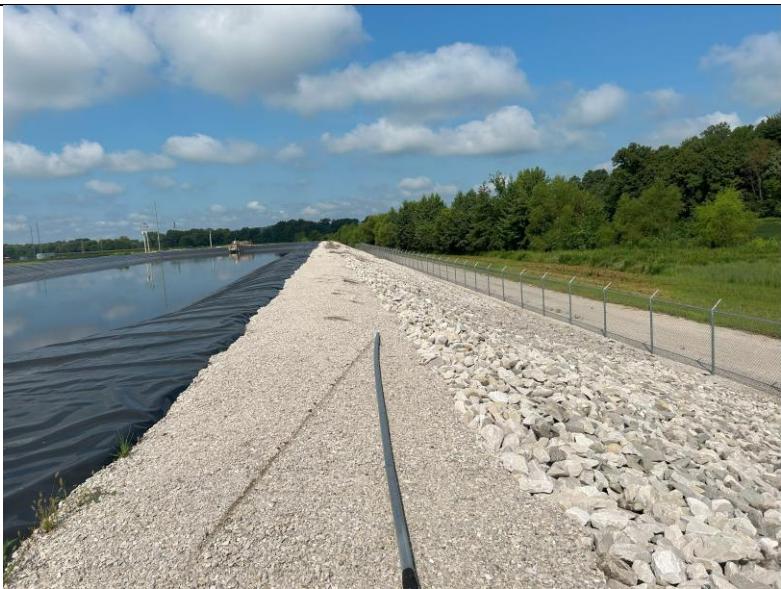
Photograph 24:

View showing the safety fence surrounding the West Leachate Pond Complex, which appeared to be in good condition.

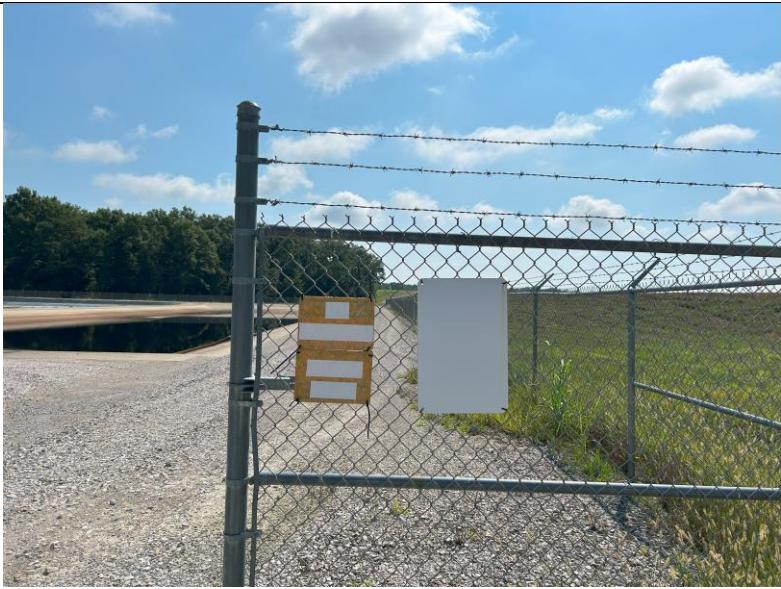
Photograph 25:

1. The signs at the fence near the entrance gate of the North Pond Complex have significantly faded, making the text nearly illegible. It is recommended that the signage be replaced or restored to clearly display all required information. (Photograph 25).
2. The fence surrounding the leachate North Pond Complex was in good condition (Photograph 26).
3. The Concrete Basin within the North Pond Complex was observed to be in good condition, with no signs of significant structural damage. Some longitudinal and transverse hairline cracks were present (Photograph 27).

View showing the signs mounted on the fence near the entrance gate of the North Pond Complex, which have significantly faded, rendering the text nearly illegible.

1. Perform regular mowing of grass-covered areas in accordance with the established schedule to preserve the integrity of the landfill cover.
2. Continue routine maintenance of any erosion.
3. Clear and remove any obstructions in stormwater management features.
4. Replace or restore the signage on the fence near the entrance gate of the North Pond Complex to ensure all required information is clearly visible and legible.

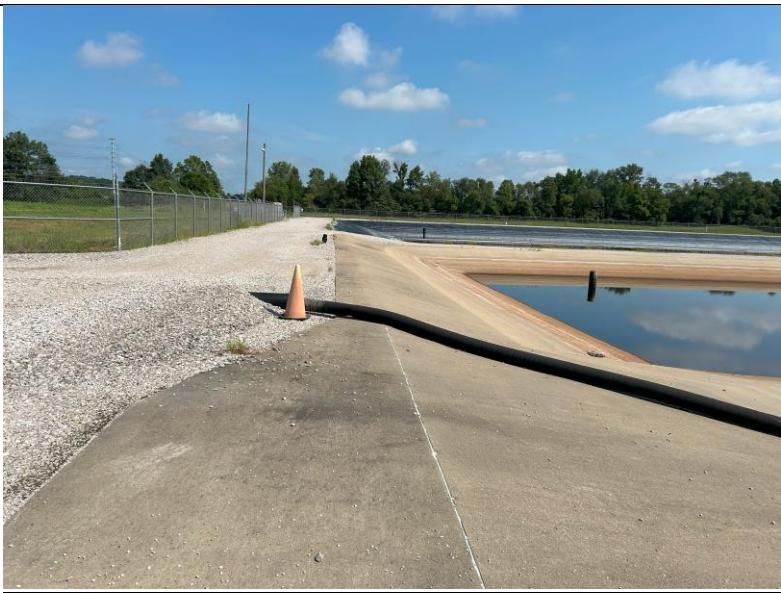
Photograph 26:

View showing the safety fence surrounding the North Leachate Pond Complex, which appeared to be in good condition.

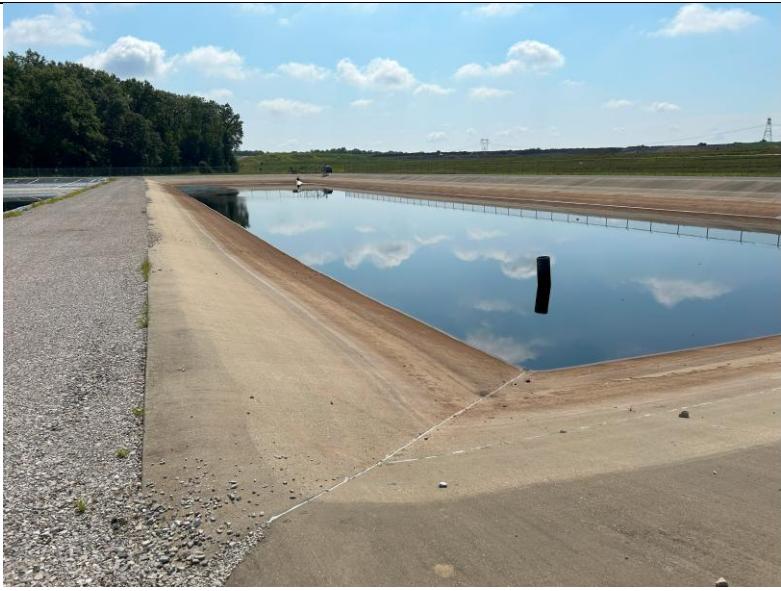
Photograph 27:

View showing the Concrete Basin within the North Pond Complex was observed to be in good condition, with no signs of significant structural damage. Some longitudinal and transverse hairline cracks were present.

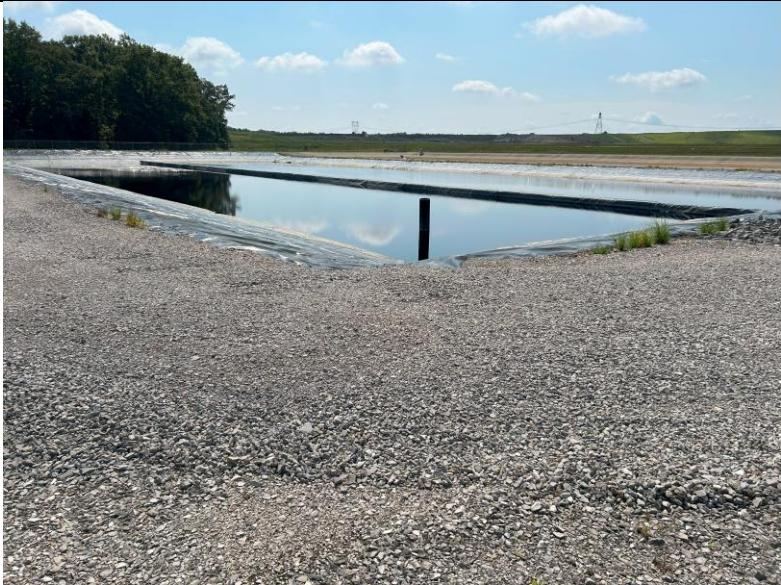
Photograph 28:

4. The North Pond within the North Pond Complex was generally observed to be in good condition, with no indications of significant structural damage (Photographs 28).

View showing the North Pond within the North Pond Complex was generally observed to be in good condition, with no indications of significant structural damage.

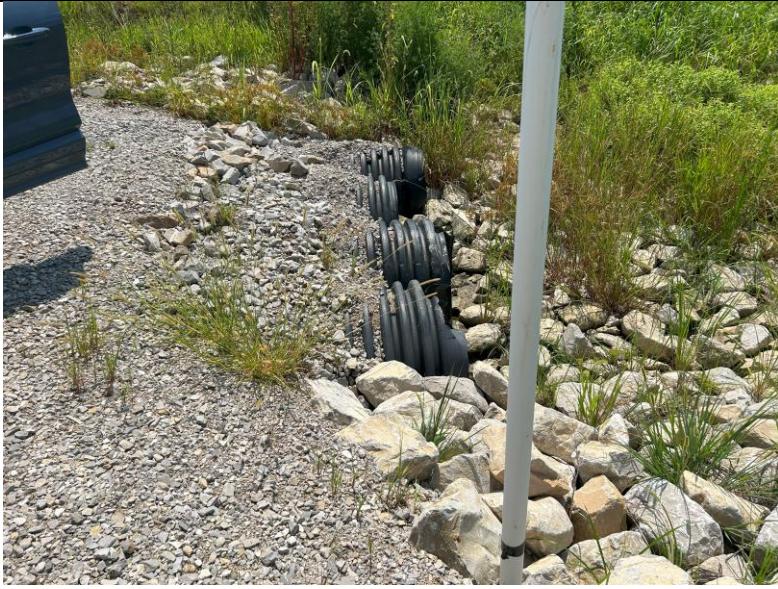
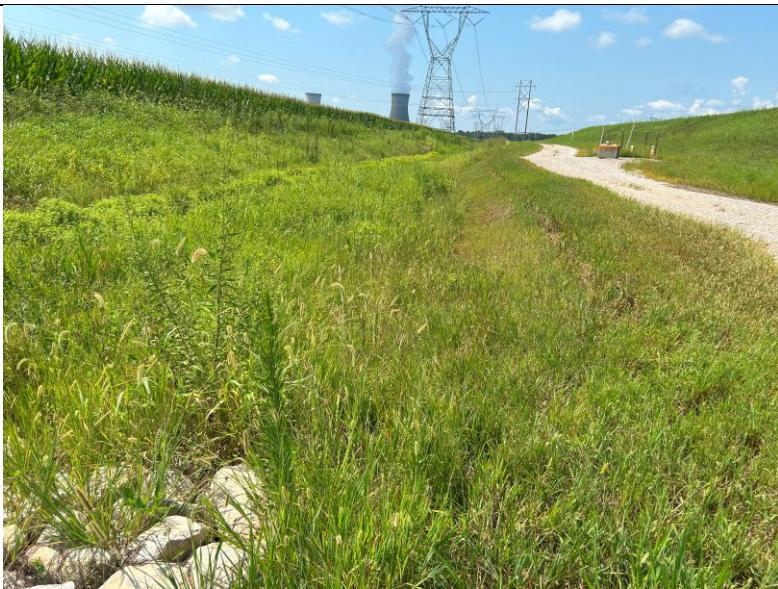
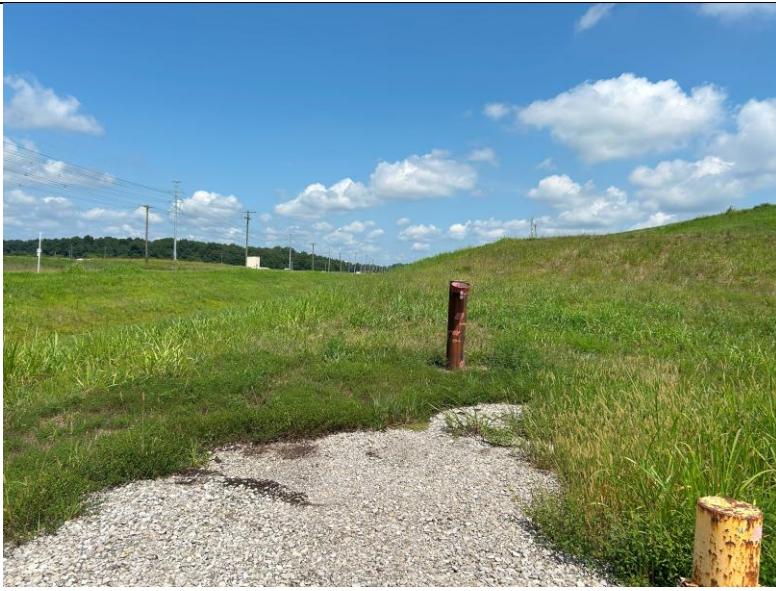
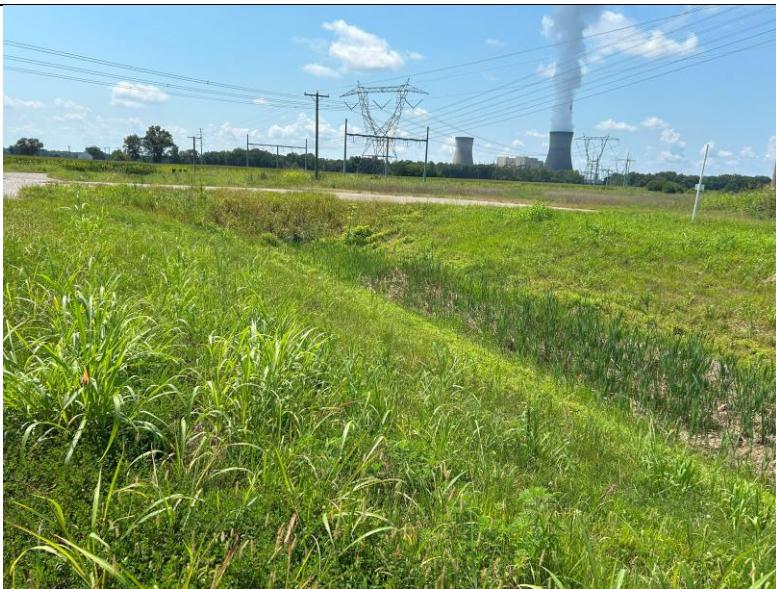
1. The perimeter ditches along the West and South sides were observed to be in good condition, with no evidence of erosion or blockage (Photos 29, 30, 31 and 32).

View showing the perimeter ditches along the West and South sides, which appeared to be in good condition with no signs of erosion or blockage.
