# **2025 Annual Dam and Dike Inspection Report**

**East Bottom Ash Pond and West Bottom Ash Pond**

**Rockport Plant  
Indiana Michigan Power Company  
Rockport, Indiana**

**Document ID: GERS-25-017**

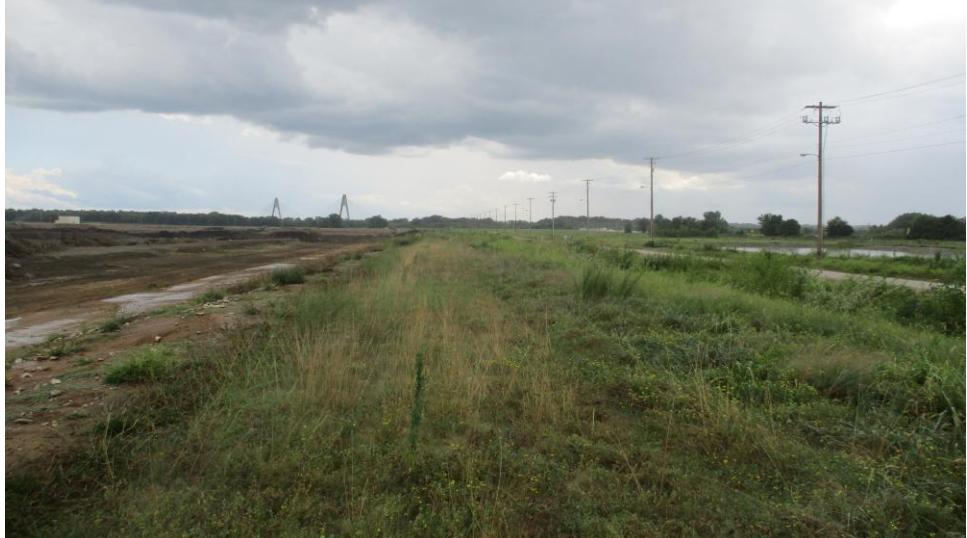
<p><b>Photo # 4</b></p>

3. The west dike is illustrated in Photograph No. 4. Overall, the dike is in good and stable condition with a buttress of bottom ash at the interior slope. Overgrown vegetation was observed along the crest and exterior slope.

- 1) Continue with the vegetation maintenance and mowing efforts at the facility.
- 2) Repair any ruts or erosion gullies by filling with stone or compatible material with compaction.

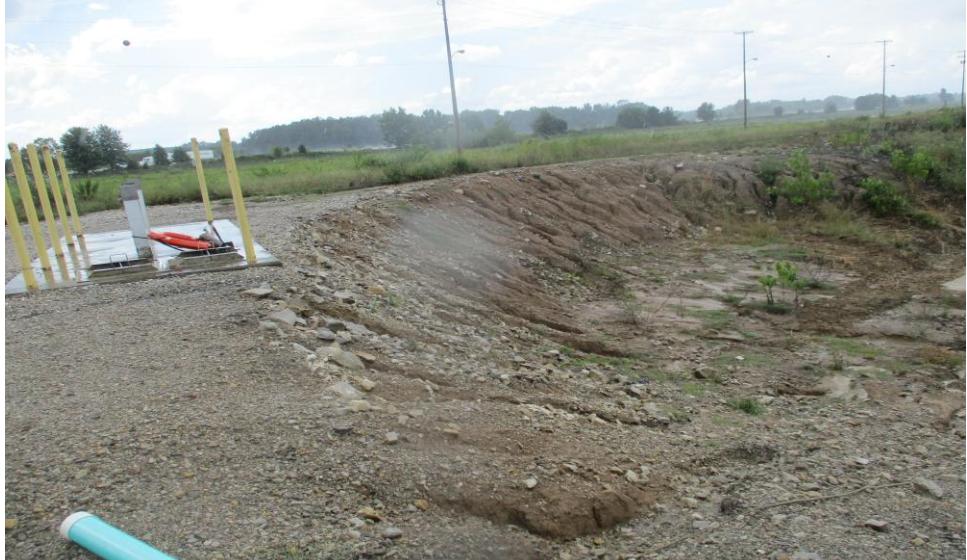
<p><b>Photo # 5</b></p>

4. Typical interior slope of the pond is illustrated in Photographs No. 5 and 6. The interior slopes showed no signs of distress such as sloughing or bulges. Minor erosion was observed at the south end of the pond.

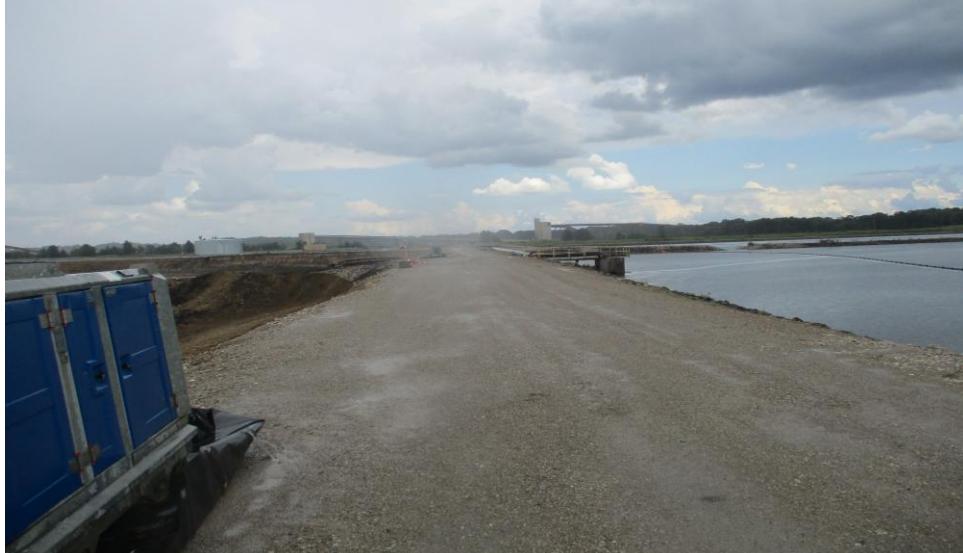
<p>Photo #7</p>

5. The splitter dike between the two ash ponds appeared to be in good condition and showed no signs of distress (Photograph No. 7). The crest of the east dike, south section appeared in good and stable condition with no signs of distress such as settlement or ruts, and erosion.

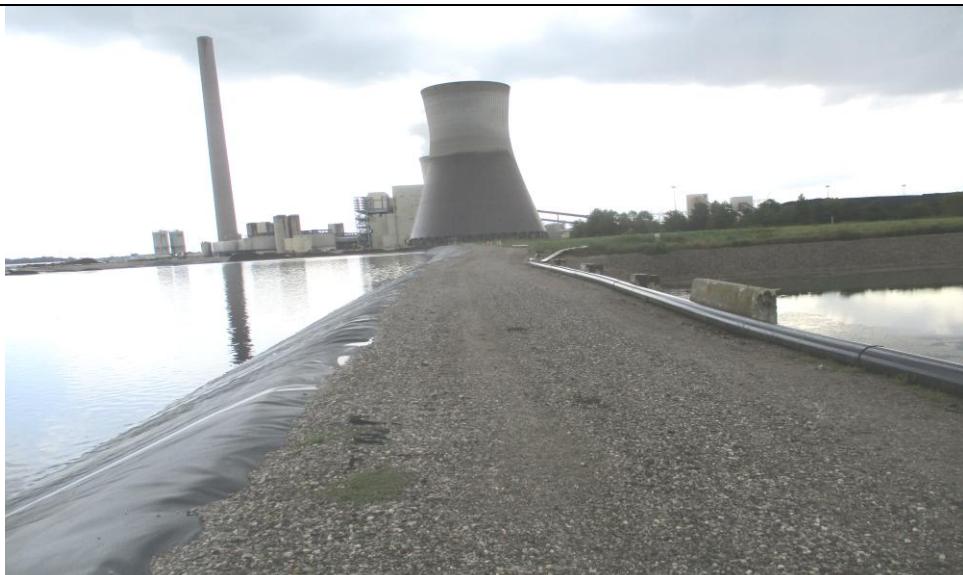
<p>Photo #8</p>

1. The east slope of the pond is illustrated in Photograph No. 8. The crest, interior, and exterior slope of the dike appeared in good and stable condition. The gravel surface over the crest appeared in good condition without any sign of settlement or distress.

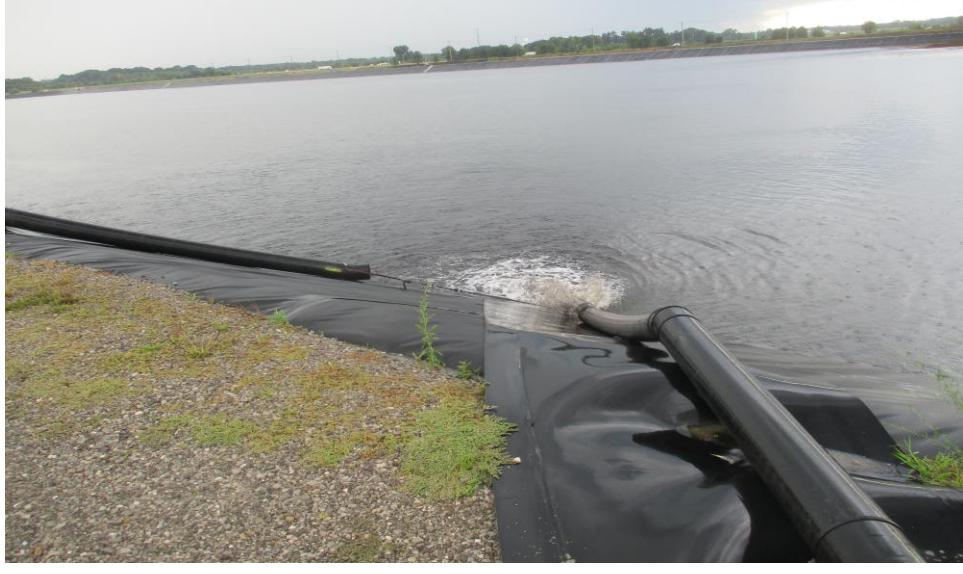
<p>Photo #9</p>

2. The interior slopes showed no signs of distress such as sloughing, bulges or erosion (Photograph No. 9). The geomembrane liner was intact and no tear or damage was noticed except the north slope where the repair was in progress. The interior slope was in good and stable condition.

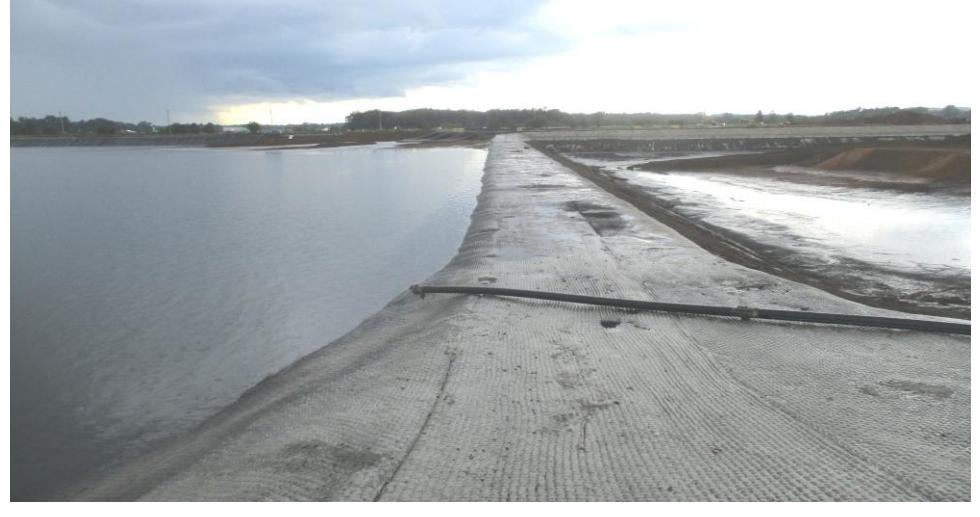
Photo #10

3. The pond is subdivided into a Forebay for managing bottom ash. A clay dike is installed covered with fabriform liner (Photograph No. 10). The pond is functioning as designed with the splitter dike. The dike is in good and stable condition.

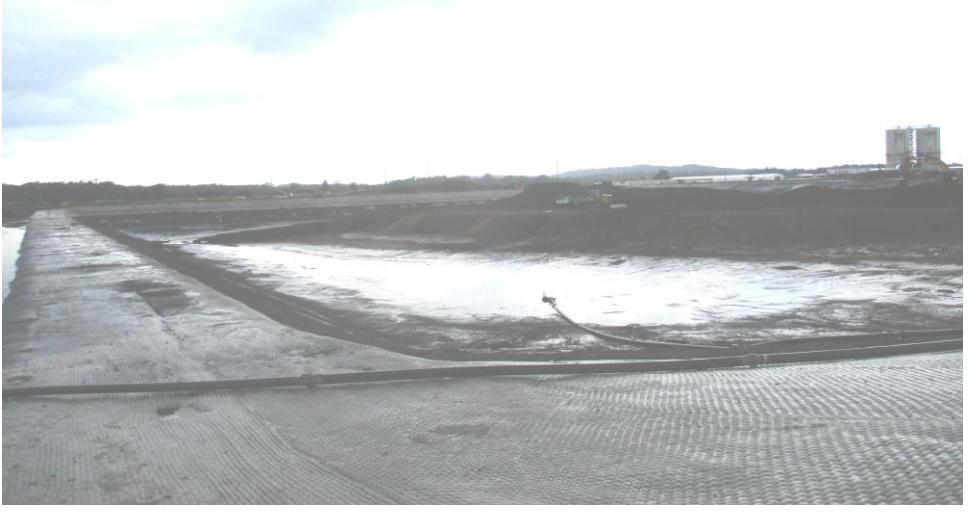
4. A section of the liner system of the north interior slope failed and currently been repaired. The main dike is in good and stable condition (Photograph No. 11). The sluice pipes are temporarily rerouted and extended into the pond south of the splitter dike (Photograph No. 12). Photograph No. 13 illustrate the exposed area of the interior slope where the failure occurred and has been repaired.

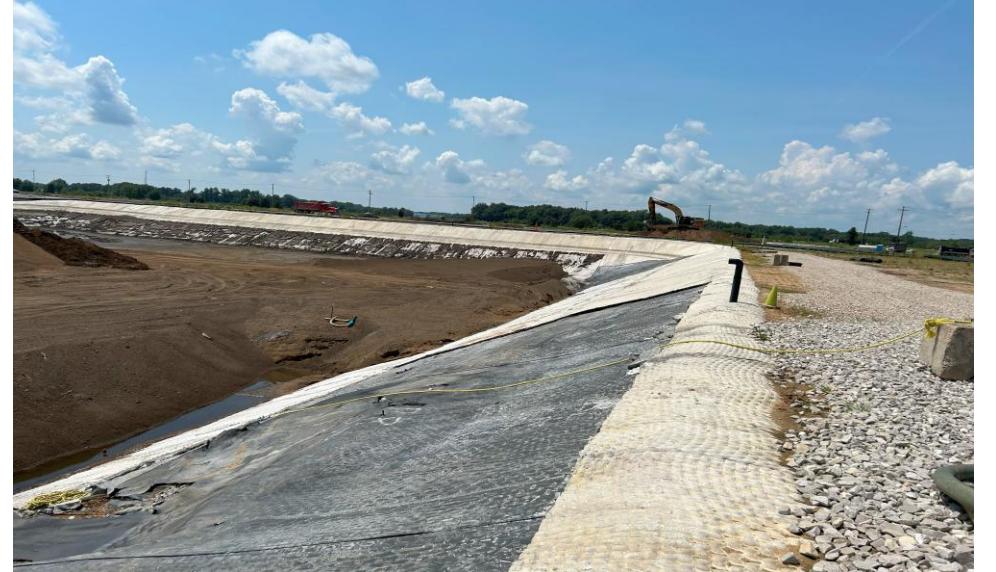
Photo #13

On September 18, 2024, a deficiency was recorded regarding concrete and liner damage at the EBAP Forebay. The concrete revetment beneath the discharge pipes in the East Bottom Ash Pond has experienced erosion, which in turn has compromised the integrity of the underlying liner system. In response, a Deficiency Corrective Measures Plan was developed and remediation efforts are currently underway.

There is repair work currently on-going deficiency discovered in 2024 where the revetment and liner system were damaged at the north slope of the EBAP forebay. There were no additional signs of structural weakness or disruptive conditions that were observed at the EBAP and WBAP at the time of the inspection that would require additional investigation or remedial action. No additional deficiencies were identified during this inspection or any of the periodic 7-day or 30-day inspections. If a deficiency is identified before the next annual inspection contact AEP Geotechnical Engineering immediately.

North interior slope  
(looking west).
