### CCR Landfill

## 2025 Annual Landfill Inspection Report

Turk Power Plant, Fulton, Arkansas

May 1, 2025  
Project 2501323  
AEP Document ID: GEVR-25-009

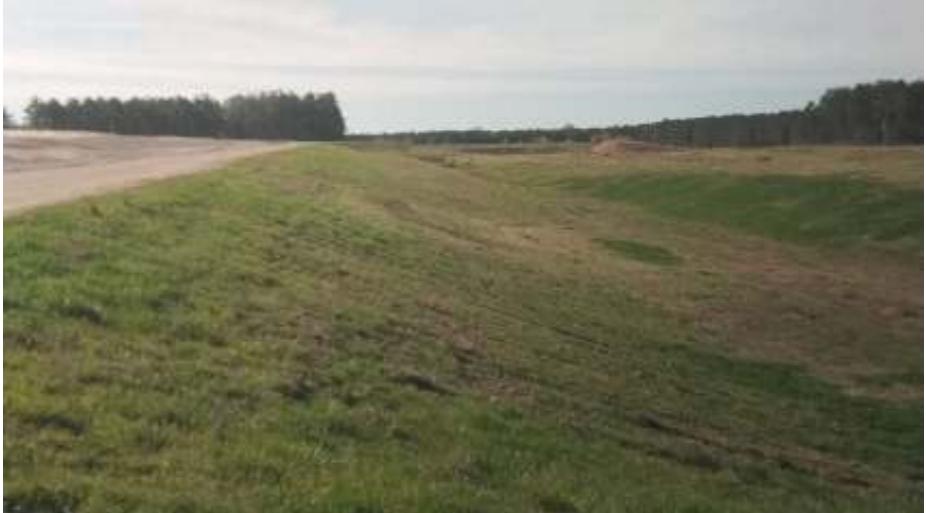
<b>PHOTOGRAPH No: 1</b>	<b>DATE:</b> March 25, 2025 10:03 AM	<b>LATITUDE:</b> 33.63844735	<b>LONGITUDE:</b> -93.81305409
<b>DIRECTION:</b> 94°	<b>SITE LOCATION:</b> TURK POWER PLANT, FULTON, ARKANSAS		
<b>DESCRIPTION:</b>  Cell 2 Perimeter Berm, Downstream Slope of Access Road. General Photo, Typical Conditions.

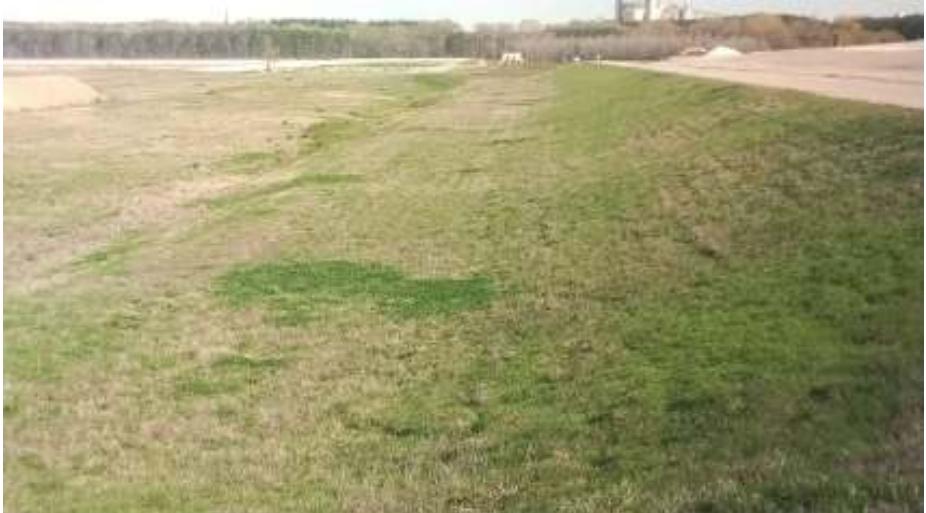
<b>PHOTO BY:</b>  GEI CONSULTANTS, INC.			
<b>PHOTOGRAPH No: 2</b>	<b>DATE:</b> March 25, 2025 10:14 AM	<b>LATITUDE:</b> 33.63499356	<b>LONGITUDE:</b> -93.81304282
<b>DIRECTION:</b> 271°	<b>SITE LOCATION:</b> TURK POWER PLANT, FULTON, ARKANSAS		
<b>DESCRIPTION:</b>  Cell 2 Perimeter Berm, Downstream Slope of Access Road. General Photo, Typical Conditions.

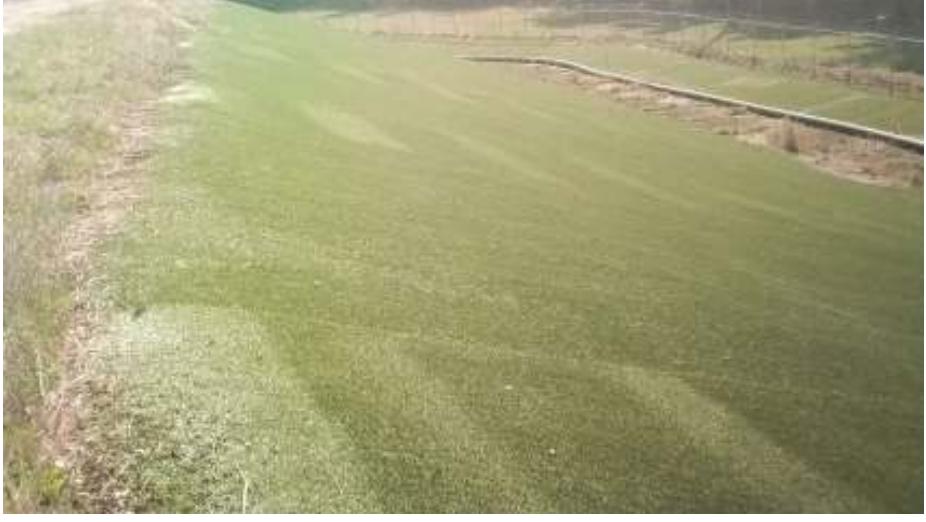
<b>PHOTOGRAPH No: 3</b>	<b>DATE:</b> March 25, 2025 10:27 AM	<b>LATITUDE:</b> 33.63488335	<b>LONGITUDE:</b> -93.81312799
<b>DIRECTION:</b> 7°	<b>SITE LOCATION:</b> TURK POWER PLANT, FULTON, ARKANSAS		
<b>DESCRIPTION:</b>  Downstream Slope of Perimeter Berm. General Photo, Typical Conditions.  Versa Cap (synthetic grass cover) on downstream perimeter berm.

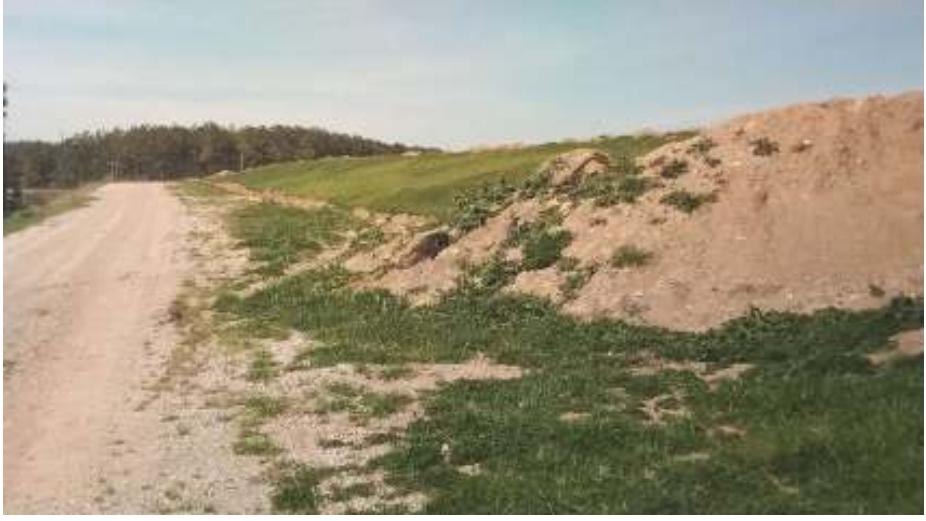
<b>PHOTO BY:</b>  GEI CONSULTANTS, INC.			
<b>PHOTOGRAPH No: 4</b>	<b>DATE:</b> March 25, 2025 10:36 AM	<b>LATITUDE:</b> 33.63537271	<b>LONGITUDE:</b> -93.81120112
<b>DIRECTION:</b> 172°	<b>SITE LOCATION:</b> TURK POWER PLANT, FULTON, ARKANSAS		
<b>DESCRIPTION:</b>  Temporary Exterior Slope of Active Cell 2. General Photo, Typical Conditions.

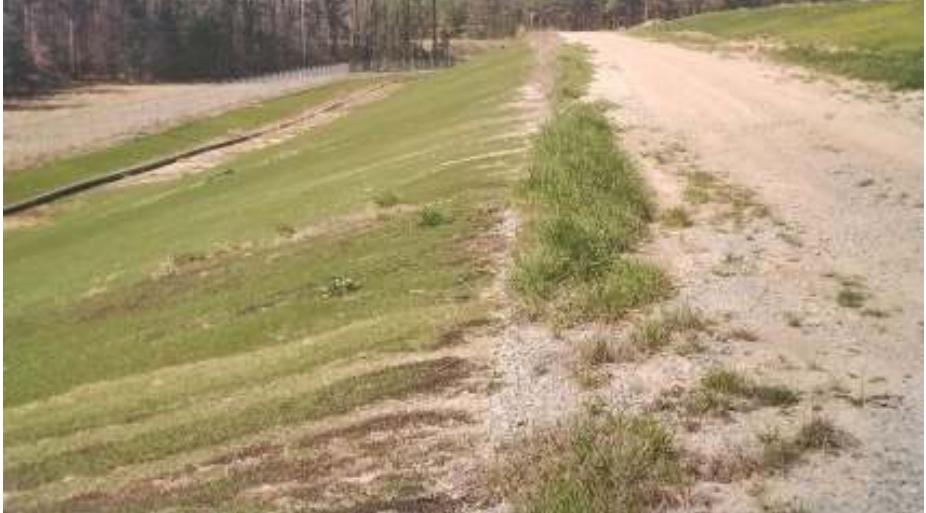
<b>PHOTOGRAPH No: 5</b>	<b>DATE:</b> March 25, 2025 10:37 AM	<b>LATITUDE:</b> 33.63548639	<b>LONGITUDE:</b> -93.81088556
<b>DIRECTION:</b> 153°	<b>SITE LOCATION:</b> TURK POWER PLANT, FULTON, ARKANSAS		
<b>DESCRIPTION:</b>  Downstream Slope of Perimeter Berm.  Address isolated vegetation growing through Versa Cap (synthetic grass cover) and in accumulated sediments in perimeter ditch.

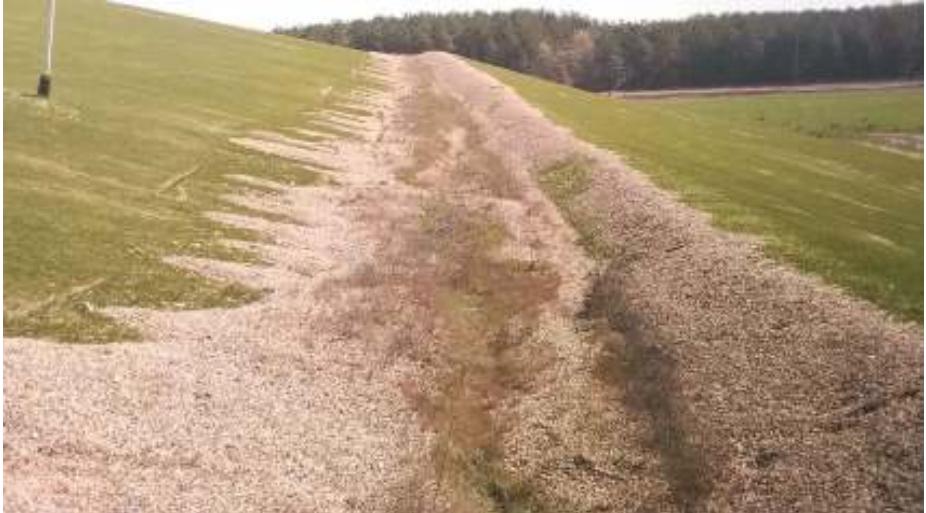
Photo 6 – Monitor minor erosion of pea gravel cover on Closurerurf® test pad.

<b>PHOTOGRAPH No: 6</b>	<b>DATE:</b> March 25, 2025 10:45 AM	<b>LATITUDE:</b> 33.63591371	<b>LONGITUDE:</b> -93.81064029
<b>DIRECTION:</b> 333°	<b>SITE LOCATION:</b> TURK POWER PLANT, FULTON, ARKANSAS		
<b>DESCRIPTION:</b>  Exterior Slope of Cell 1, Mid-Bench Drain.  Monitor minor erosion in pea gravel cover. Address / re-apply if it becomes significant.

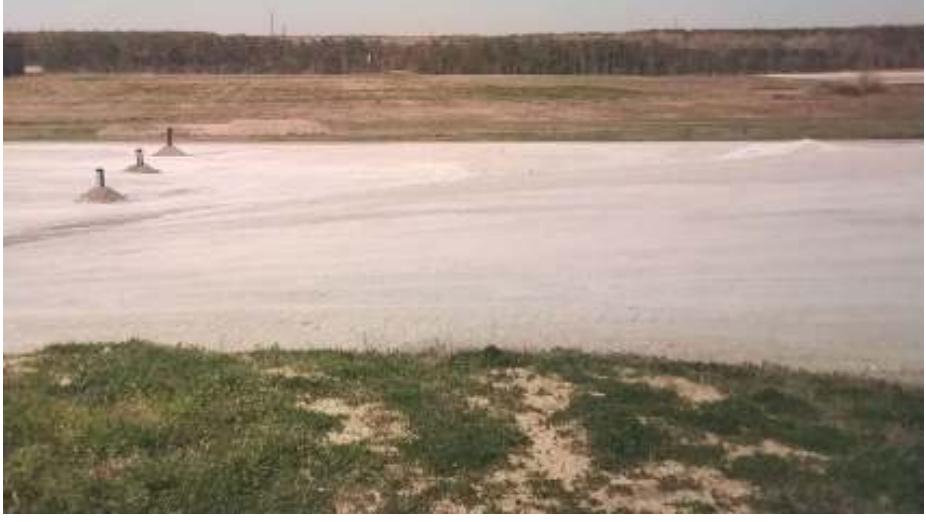
PHOTOGRAPH NO: 7	DATE: March 25, 2025 10:50 AM	LATITUDE: 33.63620407	LONGITUDE: -93.8106772
DIRECTION: 185°	<b>SITE LOCATION:</b> TURK POWER PLANT, FULTON, ARKANSAS		
<b>DESCRIPTION:</b>  Active Cell 2 Chimney Drains, General Photo, Typical Conditions.

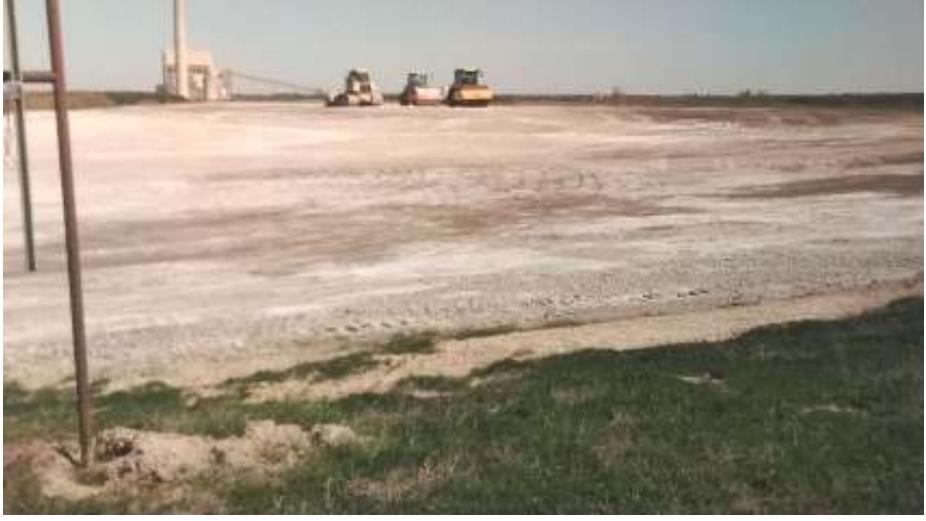
2. Cell 1 was in good and stable condition with no sign of instability, ponding water or significant erosion. The temporary access road to the west and landfill perimeter road to the south appeared in good condition. Photograph No. 8 provides general conditions observed during the inspection.

PHOTO BY:  GEI CONSULTANTS, INC.			
PHOTOGRAPH NO: 8	DATE: March 25, 2025 10:51 AM	LATITUDE: 33.63621187	LONGITUDE: -93.81069027
DIRECTION: 279°	<b>SITE LOCATION:</b> TURK POWER PLANT, FULTON, ARKANSAS		
<b>DESCRIPTION:</b>  Crest of Cell 1. General Photo, Typical Conditions.

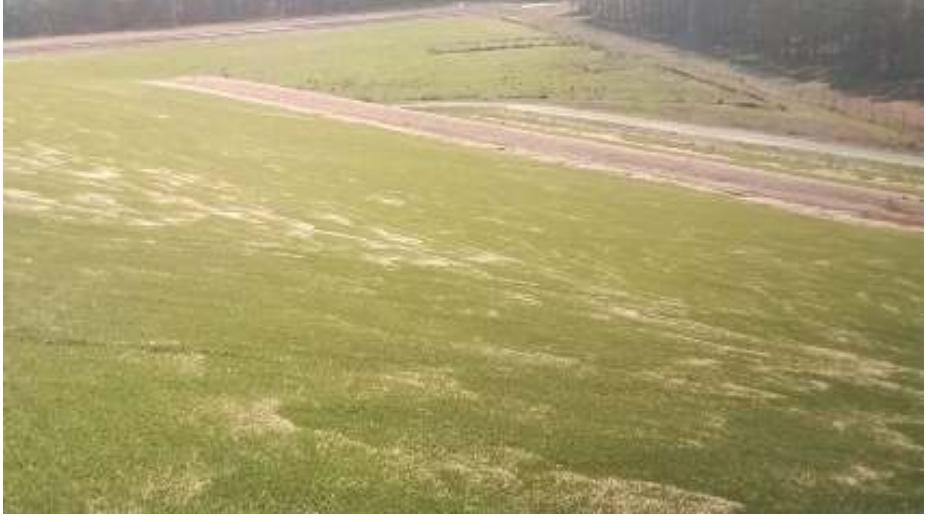
<b>PHOTOGRAPH No: 9</b>	<b>DATE:</b> March 25, 2025 10:54 AM	<b>LATITUDE:</b> 33.63619952	<b>LONGITUDE:</b> -93.8106926
<b>DIRECTION:</b> 4°	<b>SITE LOCATION:</b> TURK POWER PLANT, FULTON, ARKANSAS		
<b>DESCRIPTION:</b>  Closure Turf Test Pad. General Photo, Typical Conditions.

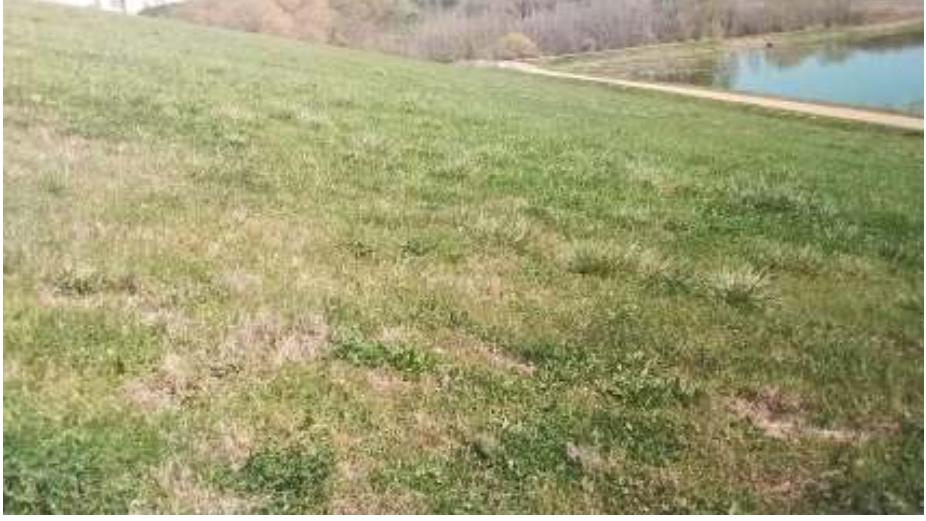
<b>PHOTO BY:</b>			
<b>GEI CONSULTANTS, INC.</b>			
<b>PHOTOGRAPH No: 10</b>	<b>DATE:</b> March 25, 2025 10:59 AM	<b>LATITUDE:</b> 33.63627434	<b>LONGITUDE:</b> -93.8098463
<b>DIRECTION:</b> 282°	<b>SITE LOCATION:</b> TURK POWER PLANT, FULTON, ARKANSAS		
<b>DESCRIPTION:</b>  Temporary Cover on Exterior Slope of Cell 1. General Photo, Typical Conditions.  Healthy and maintained vegetation.

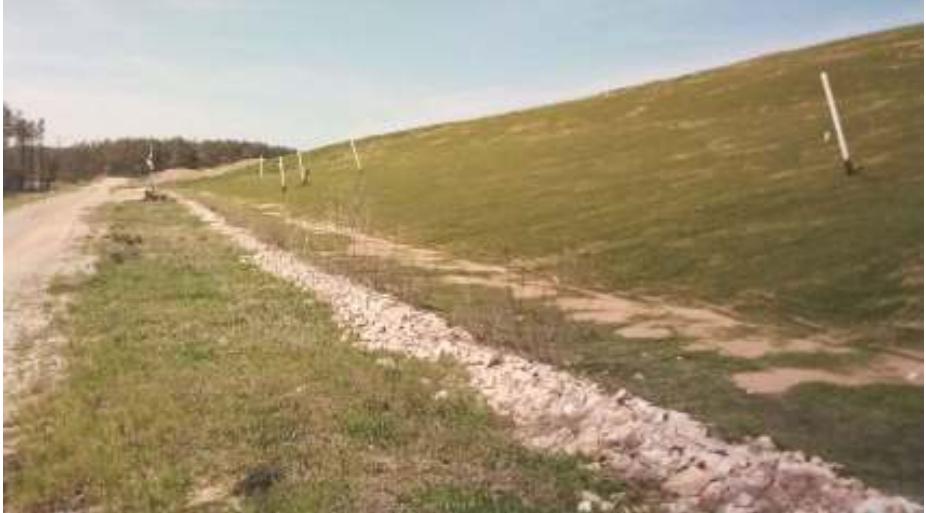
<b>PHOTOGRAPH No: 11</b>	<b>DATE:</b> March 25, 2025 11:02 AM	<b>LATITUDE:</b> 33.6360065	<b>LONGITUDE:</b> -93.80945506
<b>DIRECTION:</b> 177°	<b>SITE LOCATION:</b> TURK POWER PLANT, FULTON, ARKANSAS		
<b>DESCRIPTION:</b>  ClosureTurf Test Pad on Exterior Slope of Cell 1. General Photo, Typical Conditions.

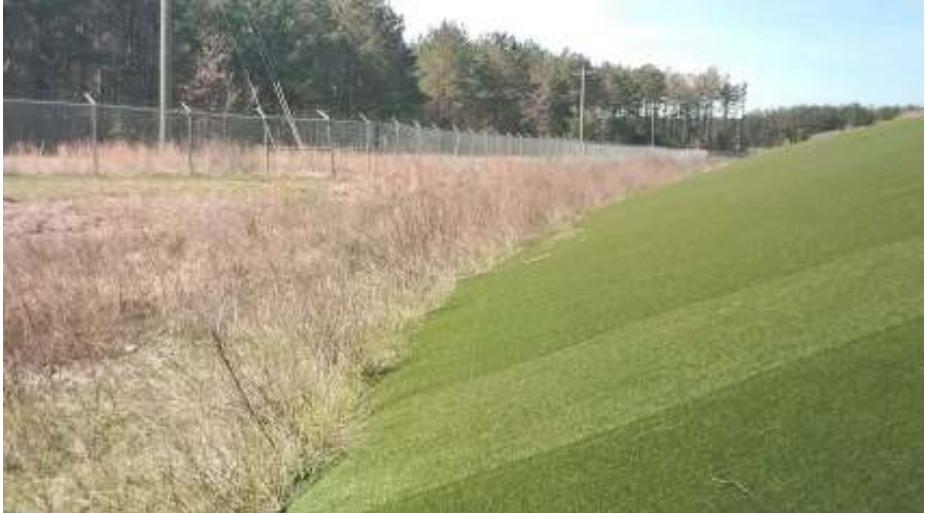
<b>PHOTOGRAPH No: 12</b>	<b>DATE:</b> March 25, 2025 11:05 AM	<b>LATITUDE:</b> 33.63591732	<b>LONGITUDE:</b> -93.80937819
<b>DIRECTION:</b> 141°	<b>SITE LOCATION:</b> TURK POWER PLANT, FULTON, ARKANSAS		
<b>DESCRIPTION:</b>  Perimeter Ditch of Cell 1. Monitor vegetation growing adjacent to Versa Cap (synthetic grass cover). Address as needed.

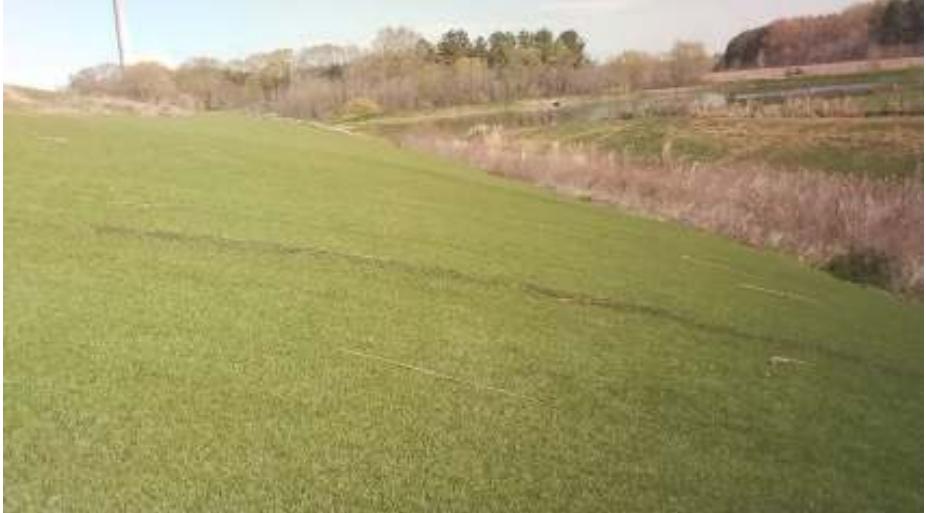
<b>PHOTOGRAPH NO: 13</b>	<b>DATE:</b> March 25, 2025 11:09 AM	<b>LATITUDE:</b> 33.63606654	<b>LONGITUDE:</b> -93.80921627
<b>DIRECTION:</b> 278°	<b>SITE LOCATION:</b> TURK POWER PLANT, FULTON, ARKANSAS		
<b>DESCRIPTION:</b>  Perimeter Ditch of Cell 1. General Photo, Typical Conditions.

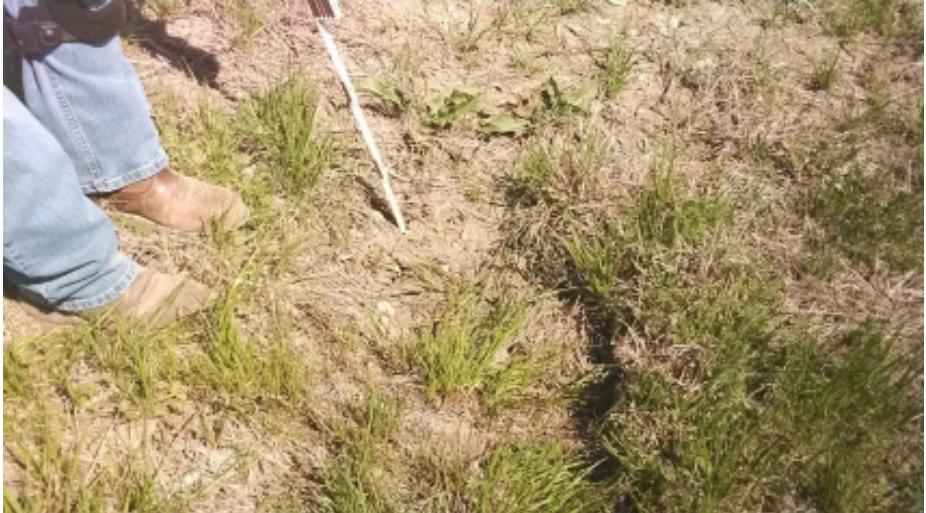
slopes are covered with temporary soil cover. All the slopes are covered with temporary grass cover and appeared in good and stable condition without any significant erosion or instability. A shallow (less than 0.5 inches deep) surface crack was present on the east landfill slope of Cell 1 below the perimeter road (Photograph No. 14). Monitoring of the crack is recommended and should be addressed if it becomes significant.

Photo 14 – Monitor surface crack in interim cover on Cell 1 exterior slope.

<b>PHOTOGRAPH NO: 14</b>	<b>DATE:</b> March 25, 2025 11:15 AM	<b>LATITUDE:</b> 33.63694303	<b>LONGITUDE:</b> -93.80922654
<b>DIRECTION:</b> 266°	<b>SITE LOCATION:</b> TURK POWER PLANT, FULTON, ARKANSAS		
<b>DESCRIPTION:</b>  Interim Cover on Exterior Slope of Cell 1. Monitor Surface Cracking and address if it becomes significant.  Approximately less than 0.5 inch deep, 31 ft long, and less than 0.5 inch wide.

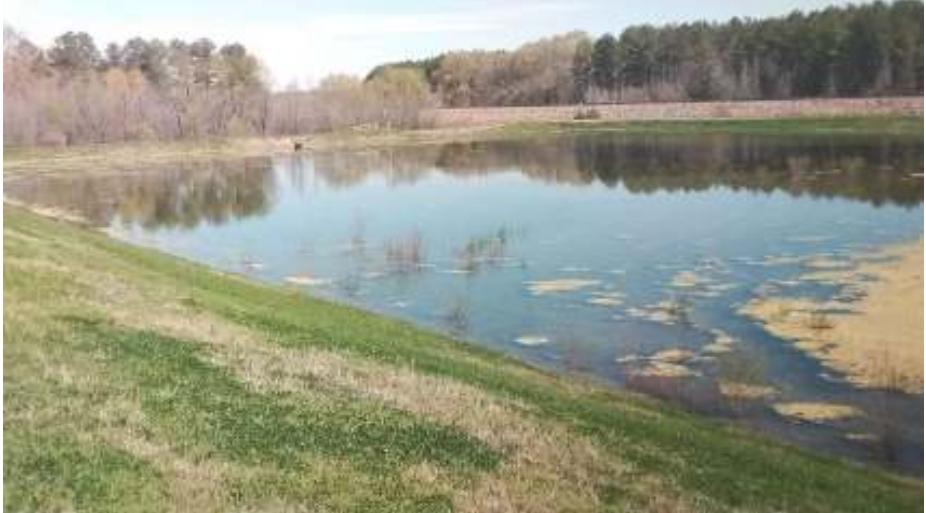
<b>PHOTOGRAPH NO: 15</b>	<b>DATE:</b> March 25, 2025 11:21 AM	<b>LATITUDE:</b> 33.63705952	<b>LONGITUDE:</b> -93.80931277
<b>DIRECTION:</b> 298°	<b>SITE LOCATION:</b> TURK POWER PLANT, FULTON, ARKANSAS		
<b>DESCRIPTION:</b>  Upstream Slope of Stormwater Runoff Pond. General Photo, Typical Conditions.

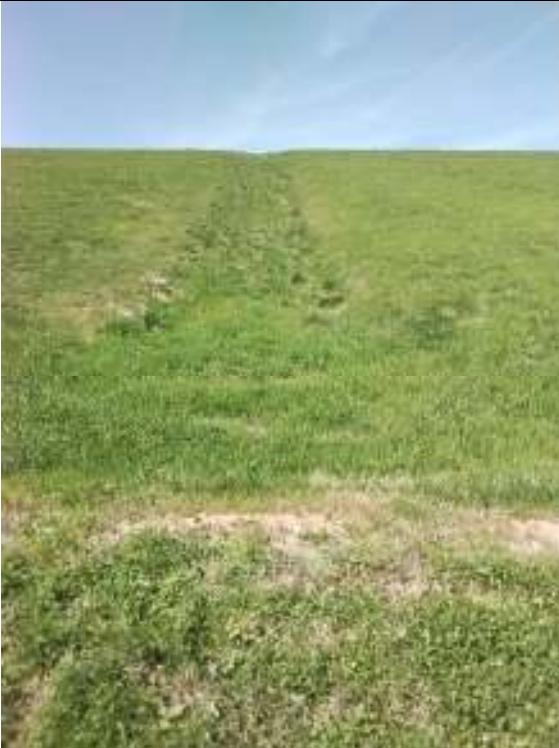
<b>PHOTOGRAPH NO: 16</b>	<b>DATE:</b> March 25, 2025 11:25 AM	<b>LATITUDE:</b> 33.63736926	<b>LONGITUDE:</b> -93.80936873
<b>DIRECTION:</b> 270°	<b>SITE LOCATION:</b> TURK POWER PLANT, FULTON, ARKANSAS		
<b>DESCRIPTION:</b>  Sideslope Drainage Feature. General Photo, Typical Conditions.  Healthy and maintained vegetation.

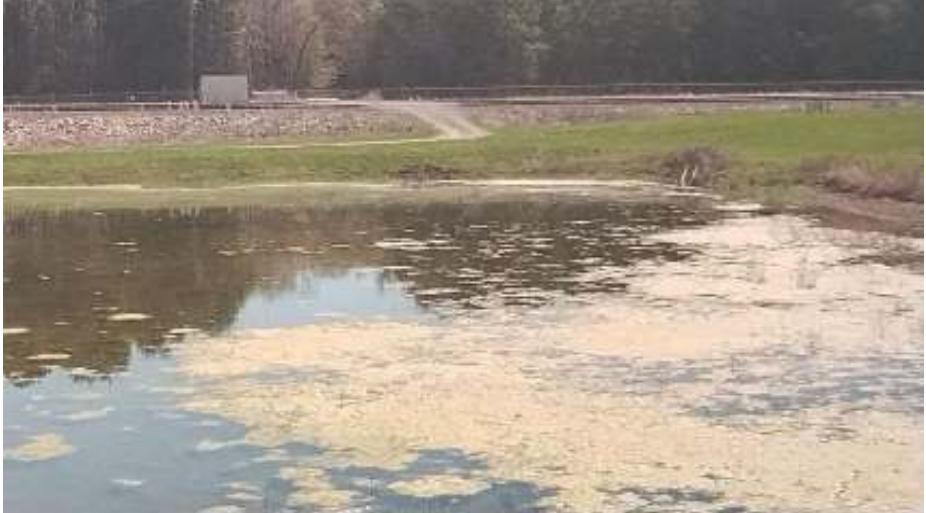
<b>PHOTOGRAPH NO: 17</b>	<b>DATE:</b> March 25, 2025 11:28 AM	<b>LATITUDE:</b> 33.63741048	<b>LONGITUDE:</b> -93.80930582
<b>DIRECTION:</b> 6°	<b>SITE LOCATION:</b> TURK POWER PLANT, FULTON, ARKANSAS		
<b>DESCRIPTION:</b>  Upstream Slope of Stormwater Runoff Pond.  Monitor minor wild animal activity, address if it becomes significant.

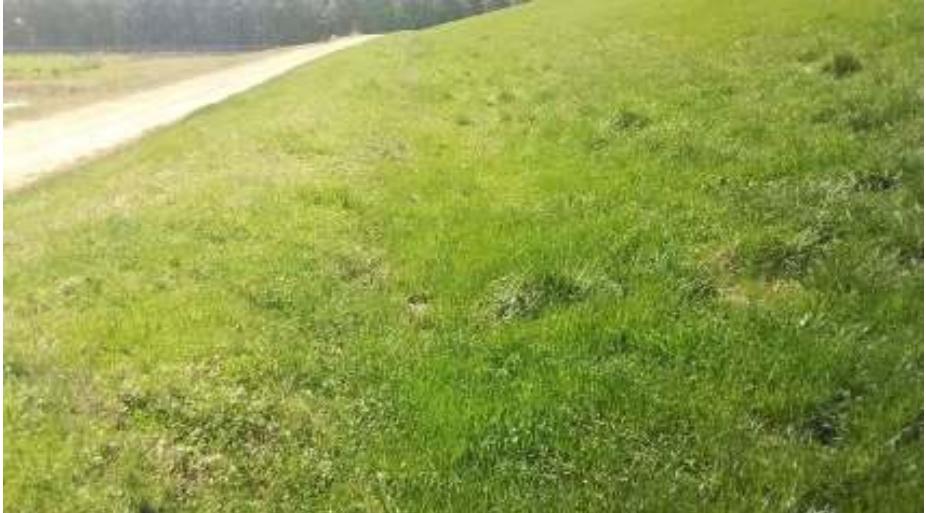
<b>PHOTOGRAPH NO: 18</b>	<b>DATE:</b> March 25, 2025 11:32 AM	<b>LATITUDE:</b> 33.63821972	<b>LONGITUDE:</b> -93.80943857
<b>DIRECTION:</b> 86°	<b>SITE LOCATION:</b> TURK POWER PLANT, FULTON, ARKANSAS		
<b>DESCRIPTION:</b>  Exterior Slope of Cell 1. Interim Cover, Typical Conditions.  Healthy and maintained vegetation.

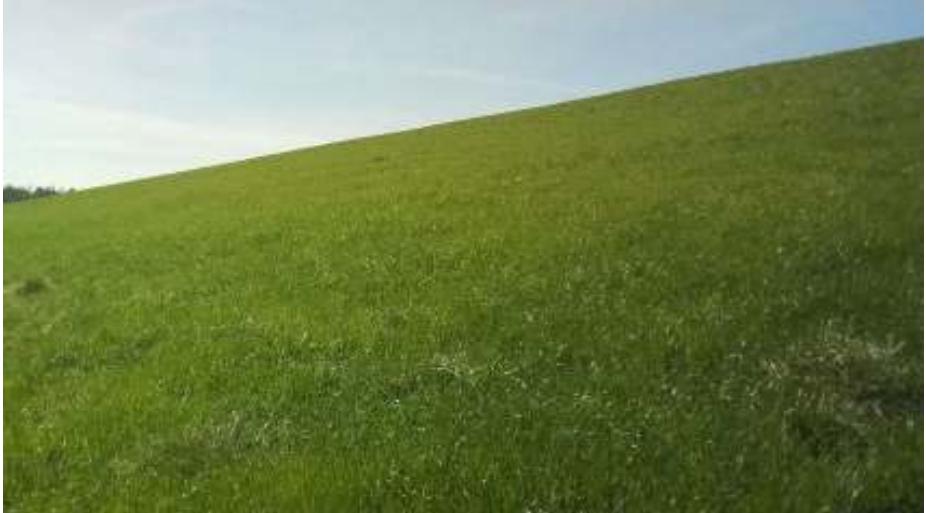
<b>PHOTOGRAPH NO: 19</b>	<b>DATE:</b> March 25, 2025 11:34 AM	<b>LATITUDE:</b> 33.6382639	<b>LONGITUDE:</b> -93.80947167
<b>DIRECTION:</b> 112°	<b>SITE LOCATION:</b> TURK POWER PLANT, FULTON, ARKANSAS		
<b>DESCRIPTION:</b>  Exterior Slope of Cell 1 General Photo, Typical Conditions.

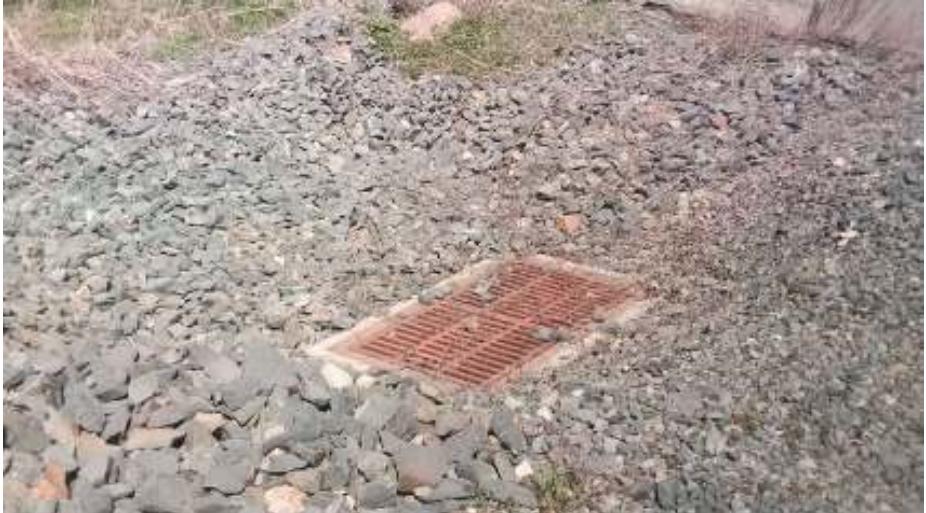
6. The catch basin in the northeast corner of the landfill at the end of the perimeter ditch is illustrated in Photograph No. 20. Two pipe culverts extend from the catch basin to the stormwater pond under the perimeter road (Photograph No. 24). The catch basin and pipe culverts appeared to be functional and in good condition.

<b>PHOTO BY:</b>  GEI CONSULTANTS, INC.			
<b>PHOTOGRAPH NO: 20</b>	<b>DATE:</b> March 25, 2025 11:35 AM	<b>LATITUDE:</b> 33.63826243	<b>LONGITUDE:</b> -93.80936773
<b>DIRECTION:</b> 235°	<b>SITE LOCATION:</b> TURK POWER PLANT, FULTON, ARKANSAS		
<b>DESCRIPTION:</b>  Drainage Structure. General Photo, Typical Conditions.  Intake structure at NE corner of Cell 1 Perimeter Berm. Outlets to Stormwater Runoff Pond.

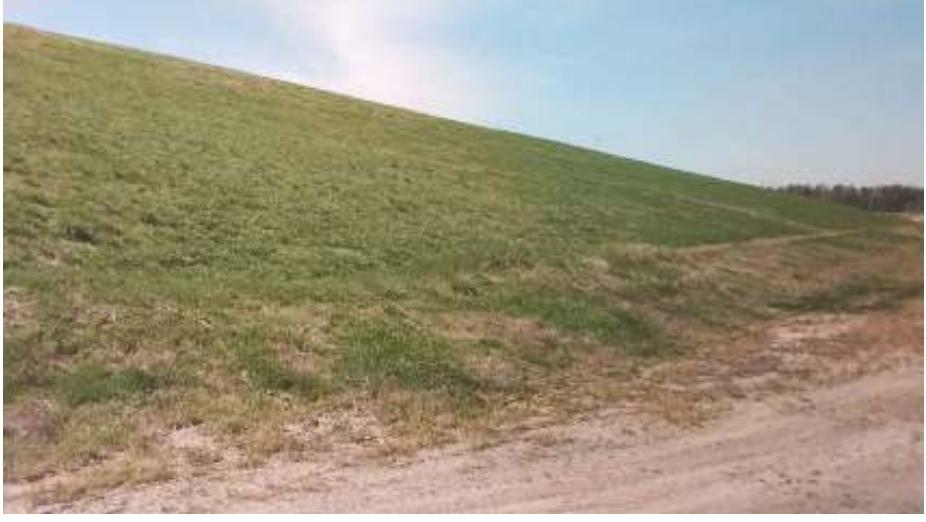
<b>PHOTOGRAPH No: 21</b>	<b>DATE:</b> March 25, 2025 11:40 AM	<b>LATITUDE:</b> 33.63854974	<b>LONGITUDE:</b> -93.80941789
<b>DIRECTION:</b> 157°	<b>SITE LOCATION:</b> TURK POWER PLANT, FULTON, ARKANSAS		
<b>DESCRIPTION:</b>  Exterior Slope of Cell 1. General Photo, Typical Conditions.

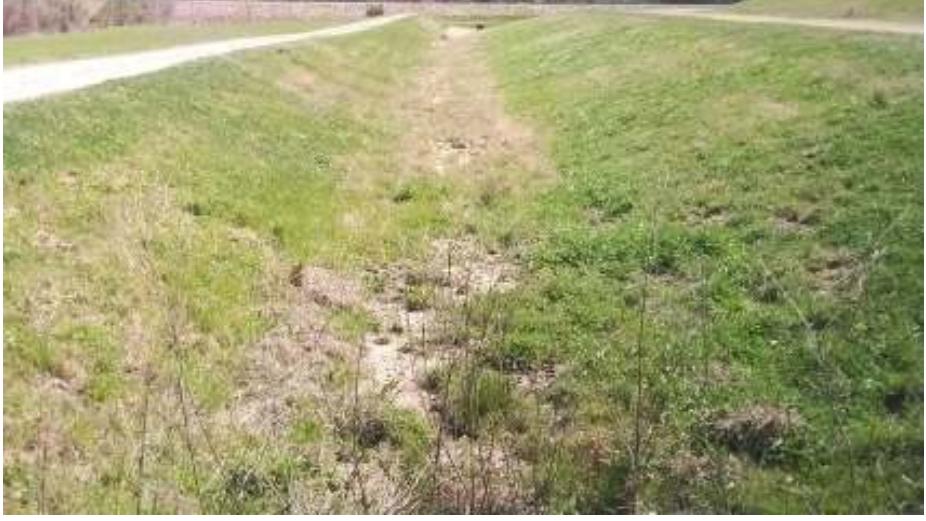
<b>PHOTO BY:</b>  GEI CONSULTANTS, INC.			
<b>PHOTOGRAPH No: 22</b>	<b>DATE:</b> March 25, 2025 11:43 AM	<b>LATITUDE:</b> 33.63868112	<b>LONGITUDE:</b> -93.81059852
<b>DIRECTION:</b> 359°	<b>SITE LOCATION:</b> TURK POWER PLANT, FULTON, ARKANSAS		
<b>DESCRIPTION:</b>  Perimeter Ditch of Cell 1. General Photo, Typical Conditions.  Perimeter ditch drains to Stormwater Runoff Pond.

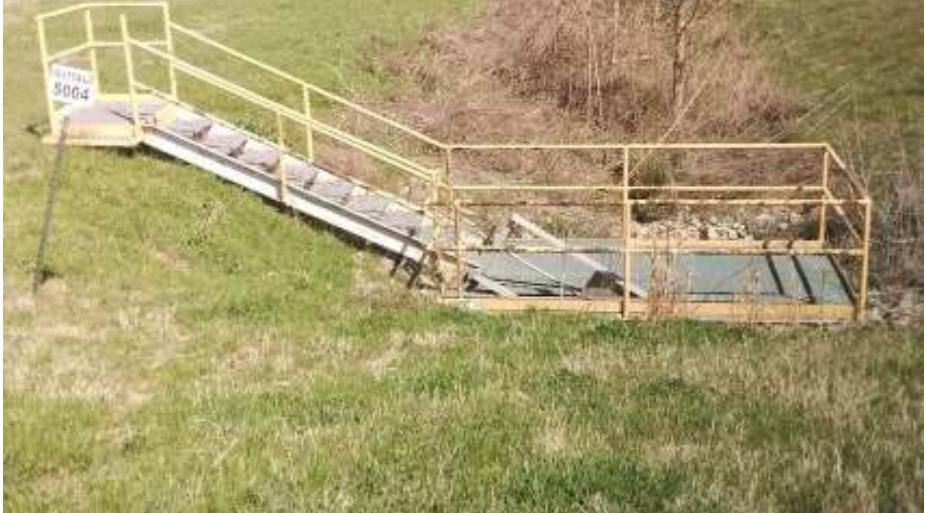
<b>PHOTOGRAPH NO: 23</b>	<b>DATE:</b> March 25, 2025 11:48 AM	<b>LATITUDE:</b> 33.63877253	<b>LONGITUDE:</b> -93.80863352
<b>DIRECTION:</b> 266°	<b>SITE LOCATION:</b> TURK POWER PLANT, FULTON, ARKANSAS		
<b>DESCRIPTION:</b>  Stormwater Runoff Pond Outfall S004. General Photo, Typical Conditions.  No blockages observed.

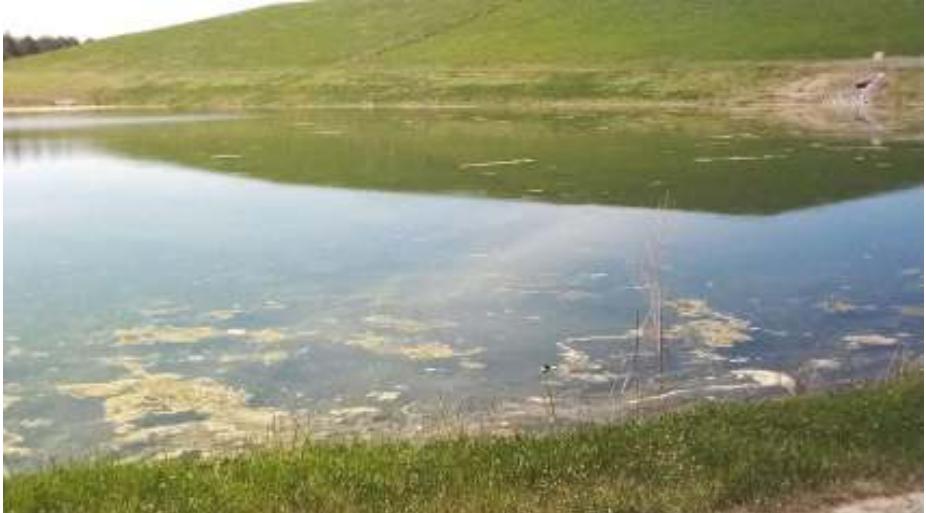
<b>PHOTOGRAPH NO: 24</b>	<b>DATE:</b> March 25, 2025 11:50 AM	<b>LATITUDE:</b> 33.63876392	<b>LONGITUDE:</b> -93.80803637
<b>DIRECTION:</b> 137°	<b>SITE LOCATION:</b> TURK POWER PLANT, FULTON, ARKANSAS		
<b>DESCRIPTION:</b>  Stormwater Runoff Pond. General Photo, Typical Conditions.

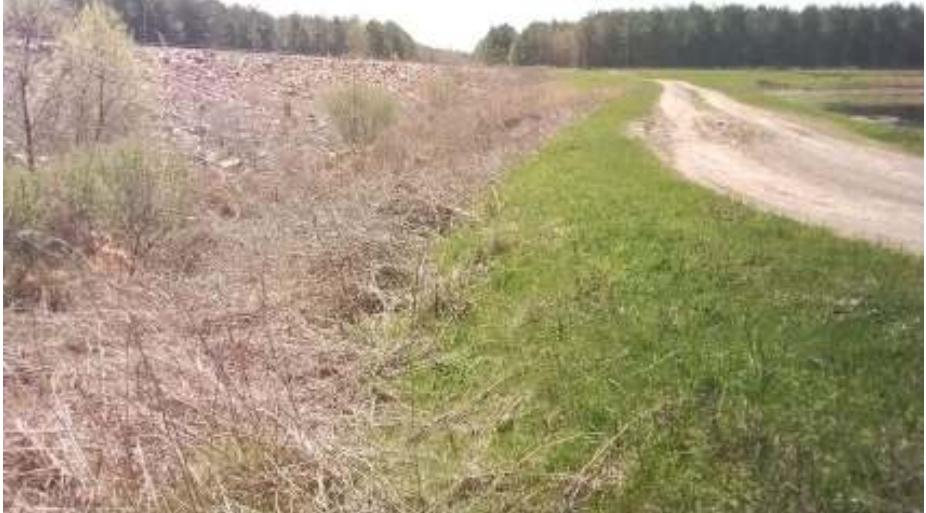
7. The Stormwater Pond is located to the east of the landfill and receives non-contact stormwater run-off from the slopes of Cell 1 and areas outside the landfill. The pond appeared to be functioning with some minor erosion due to wild animal activity along the interior slopes (Photographs No. 15, No. 17, and No. 24). The outfall structure (Outfall S004) appeared in good condition and no blockages were observed (Photograph No. 23). Excessive vegetation was present on the exterior slope and at the toe along the railroad embankment, as shown in Photograph No. 25. The excessive vegetation should be addressed and maintained to 12 inches or less to 25 feet from the toe.

<b>PHOTOGRAPH NO: 25</b>	<b>DATE:</b> March 25, 2025 11:53 AM	<b>LATITUDE:</b> 33.6387717	<b>LONGITUDE:</b> -93.80795515
<b>DIRECTION:</b> 75°	<b>SITE LOCATION:</b> TURK POWER PLANT, FULTON, ARKANSAS		
<b>DESCRIPTION:</b>  Downstream Slope of Stormwater Runoff Pond.  Address/maintain vegetation to 12-inches or less to 25 feet from toe of slope.

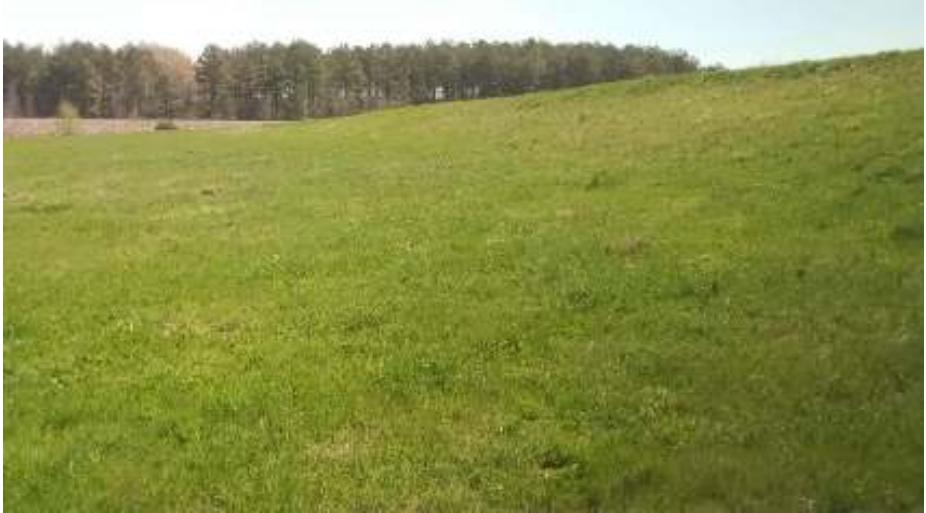
<b>PHOTOGRAPH NO: 26</b>	<b>DATE:</b> March 25, 2025 11:59 AM	<b>LATITUDE:</b> 33.63890154	<b>LONGITUDE:</b> -93.81057375
<b>DIRECTION:</b> 12°	<b>SITE LOCATION:</b> TURK POWER PLANT, FULTON, ARKANSAS		
<b>DESCRIPTION:</b>  Downstream Slope and Toe of Cell 1 Perimeter Berm. General Photo, Typical Conditions.  Vegetation healthy and maintained.

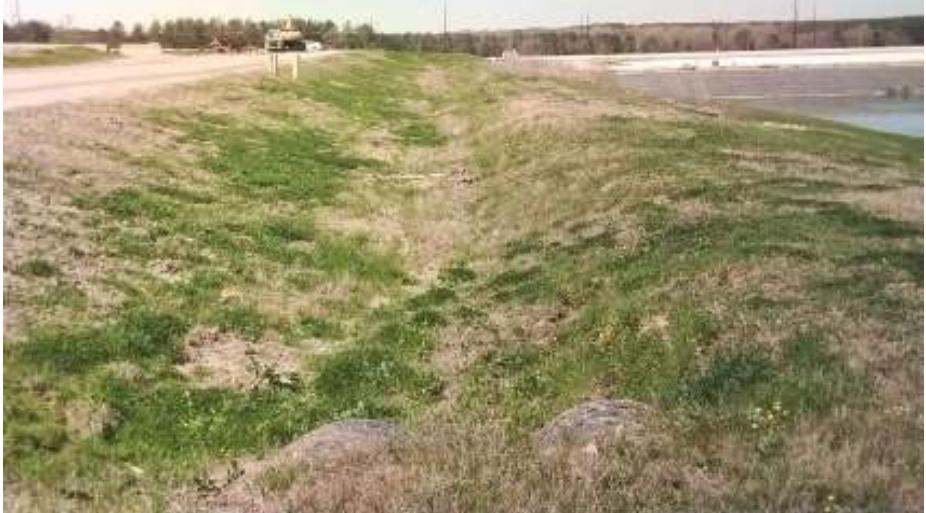
PHOTOGRAPH NO: 27	DATE: March 25, 2025 12:02 PM	LATITUDE: 33.63865618	LONGITUDE: -93.81107849
DIRECTION: 180°	<b>SITE LOCATION:</b> TURK POWER PLANT, FULTON, ARKANSAS		
<b>DESCRIPTION:</b>  Perimeter Ditch. General Photo, Typical Conditions.  Stormwater ditch along north edge of Cell 2 – no blockages observed.

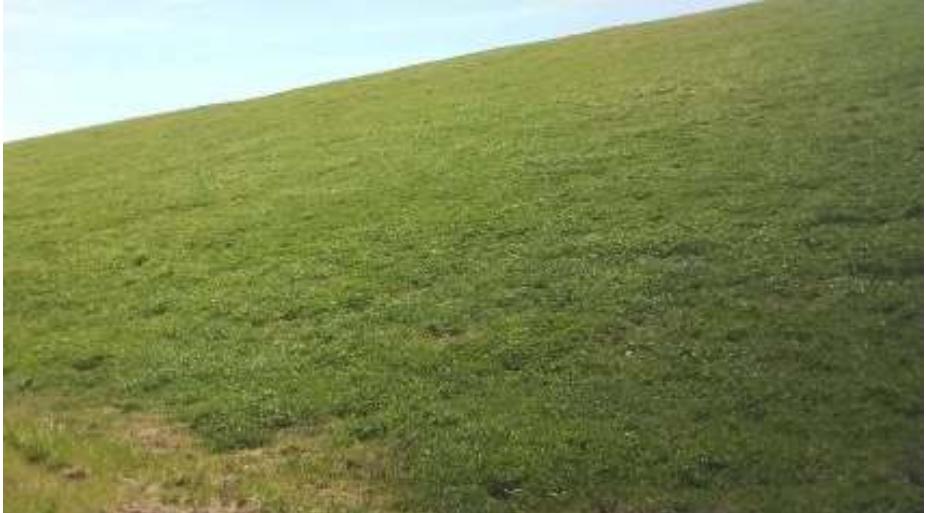
PHOTO BY:  GEI CONSULTANTS, INC.			
PHOTOGRAPH NO: 28	DATE: March 25, 2025 12:04 PM	LATITUDE: 33.63849083	LONGITUDE: -93.81133036
DIRECTION: 40°	<b>SITE LOCATION:</b> TURK POWER PLANT, FULTON, ARKANSAS		
<b>DESCRIPTION:</b>  Exterior Slope of Cell 1. General Photo, Typical Conditions.

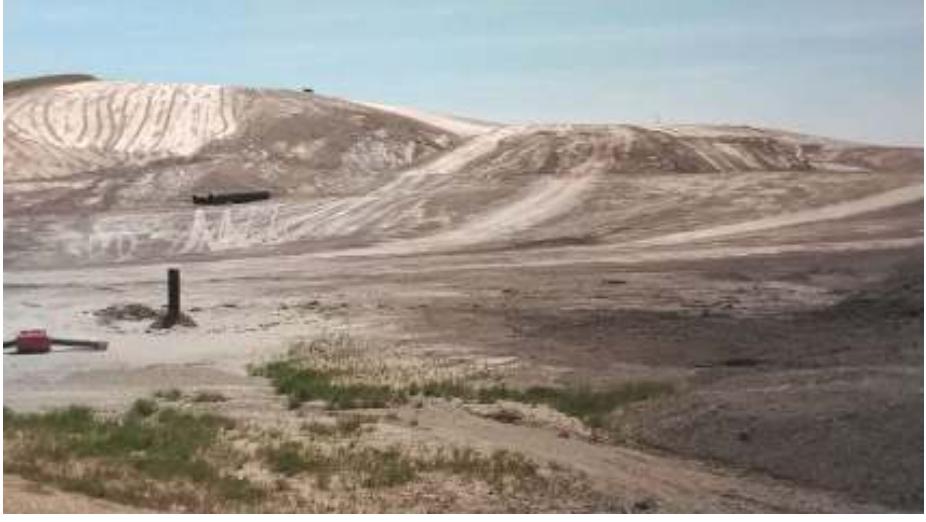
<b>PHOTOGRAPH NO: 29</b>	<b>DATE:</b> March 25, 2025 12:08 PM	<b>LATITUDE:</b> 33.63845139	<b>LONGITUDE:</b> -93.81260522
<b>DIRECTION:</b> 41°	<b>SITE LOCATION:</b> TURK POWER PLANT, FULTON, ARKANSAS		
<b>DESCRIPTION:</b>  Active Cell 2, typical conditions.  CCR placement along edges to direct runoff to chimney drains.

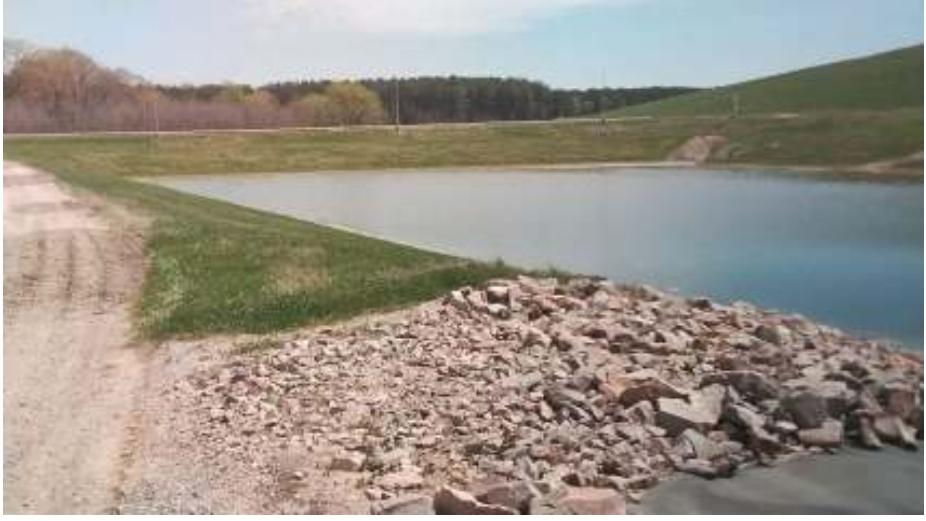
<b>PHOTOGRAPH NO: 30</b>	<b>DATE:</b> March 25, 2025 1:15 PM	<b>LATITUDE:</b> 33.64007615	<b>LONGITUDE:</b> -93.81326171
<b>DIRECTION:</b> 16°	<b>SITE LOCATION:</b> TURK POWER PLANT, FULTON, ARKANSAS		
<b>DESCRIPTION:</b>  Leachate Pond. General Photo, Typical Conditions.

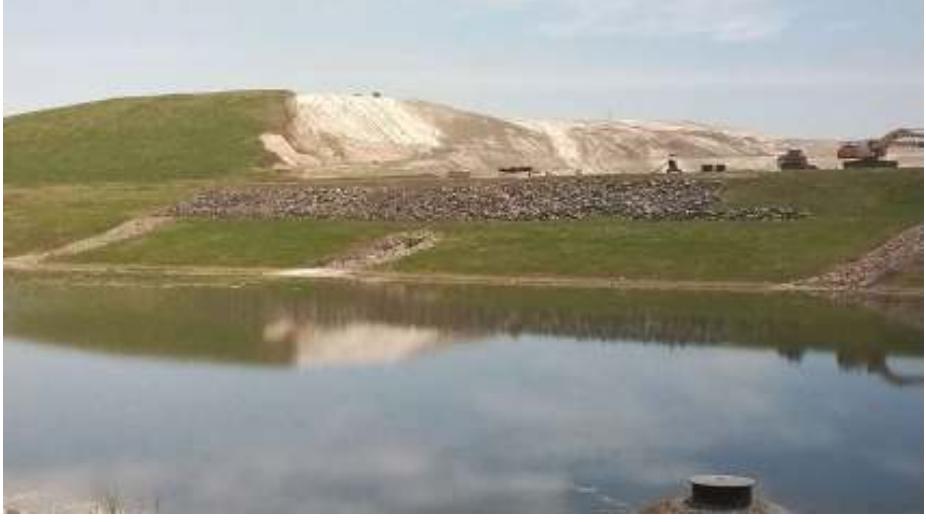
PHOTOGRAPH NO: 31	DATE: March 25, 2025 1:17 PM	LATITUDE: 33.64002865	LONGITUDE: -93.81324096
<b>DIRECTION:</b> 51°	<b>SITE LOCATION:</b> TURK POWER PLANT, FULTON, ARKANSAS		
<b>DESCRIPTION:</b>  Upstream Slope Leachate Pond. General Photo, Typical Conditions.  Note: significant slope erosion noted in 2024 annual inspection was appropriately addressed with riprap. No erosion observed.

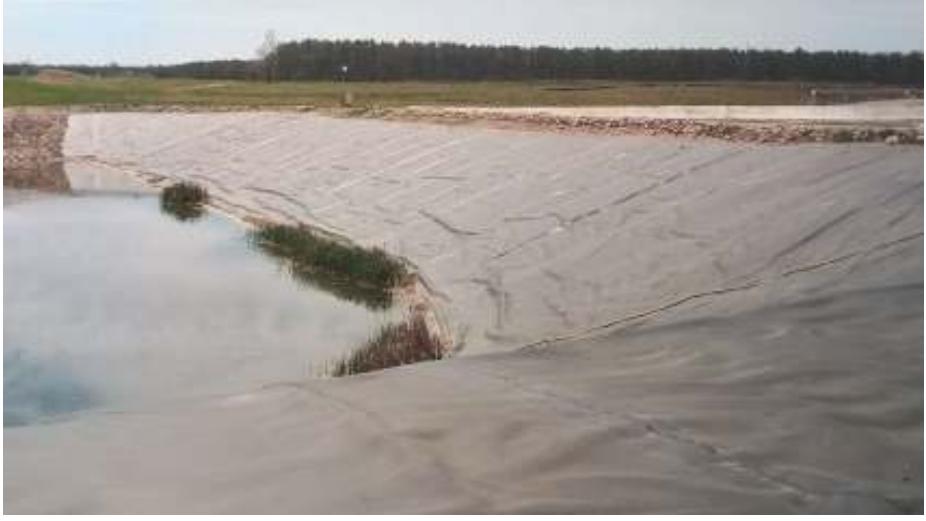
10. Photograph No. 32 illustrates the west slope of the pond. This slope was repaired a few years ago by replacing vegetative cover with a geosynthetic liner. The liner appeared in good condition without any damage or observable displacement. The slope appeared in good and stable condition without any sign of imminent failure. Vegetation was observed growing along the shoreline against the liner and should be removed as part of the continuing maintenance of the facility.

<b>PHOTO BY:</b>  GEI CONSULTANTS, INC.			
PHOTOGRAPH NO: 32	DATE: March 25, 2025 1:18 PM	LATITUDE: 33.64003161	LONGITUDE: -93.81324616
<b>DIRECTION:</b> 111°	<b>SITE LOCATION:</b> TURK POWER PLANT, FULTON, ARKANSAS		
<b>DESCRIPTION:</b>  Upstream Slope of Leachate Pond.  Address/remove vegetation along the shoreline.
