CCR Bottom Ash Storage Pond 2025 Annual Dam and Dike Inspection Report

Welsh Power Plant, Cason, Texas

August 14, 2025
Project 2501323
AEP Document ID: GEVR-25-015

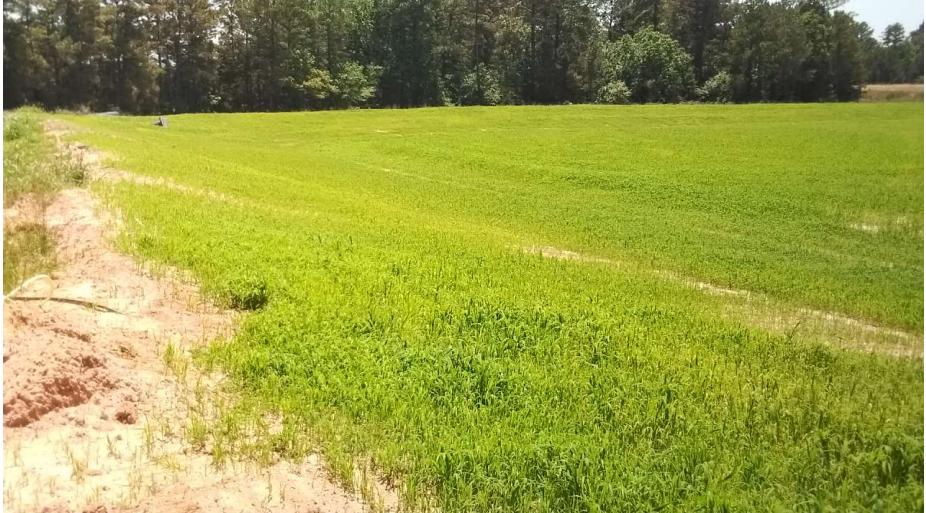
PHOTOGRAPH NO: 1	DATE: May 13, 2025 1:27 PM	LATITUDE: 33.04676743	LONGITUDE: -94.84270722
DIRECTION: 95°	SITE LOCATION: CASON, TEXAS		
DESCRIPTION: Upstream Slope. General Photo, Typical Conditions.

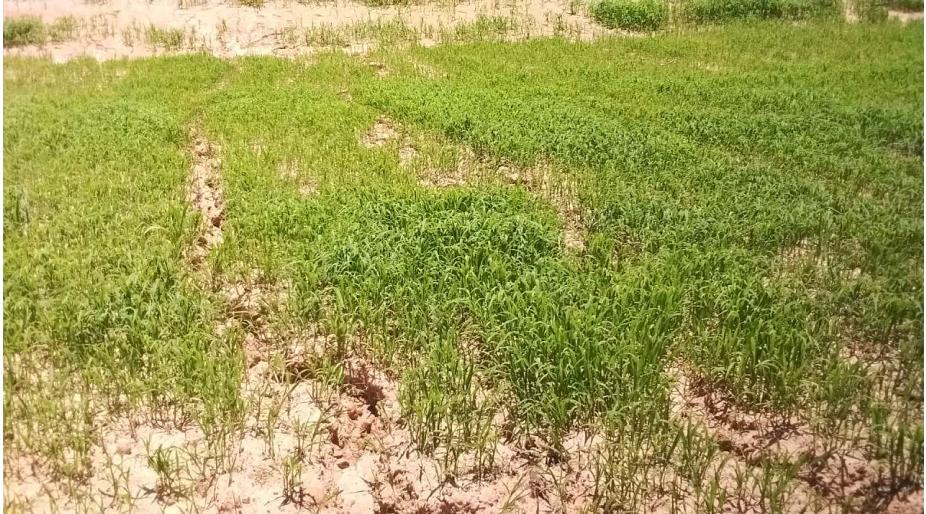
PHOTO BY: GEI CONSULTANTS, INC.			
PHOTOGRAPH NO: 2	DATE: May 13, 2025 1:30 PM	LATITUDE: 33.04705888	LONGITUDE: -94.84315055
DIRECTION: 111°	SITE LOCATION: CASON, TEXAS		
DESCRIPTION: Upstream Slope. Minor Erosion. Monitor conditions, address if erosion becomes significant.

- Item 2 – Monitor the minor erosion on the upstream slope and address if it becomes significant.
- Item 12 – Monitor the sediment trap/check dam. Consider adding routine cleanup of the sediment traps and until vegetation is well established. Once the vegetation is well established onsite, consider revegetating the sediment traps.

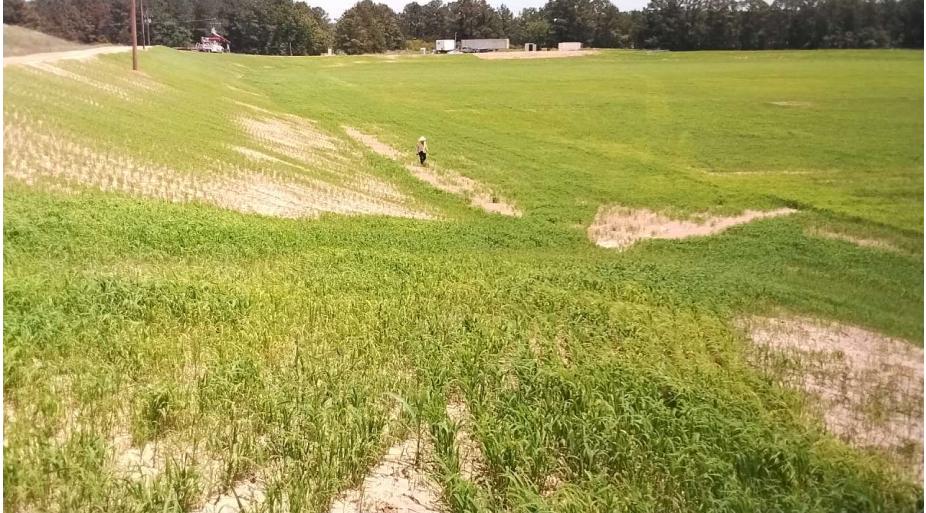
PHOTOGRAPH NO: 3	DATE: May 13, 2025 1:30 PM	LATITUDE: 33.0470671	LONGITUDE: -94.84314964
DIRECTION: 358°	SITE LOCATION: CASON, TEXAS		
DESCRIPTION: Upstream slope. General Photo, Typical Conditions. Vegetation establishment is work in progress.

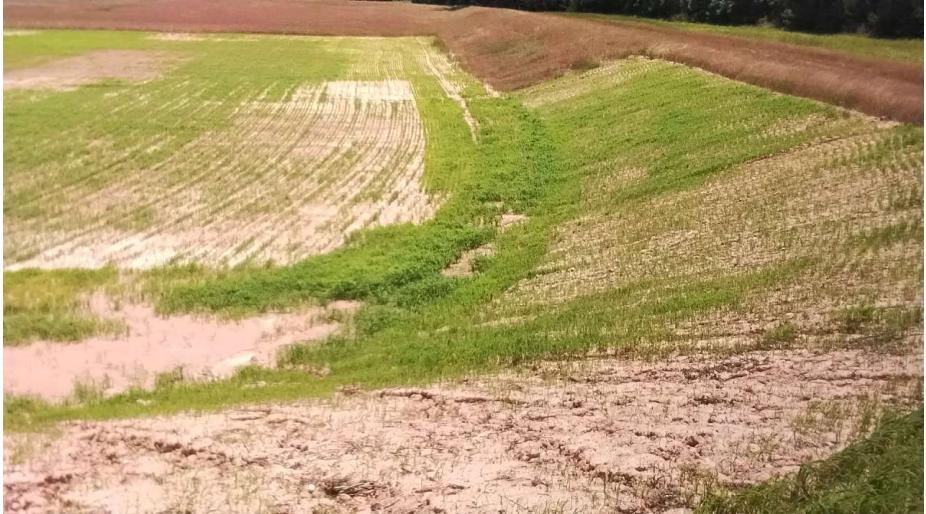
PHOTO BY: GEI CONSULTANTS, INC.			
PHOTOGRAPH NO: 4	DATE: May 13, 2025 1:34 PM	LATITUDE: 33.04695031	LONGITUDE: -94.84604079
DIRECTION: 94°	SITE LOCATION: CASON, TEXAS		
DESCRIPTION: Upstream Slope. General Photo, Typical Conditions. Vegetation establishment is work in progress.

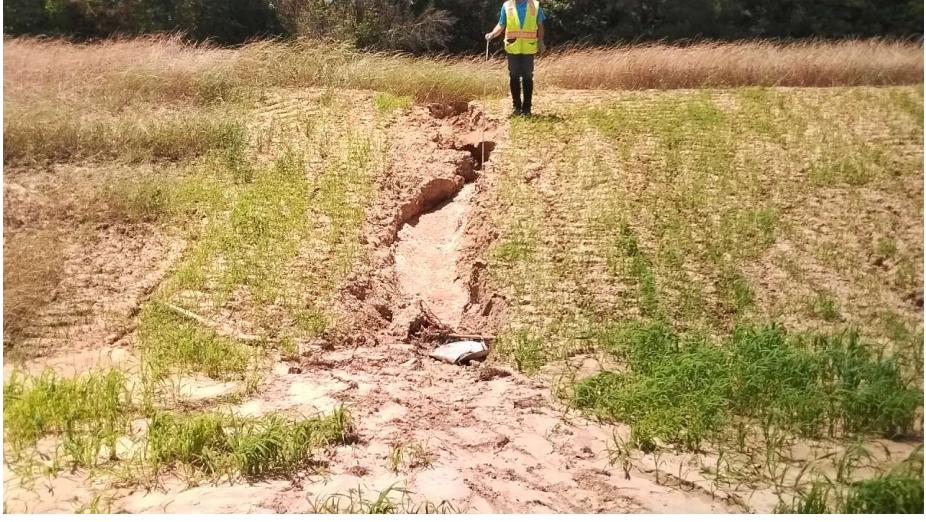
PHOTOGRAPH NO: 5	DATE: May 13, 2025 1:37 PM	LATITUDE: 33.0462843	LONGITUDE: -94.84611522
DIRECTION: 189°	SITE LOCATION: CASON, TEXAS		
DESCRIPTION: Upstream Slope. Major Erosion, Address line / grade and reseed. Some additional regrading may be necessary to limit preferential flow path. Depth is 2.7 ft, 37 ft long

- Item 5 – Address major erosion on the upstream slope. Consider re-evaluating the area to limit concentrated flows.
- Item 6 – Address major erosion on the upstream slope. Consider re-evaluating the area to limit concentrated flows.
- Item 7 – Address major erosion on the upstream slope. Consider re-evaluating the area to limit concentrated flows.
- Item 14 – Address major erosion at the riprap outfall. Consider revisiting the hydraulic/stormwater design of this structure to assure width and riprap size is appropriate before making the repair.
- Item 15 – Address major erosion/silt buildup at check dam. Once cleaned out to design grades – consider re-establishing vegetation.

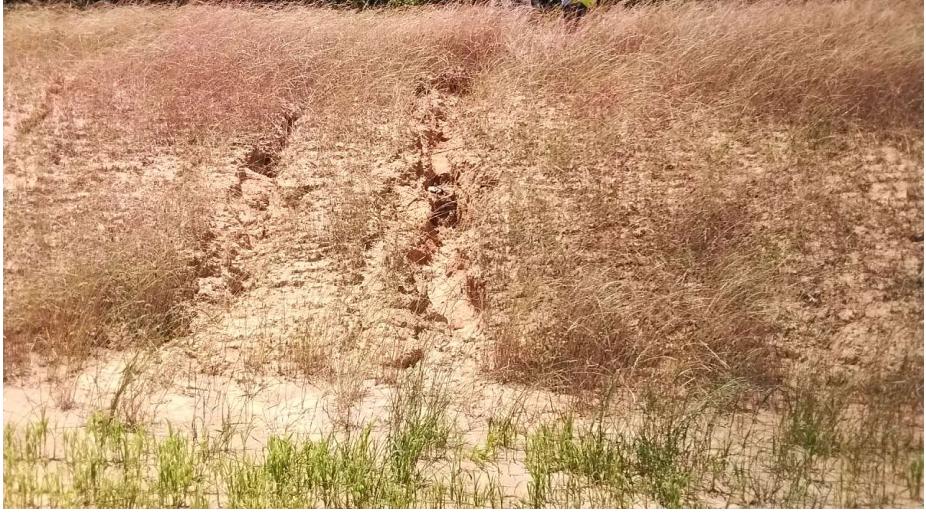
PHOTO BY: GEI CONSULTANTS, INC.			
PHOTOGRAPH NO: 6	DATE: May 13, 2025 1:44 PM	LATITUDE: 33.04566174	LONGITUDE: -94.84617575
DIRECTION: 188°	SITE LOCATION: CASON, TEXAS		
DESCRIPTION: Upstream Slope. Major Erosion, Address line / grade and reseed. Some additional regrading may be necessary to limit preferential flow path. Depth 2.5 ft, 37 ft long.

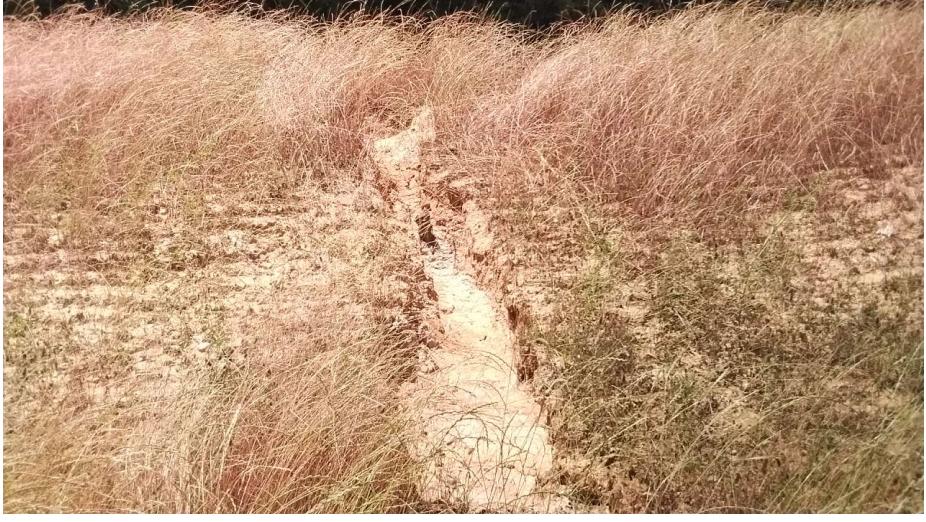
PHOTOGRAPH NO: 7	DATE: May 13, 2025 1:51 PM	LATITUDE: 33.04519321	LONGITUDE: -94.846202
DIRECTION: 208°	SITE LOCATION: CASON, TEXAS		
DESCRIPTION: Upstream Slope. Major Erosion, Address line / grade and reseed. Some additional regrading may be necessary to limit preferential flow path. Depth 2-3 ft, 37 ft long

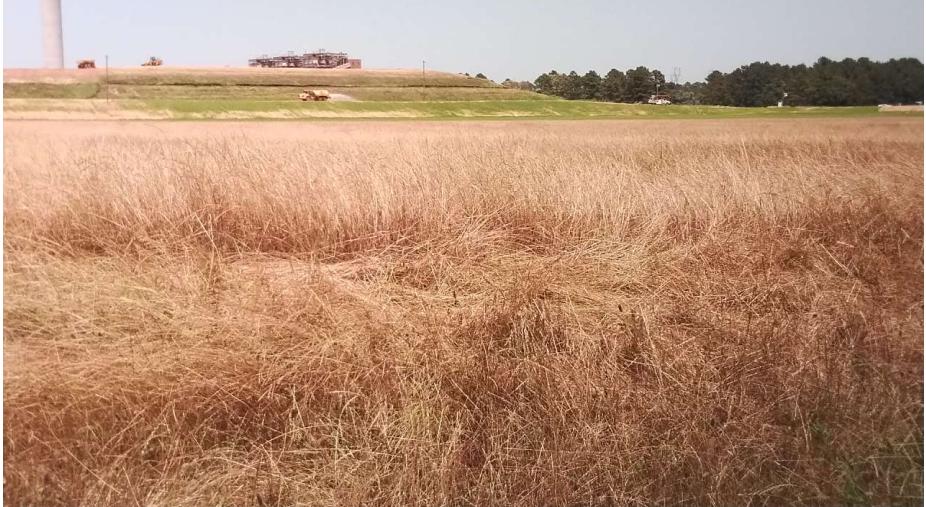
PHOTO BY: GEI CONSULTANTS, INC.			
PHOTOGRAPH NO: 8	DATE: May 13, 2025 1:58 PM	LATITUDE: 33.0439579	LONGITUDE: -94.84615578
DIRECTION: 298°	SITE LOCATION: CASON, TEXAS		
DESCRIPTION: Upstream Slope. General Photo, Typical Conditions.

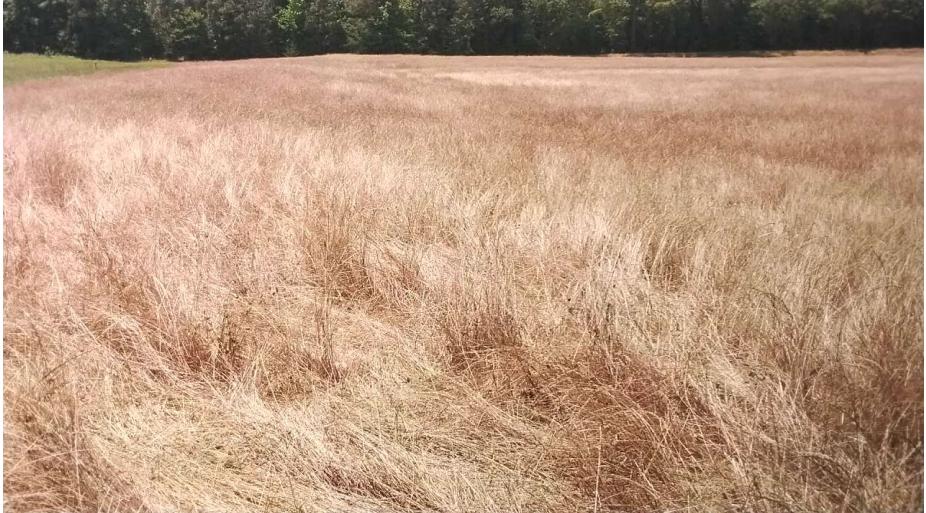
PHOTOGRAPH No: 9	DATE: May 13, 2025 2:02 PM	LATITUDE: 33.04392495	LONGITUDE: -94.84402481
DIRECTION: 194°	SITE LOCATION: CASON, TEXAS		
DESCRIPTION: Upstream Slope. General Photo, Typical Conditions. Note thick/healthy vegetative cover.

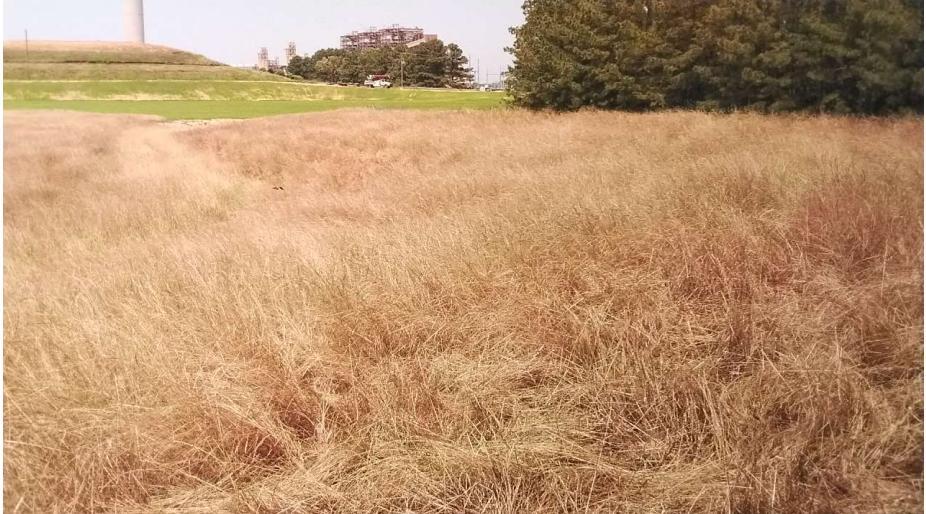
PHOTO BY: GEI CONSULTANTS, INC.			
PHOTOGRAPH No: 10	DATE: May 13, 2025 2:03 PM	LATITUDE: 33.04392709	LONGITUDE: -94.8440283
DIRECTION: 286°	SITE LOCATION: CASON, TEXAS		
DESCRIPTION: Upstream Slope. General Photo, Typical Conditions. Thick/healthy vegetation

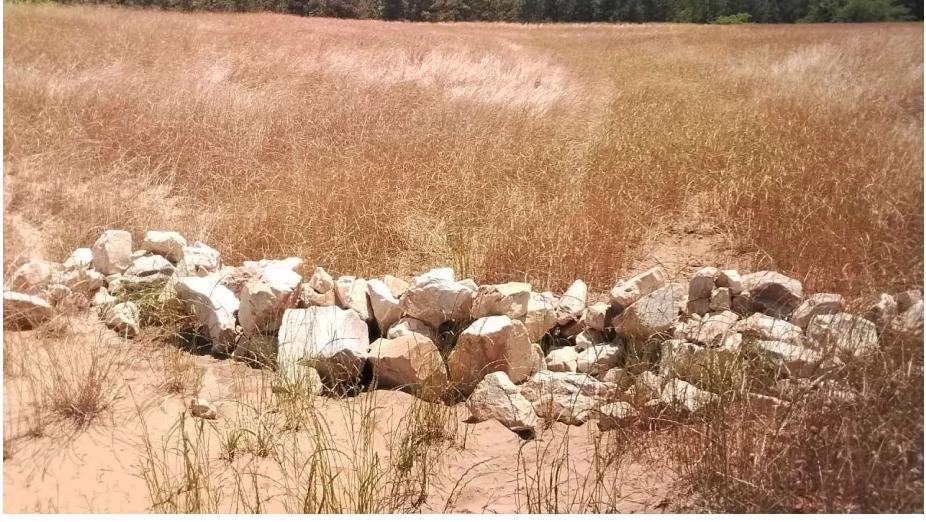
PHOTOGRAPH No: 11	DATE: May 13, 2025 2:09 PM	LATITUDE: 33.04533677	LONGITUDE: -94.84381825
DIRECTION: 94°	SITE LOCATION: CASON, TEXAS		
DESCRIPTION: Drainage Feature. General Photo, Typical Conditions.

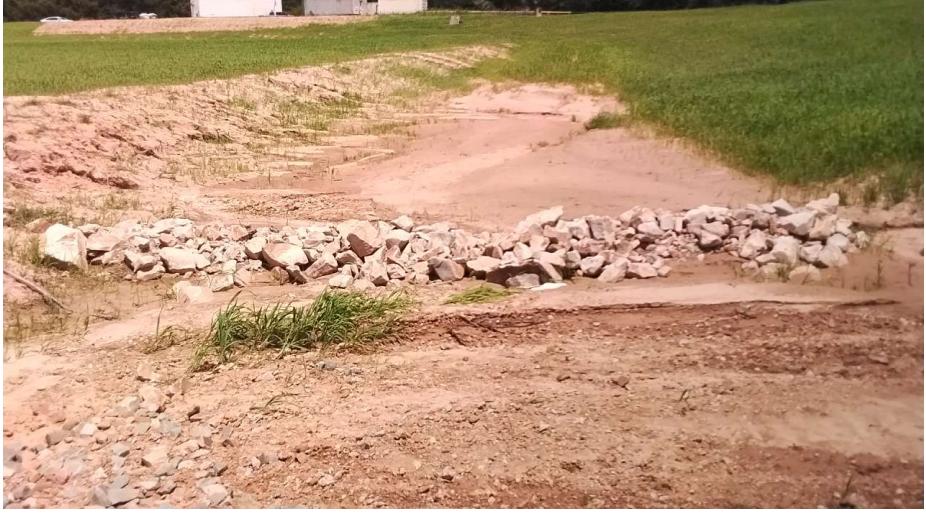
PHOTO BY: GEI CONSULTANTS, INC.			
PHOTOGRAPH No: 12	DATE: May 13, 2025 2:10 PM	LATITUDE: 33.04534183	LONGITUDE: -94.84382231
DIRECTION: 324°	SITE LOCATION: CASON, TEXAS		
DESCRIPTION: Drainage Feature. Monitor silt buildup in checkdam. Consider cleaning out the silt built up in the checkdam and re-establish vegetation.

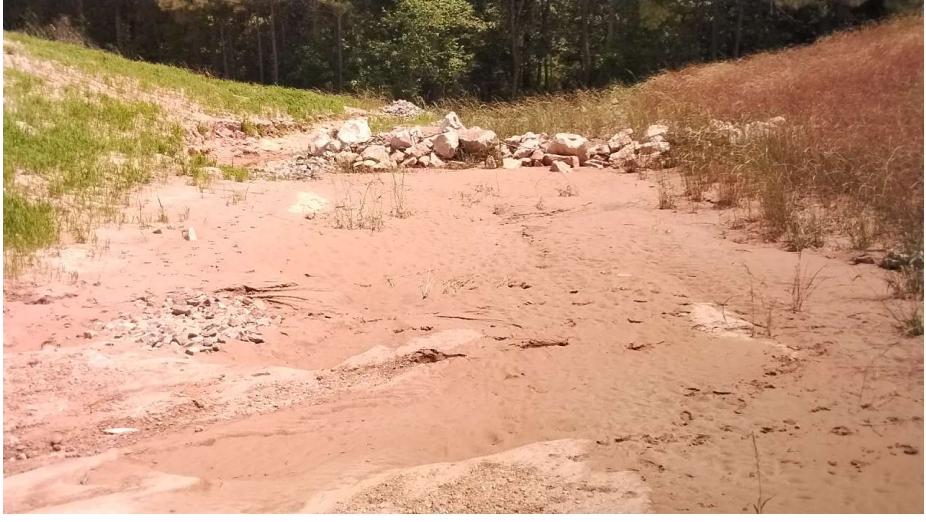
PHOTOGRAPH NO: 13	DATE: May 13, 2025 2:11 PM	LATITUDE: 33.04536002	LONGITUDE: -94.84379958
DIRECTION: 30°	SITE LOCATION: CASON, TEXAS		
DESCRIPTION: Drainage Feature. Monitor Conditions. Consider cleaning out the silt built up in the checkdam and re-establish vegetation.

- Item 13 – Monitor the sediment trap/check dam. Consider adding routine cleanup of the sediment traps and until vegetation is well established. Once the vegetation is well established onsite, consider revegetating the sediment traps.

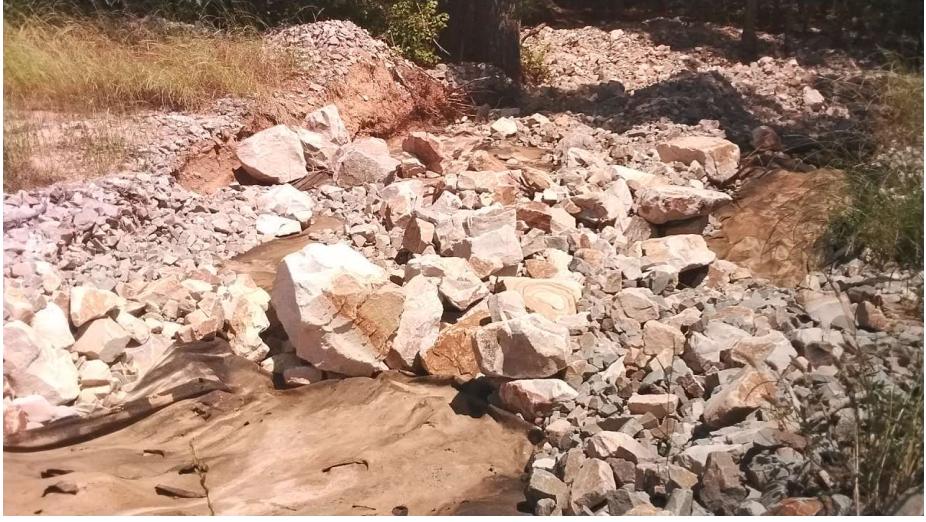
3. The riprap lined outfall structure experienced major erosion as shown in Photo No. 14. The major erosion should be addressed but it is recommended that the outfall design be re-evaluated or the hydraulic design and riprap sizing be confirmed to assure an appropriate repair is implemented.

PHOTO BY: GEI CONSULTANTS, INC.			
PHOTOGRAPH NO: 14	DATE: May 13, 2025 2:12 PM	LATITUDE: 33.04513171	LONGITUDE: -94.84355908
DIRECTION: 7°	SITE LOCATION: CASON, TEXAS		
DESCRIPTION: Drainage Feature. Address major erosion at the downstream end of the spillway. Consider revisiting the hydraulics, stormwater design, riprap and thickness before making a repair.

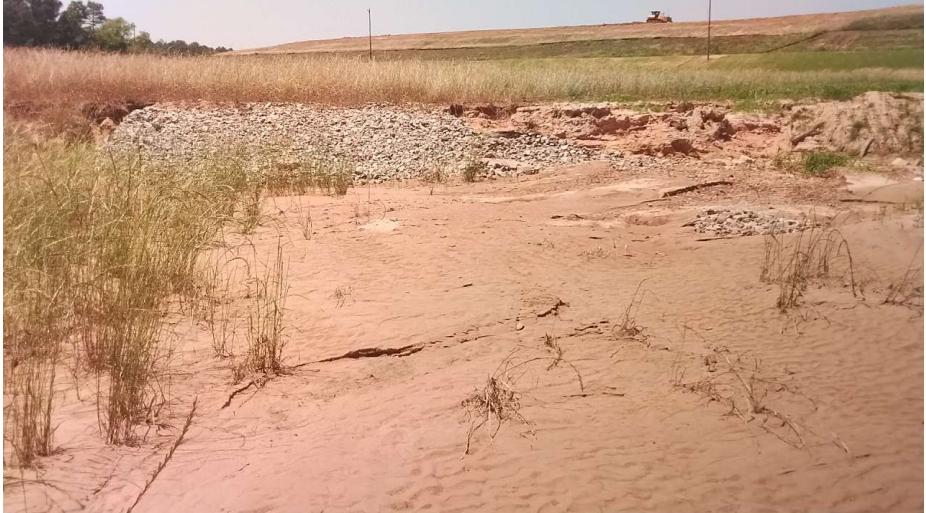
PHOTOGRAPH NO: 15	DATE: May 13, 2025 2:13 PM	LATITUDE: 33.04522075	LONGITUDE: -94.84364288
DIRECTION: 229°	SITE LOCATION: CASON, TEXAS		
DESCRIPTION: Drainage Feature. Address Major Erosion, Consider cleaning out the silt built up in the checkdam and re- establish vegetation.
