Consulting  
Engineers and  
Scientists

## Ash Landfill

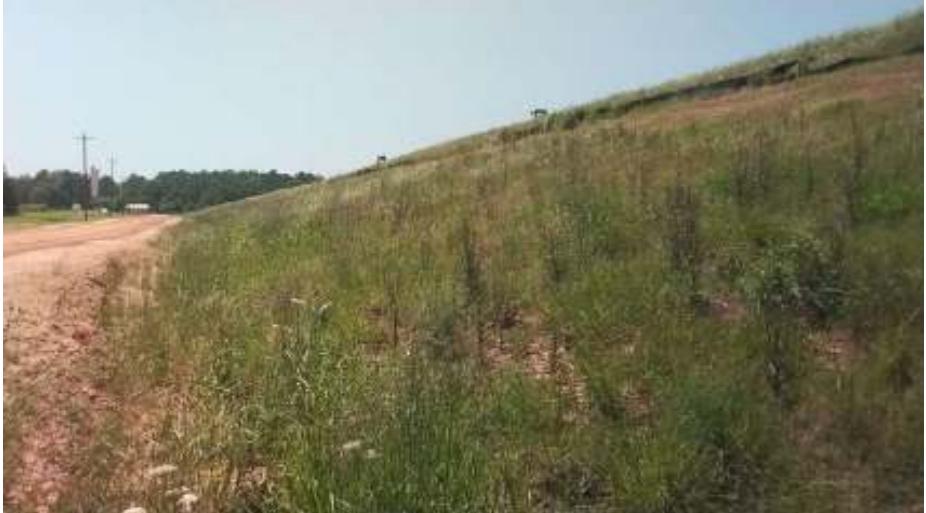
<b>PHOTO BY:</b>  GEI CONSULTANTS, INC.			
<b>PHOTOGRAPH NO: 2</b>	<b>DATE:</b> May 13, 2025 2:30 PM	<b>LATITUDE:</b> 33.04727731	<b>LONGITUDE:</b> -94.84523504
<b>DIRECTION:</b> 259°	<b>SITE LOCATION:</b> CASON, TEXAS		
<b>DESCRIPTION:</b>  Landfill Sideslope. Monitor minor erosion, and address if it becomes significant.

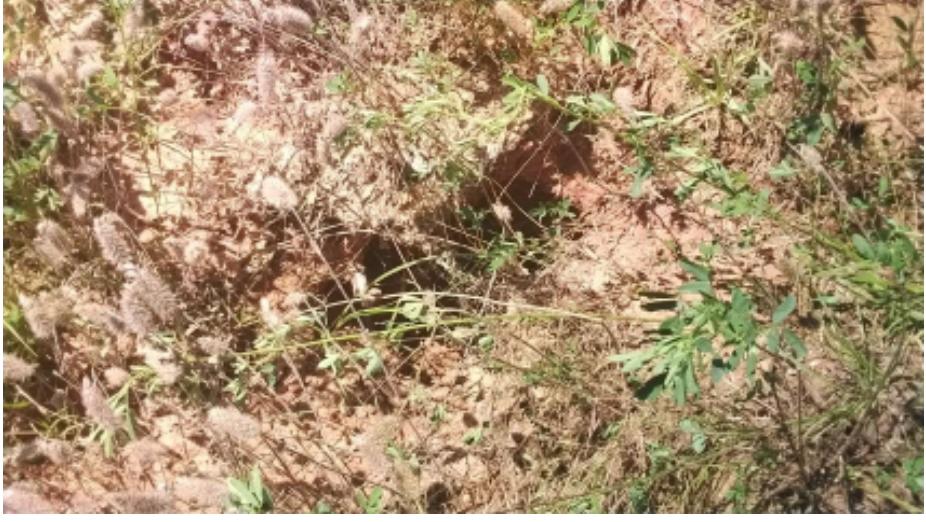
<b>PHOTO BY:</b>  GEI CONSULTANTS, INC.			
<b>PHOTOGRAPH NO: 4</b>	<b>DATE:</b> May 13, 2025 2:43 PM	<b>LATITUDE:</b> 33.0472222	<b>LONGITUDE:</b> -94.84730616
<b>DIRECTION:</b> 355°	<b>SITE LOCATION:</b> CASON, TEXAS		
<b>DESCRIPTION:</b>  Landfill Sideslope, General Photo, Typical Conditions.

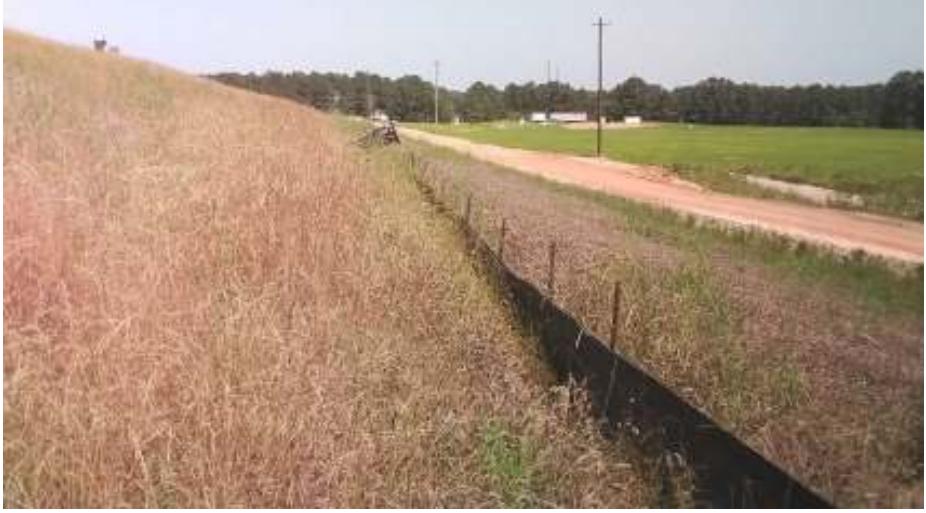
<b>PHOTO BY:</b>  GEI CONSULTANTS, INC.

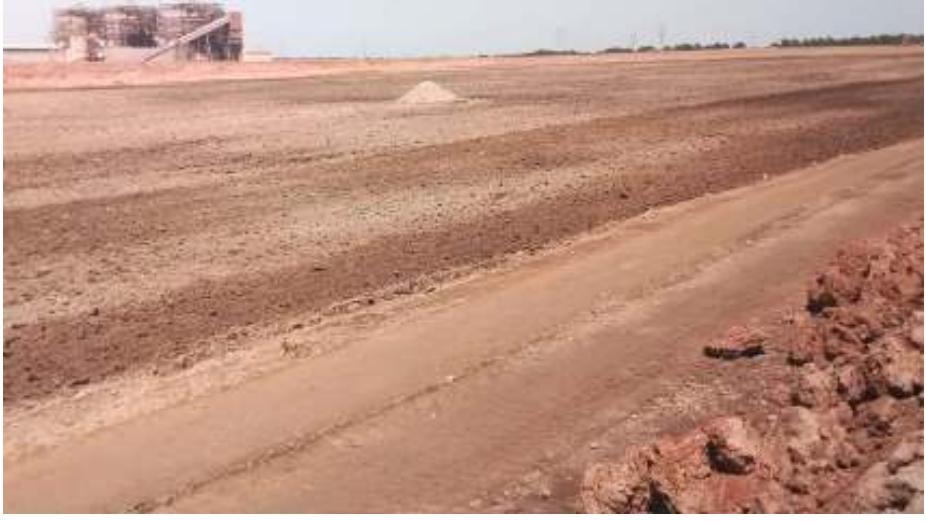
<b>PHOTO BY:</b>  GEI CONSULTANTS, INC.			
<b>PHOTOGRAPH NO: 6</b>	<b>DATE:</b> May 13, 2025 2:47 PM	<b>LATITUDE:</b> 33.04745	<b>LONGITUDE:</b> -94.84750166
<b>DIRECTION:</b> 221°	<b>SITE LOCATION:</b> CASON, TEXAS		
<b>DESCRIPTION:</b>  Landfill Processing Area. General Photo, Typical Conditions.

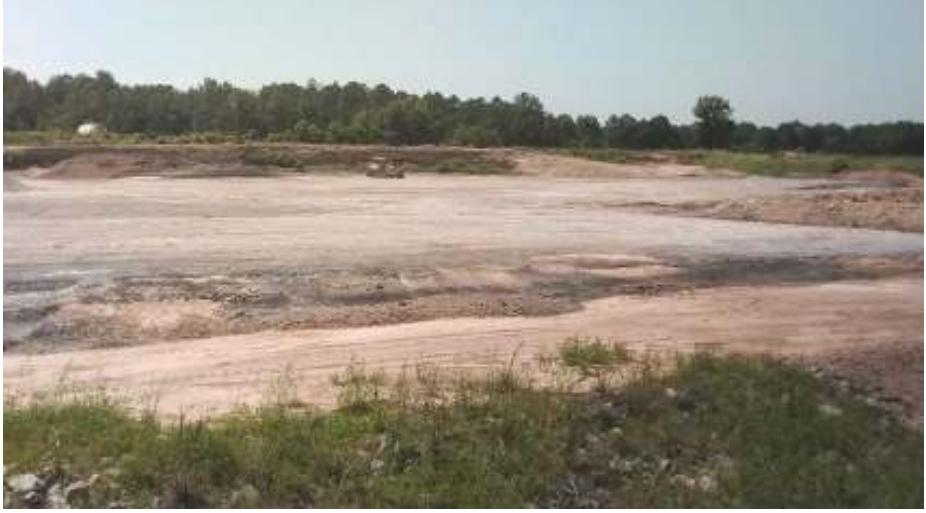
<b>PHOTO BY:</b>  GEI CONSULTANTS, INC.

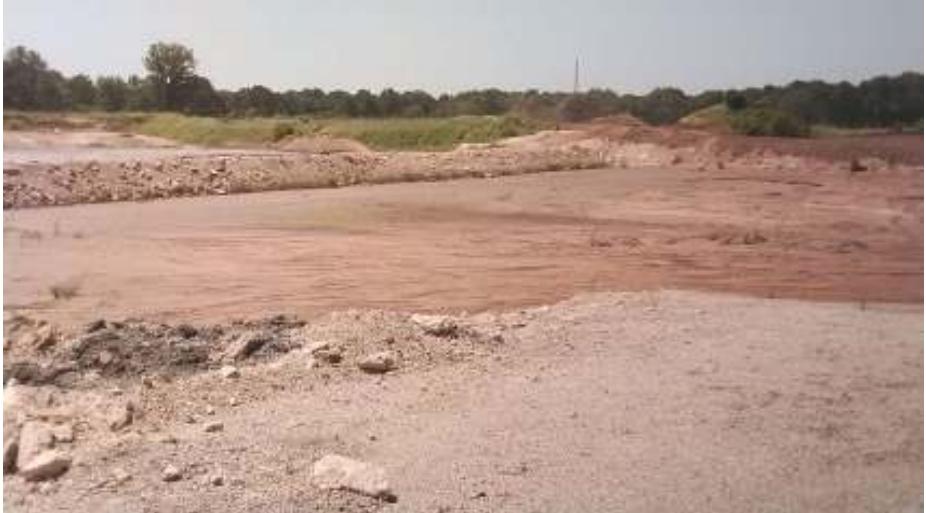
<b>PHOTO BY:</b>  GEI CONSULTANTS, INC.			
<b>PHOTOGRAPH NO: 8</b>	<b>DATE:</b> May 13, 2025 2:56 PM	<b>LATITUDE:</b> 33.04700884	<b>LONGITUDE:</b> -94.84943639
<b>DIRECTION:</b> 263°	<b>SITE LOCATION:</b> CASON, TEXAS		
<b>DESCRIPTION:</b>  Material Processing Area. General Photo, Typical Conditions.

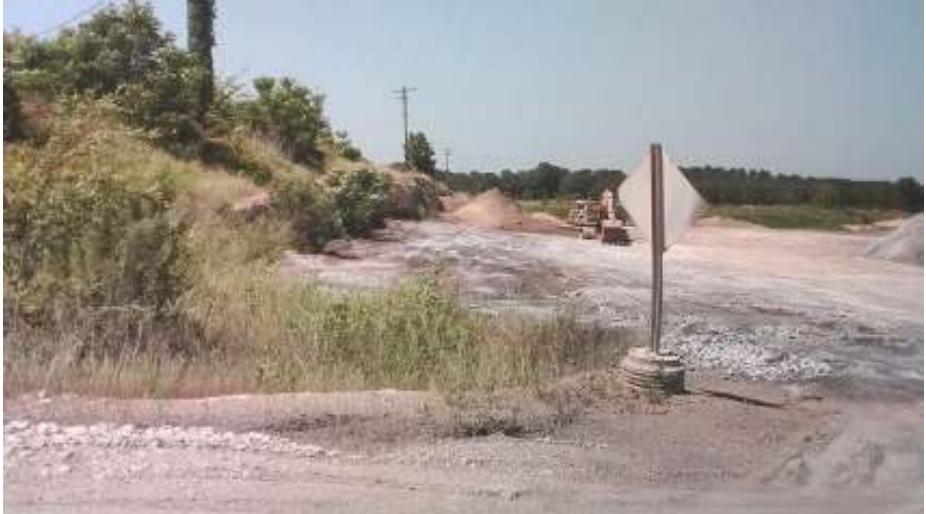
<b>PHOTO BY:</b>  GEI CONSULTANTS, INC.

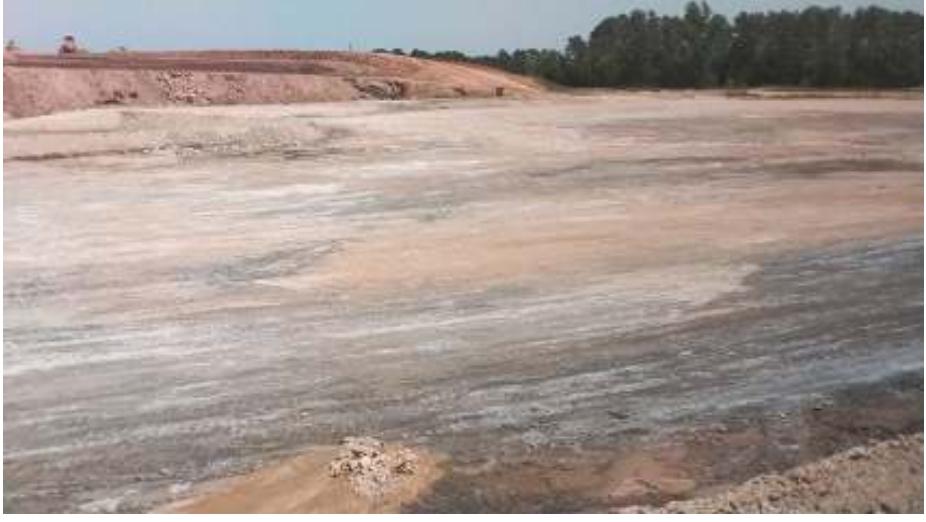
<b>PHOTO BY:</b>  GEI CONSULTANTS, INC.			
<b>PHOTOGRAPH No: 10</b>	<b>DATE:</b> May 13, 2025 3:11 PM	<b>LATITUDE:</b> 33.04900653	<b>LONGITUDE:</b> -94.84768009
<b>DIRECTION:</b> 345°	<b>SITE LOCATION:</b> CASON, TEXAS		
<b>DESCRIPTION:</b>  Landfill Sideslope, Interim Cover Conditions. General Photo, Typical Conditions.

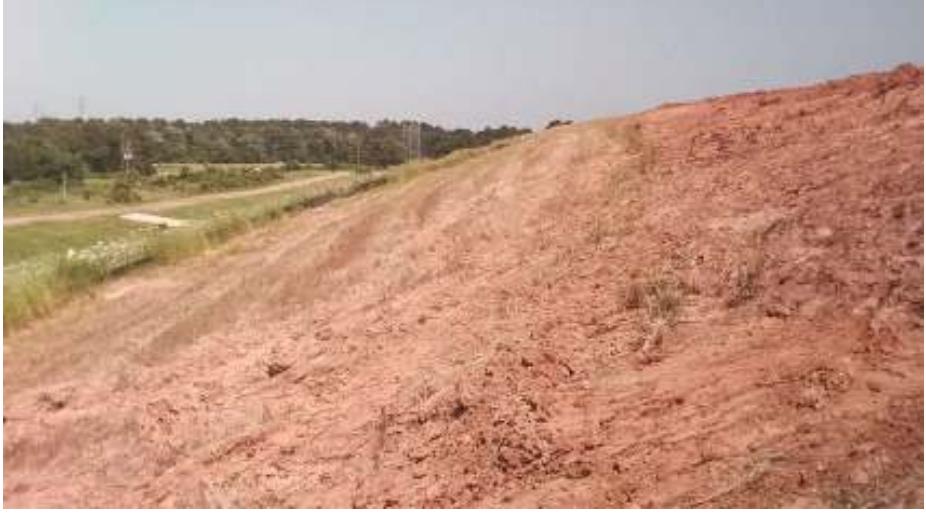
<b>PHOTO BY:</b>  GEI CONSULTANTS, INC.

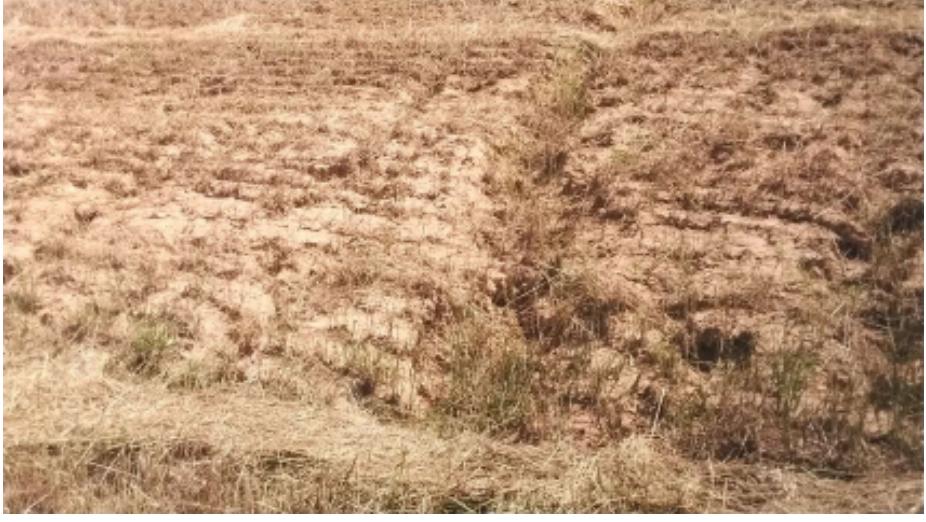
<b>PHOTO BY:</b>  GEI CONSULTANTS, INC.			
<b>PHOTOGRAPH NO: 12</b>	<b>DATE:</b> May 13, 2025 3:21 PM	<b>LATITUDE:</b> 33.04897045	<b>LONGITUDE:</b> -94.84610098
<b>DIRECTION:</b> 96°	<b>SITE LOCATION:</b> CASON, TEXAS		
<b>DESCRIPTION:</b>  Landfill Sideslope. Monitor minor erosion and address if it becomes significant.

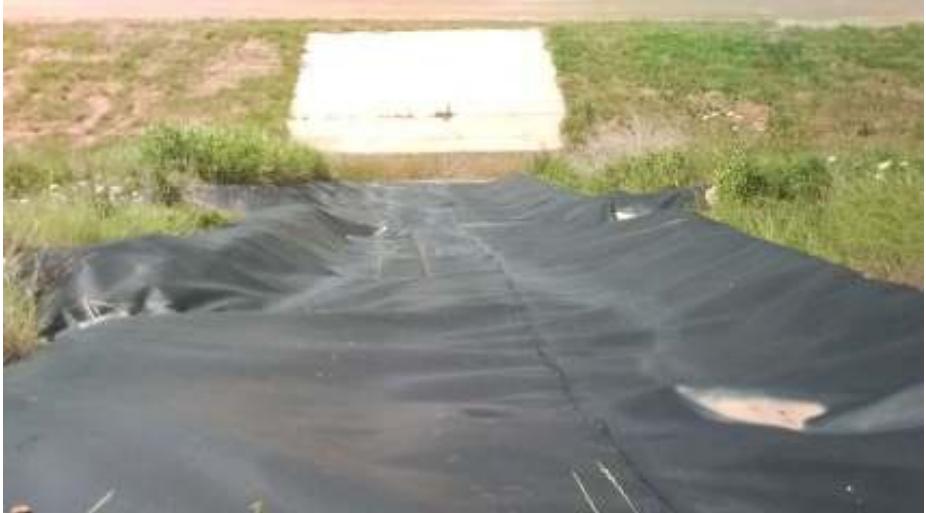
<b>PHOTO BY:</b>  GEI CONSULTANTS, INC.			
<b>PHOTOGRAPH NO: 14</b>	<b>DATE:</b> May 13, 2025 3:24 PM	<b>LATITUDE:</b> 33.04893775	<b>LONGITUDE:</b> -94.84579791
<b>DIRECTION:</b> 53°	<b>SITE LOCATION:</b> CASON, TEXAS		
<b>DESCRIPTION:</b>  Landfill Sideslope. Address major erosion. Erosion observed to be 2-3 ft in depth, 20 ft long.

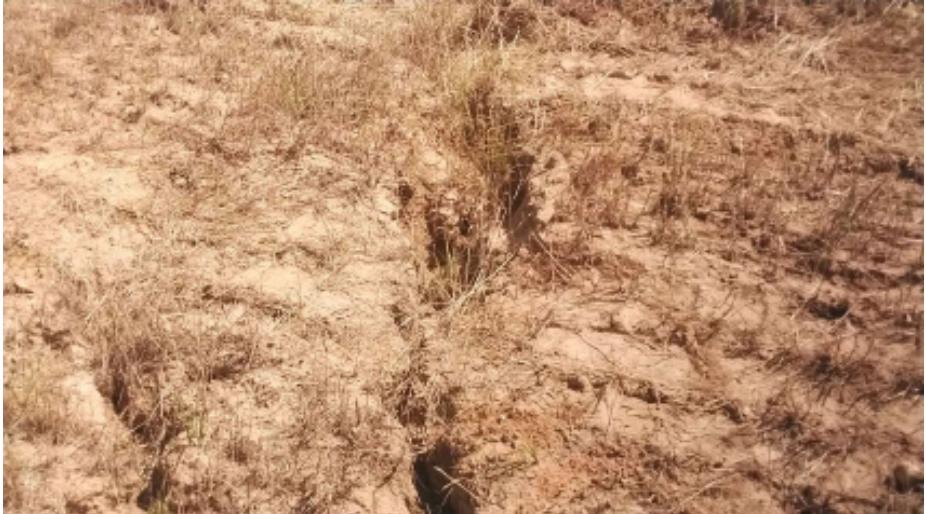
<b>PHOTO BY:</b>  GEI CONSULTANTS, INC.

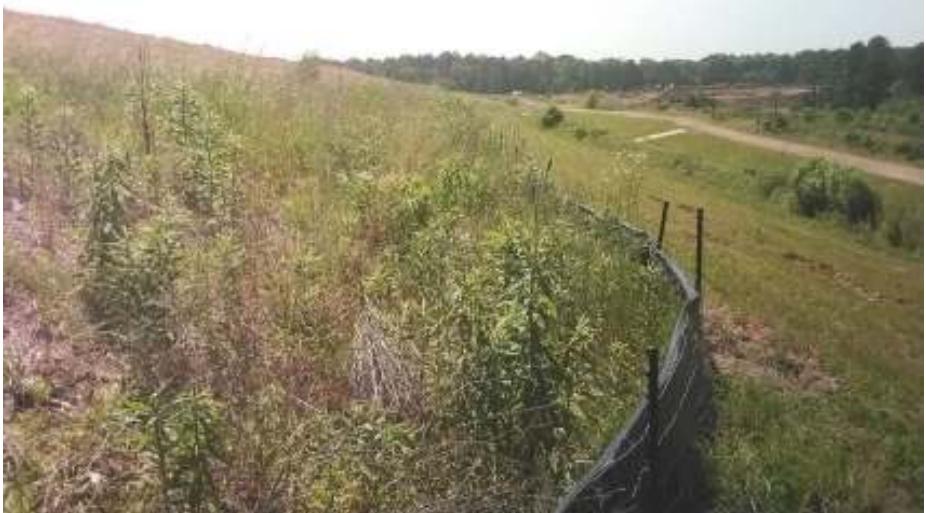
<b>PHOTO BY:</b>  GEI CONSULTANTS, INC.			
<b>PHOTOGRAPH NO: 16</b>	<b>DATE:</b> May 13, 2025 3:32 PM	<b>LATITUDE:</b> 33.04897738	<b>LONGITUDE:</b> -94.84332701
<b>DIRECTION:</b> 306°	<b>SITE LOCATION:</b> CASON, TEXAS		
<b>DESCRIPTION:</b>  Drainage Feature, Letdown Channel. General Photo, Typical Conditions.

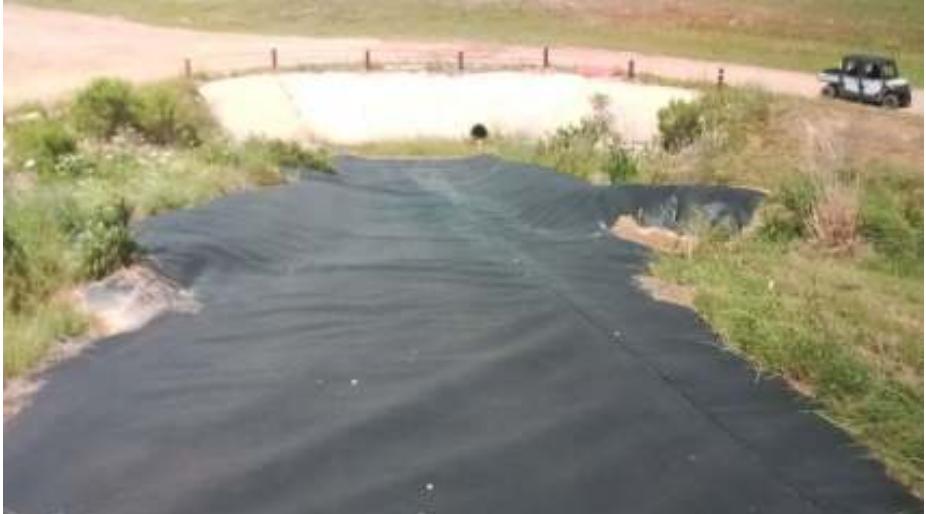
<b>PHOTO BY:</b>  GEI CONSULTANTS, INC.

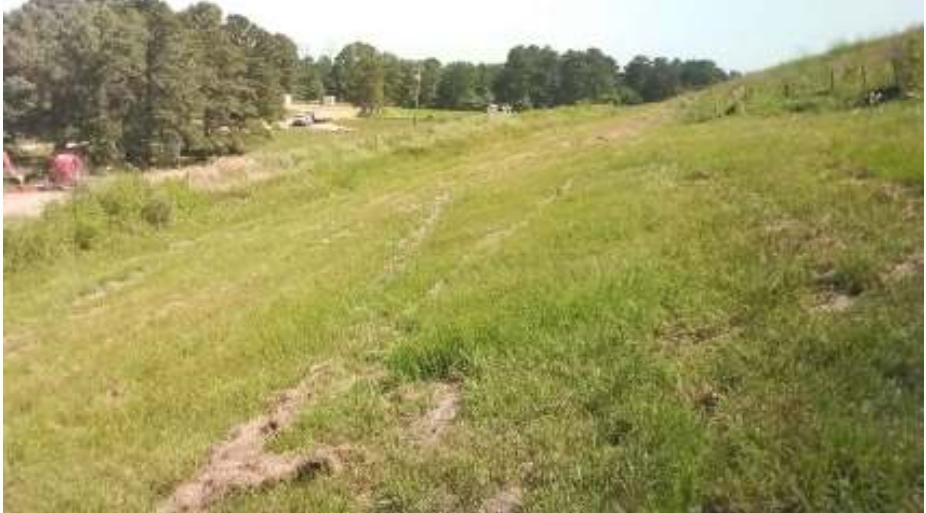
<b>PHOTO BY:</b>  GEI CONSULTANTS, INC.			
<b>PHOTOGRAPH NO: 18</b>	<b>DATE:</b> May 13, 2025 3:40 PM	<b>LATITUDE:</b> 33.04740684	<b>LONGITUDE:</b> -94.84325835
<b>DIRECTION:</b> 360°	<b>SITE LOCATION:</b> CASON, TEXAS		
<b>DESCRIPTION:</b>  Drainage Feature, Letdown Channel. Address/maintain vegetation to 12-inches or less.

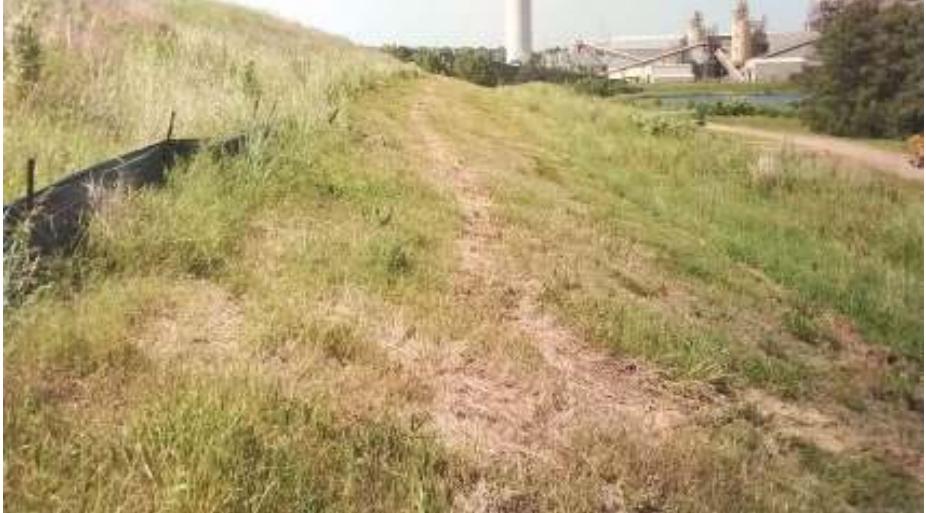
<b>PHOTO BY:</b>			
<b>GEI CONSULTANTS, INC.</b>
