Primary Bottom Ash and Clearwater Pond 2025 Annual Dam and Dike Inspection Report

Welsh Power Plant, Cason, Texas

August 14, 2025
Project 2501323
AEP Document ID: GEVR-25-008

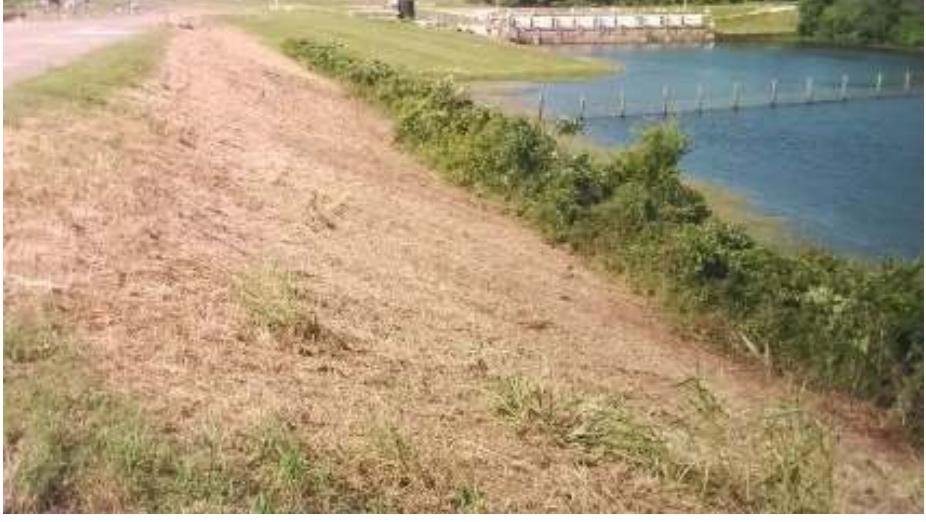
The downstream was in good condition with most of vegetation maintained to 12-inches or less as shown in Photo No. 1 and No. 2. Some minor woody vegetation is becoming established along the shoreline as shown in Photo 18 and should be addressed every few years before it becomes significant, and more effort is required to address.

PHOTOGRAPH NO: 1	DATE: May 13, 2025 4:54 PM	LATITUDE: 33.05048792	LONGITUDE: -94.84133154
DIRECTION: 301°	SITE LOCATION: CASON, TEXAS		
DESCRIPTION: Downstream Slope General Photo, Typical Conditions. Consider maintaining vegetation to 12-inches or less, on the slope as close to the water's edge as it is safe to limit woody vegetation establishment.

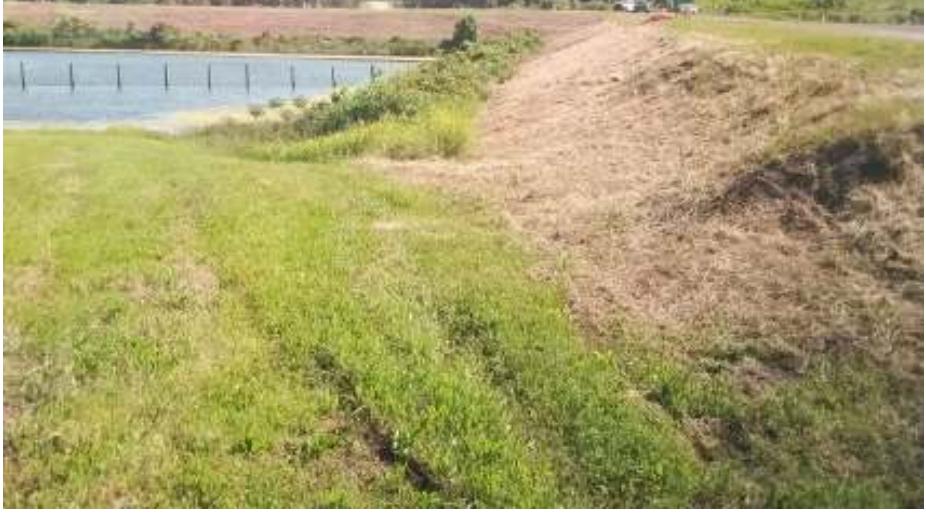
PHOTO BY: GEI CONSULTANTS, INC.			
PHOTOGRAPH NO: 2	DATE: May 13, 2025 4:59 PM	LATITUDE: 33.0518952	LONGITUDE: -94.84030836
DIRECTION: 119°	SITE LOCATION: CASON, TEXAS		
DESCRIPTION: Downstream Slope, General Photo, Typical Conditions. Consider maintaining vegetation to 12-inches or less, on the slope as close to the water's edge as it is safe to limit woody vegetation establishment.

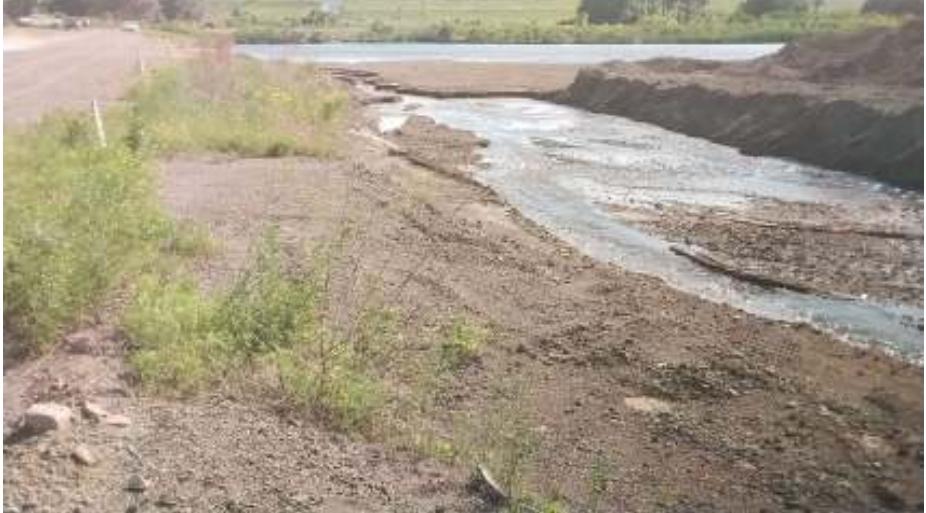
The upstream slope was in good condition with vegetation maintained to 12-inches or less as shown in Photo No. 3.

PHOTOGRAPH NO: 3	DATE: May 13, 2025 5:00 PM	LATITUDE: 33.05201448	LONGITUDE: -94.8404717
DIRECTION: 137°	SITE LOCATION: CASON, TEXAS		
DESCRIPTION: Upstream Slope. General Photo, Typical Conditions.

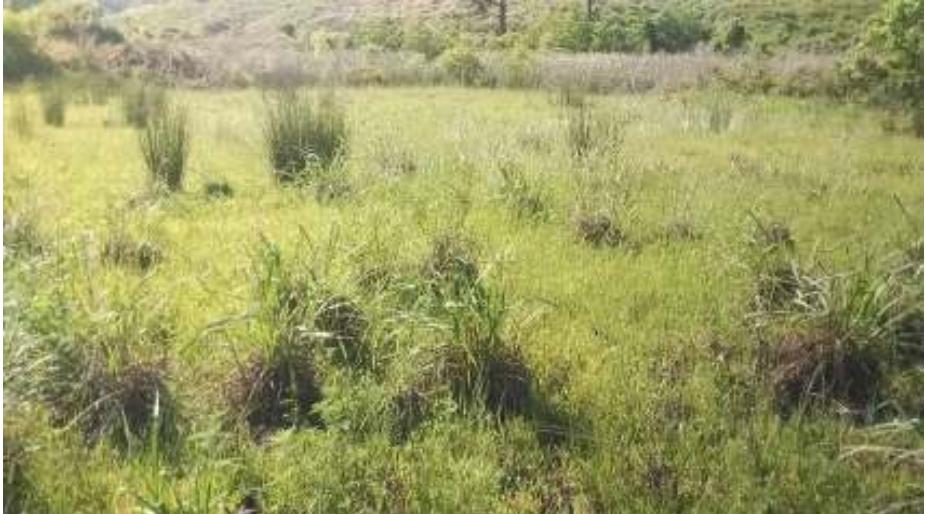
The primary spillway was in good condition with vegetation maintained to 12-inches or less and no blockages that would restrict flow as shown in Photo No. 4 and No. 5.

PHOTO BY: GEI CONSULTANTS, INC.			
PHOTOGRAPH NO: 4	DATE: May 13, 2025 5:06 PM	LATITUDE: 33.05041885	LONGITUDE: -94.84502222
DIRECTION: 237°	SITE LOCATION: CASON, TEXAS		
DESCRIPTION: Drainage Feature, Spillway, Looking Upstream, General Photo, Typical Conditions.

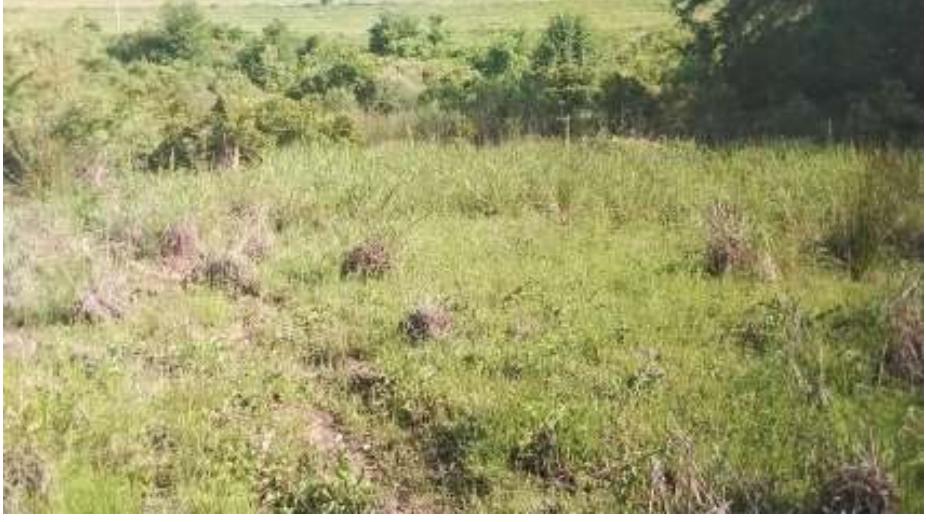
PHOTOGRAPH NO: 5	DATE: May 13, 2025 5:07 PM	LATITUDE: 33.05041155	LONGITUDE: -94.84501821
DIRECTION: 69°	SITE LOCATION: CASON, TEXAS		
DESCRIPTION: Drainage Feature, Spillway, Looking Downstream, General Photo, Typical Conditions.

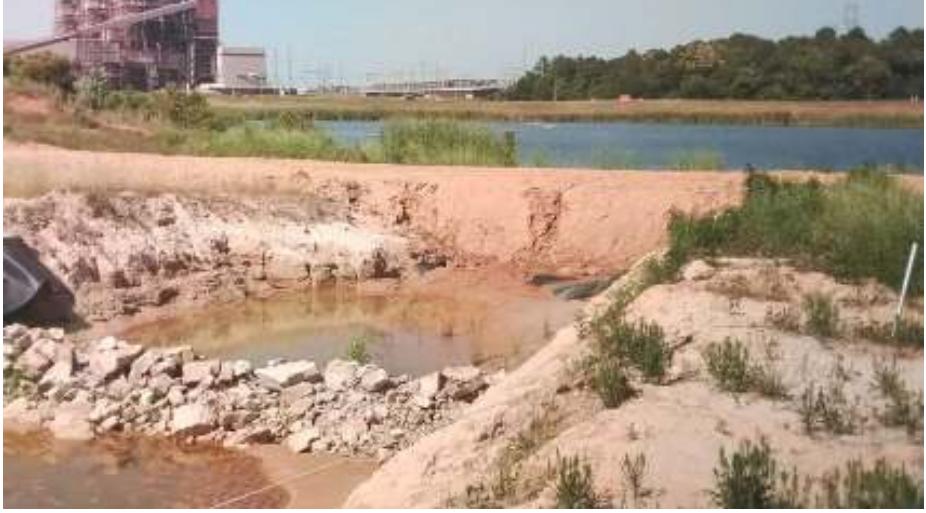
The check dam / spillway was in good condition with little silt accumulation as shown in Photo No. 6 and No. 8

PHOTO BY: GEI CONSULTANTS, INC.			
PHOTOGRAPH NO: 6	DATE: May 13, 2025 4:02 PM	LATITUDE: 33.048303	LONGITUDE: -94.84203538
DIRECTION: 292°	SITE LOCATION: CASON, TEXAS		
DESCRIPTION: Drainage Feature, Spillway Area, Looking Upstream. General Photo, Typical Conditions.

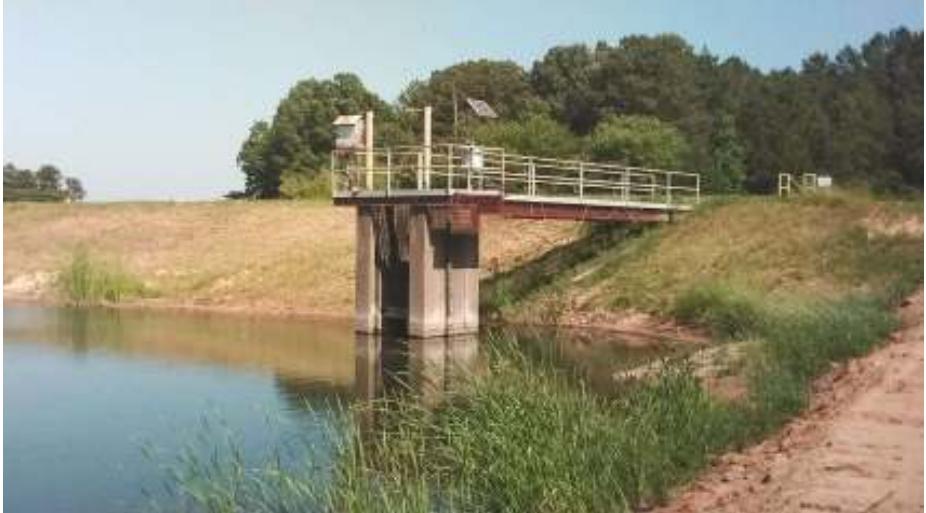
The outlet structure / piping was in good condition with no blockages observed that would restrict flow as shown in Photo No. 7, 9, 10, and 11. The staff gauge read elevation 329.

PHOTOGRAPH NO: 7	DATE: May 13, 2025 4:04 PM	LATITUDE: 33.04860805	LONGITUDE: -94.84186602
DIRECTION: 9°	SITE LOCATION: CASON, TEXAS		
DESCRIPTION: Drainage Feature, Outlet Structure. General Photo, Typical Conditions.

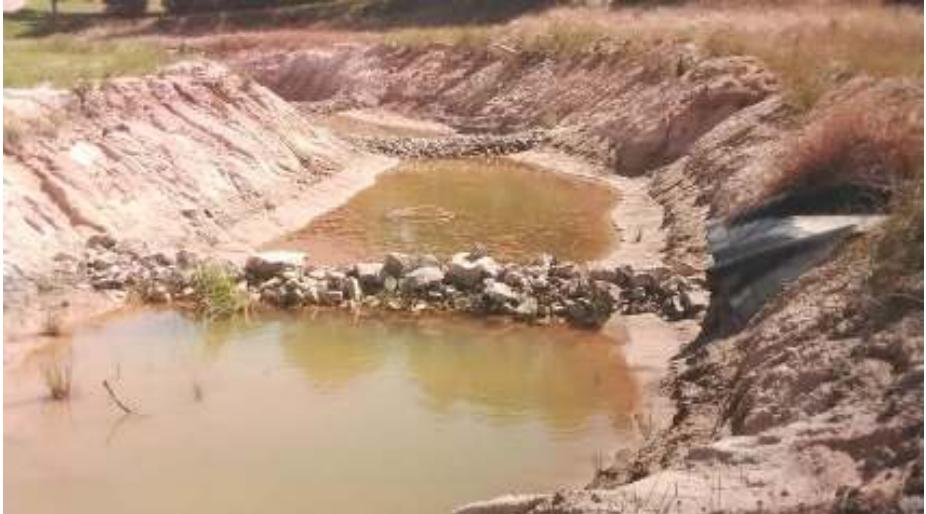
PHOTO BY: GEI CONSULTANTS, INC.			
PHOTOGRAPH NO: 8	DATE: May 13, 2025 4:05 PM	LATITUDE: 33.04855782	LONGITUDE: -94.8419117
DIRECTION: 138°	SITE LOCATION: CASON, TEXAS		
DESCRIPTION: Drainage Feature. Spillway, Looking Downstream. General Photo, Typical Conditions.

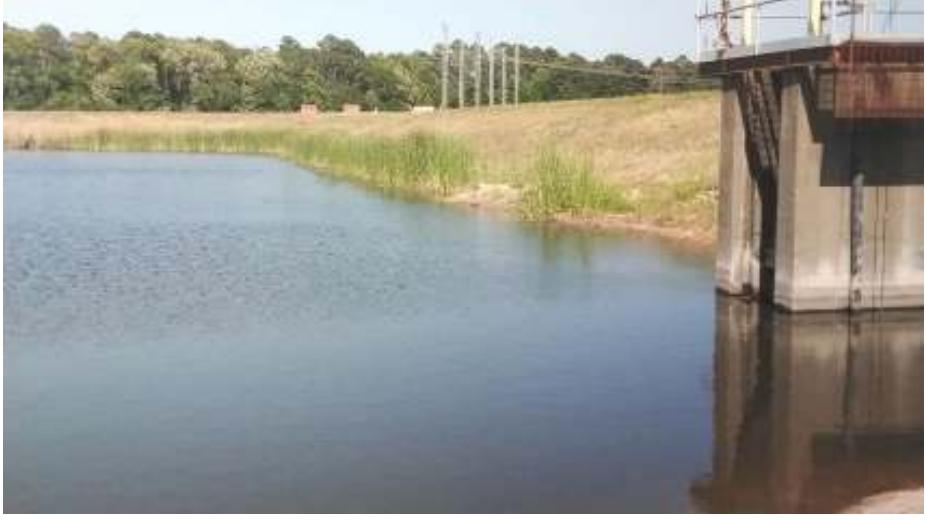
PHOTOGRAPH No: 9	DATE: May 13, 2025 4:06 PM	LATITUDE: 33.0485161	LONGITUDE: -94.84176361
DIRECTION: 332°	SITE LOCATION: CASON, TEXAS		
DESCRIPTION: Upstream Slope. General Photo, Typical Conditions. Consider maintaining vegetation to 12-inches or less, on the slope as close to the water's edge as it is safe to limit woody vegetation establishment.

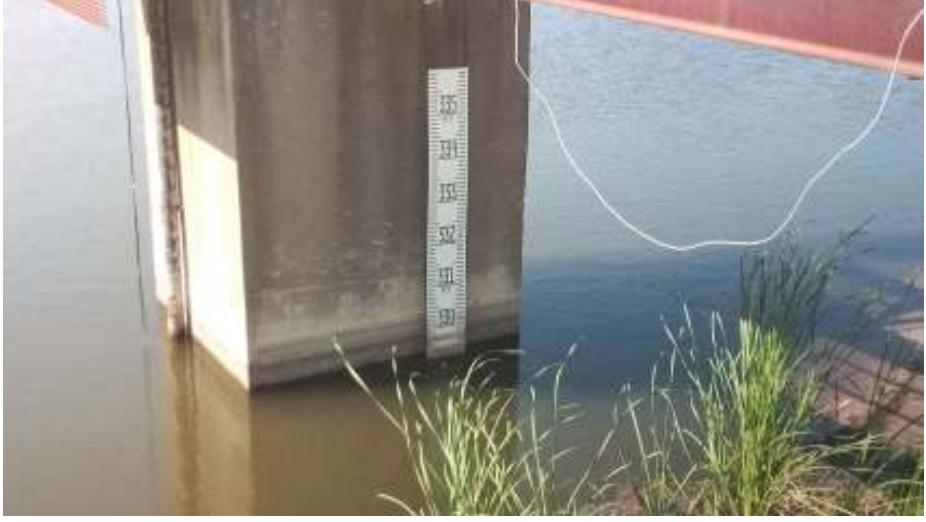
PHOTO BY: GEI CONSULTANTS, INC.			
PHOTOGRAPH No: 10	DATE: May 13, 2025 4:12 PM	LATITUDE: 33.04844225	LONGITUDE: -94.84156042
DIRECTION: 264°	SITE LOCATION: CASON, TEXAS		
DESCRIPTION: Drainage Feature, Outlet Structure. General Photo, Typical Conditions. Staff gauge - water level at elevation 329 feet

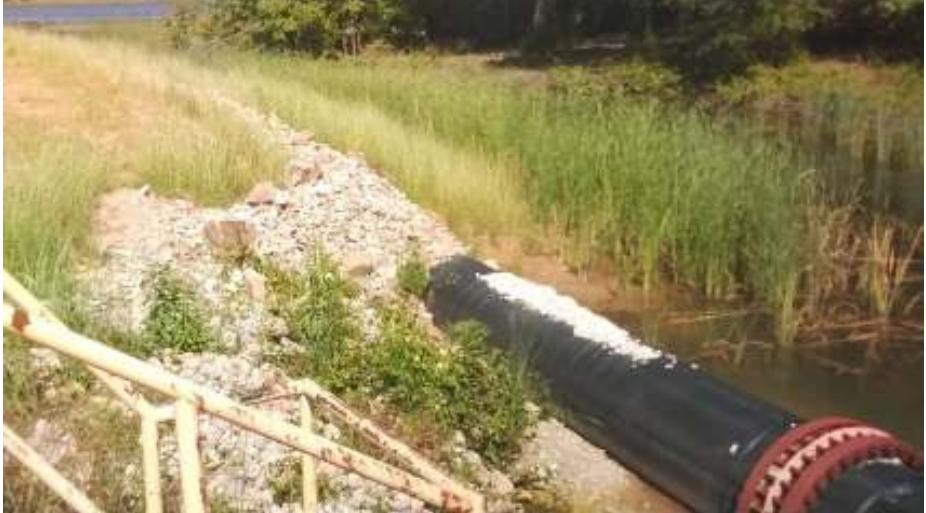
PHOTOGRAPH NO: 11	DATE: May 13, 2025 4:16 PM	LATITUDE: 33.04819451	LONGITUDE: -94.84136904
DIRECTION: 360°	SITE LOCATION: CASON, TEXAS		
DESCRIPTION: Drainage Feature, Outlet Structure. Looking downstream. General Photo, Typical Conditions. Outfall 001 to Welsh Lake

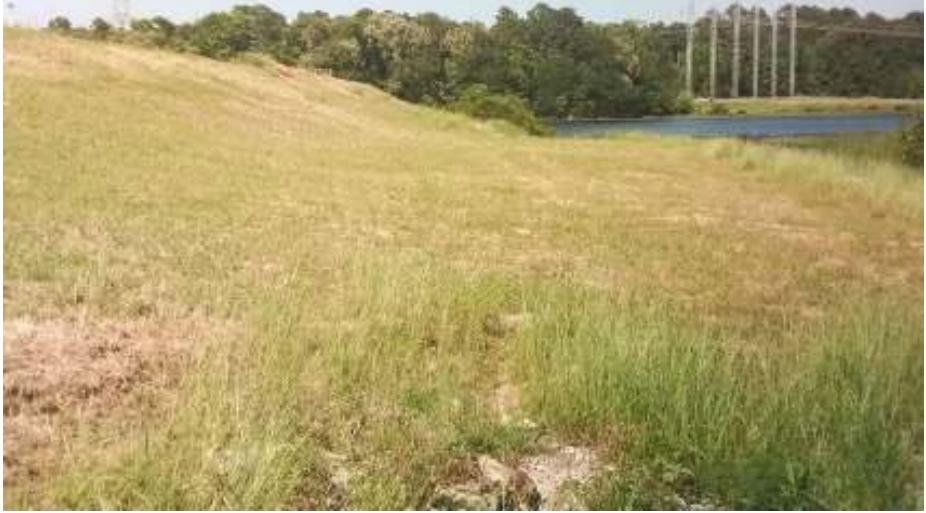
The downstream slope was in good condition with vegetation maintained to 12-inches or less as shown in Photo No. 12 and No. 13.

PHOTO BY: GEI CONSULTANTS, INC.			
PHOTOGRAPH NO: 12	DATE: May 13, 2025 4:20 PM	LATITUDE: 33.04820681	LONGITUDE: -94.84134954
DIRECTION: 324°	SITE LOCATION: CASON, TEXAS		
DESCRIPTION: Downstream Slope. General Photo, Typical Conditions. Vegetation maintained to 12-inches or less.

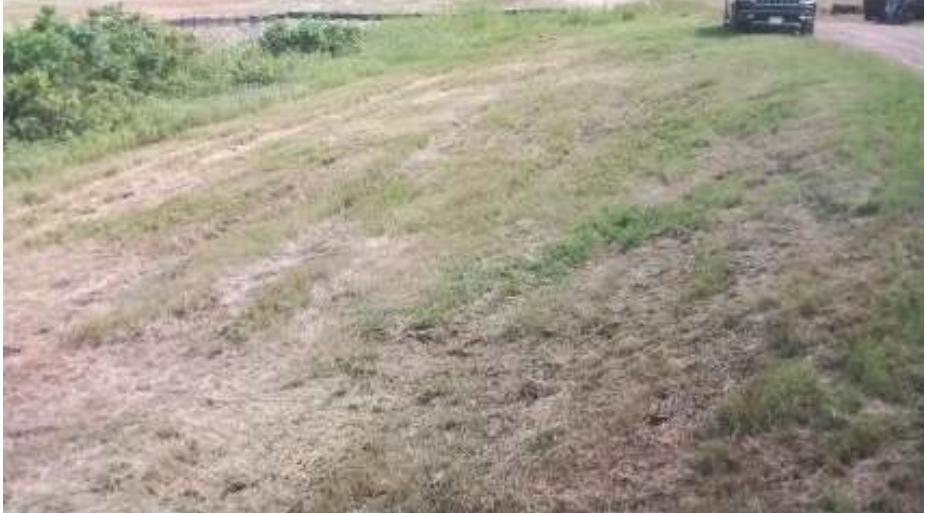
PHOTOGRAPH NO: 13	DATE: May 13, 2025 4:22 PM	LATITUDE: 33.04833355	LONGITUDE: -94.84146811
DIRECTION: 132°	SITE LOCATION: CASON, TEXAS		
DESCRIPTION: Downstream Slope. General Photo, Typical Conditions. Consider maintaining vegetation to 12-inches or less, on the slope as close to the water's edge as it is safe to limit woody vegetation establishment.

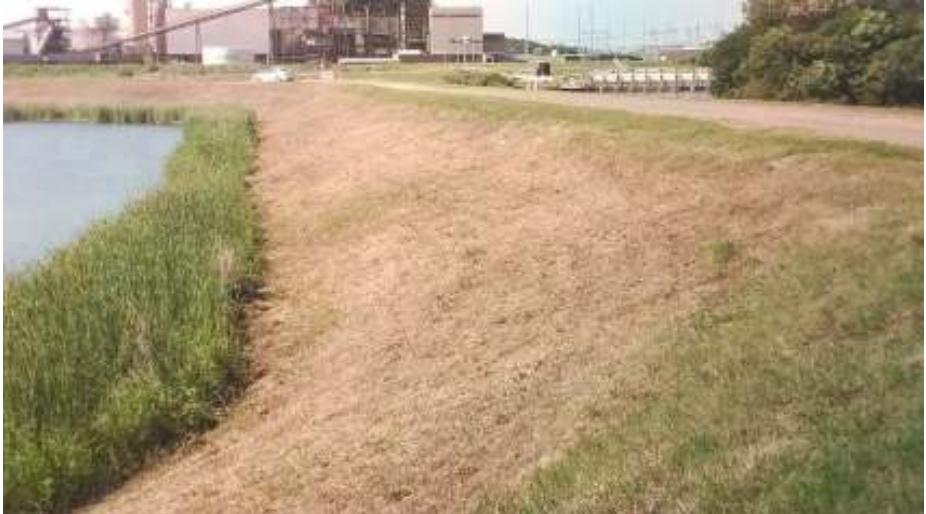
The upstream was in good condition and well maintained as shown in Photo No. 14, 15, 16, 17, and 19. Some minor vegetation along the shoreline should be addressed in the future before it becomes significant, and more effort is required to remove it.

PHOTO BY: GEI CONSULTANTS, INC.			
PHOTOGRAPH NO: 14	DATE: May 13, 2025 4:43 PM	LATITUDE: 33.04880751	LONGITUDE: -94.84061742
DIRECTION: 274°	SITE LOCATION: CASON, TEXAS		
DESCRIPTION: Upstream Slope, General Photo, Typical Conditions. Consider maintaining vegetation to 12-inches or less, on the slope as close to the water's edge as it is safe to limit woody vegetation establishment.

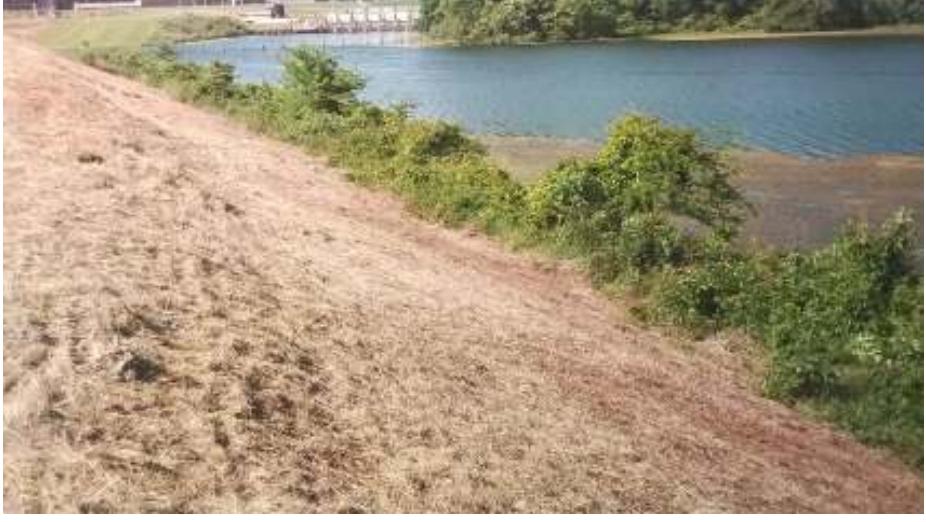
PHOTOGRAPH NO: 15	DATE: May 13, 2025 4:44 PM	LATITUDE: 33.04883624	LONGITUDE: -94.84044941
DIRECTION: 283°	SITE LOCATION: CASON, TEXAS		
DESCRIPTION: Downstream Slope. General Photo, Typical Conditions. Consider maintaining vegetation to 12-inches or less, on the slope as close to the water's edge as it is safe to limit woody vegetation establishment.

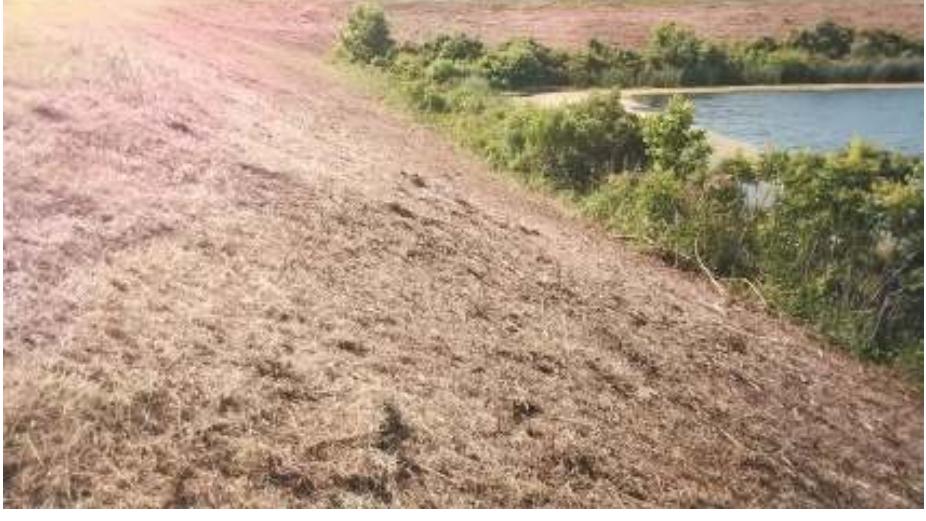
PHOTO BY:			
GEI CONSULTANTS, INC.			
PHOTOGRAPH NO: 16	DATE: May 13, 2025 4:47 PM	LATITUDE: 33.04998845	LONGITUDE: -94.84050559
DIRECTION: 232°	SITE LOCATION: CASON, TEXAS		
DESCRIPTION: Downstream Slope. General Photo, Typical Conditions. Consider maintaining vegetation to 12-inches or less, on the slope as close to the water's edge as it is safe to limit woody vegetation establishment.

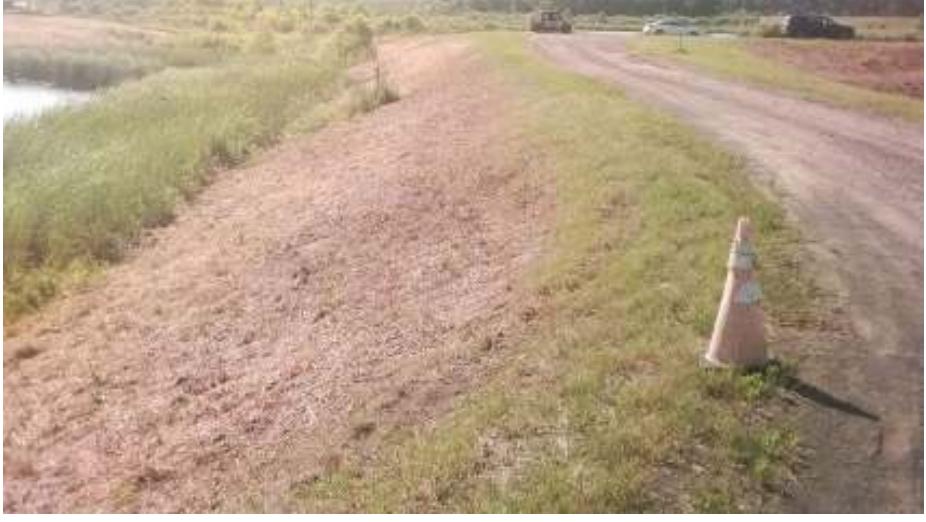
PHOTOGRAPH NO: 17	DATE: May 13, 2025 4:48 PM	LATITUDE: 33.04994921	LONGITUDE: -94.84060074
DIRECTION: 216°	SITE LOCATION: CASON, TEXAS		
DESCRIPTION: Upstream Slope. General Photo, Typical Conditions. Consider maintaining vegetation to 12-inches or less, on the slope as close to the water's edge as it is safe to limit woody vegetation establishment.

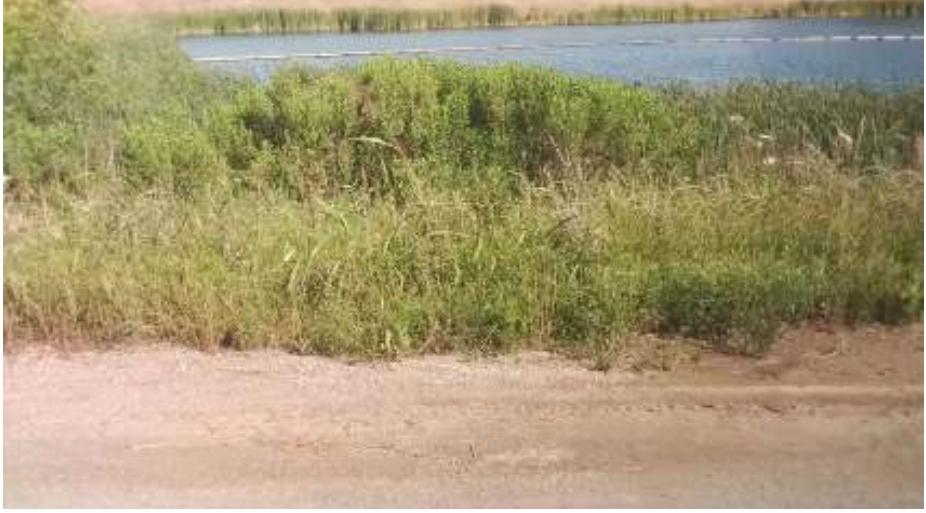
PHOTO BY:			
GEI CONSULTANTS, INC.			
PHOTOGRAPH NO: 18	DATE: May 13, 2025 4:50 PM	LATITUDE: 33.05022844	LONGITUDE: -94.84164656
DIRECTION: 30°	SITE LOCATION: CASON, TEXAS		
DESCRIPTION: Downstream Slope. Address/Maintain vegetation to 12-inches or less.

- Item 18 – Address/maintain the vegetation to 12-inches or less on the downstream slope of the Primary Bottom Ash Pond / Upstream slope of the Clearwater Pond.

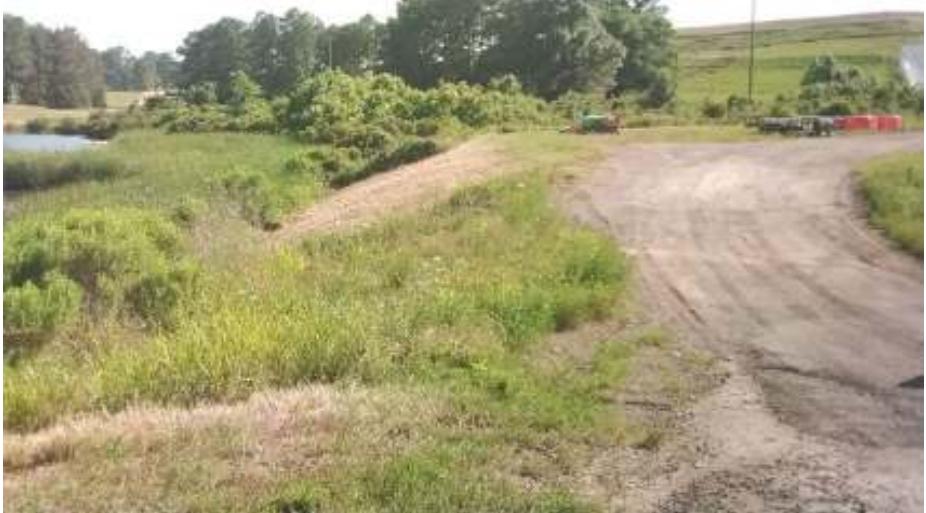
PHOTOGRAPH NO: 19	DATE: May 13, 2025 4:53 PM	LATITUDE: 33.05036127	LONGITUDE: -94.84147353
DIRECTION: 128°	SITE LOCATION: CASON, TEXAS		
DESCRIPTION: Upstream Slope / Secondary spillway General Photo, Typical Conditions. Consider maintaining vegetation to 12-inches or less, on the slope as close to the water's edge as it is safe to limit woody vegetation establishment.

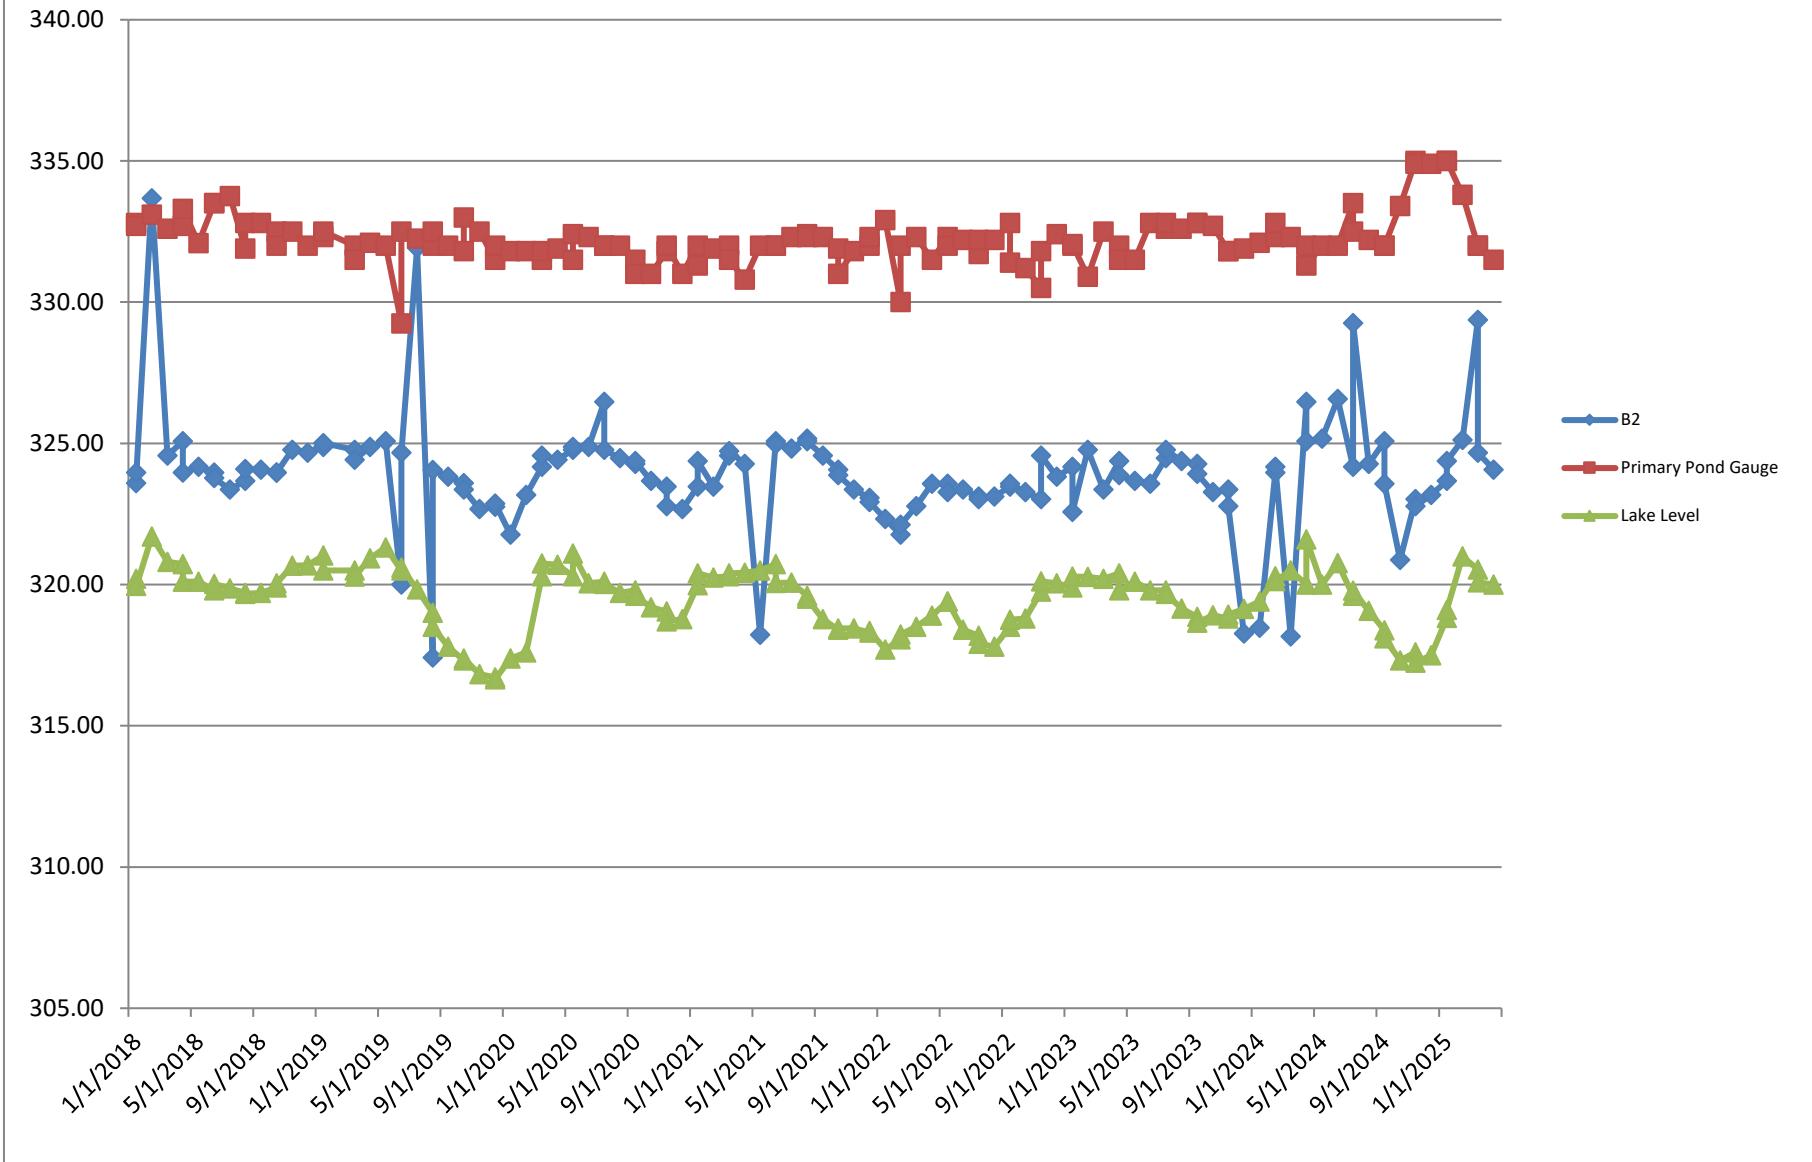
Primary Pond Piezometer Monitoring Results

The monitoring instrumentation for the Primary Bottom Ash Pond consists of the one piezometer (B-2) located through the main embankment area. Piezometer B-2 levels appeared consistent from month to month and reacted to the fluctuation in tail water levels (i.e., main lake). The piezometer monitoring results are provided in Appendix B – Instrumentation Monitoring Results.

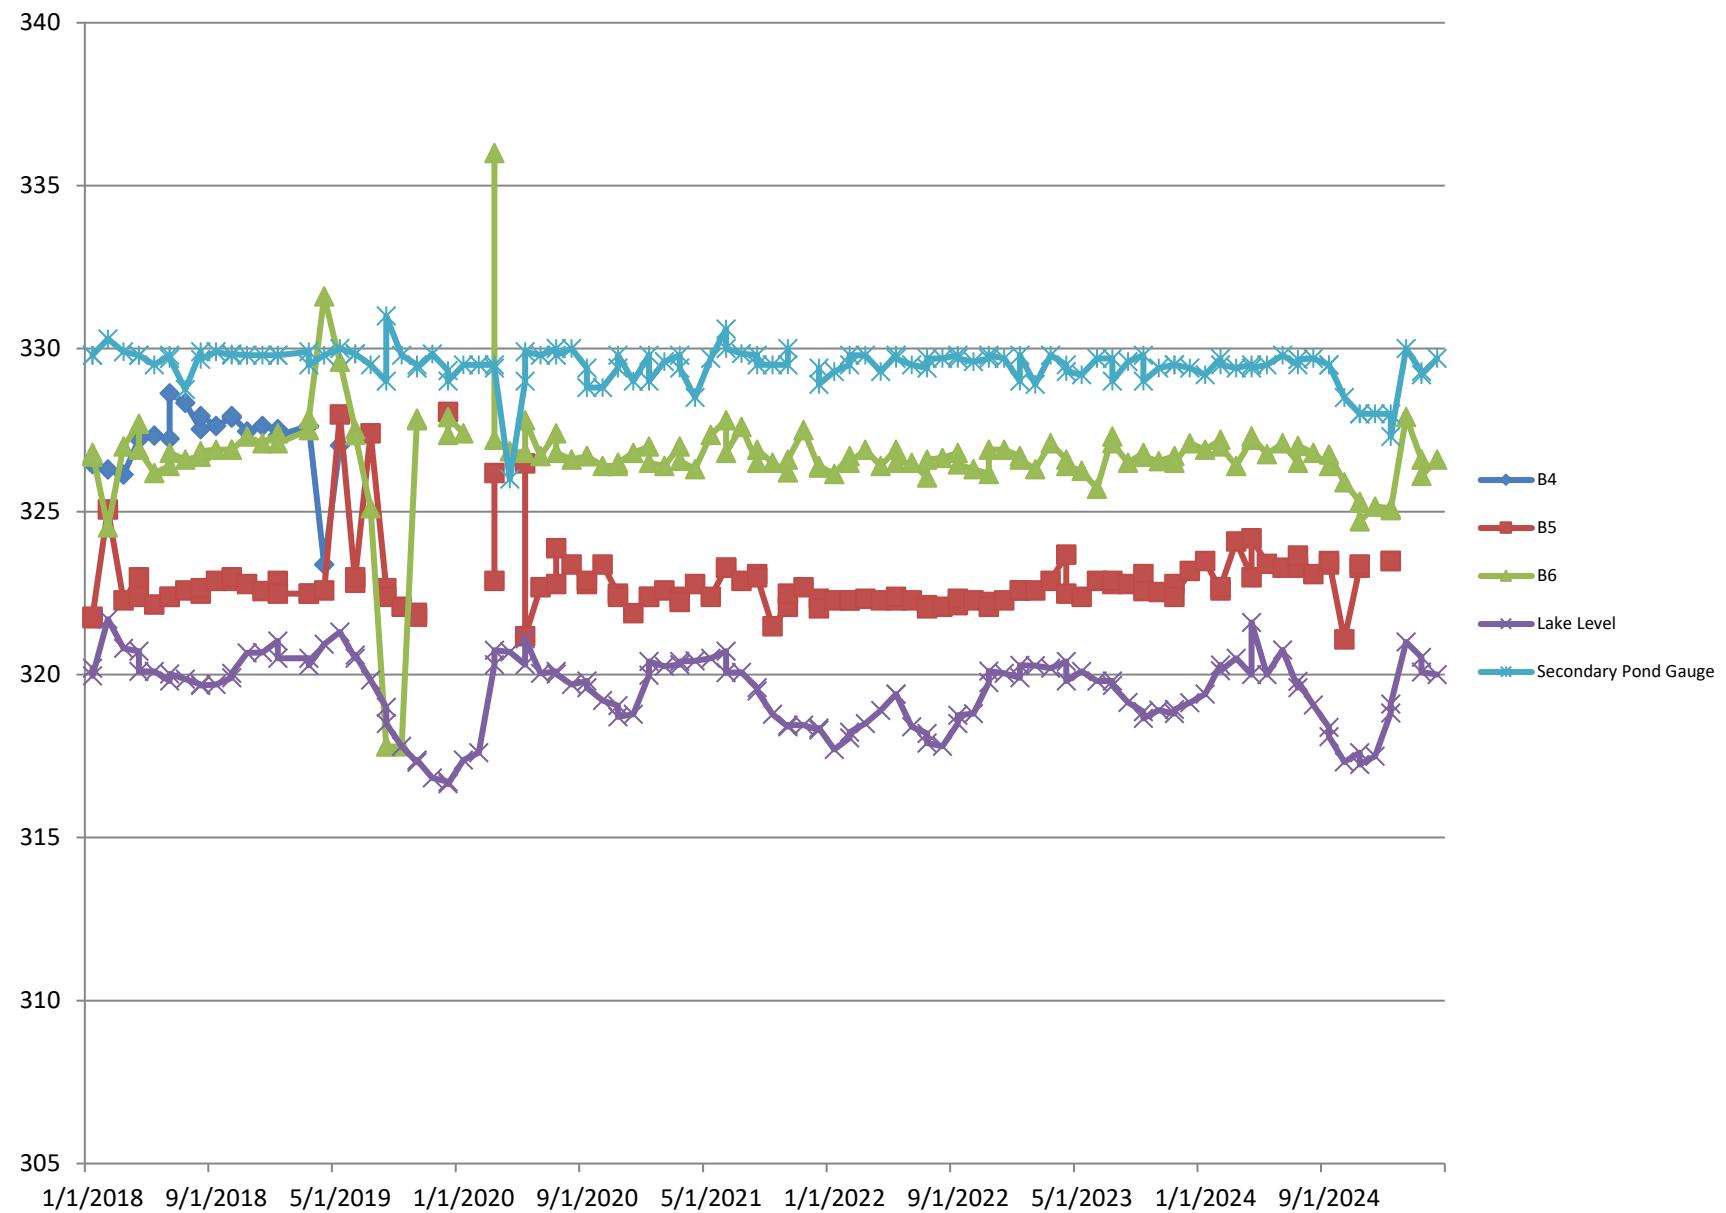
Clearwater Pond Piezometer Monitoring Results

The monitoring instrumentation for the Clearwater Pond consists of three piezometers (B-4, B-5, and B-6). The piezometer levels appeared consistent from month to month and reacted to the fluctuation in tail water levels (i.e., main lake). The piezometer monitoring results are provided in Appendix B – Instrumentation Monitoring Results.
