2025 Annual Dam and Dike Inspection Report

Cabin Creek Ash Pond

**Cabin Creek Power Plant
Appalachian Power Company
Chelyan, WV**

September 2025

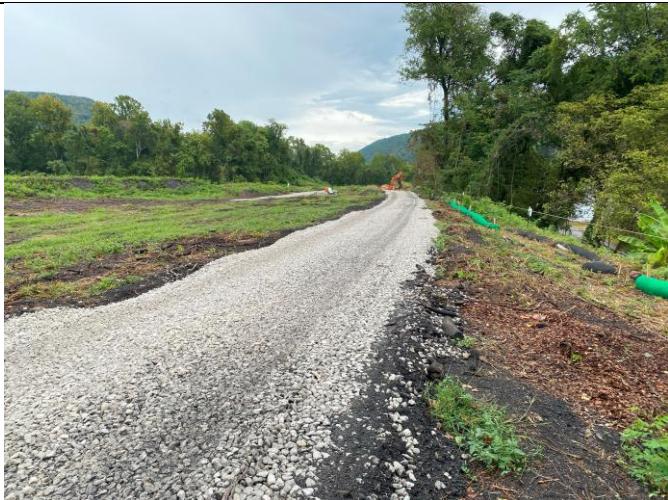
Photograph 1:

- The crest of the dam is in fair condition and is used as an access road. There were minor ruts along sections around the pond.
- The spillway structure is in poor condition. The spillway is a pipe/riser with a notch for retaining stop logs. The riser structure appears to be significantly blocked by concrete rubble/debris. The outlet pipe on the edge of the Kanawha River is concrete material and is approximately 75% blocked by silt/sediment. The outlet pipe was difficult to inspect due to trees and brush.

View of access road along the southern crest of the dam.

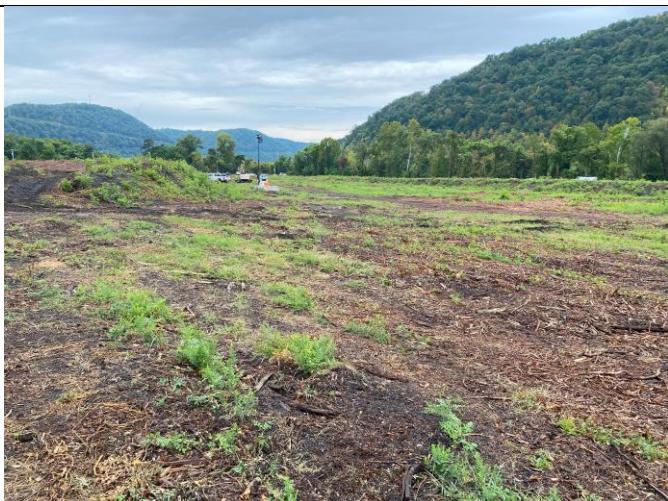
Photograph 2:

Typical view across the ash pond.

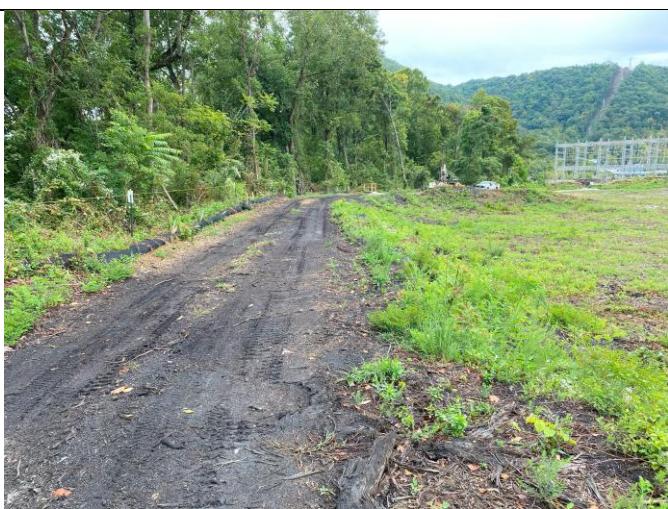
Photograph 3:

- The upstream slope of the Ash Pond is in fair condition. Trees and brush have been recently removed from the upstream slope of the Ash Pond. There was no signs of instability or erosion.

View of the crest and interior slope of the dam near the northeast corner of the ash pond.

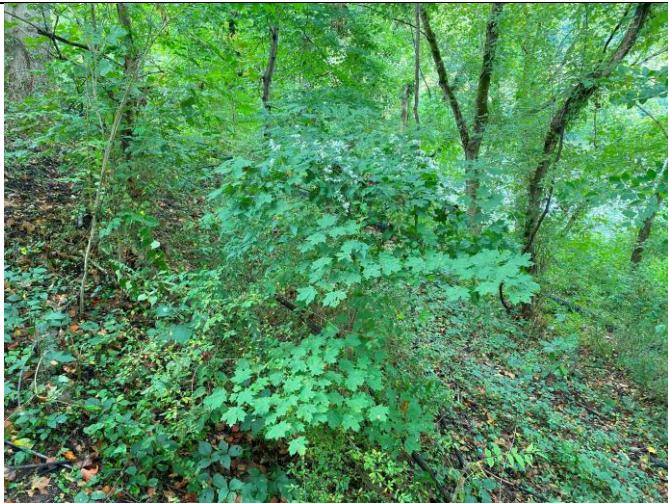
Photograph 4:

- The downstream slope of the dam is in fair to poor condition. The slope is overgrown with mature woody vegetation. Wooden pedestrian stairs were constructed in three locations for inspection. There were no signs of seepage, instability or erosion problems.

Typical view of the downstream slope of the dam along the Kanawha River.

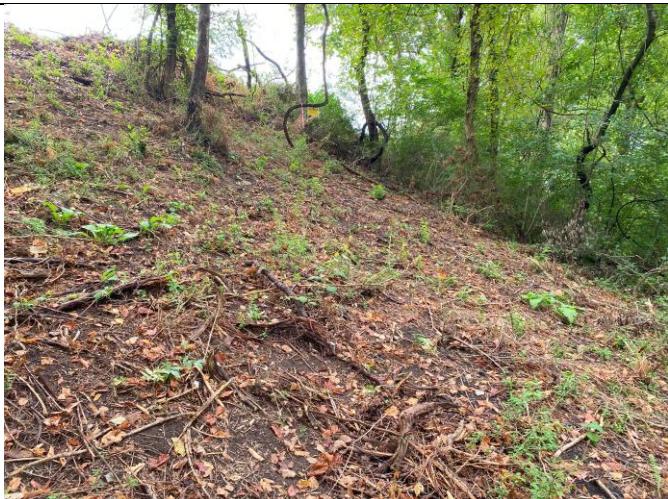
Photograph 5:

Typical view of the downstream slope of the dam along the Kanawha River.

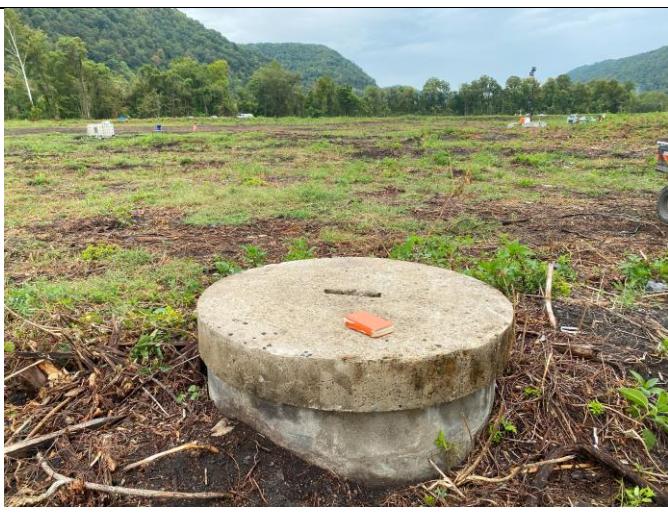
Photograph 6:

- There are two stormwater drain pipes that pass underneath the Ash Pond:
 - A stormwater drainpipe passes through the ash pond and outlets in the Kanawha River. There is a concrete manhole with a concrete lid located in the ash pond related to this storm drainpipe. The final outlet pipe is corrugated metal and approximately half filled with sediments however the flow does not appear completely obstructed.

View of a concrete manhole for a storm drain passing underneath the ash pond.

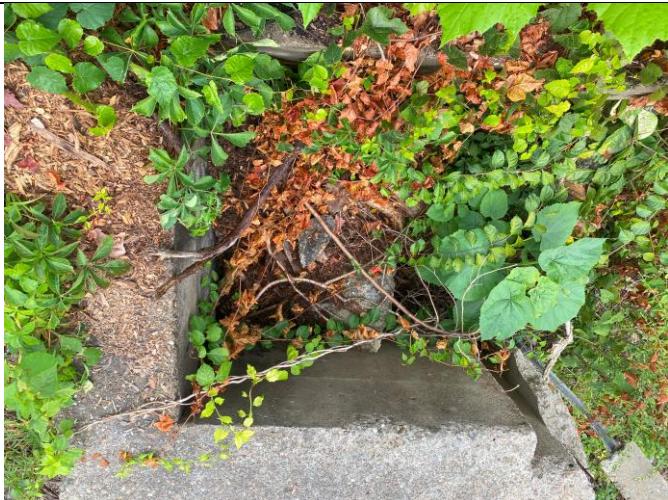
Photograph 7:
View looking down the
spillway riser.

- 1) Remove the debris and sediment blockage in the riser of the spillway.
- 2) Continue with the vegetation establishment and erosion/sediment control maintenance at the site. Remove the trees and brush near the spillway outlet. Remove the trees and brush around the storm drain located on the eastern edge of the property.
- 3) Develop plans to remove the trees from the exterior/downstream slope.
- 4) Remove the sediment accumulation inside the storm drain along the western edge of the property.

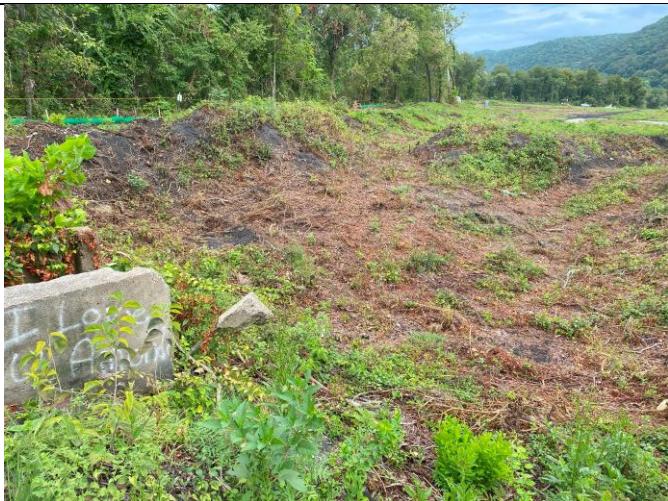
Photograph 8:
View of the spillway inlet
area.

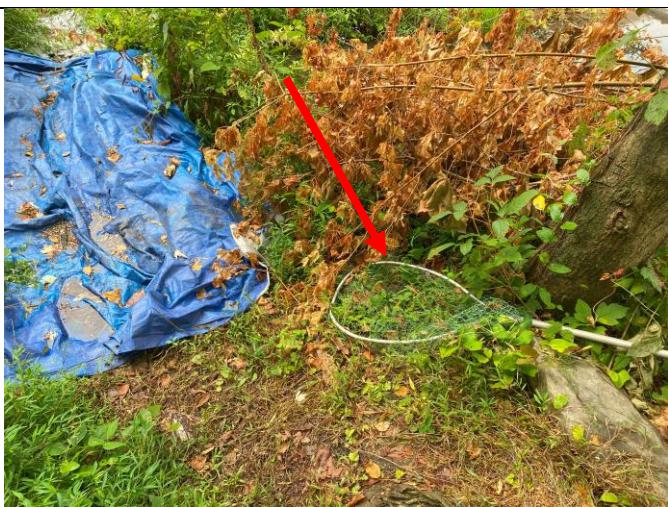
Photograph 9:
View of the spillway
outlet area. The concrete
pipe is identified by the
red arrow.

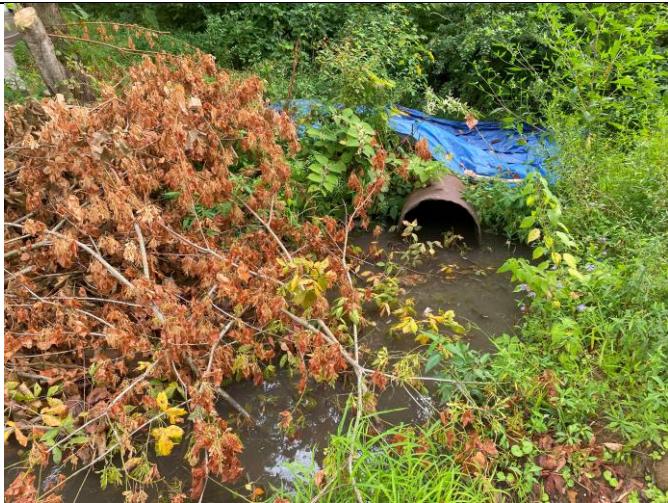
Photograph 10:

View of the stormdrain outlet pipe on the western edge of Ash Pond.

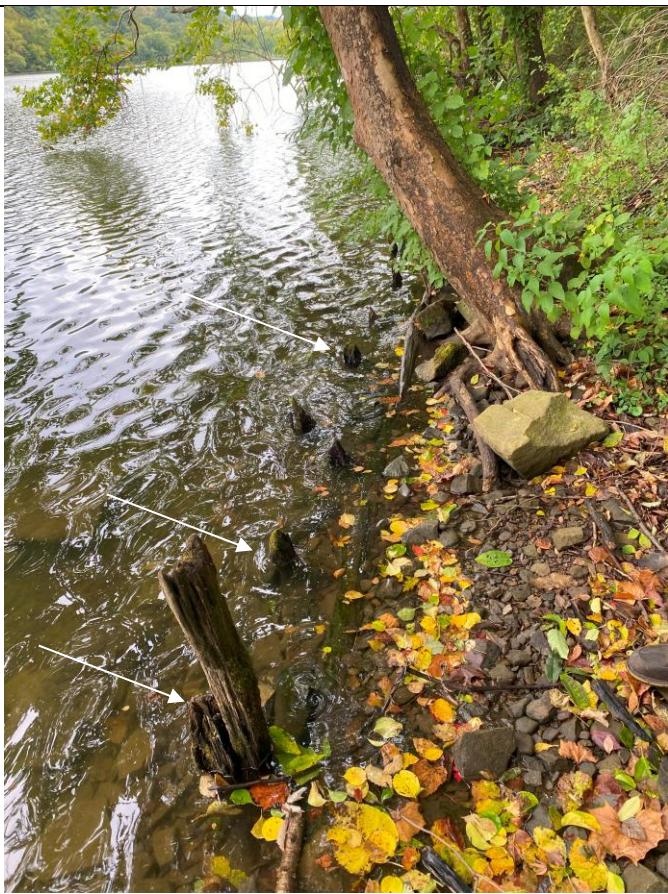
Photograph 11:

View of timber pile remnants located along the shoreline.
