2025 Annual Dam and Dike Inspection Report

Auxiliary Ash Pond Complex

Appalachian Power Company
Glen Lyn, Virginia

August 2025

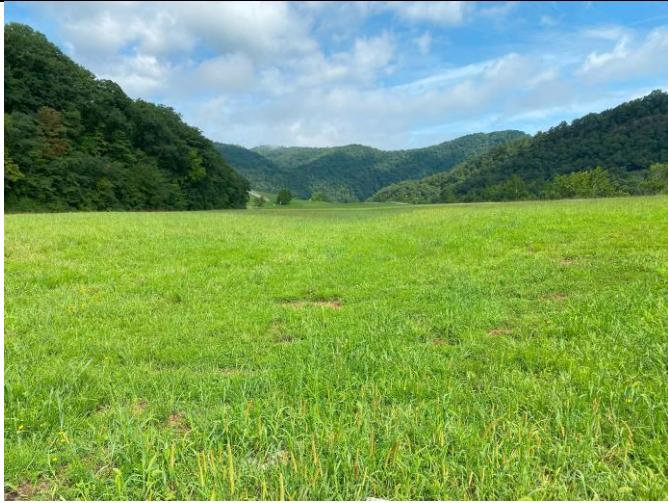
Photograph 1:

View of the outlet of the ditch on the cap of the Auxiliary pond, facing west.

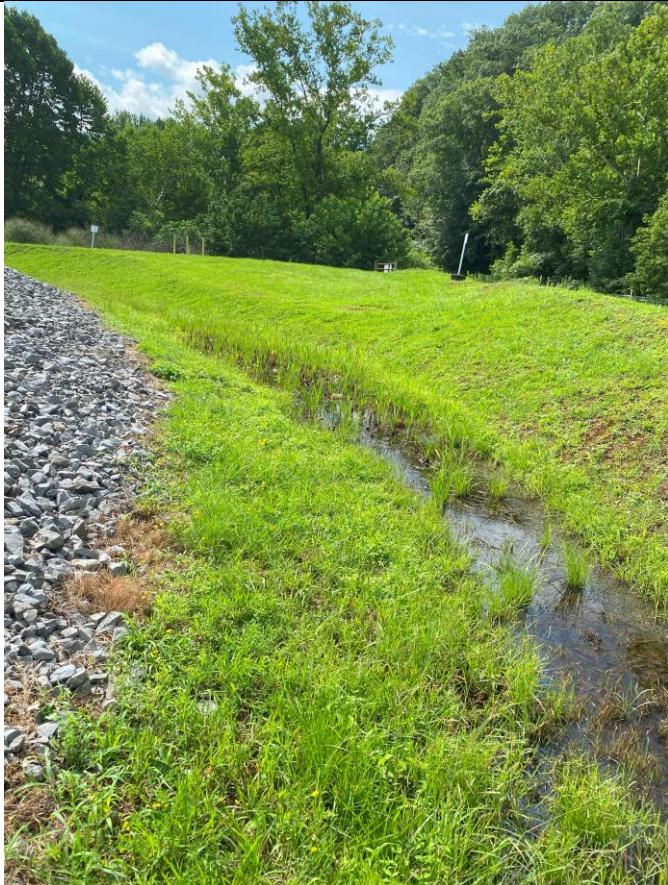
Photograph 2:

View of minor standing water in the perimeter ditch near the southeast corner of the Auxiliary pond.

- 1) Monitor the loose anchor plates at the emergency spillway channel.
- 2) Monitor the standing water in the ditch on the southeast perimeter of the Auxiliary Pond.

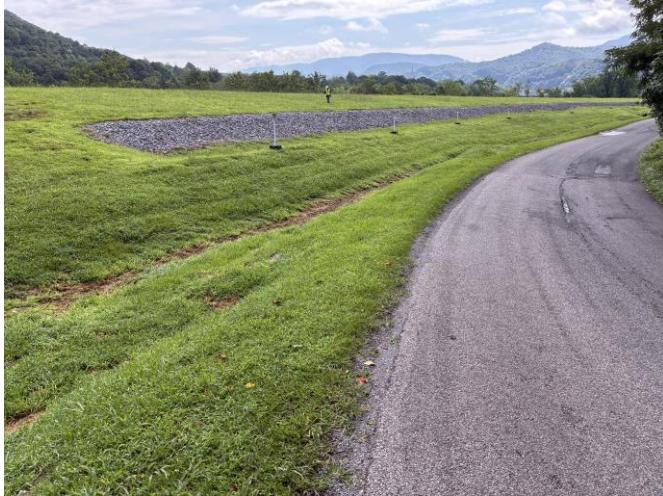
Photograph 3:

View of the southwest corner of the Auxiliary pond.

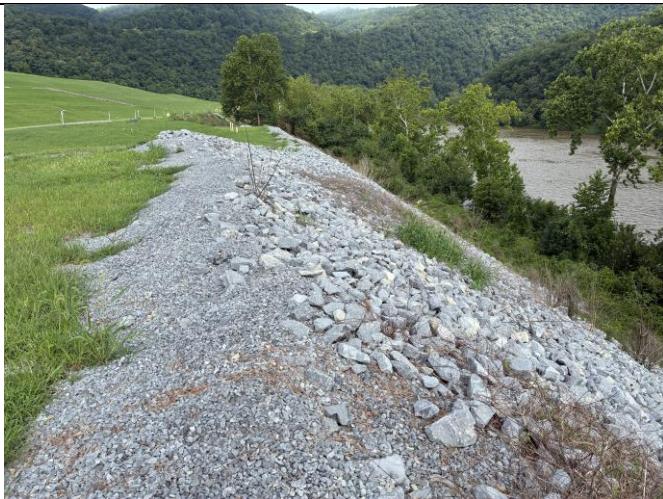
Photograph 4:

View of the downstream slope/ riprap revetment on the Auxiliary Pond, facing west.

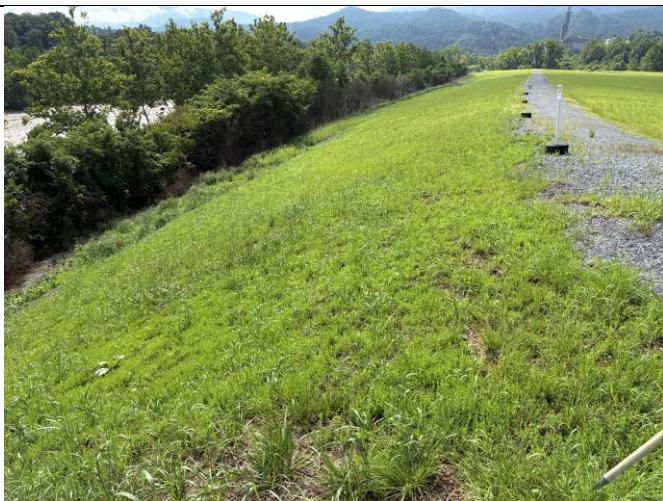
Photograph 5:

1. The slopes and cap of the Auxiliary Pond was observed to be in fair condition. The vegetation on the downstream slope was exceeding 12 inches in height in some areas. The vegetation on the cap was in good condition. There were no signs of erosion, seepage or instability.
2. The previously repaired areas/riprap revetment on the downstream slope appeared to be stable and functioning properly.
3. There was minor standing water observed in the perimeter ditch on the southeastern corner of the Auxiliary Pond.

View of the downstream slope of the Auxiliary Pond, facing east.

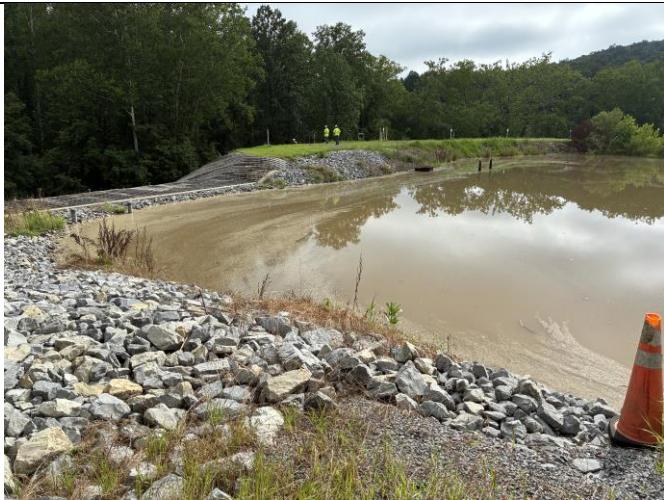
2. The fabric formed concrete emergency spillway of the West Pond was observed to be in good condition and functioning properly.
3. The western most underdrain was observed to be flowing under pressure in the emergency spillway. Several of the weep holes drilled into the cap were observed to be slightly blocked. All other underdrain outlets were observed to be dry and unobstructed.

Photograph 6:
View of the West Pond
emergency spillway channel.

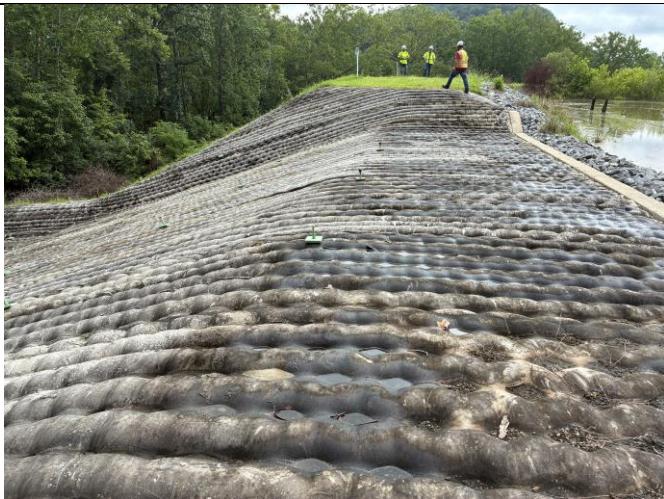
4. There were numerous loose anchor rods/plate washers on the emergency spillway. The loose nut on the end of the anchor rods meets the design intent of providing shear/sliding resistance without being tightened.

Photograph 7:
Another view of the West
Pond emergency spillway
channel.

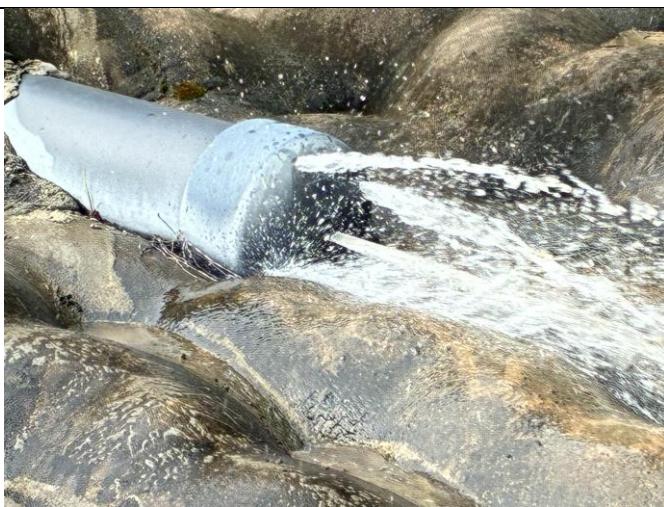
Photograph 8:
View showing the
underdrain flowing under
pressure

- 1) Continue with the vegetation maintenance & mowing efforts at the facility.
- 2) Ensure the weep holes for the underdrain outlet cap of the emergency spillway remain unobstructed to prevent hydrostatic loading under the emergency spillway slab. Consider enlarging the holes to $\frac{1}{2}$ inch diameter to avoid frequently plugging.
- 3) Continue with the hard armoring of dedicated overflow areas along the perimeter drainage channel to the west/south of the West Pond.

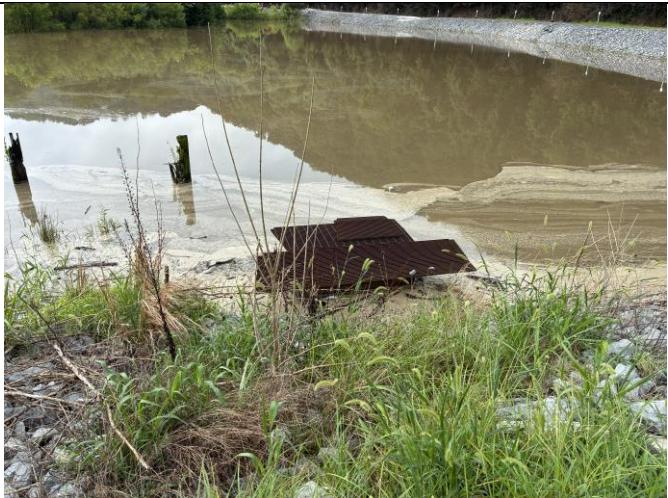
Photograph 9:

View of the inlet of the primary spillway of the West Pond.

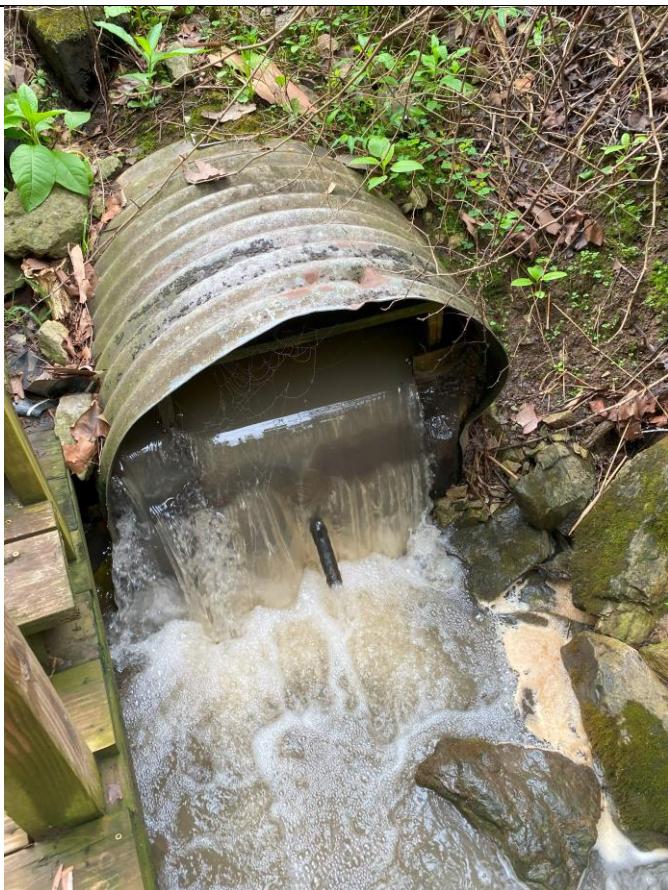
Photograph 10:

View of the outlet of the primary spillway of the West Pond.

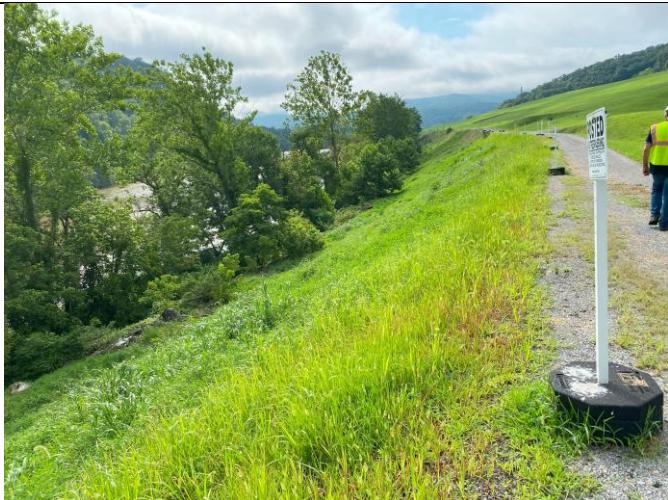
5. The crest of the West Pond was in good condition with no rutting, cracking or misalignment observed.
6. The slopes of the West Pond were in fair condition. The vegetation on the downstream slope was exceeding 12 inches in height. There were no signs of erosion, seepage or instability.

Photograph 11:
Typical view of the downstream slope of the West Pond.

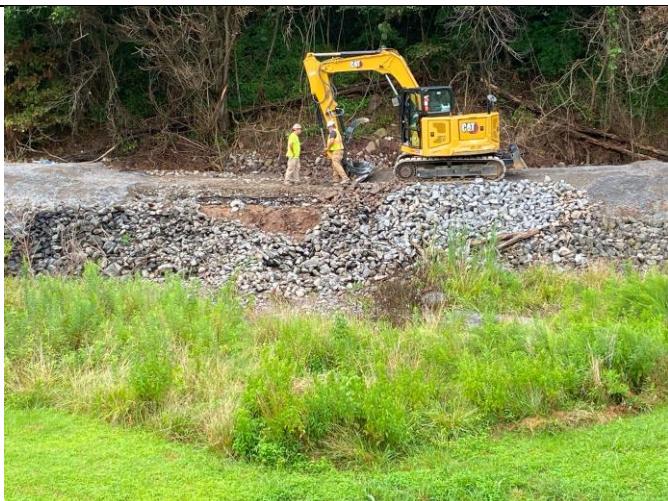
1. The drainage channel located to the south/west perimeter of the West Pond has experienced some minor erosion. A contractor was actively repairing the erosion during the inspection by installing hard armored overflow areas along the interior access road.

- 1) The erosion in the perimeter channel to the south/west of West Pond apparently occurred when the outlet of the drainage channel at the western end of the West Pond became obstructed by woody debris and sediments. Water began backing up in the drainage channel and eventually overtopped the access road. The water which overtopped and eroded the access road entered another location in the West Pond and discharge through the appropriate outfall. The erosion was limited to the interior areas of the Auxiliary Ash Pond Complex access roads and did not impact the integrity of the impounding structure/dam

Photograph 12:
View of erosion repair on the interior access road.

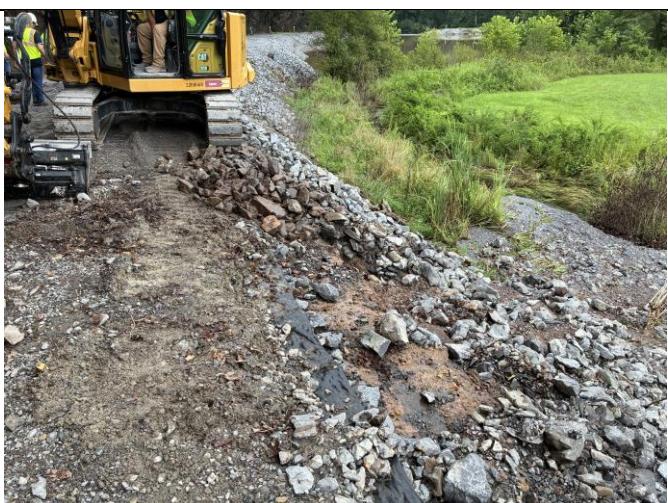
Photograph 13:
Another view of erosion repair on the interior access road.
