2025 Annual Dam and Dike Inspection Report

Bottom Ash Pond Complex

**Glen Lyn Plant
Appalachian Power Company
Glen Lyn, VA**

August 2025

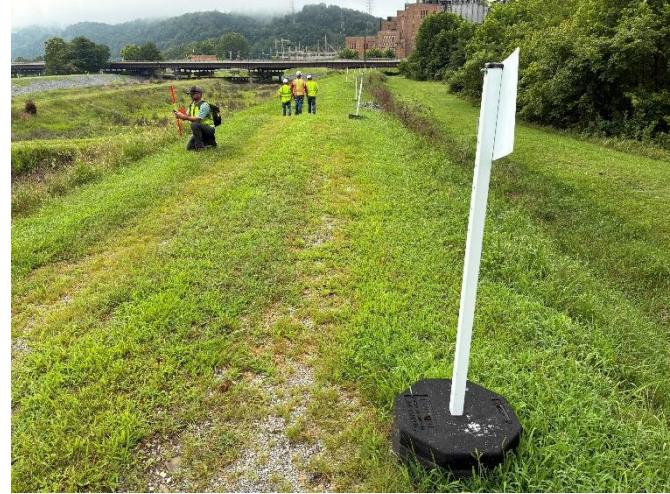
<p>Photograph 1: Southern Dike along Bottom Ash Pond Complex</p>

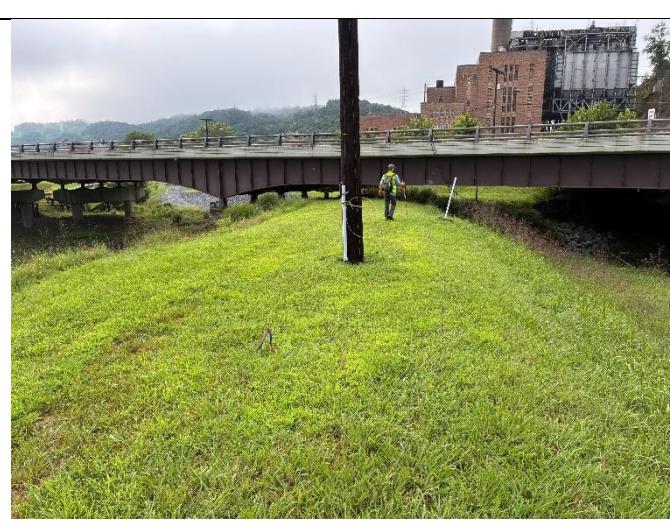
<p>Photograph 2: Southern Dike along Southern Bottom Ash Pond looking towards idle plant.</p>

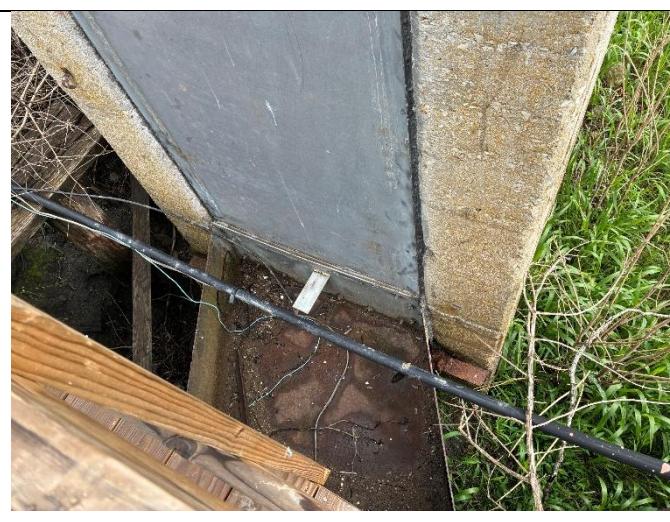
- The crest of the dam is in fair condition and is used as an access road. There were no signs of cracks, rutting or low areas.
- The spillway structures were in fair condition. Metal plates have been installed on the concrete riser of the Clearwater Pond to contain floodwaters from the New River within the riser. The top of the metal plate is estimated to be elevation 1512 ft msl.

<p>Photograph 3: Outlet Spillway Weir – level raised by plates in Concrete Riser.</p>

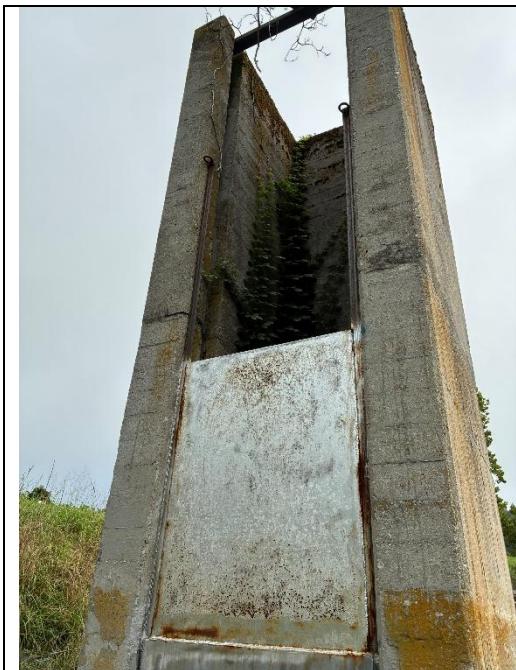
Photograph 4:

Outlet Spillway for Clearwater Pond – level raised by plates in Concrete Riser.

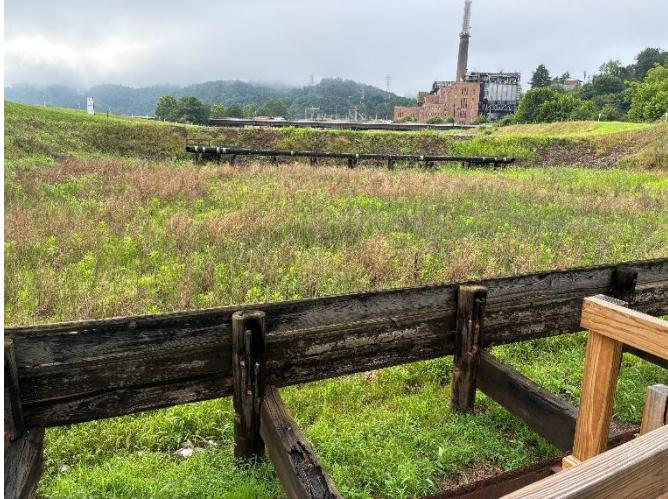
Photograph 5:

Clearwater Pond – Looking towards inlet distribution weir.

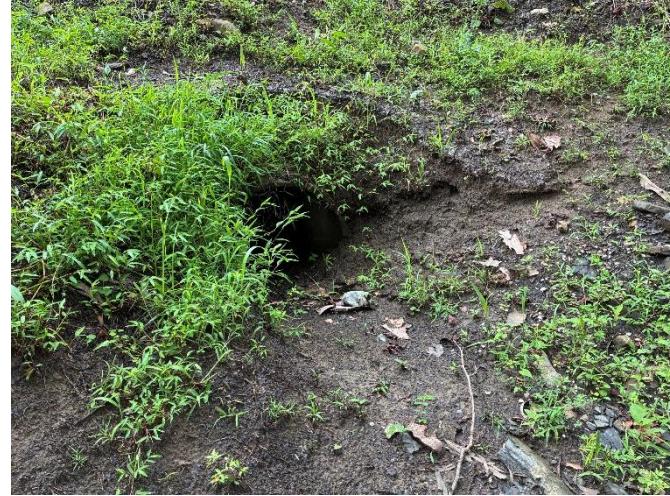
- Areas around the structures have vegetation that should be maintained to 12-inches or less.
- A minor blockage was observed at the outlet of the Clearwater Pond spillway. Sediment build-up around drainage structures should be monitored and addressed as needed.

A photograph showing a circular opening in the ground, likely a pipe outlet, surrounded by grass and dirt. The opening is partially covered with sediment and debris.	<p>Photograph 6: Spillway Outlet Pipe at River. Partially blocked with sediment.</p>

- 1) Monitor the vegetation within 25-feet of the upstream and downstream side slopes and around drainage features and maintain to a height of 12- inches or less.
- 2) Monitor the inlets and outlets of drainage features and maintain sediment build-up if sediment build-up becomes significant or restricts flow.
- 3) Monitor the areas underneath the bridge scuppers of the US 460 bridge for erosion.

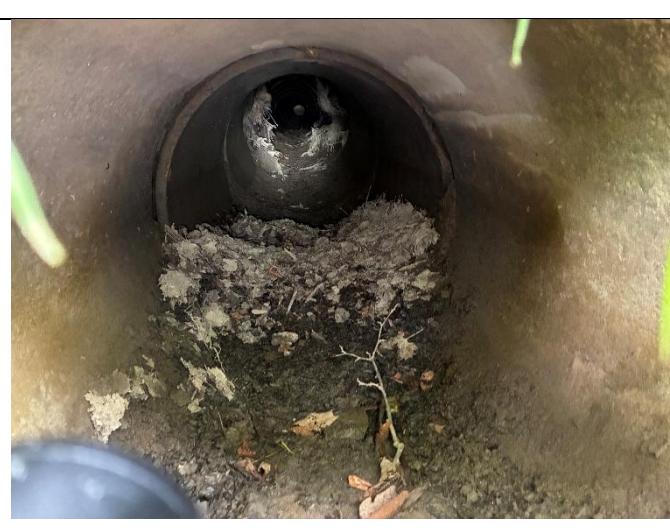
A photograph looking down the interior of a large, dark, cylindrical pipe. The interior is lined with sediment and debris, including some small plants growing from the bottom.	<p>Photograph 7: Outlet Spillway Pipe.</p>

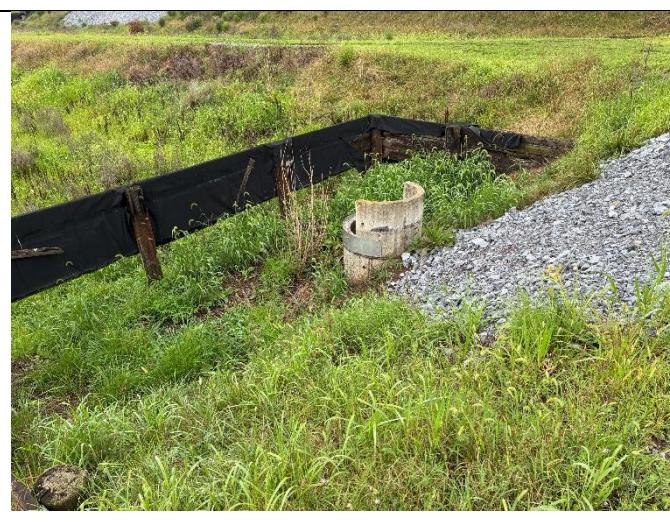
A photograph of a black metal outlet riser standing in a grassy area. The riser is connected to a pipe that runs along the ground. The surrounding area is covered in green grass and some gravel.	<p>Photograph 8: Northern Bottom Ash Pond – Outlet Riser.</p>

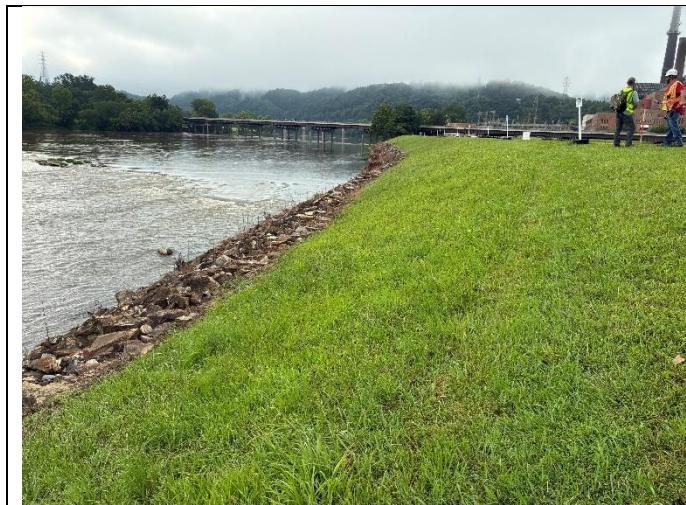
Photograph 9:

BAP Dike along New River – Looking towards Plant

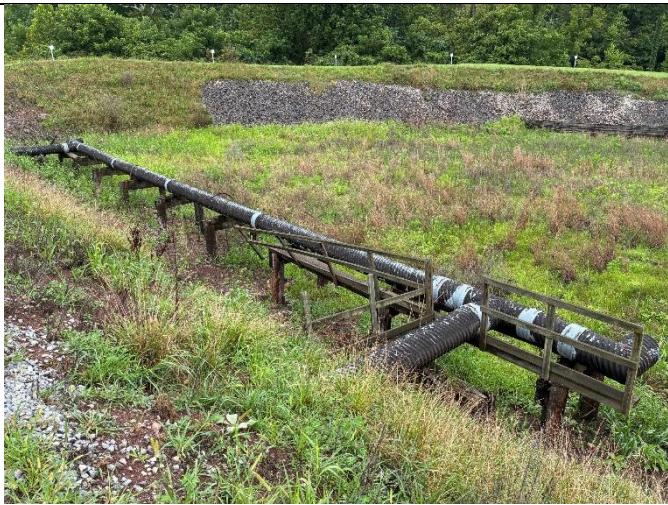
Photograph 10:

Clearwater Pond – Inlet distribution weir

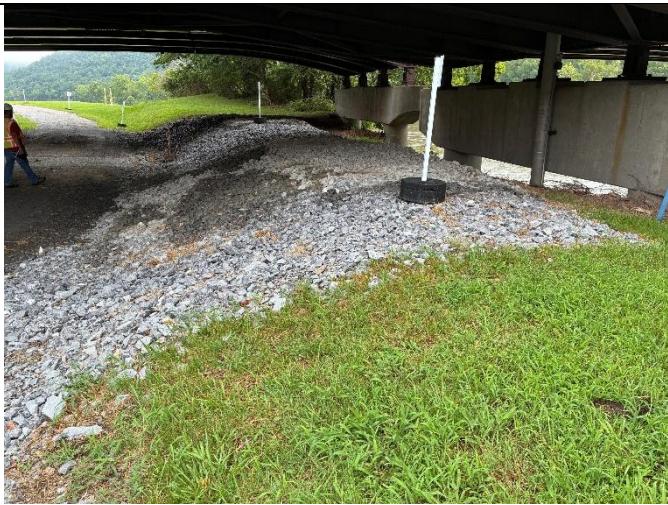
Photograph 11:

North Bottom Ash Pond – Dike along highway bridge abutment.
