# **2025 Annual Dam and Dike Inspection Report**

**Ash Pond  
Kammer Power Plant  
Marshall County, West Virginia**

**September 2025**

Prepared for: Franklin Realty

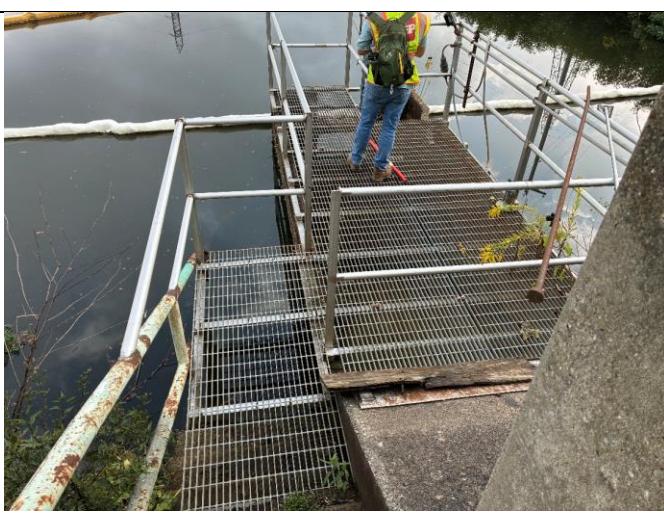
The primary discharge structure is in good condition with no observed blockages. The oil boom around the structure appeared in functioning condition.

Photograph 3:  
Outlet Structure.

1. After completing vegetation maintenance, investigate the apparent depression located on the eastern exterior slope.
2. Monitor the erosion on the northern interior slope.
3. Monitor the oil boom and replace as necessary.

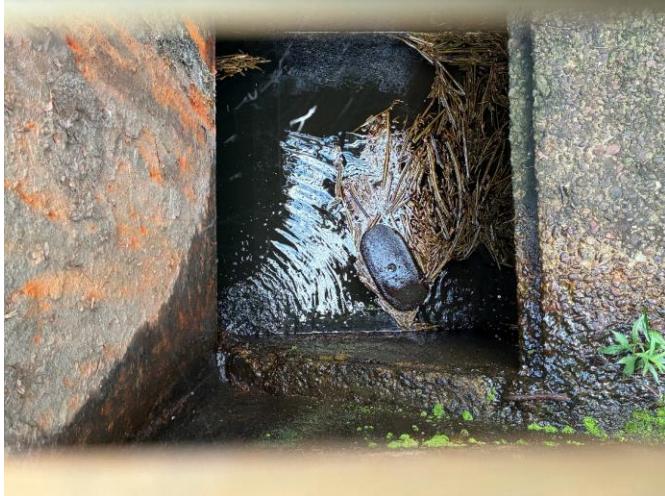
Photograph 4:  
Looking into Outlet  
Structure.

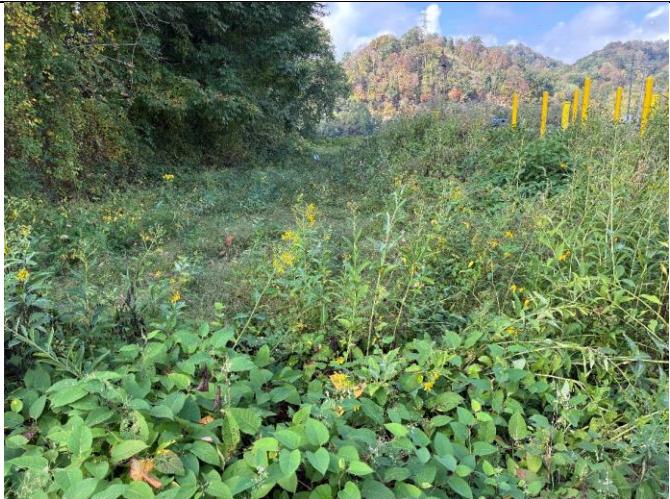
Photograph 8:

Looking west along southern dike. Vegetation needs maintained.

1. Maintain vegetation to 12-inches or less on the slopes.

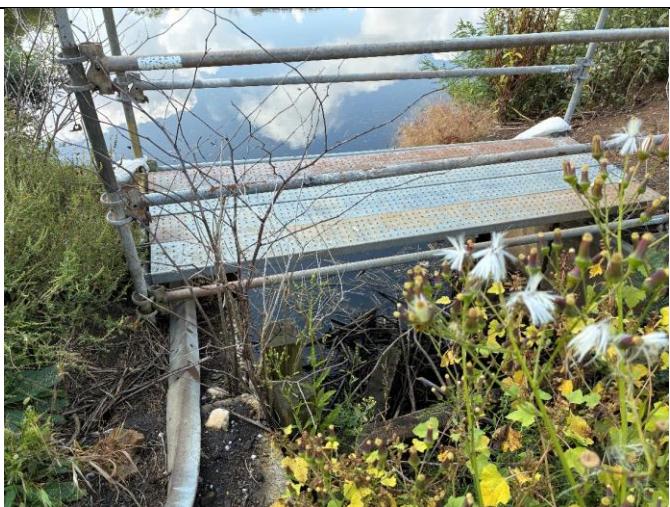
Photograph 9:

The interior discharge structure on the splitter dike is in fair condition and should be cleared of vegetation to allow the structure to operate as designed. There was no evidence of beaver activity in this area during this inspection.

Interior control structure.

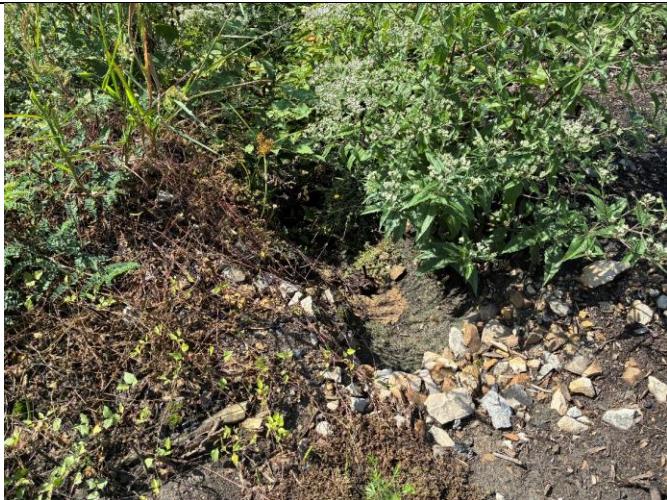
The exterior slopes showed no signs of distress such as sloughing, bulges or erosion. One location on the northern interior slope showed an erosion rill approximately 12" deep. The interior and exterior slopes are overgrown with vegetation that should be maintained to 12 inches or less, and made visual inspection difficult. There was one area of a possible depression located on the eastern exterior slope, across the pond from groundwater monitoring well AP-5D/5S. The dense vegetation prevented a close inspection of this area. Woody vegetation should be removed to prevent root intrusion into the dike.

Photograph 10:  
Erosion on Northern pond slope.

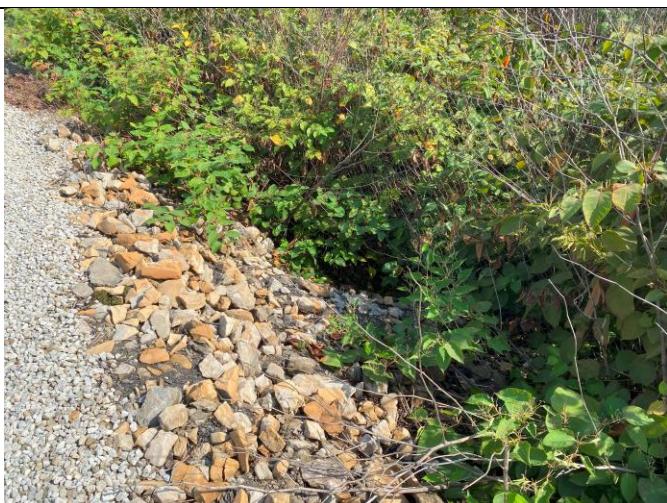
Photograph 11:  
View of the apparent depression on eastern exterior slope

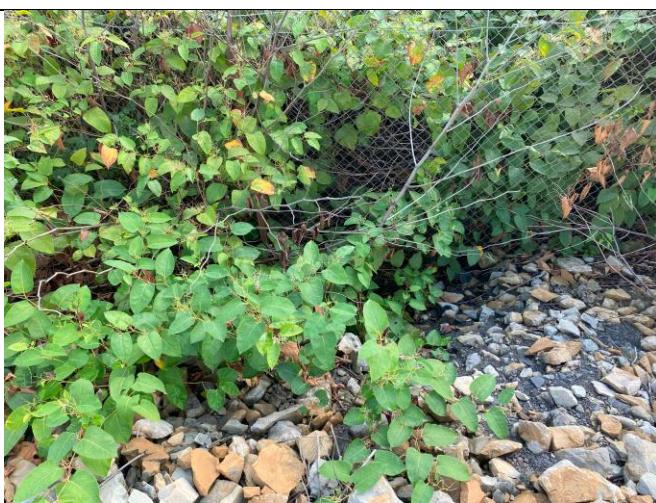
Photograph 12:  
Another view of the apparent depression on the eastern slope.
