# **2025 Annual Dam and Dike Inspection Report**

**Bottom Ash Pond Complex**

**Kanawha River Plant  
Appalachian Power Company  
Glasgow, Ohio**

**November 2025**

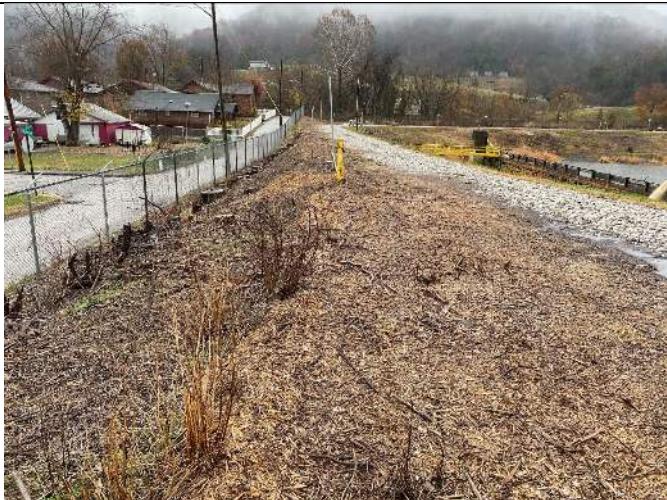
Photograph 1:

1. The pool level in the Clearwater Pond was roughly elevation 610 ft-msl. There was no water spilling through the outfall riser structure.
2. The interior and exterior slopes showed no signs of distress such as sloughing, bulges or erosion. The vegetation on both slopes is being regularly maintained.
3. The western dike had trees removed on the exterior slope and showed no signs of seepage.

View of the exterior slope of the Clearwater Pond dike.

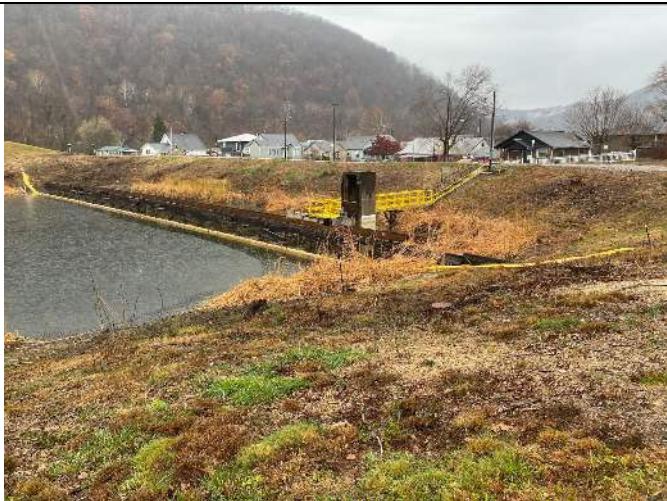
Photograph 2:

View of the interior slope of the Clearwater Pond.

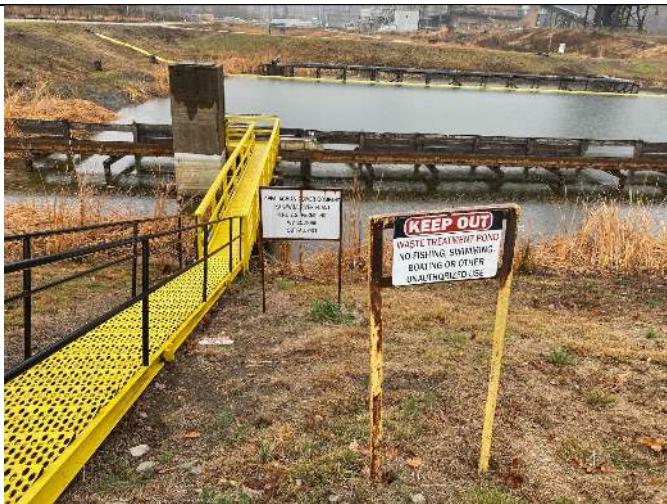
Photograph 3:

4. The primary discharge structure was in fair condition. There was some minor concrete deterioration on the face from previous bolting. The discharge is permitted as NPDES Permit No. WV 0001066 Outfall 001.

View of the discharge structure of the Clearwater Pond.

- 1) Monitor the concrete on the Clearwater Pond discharge structure (Outfall 001) for any further deterioration.
- 2) Monitor the near vertical section of the interior slope of the North Bottom Ash Pond for any slope movement or distress.
- 3) Continue periodic camera inspections of the storm drainpipe underneath the Bottom Ash Pond Complex.
- 4) Monitor the inlet of the storm drain structures for any blockages and notify neighboring property owners if issues as necessary to ensure the system functions properly and remains unobstructed.

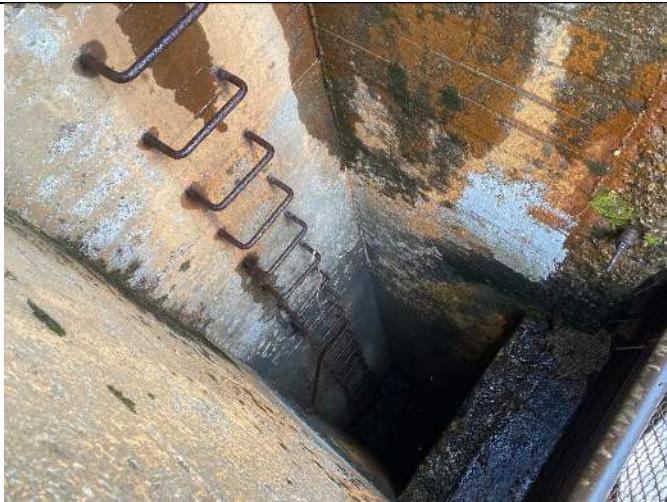
Photograph 4:

View looking down inside the Clearwater Pond discharge structure.

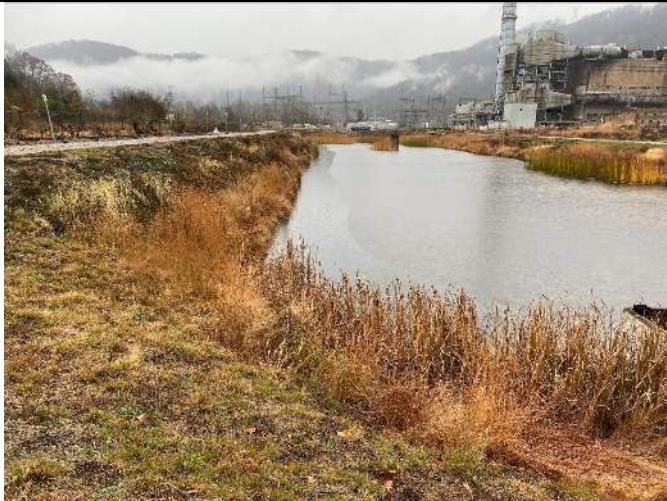
Photograph 5:

1. The pool level in the North Bottom Ash Pond was approximately 4 feet deep with the water surface at elevation 615 ft-msl.
2. The interior and exterior slopes showed no signs of distress such as sloughing, bulges or erosion. The interior slopes are growing vegetation that is being regularly maintained.
3. There is a section of the interior slope near a headwall for a storm drain that is near vertical.
4. No evidence of seepage though the splitter dike separating the North Bottom Ash Pond and South Bottom Ash Pond and Clearwater Pond.
5. The primary discharge structure was in poor condition. The corrugated metal pipe riser showed signs of corrosion, but is not a critical element, as the discharge structure is internal to the pond complex, and discharge pipe inlet is sufficient for water control of the inactive plant.

View looking east across the North Bottom Ash Pond.

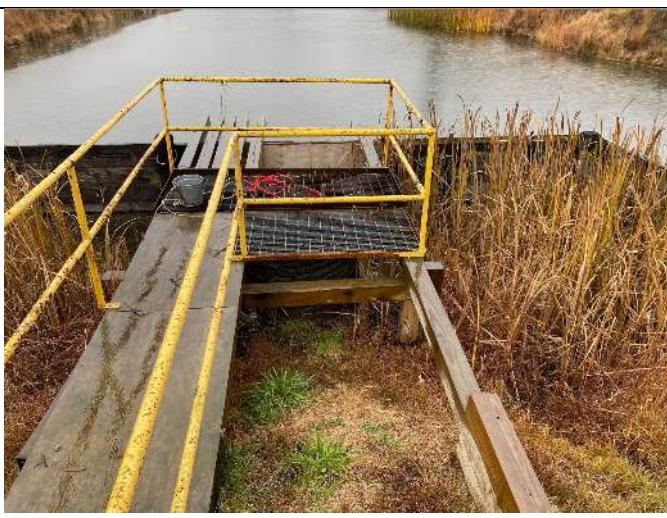
Photograph 6:

View of the riser pipe inlet in the North Bottom Ash Pond.

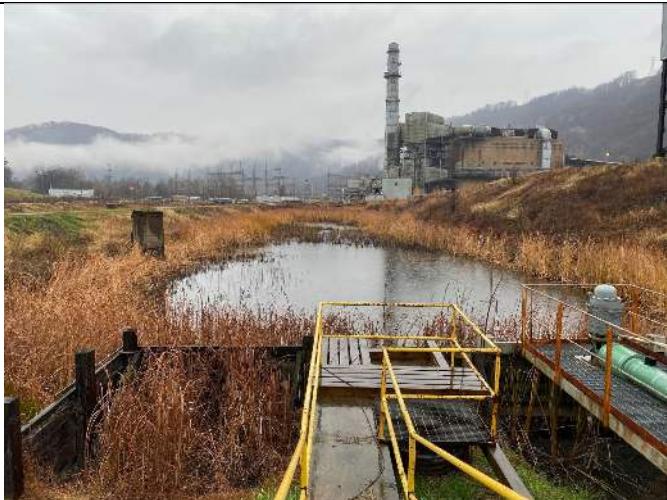
Photograph 7:  
View looking east across the South Bottom Ash Pond with the riser pipe inlet in the foreground.

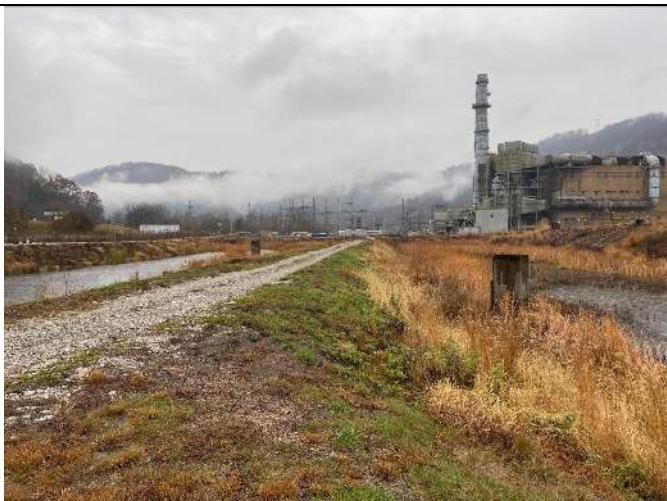
Photograph 8:  
View of the splitter dike separating the North and South Bottom Ash Ponds.

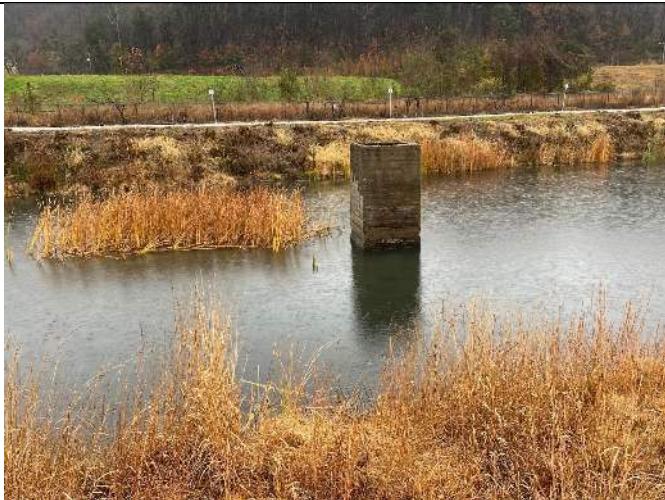
Photograph 9:

View of the stormdrain manhole in the North Bottom Ash Pond.

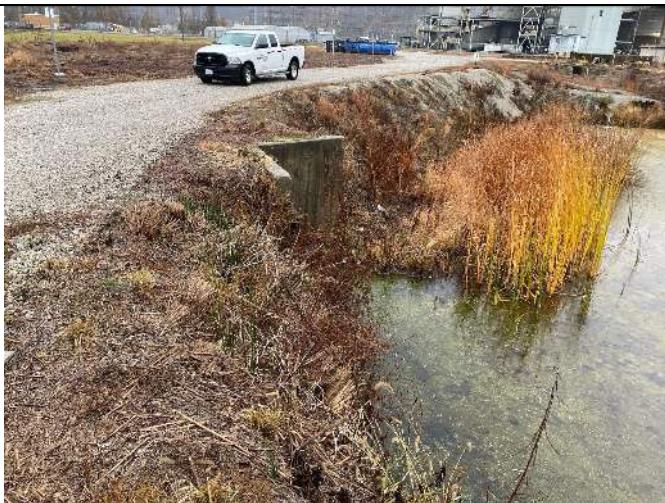
Photograph 10:

View of a headwall at the south end of the North Bottom Ash Pond.

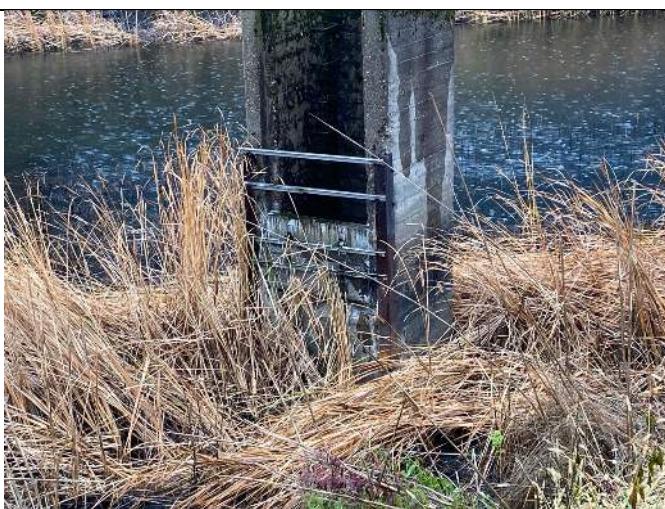
Photograph 11:

View of the manhole for the stormwater structure in the South Bottom Ash Pond.

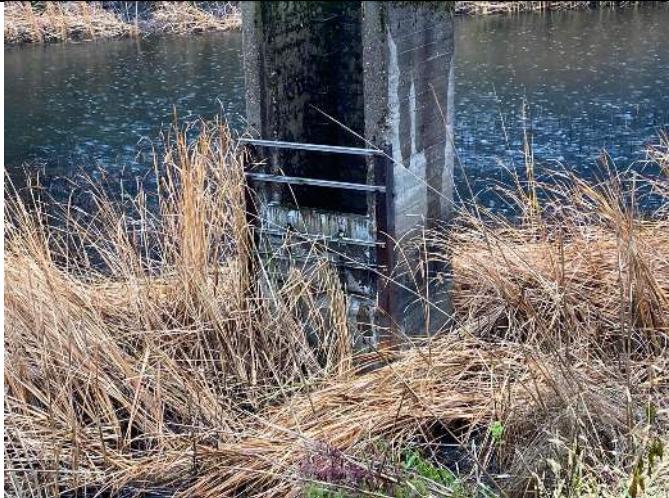
Photograph 12:  
View of the manhole for  
the stormwater structure  
in the South Bottom Ash  
Pond.
