# **2025 Annual Dam and Dike Inspection Report**

**East Fly Ash Pond**

**Kanawha River Power Plant  
Appalachian Power Company  
Glasgow, WV**

**September 2025**

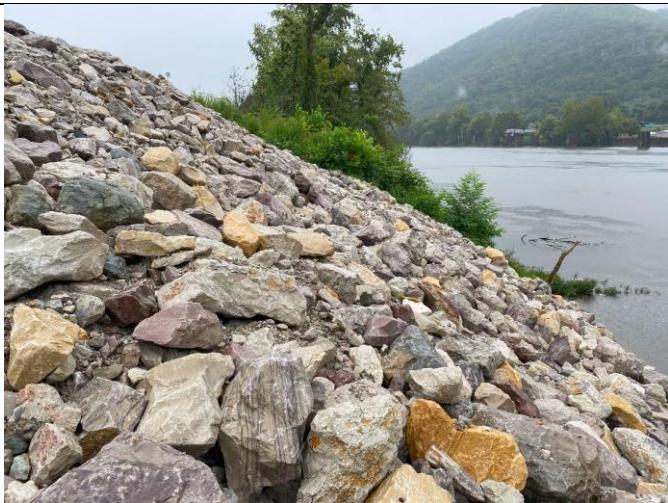
Photograph 1:

- The downstream slope of the dam is in fair condition. The slope is overgrown with mature woody vegetation. Areas of the downstream slope with significant erosion identified in the previous inspection have been repaired by placement of riprap buttress. The repairs appeared to have stabilized the areas impacted. There were some smaller erosion features noted in several areas along the length of the dike.

View of repaired area on the downstream slope of the dam.

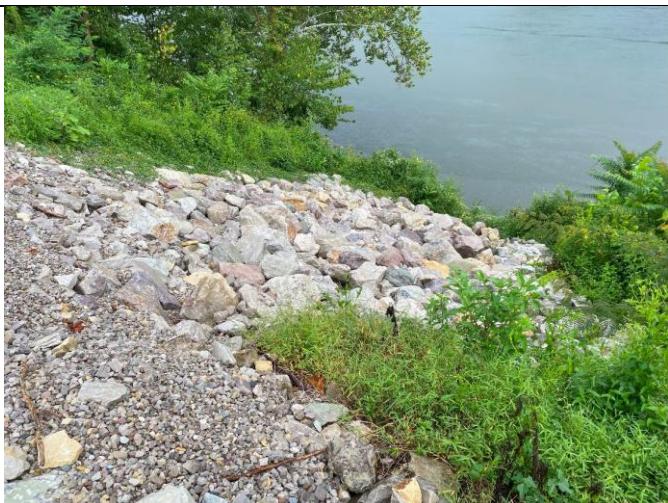
Photograph 2:

Another repaired area on the downstream slope.

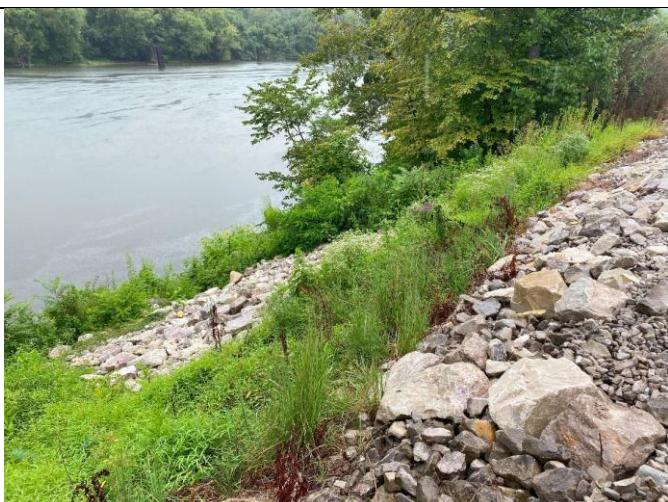
Photograph 3:

Another repaired area on the downstream slope.

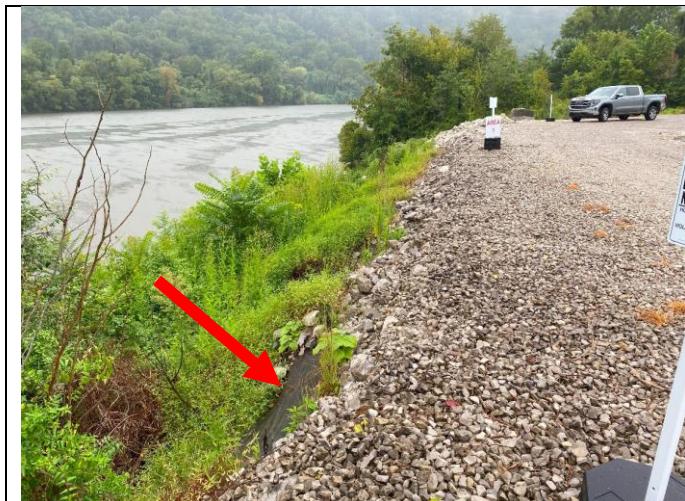
Photograph 4:

View of a small erosional area beginning to form. Monitor this area for additional erosion.

- 1) Monitor the downstream slope for erosion features to develop below the geocomposite drainage layer.

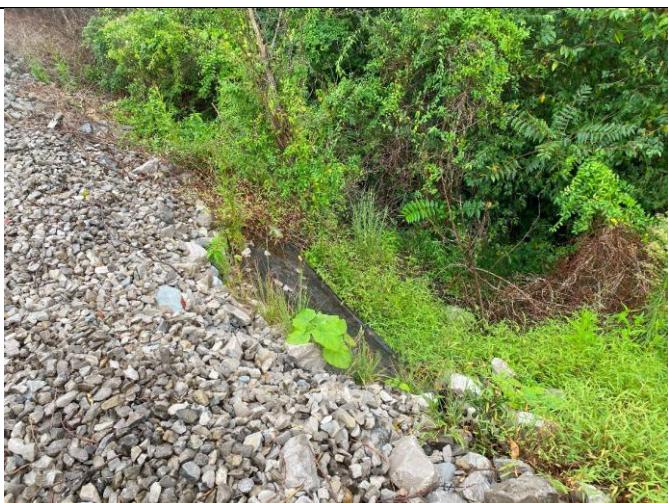
Photograph 5:

View of a small erosional area beginning to form. Monitor this area for additional erosion.

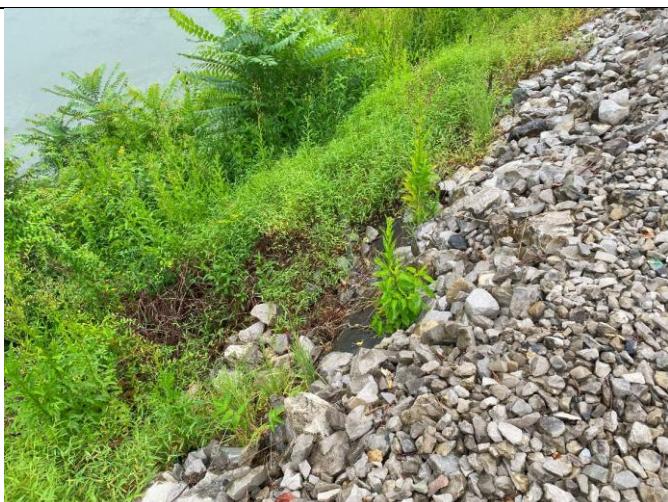
Photograph 6:

View of a small erosional area beginning to form. Monitor this area for additional erosion.

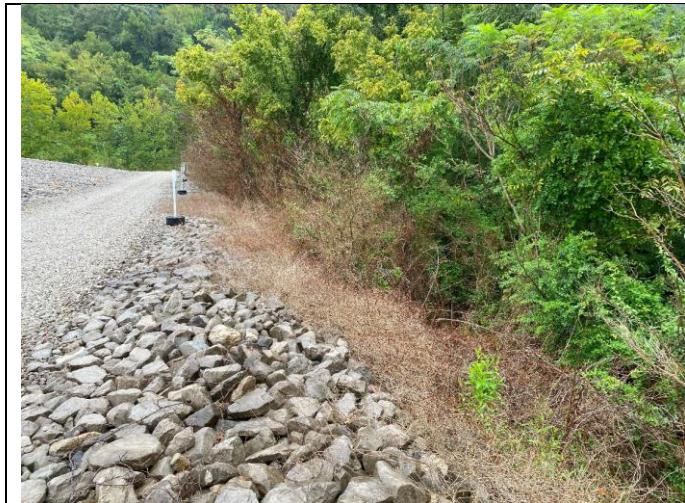
Photograph 7:

The vegetation on the downstream slopes of the dam is in poor condition and consists of mature trees and dense brush. There were no signs of depression, settlement, or sinkholes along the general inspected areas. The East Fly Ash Pond is graded like a turtle back to promote positive drainage and there was no ponded water visible during the inspection.

Typical view of the vegetation on the downstream slope.

- 1) Continue with the vegetation control and maintenance at the site. Continue periodically spraying the woody vegetation on the riprap cap of the East Fly Ash Pond. Develop plans to address vegetation on the downstream slope of the dam.

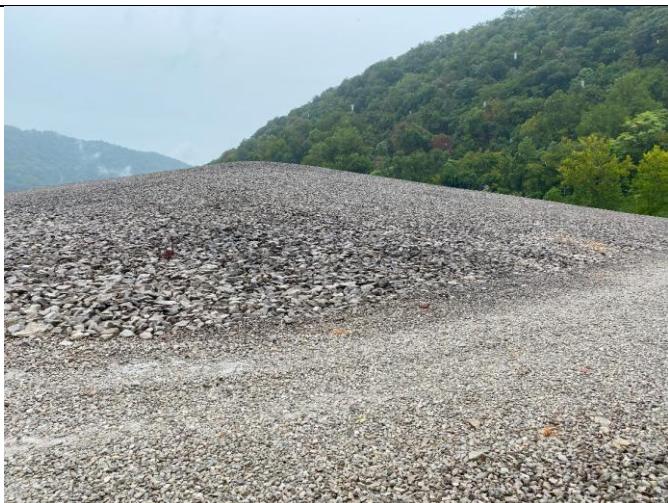
Photograph 8:

- The riprap cap overlying the landfill was observed to be in good condition. There were minor amount of woody vegetation in sparse patches around the site. There was no evidence of erosion or instability.

Typical view of the riprap cap.

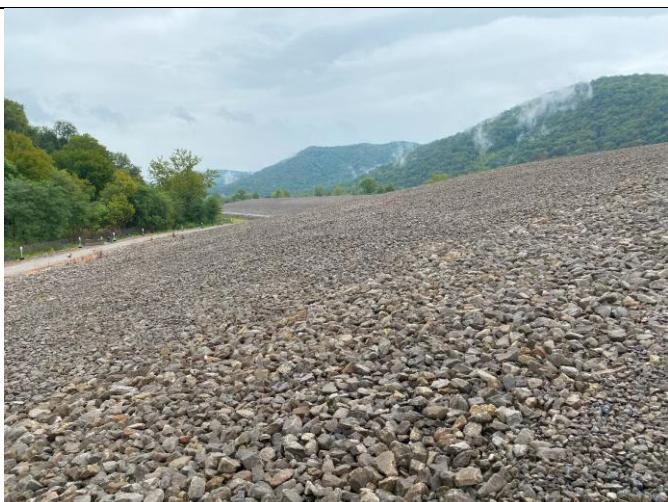
Photograph 9:

Typical view of the riprap cap.

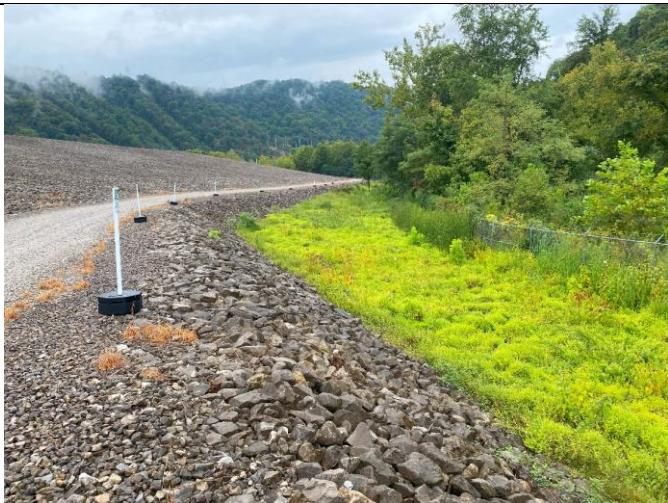
- The crest of the dam is in good condition and is used as a gravel access road. There were no signs of rutting or misalignment.
- The stormwater outfall was in good condition. Wooden pedestrian stairs have been constructed to provide safe access for sampling events.

Photograph 10:  
View along the crest of  
the dam, looking west.

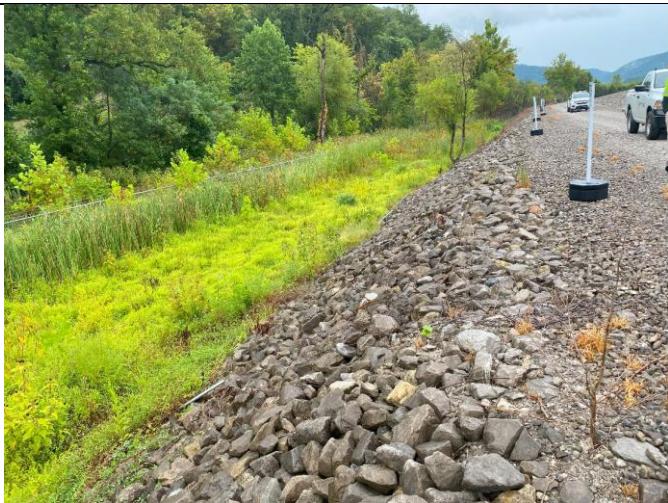
Photograph 11:  
View along the crest of  
the dam, looking east.

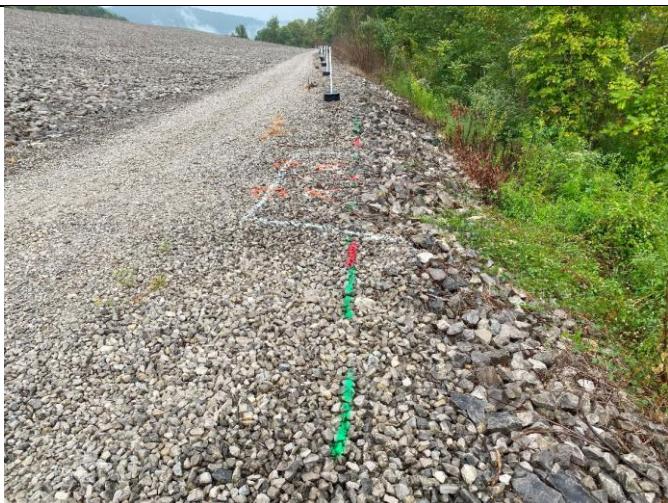
Photograph 12:  
View along the crest of  
the dam, noting the  
markings associated with  
proposed monitoring  
wells.

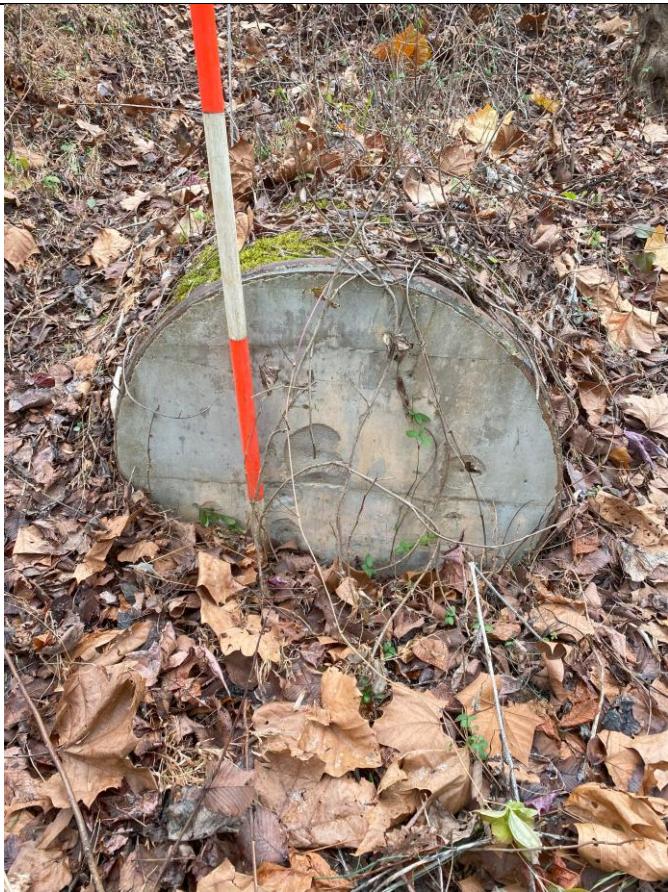
Photograph 13:

- There are 3 abandoned in place corrugated metal pipes that pass underneath the East Fly Ash Pond. The pipes were permanently abandoned via grout placement in 2015 and storm water drainage was rerouted around the footprint of the East Fly Ash Pond. Two of the pipe outlets were dry and observed to be sealed off with grout. The western most pipe outlet was not able to be located because of construction of a riprap revetment.

View of an abandoned in place corrugated metal culvert near the rivers edge. Photo taken in December, 2024.

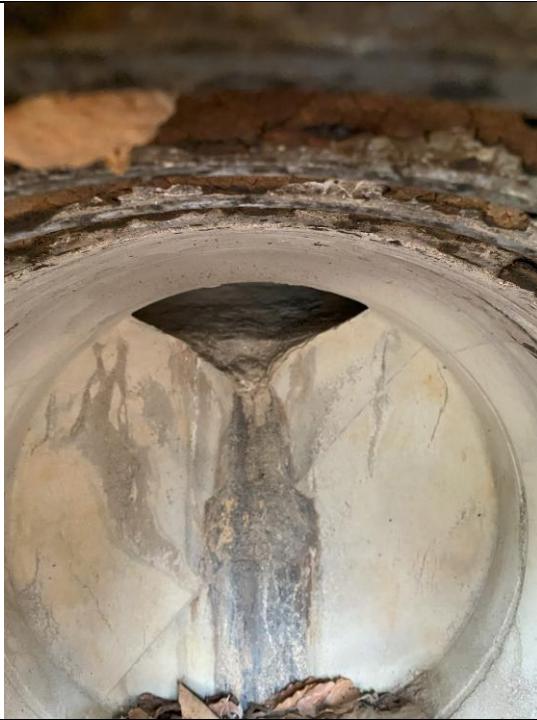
Photograph 14:

View of an abandoned in place corrugated metal culvert near the rivers edge. This is the former discharge structure from the impoundment. Photo taken in December, 2024.
