# **2025 Annual Dam and Dike Inspection Report**

**Bottom Ash Pond Complex**

**Former Philo Power Plant  
Franklin Realty Company  
Philo, OH**

**November 2025**

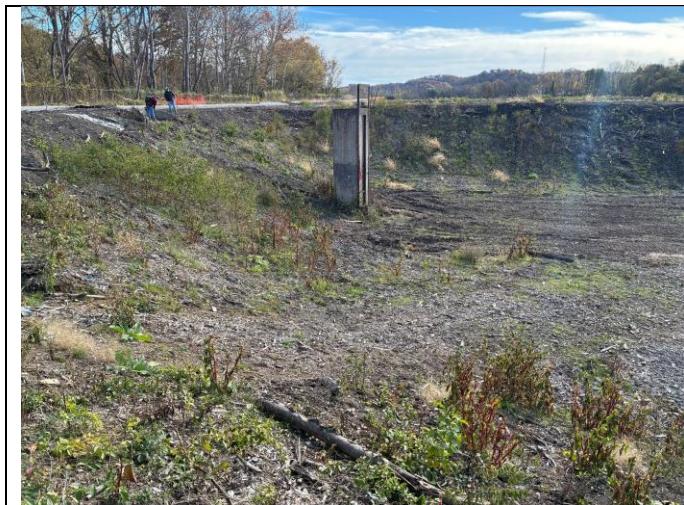
Photograph 1:  
Pond Complex Spillway  
Riser

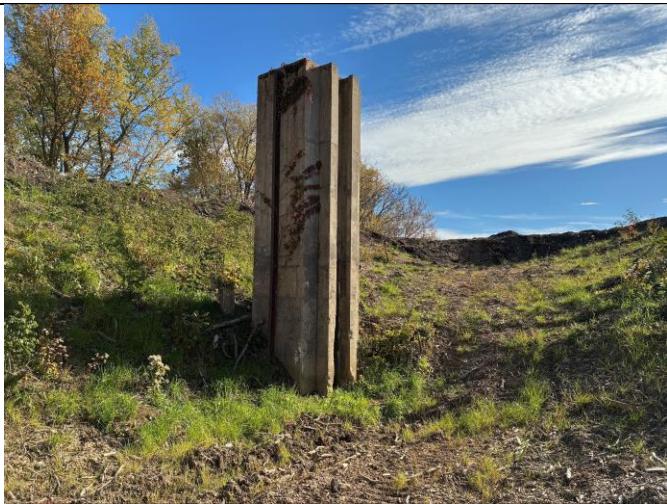
Photograph 2:  
Pond Complex Spillway  
Riser.

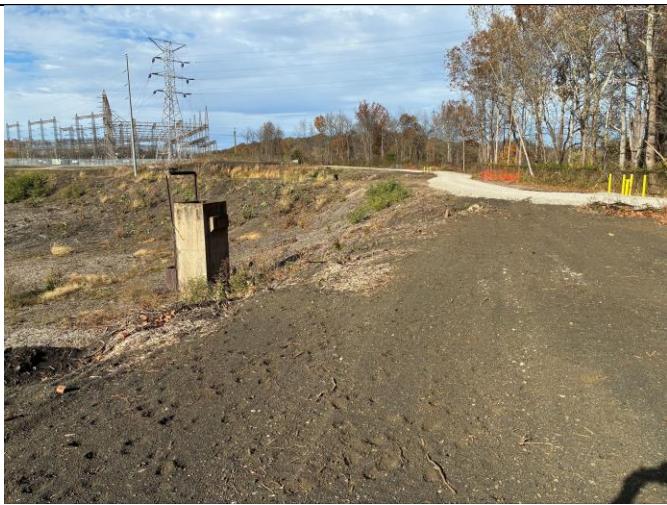
Photograph 3:  
General View of Pond  
Complex Dike looking  
North.

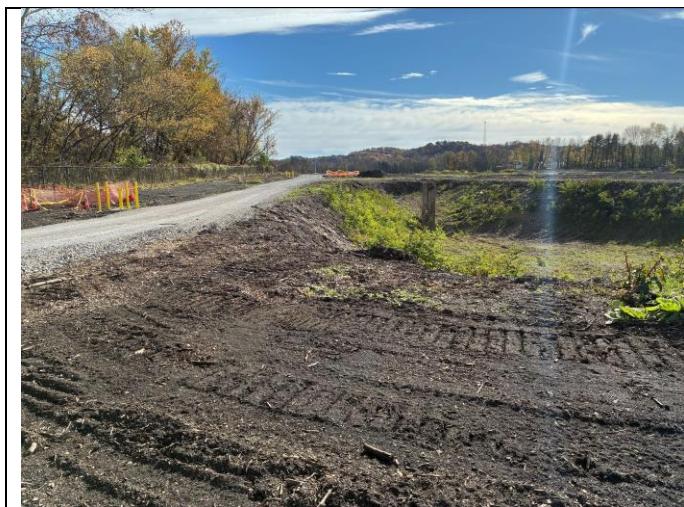
Photograph 4:  
General View of Pond  
Complex Dike looking  
South.

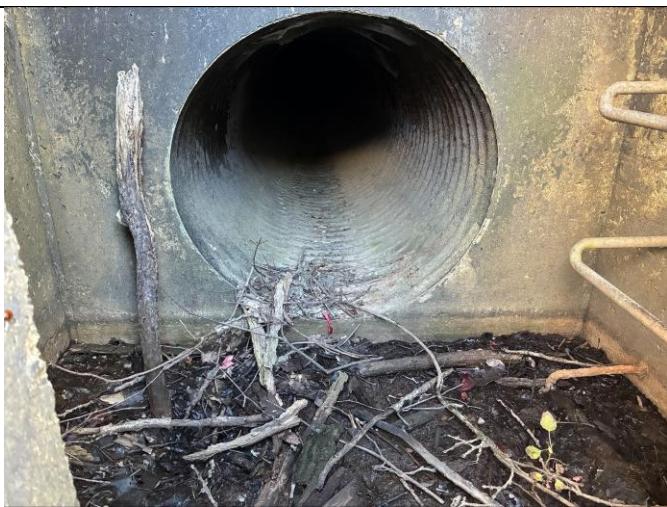
Photograph 5:  
Spillway outlet pipe at  
entrance.

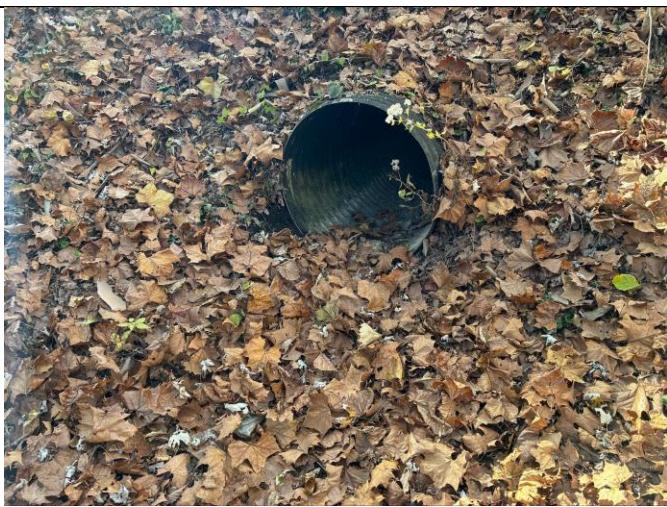
Photograph 6:  
Pond Complex outlet  
pipe.

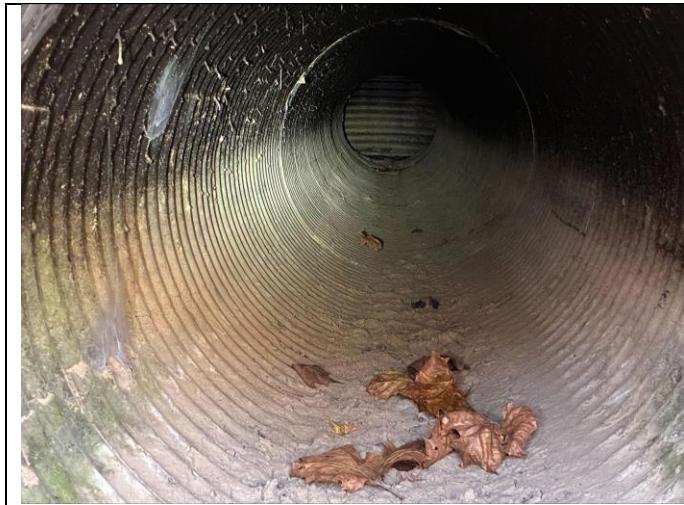
Photograph 7: Pond Complex Outlet Pipe in generally good condition with no signs of blockage.
