2025 Annual Dam and Dike Inspection Report

Fly Ash Pond

**Former Philo Power Plant
Franklin Realty Company
Philo, OH**

November 2025

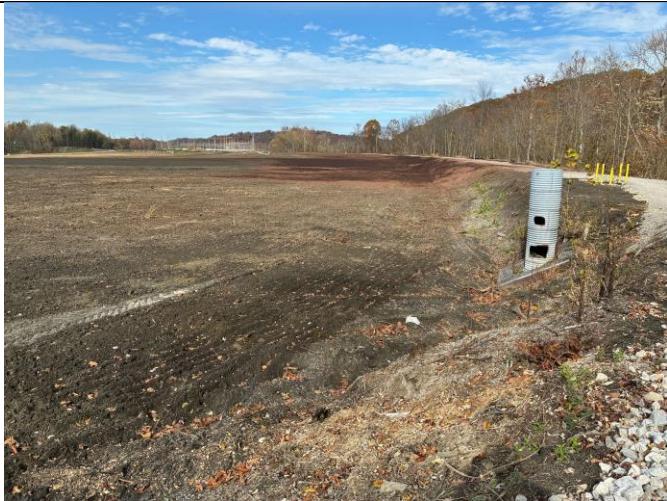
Photograph 1:

Eastern Dike and Outlet Riser along Fly Ash Pond

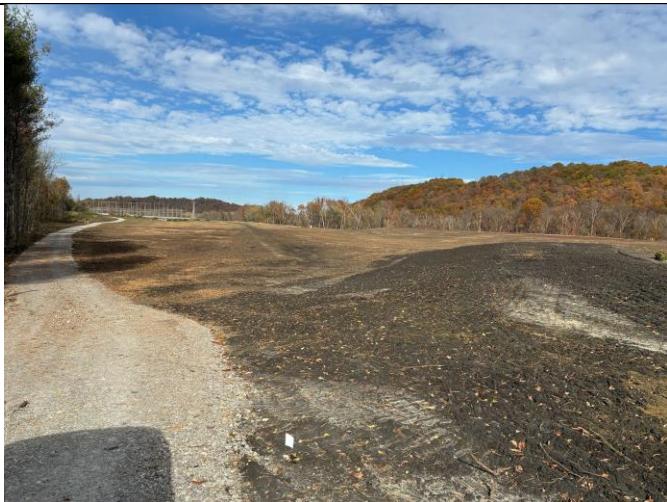
Photograph 2:

Western Dike looking north.

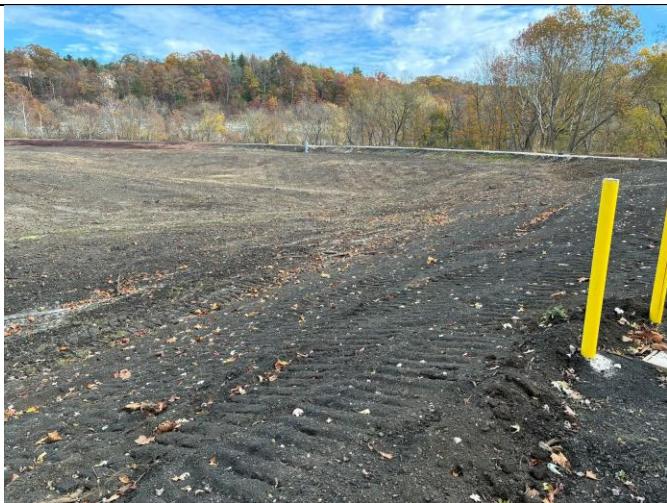
Photograph 3:

General View looking east towards outlet riser.

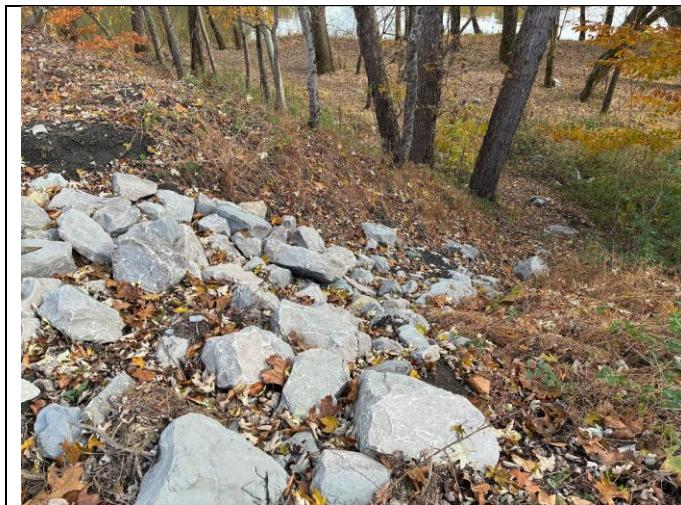
Photograph 4:

1. The upstream and downstream slopes of the Fly Ash Pond are in fair condition. Riprap has been placed in several erosion areas and ATV ruts on the outslope to stabilize them. All of the slopes need vegetation established to stabilize them from erosion.
2. The crest of the dam is in fair condition and is used as an access road. There were no signs of cracks, rutting or low areas.
3. The spillway structure is in poor condition with visible corrosion on the riser, and the outlet appears to be buried in the outslope. The outlet of the spillway should be located and uncovered as part of the pond maintenance, or properly abandoned if no longer needed.
4. The northwest side of the pond dike was originally dry ash storage, and was removed in the past, limiting the overall storage capacity of the pond.

Riprap dike repair.

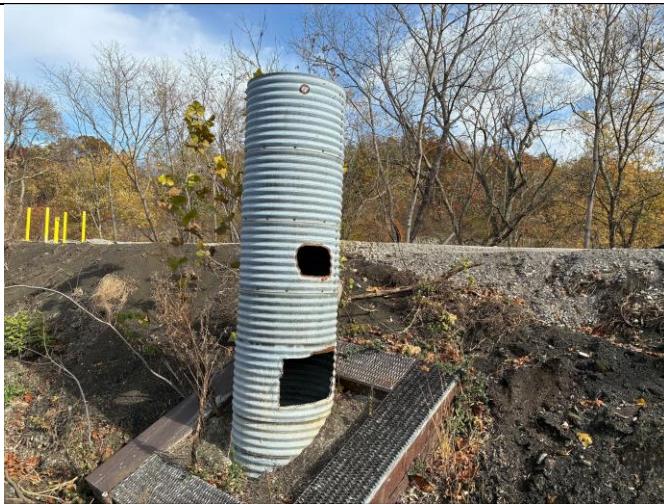
Photograph 5:
Outlet riser.

- 1) Vegetation should be established on areas with bare ash.
- 2) The outlet of the spillway should be located and uncovered or properly abandoned if no longer needed.

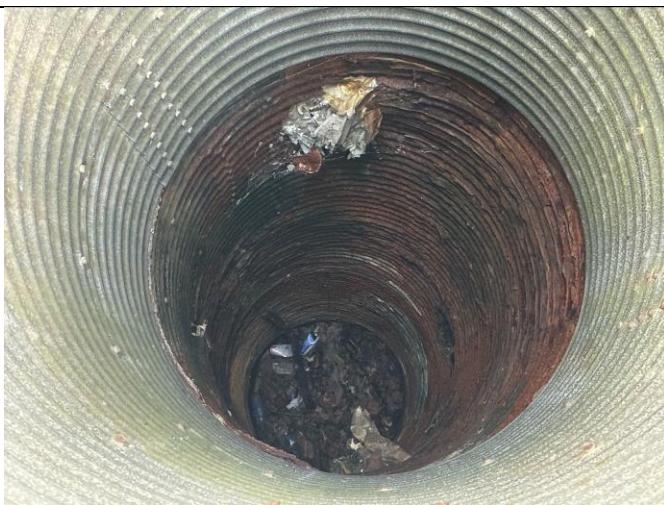
Photograph 6:

Interior of riser. Note corrosion on lower half.

- 1) Monitor the spillway riser corrosion to determine if it has the potential to affect the structural integrity.
- 2) Monitor seed and mulch to ensure adequate coverage is established.
