2025 Annual Dam and Dike Inspection Report

Ash Pond

**Former Poston Power Plant
Franklin Realty Company
Athens County, OH**

November 2025

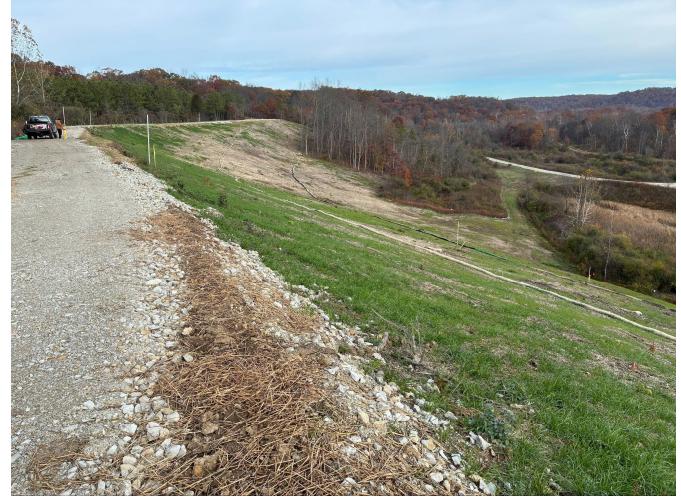
<p>Photograph 1: General View of Dam looking North along Crest</p>

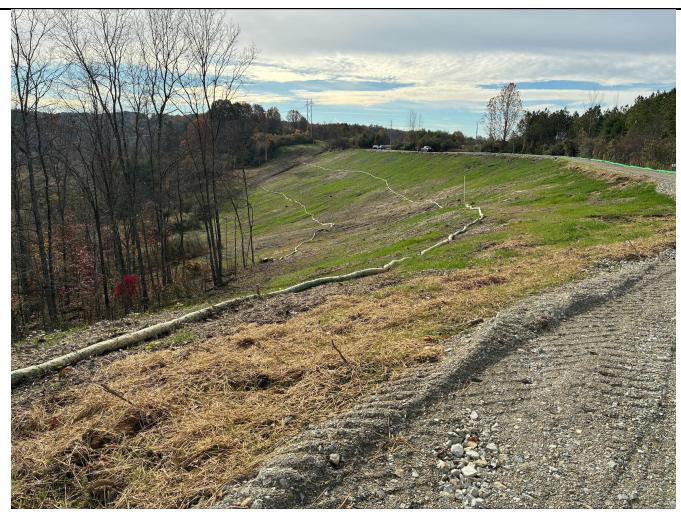
1. The downstream slope of the dam is in fair condition. Overgrown vegetation has been removed, and seed and mulch have been applied to restore vegetative growth. Vegetation is spotty in areas and should be monitored for future growth and potential erosion. Midslope erosion control socks have irregular dips not following the level contour. These areas should be monitored to ensure erosion does not form.

<p>Photograph 2: General View of Dam looking South along Crest. Note irregular elevation of mid slope sock.</p>

- 1) Monitor downslope vegetation to ensure it gets established. Monitor midslope silt sock to ensure erosion is not forming.
- 2) Monitor the right abutment toe area ensure the seepage conditions do not change or become uncontrolled.
- 3) Monitor the horizontal offset at the joint in the training wall.

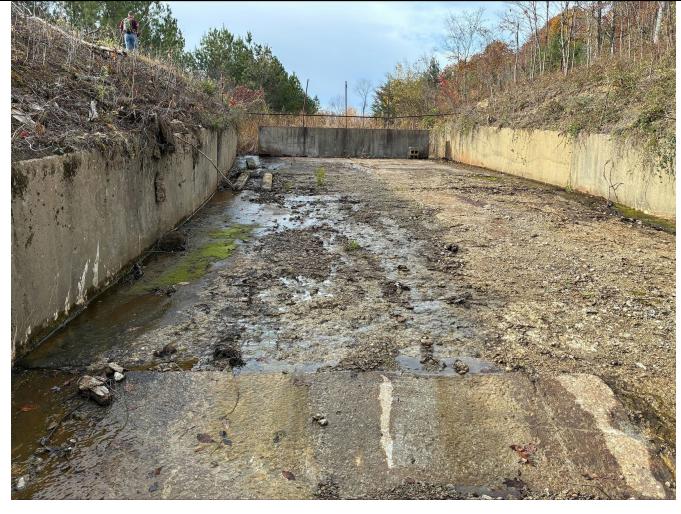
3. The concrete spillway is in poor condition. The spillway has been cleared of vegetation. The concrete is heavily spalled in approximately half of the floor area, exposing some of the reinforcement. Concrete should be repaired to prevent further damage. The wall on the upstream right side is leaning in approximately 2.5 inches and should be monitored for future movement. The low flow catch basin in the spillway is missing its grate to prevent larger debris from clogging the pipe and should be replaced.

<p>Photograph 3: Concrete Spillway</p>

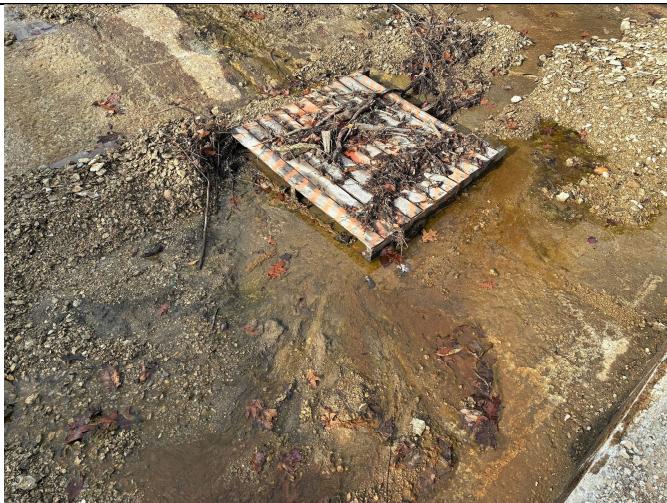
Photograph 4:

Spillway low flow outlet.
Grate needs replaced to
prevent clogging.

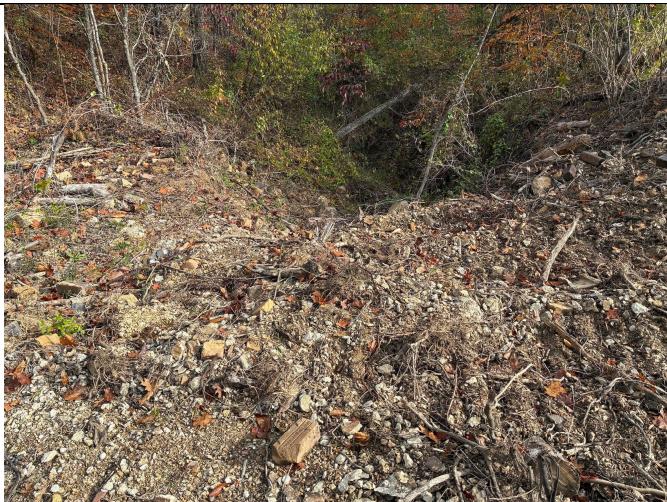
4. The receiving channel below the concrete spillway is eroded and should be stabilized to prevent further erosion from forming.
5. The concrete stilling basin at the outfall of the low flow pipe is in good condition. No maintenance is needed.

Photograph 5:
Spillway downstream
receiving channel.

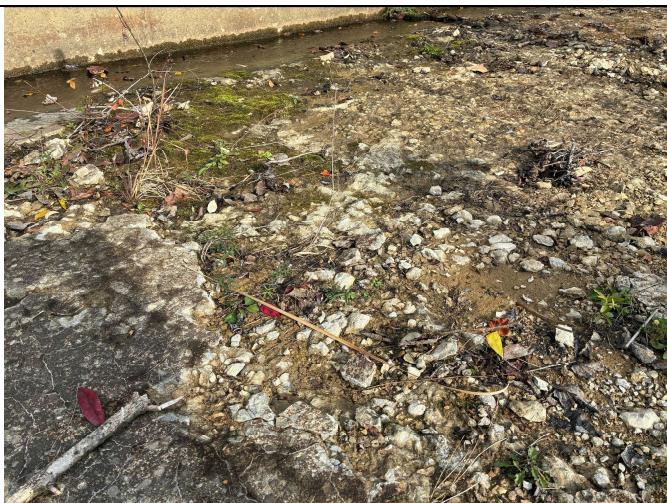
Photograph 6:

Concrete Spillway
spalling.

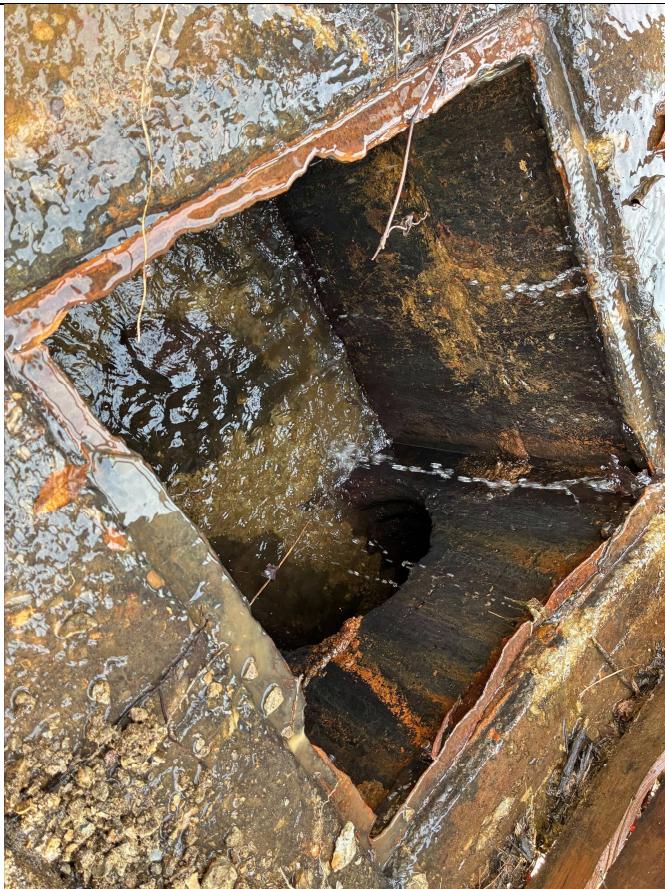
Photograph 7:
Spillway Outlet Pipe.

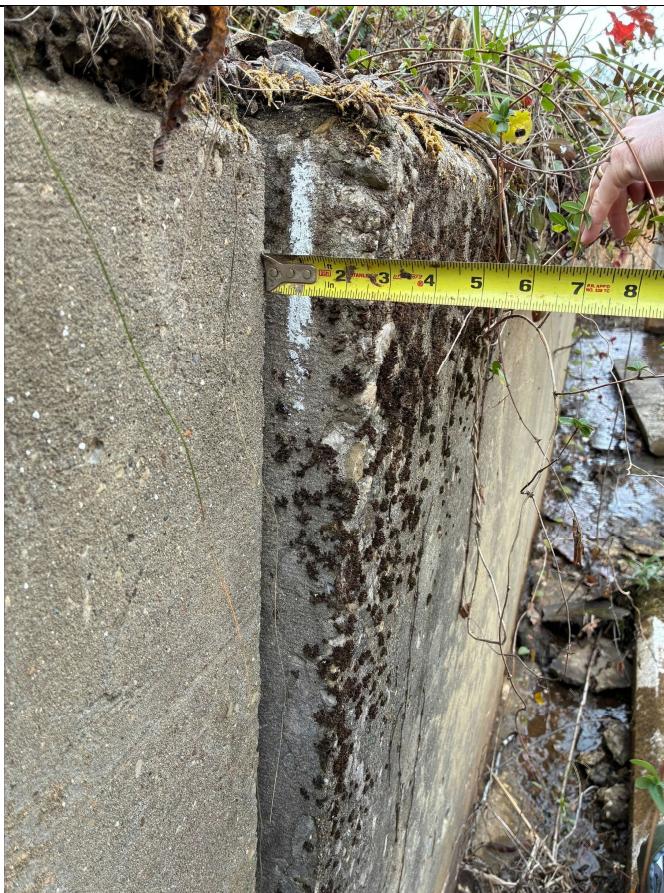
Photograph 8:
Leaning Wall separation
at joint.

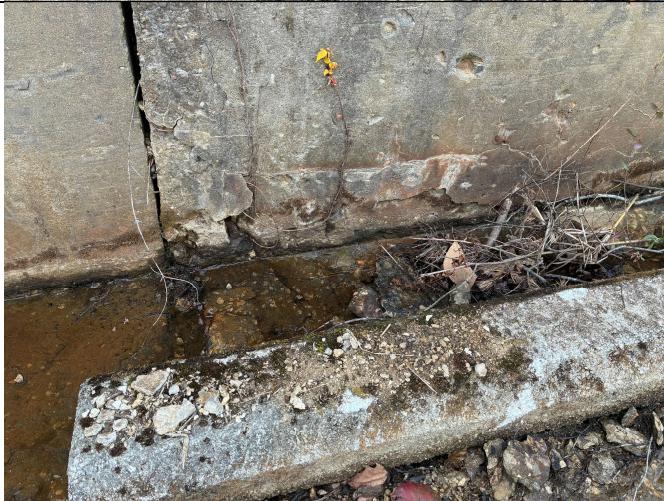
Photograph 9:
Concrete deterioration at
base of wall

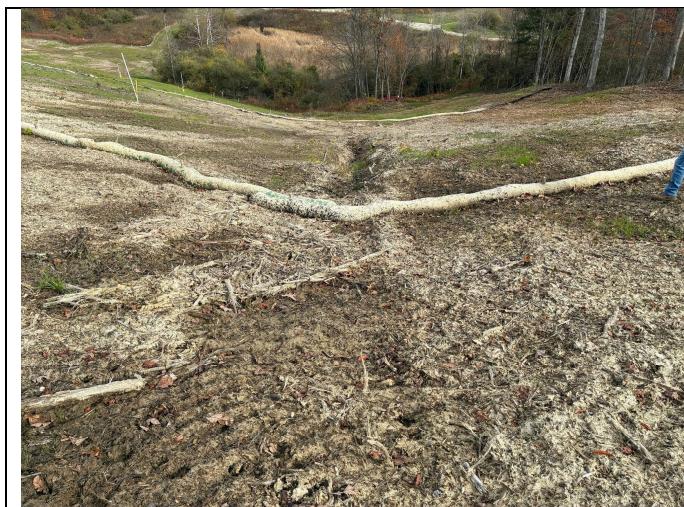
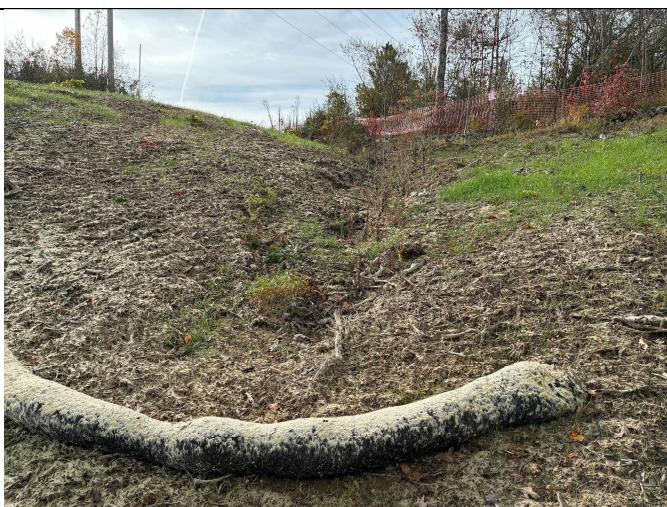
6. There is an area of seepage and erosion along the toe where the right abutment meets the dam. This was noted in prior reports as far back as the 1980s. This area should be monitored and may need maintenance to stabilize the erosion.

Photograph 10:
Erosion at right abutment

Photograph 11:
Erosion at right abutment.

- 1) Develop plans to remove overgrown vegetation. This includes the upstream slope vegetation on the main dam and the downstream slope of the saddle dam. Work in this area may require environmental permitting.
- 2) Develop plans to address the deteriorated concrete in the spillway. Develop plans to repair the erosion in the downstream channel.
- 3) Develop plans to locate and daylight the toe drain headwall. Performing this work may require environmental permitting.
- 4) Install a grate on the low flow outlet.
- 5) Repair the erosion in the right downstream groin contact between the main dam and the right abutment.

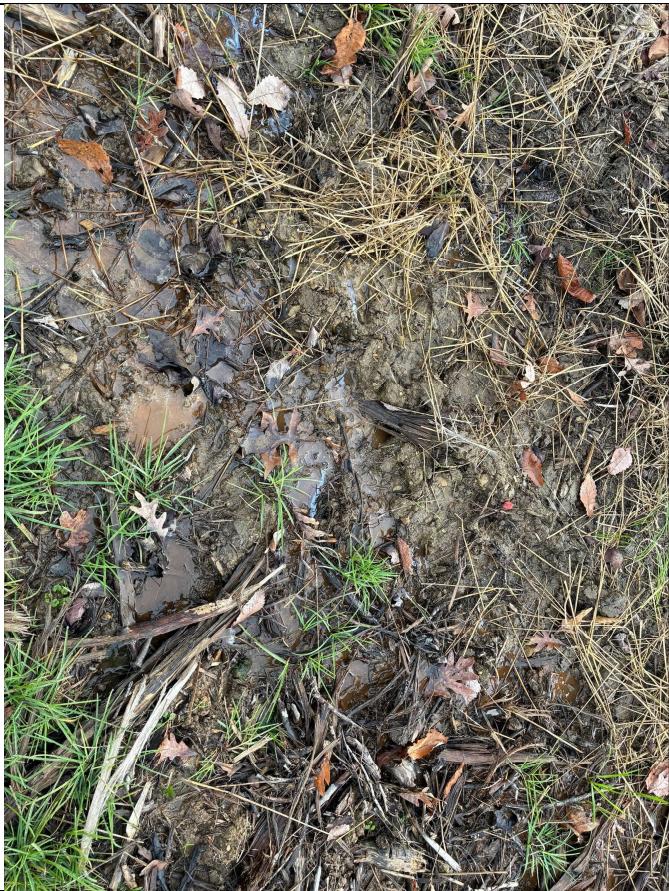
Photograph 12: Saturation at right abutment toe

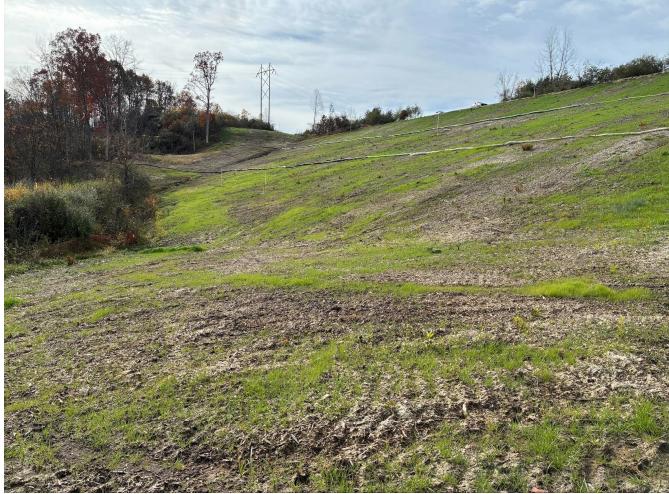
Photograph 13: General view of dam showing spotty vegetation

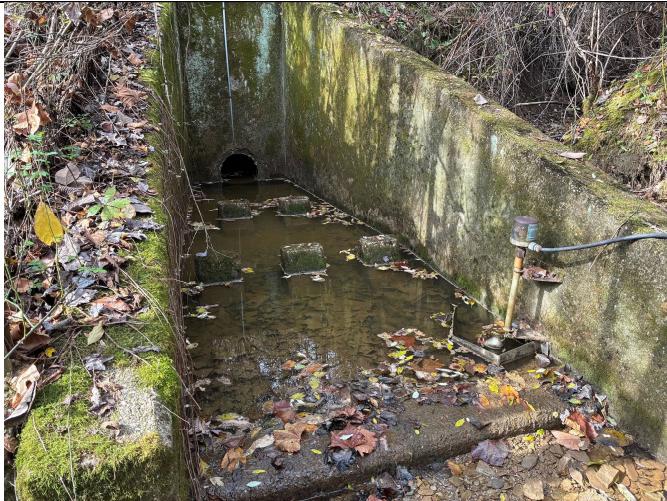
Photograph 14: Stilling basin from low flow outlet pipe.

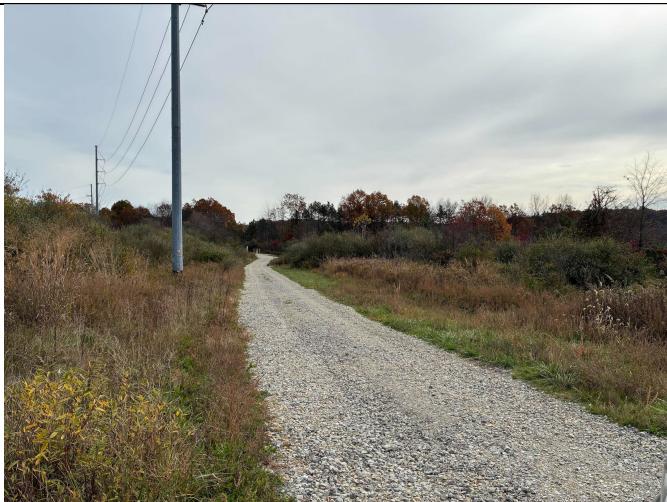
Photograph 15: General view of access road on top of saddle dam.
