# INITIAL STRUCTURAL STABILITY ASSESSMENT

East Fly Ash Pond

Kanawha River Site

# Initial Structural Stability Assessment

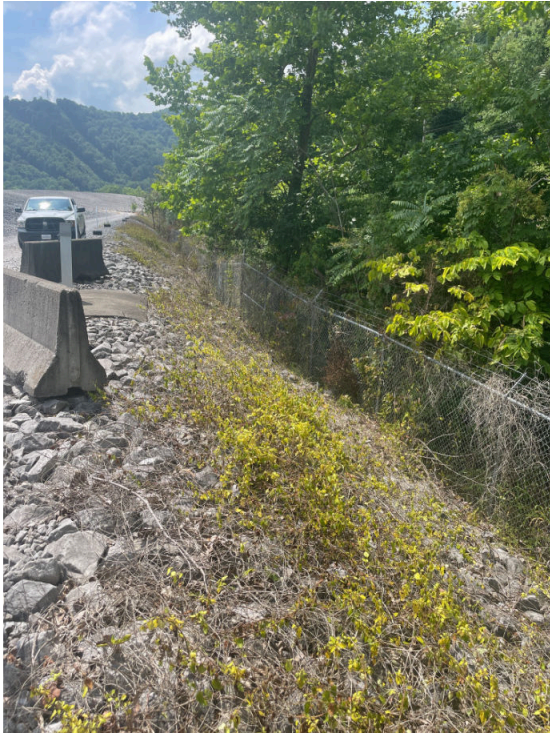
Media 1: Northeastern slope on EFA looking west

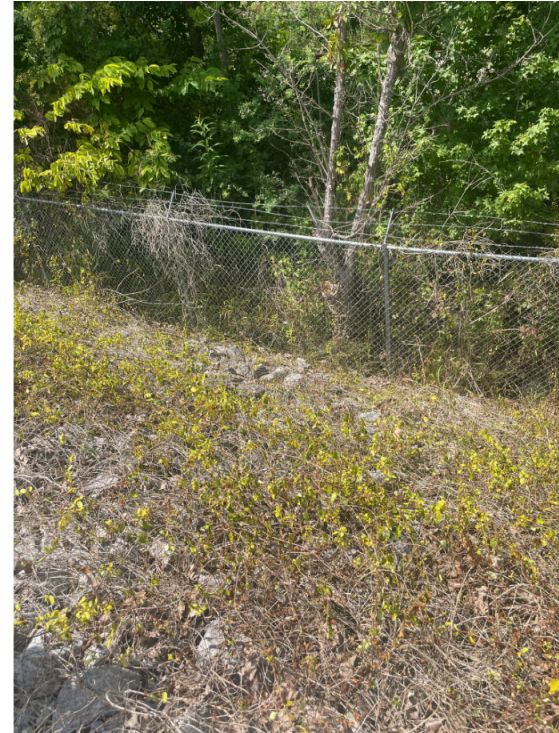
Media 2: Northeastern slope on EFA showing the fence looking north

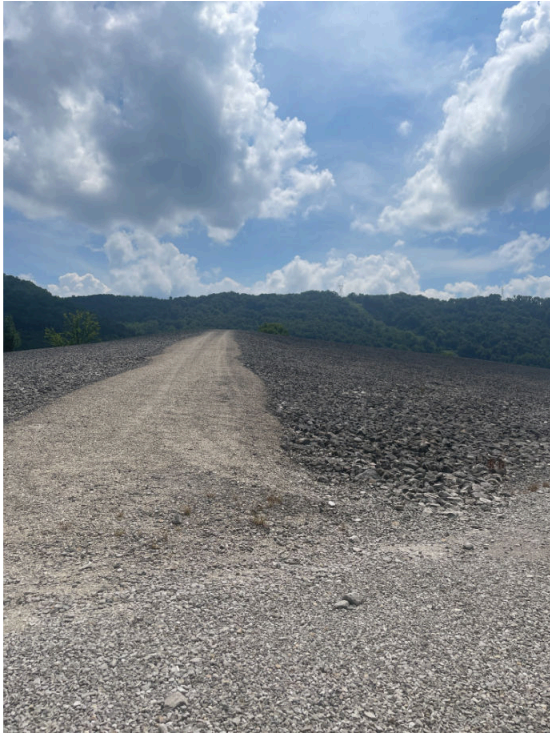
Media 3: existing stone riprap cover and path towards the eastern portion of EFA

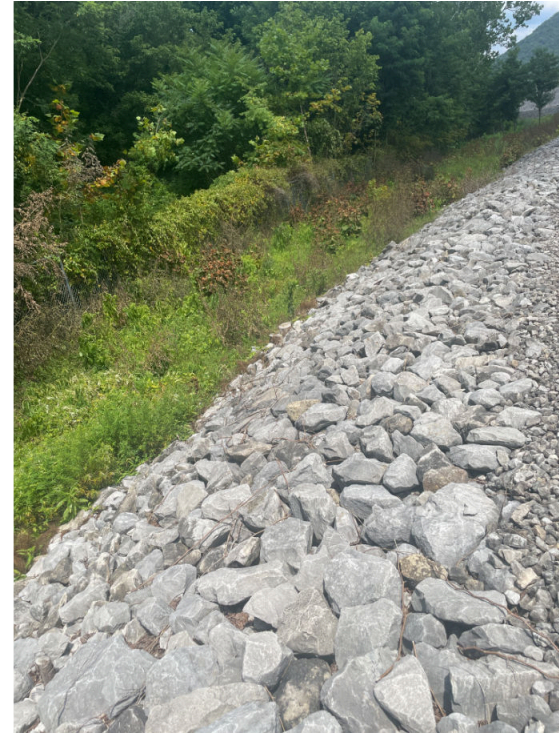
Media 4: Northern slope of EFA looking west shows riprap armoring on slope

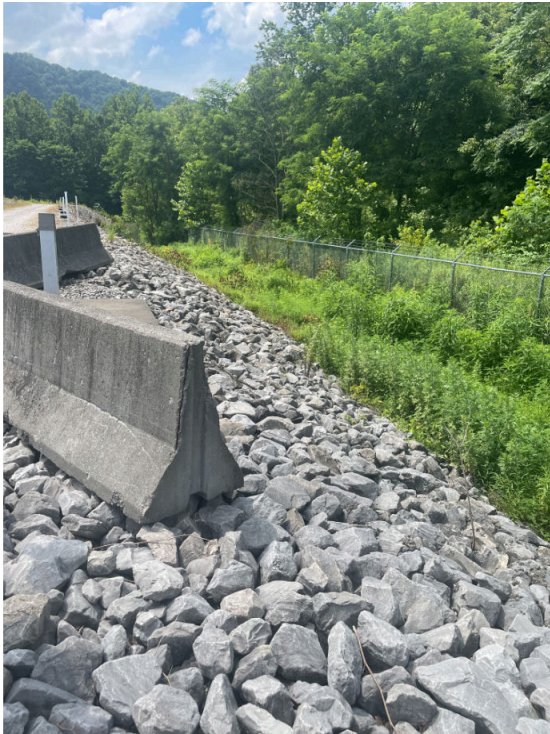
Media 5: Northern slope of the EFA looking west. Showing riprap armoring on the slope

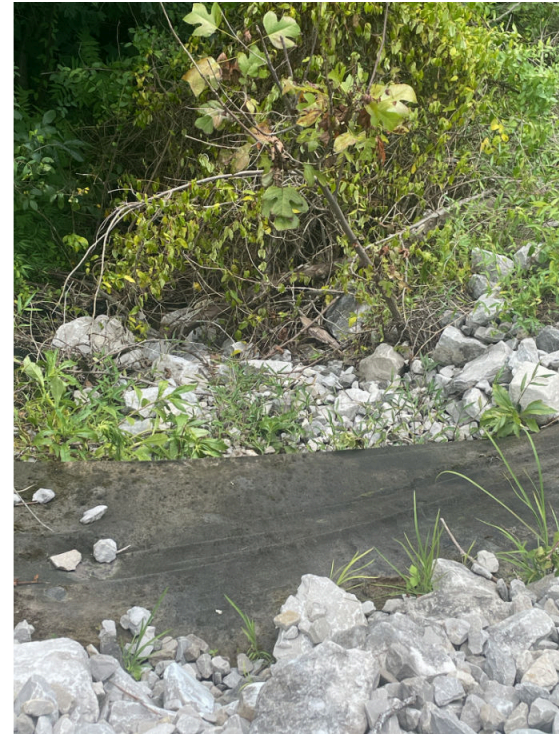
- Areas of erosion were observed along the southern perimeter dike slope adjacent to the Kanawha River. Based on site observations, runoff from the surge stone cover system appears to concentrate stormwater flow and increase runoff velocities along the dike face, contributing to this localized erosion. At the time of the site visit, AEP was actively performing erosion repairs, including removal of disturbed material and backfilling with geotextile and riprap.

Media 6: Southern slope of EFA looking towards the Kanawha River. Showing erosion repairs on steeper dike slopes

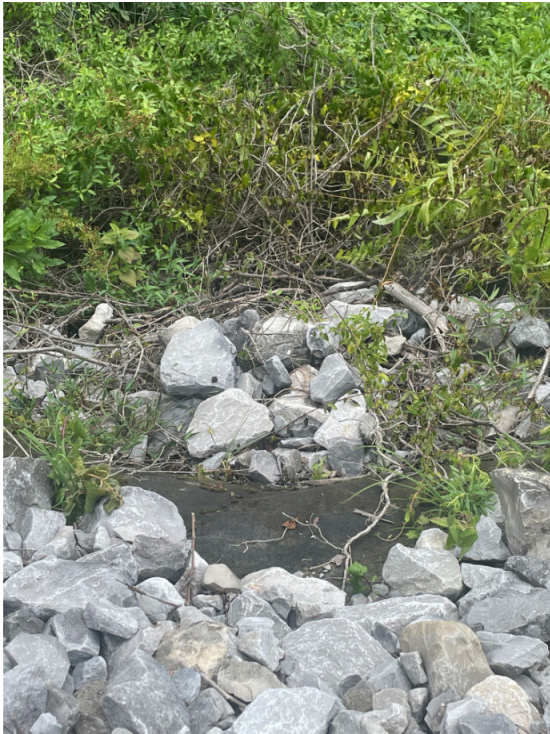
Media 7: Southern slope of EFA looking towards the Kanawha River showing riprap repair section on dike and soil/vegetative slope below

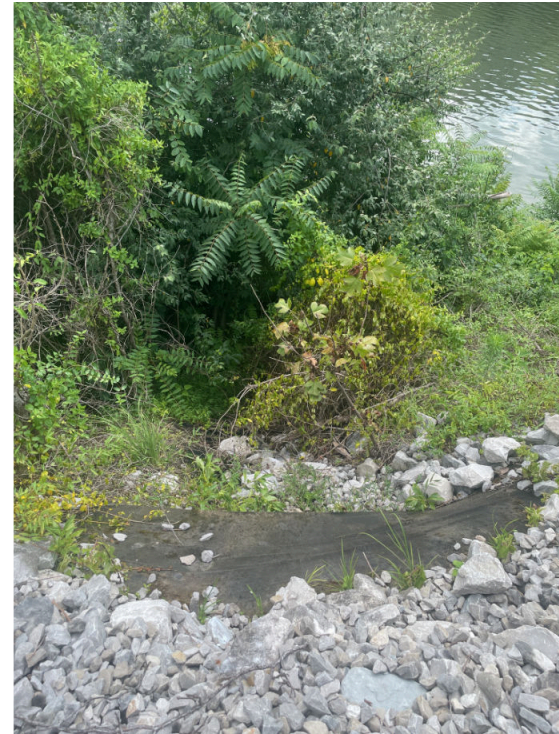
Media 8: Southern slope of EFA showing erosion damage on perimeter dike adjacent to the Kanawha River

Modifications to the EFA will be required to meet the prescribed factors of safety for the site and demonstrate stable foundations. A detailed corrective action plan will be developed by AEP to address the identified stability deficiencies and demonstrate compliance with the CCR Rule.

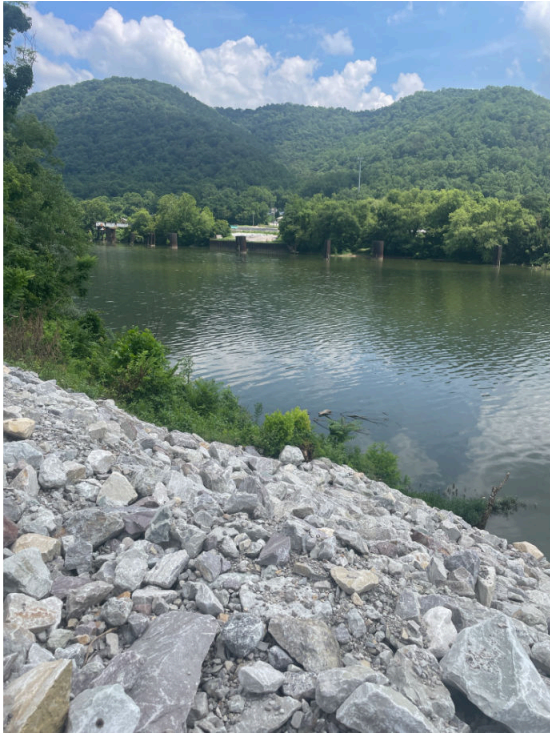
Media 9: Southern slope of EFA showing repaired erosion area along the Kanawha River

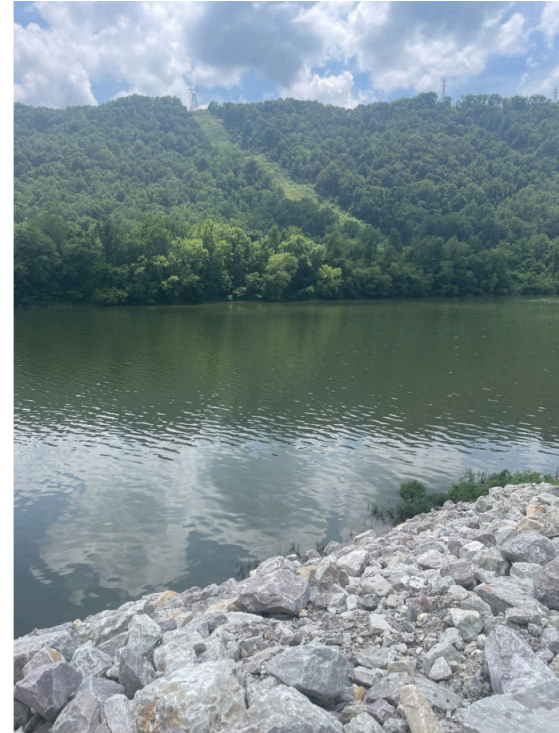
Media 10: Southern slope of EFA showing repaired erosion area along the Kanawha River

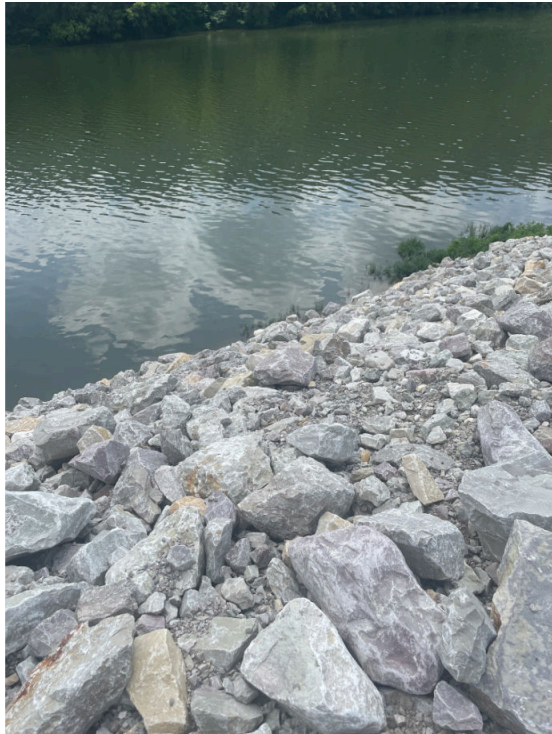
Media 11: Southern slope of EFA showing repaired erosion area along the Kanawha River. Repairs extend to the water level

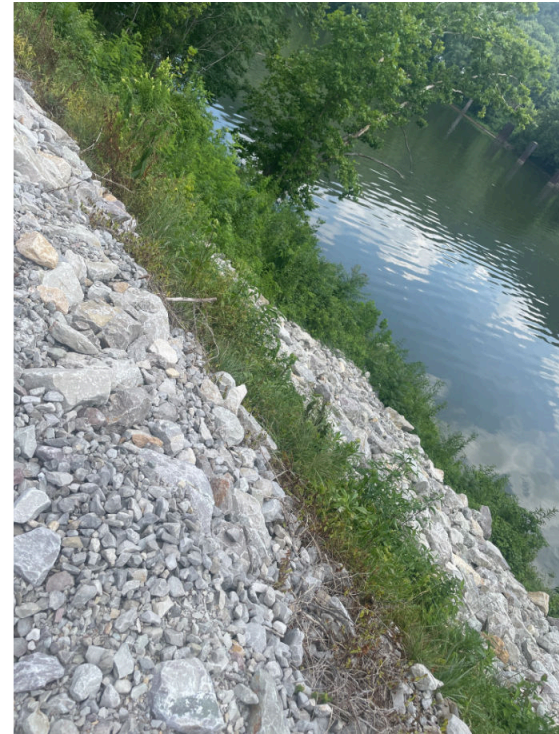
Media 12: Southern slope of EFA along the Kanawha River showing erosion repair that was backfilled with geotextile and riprap

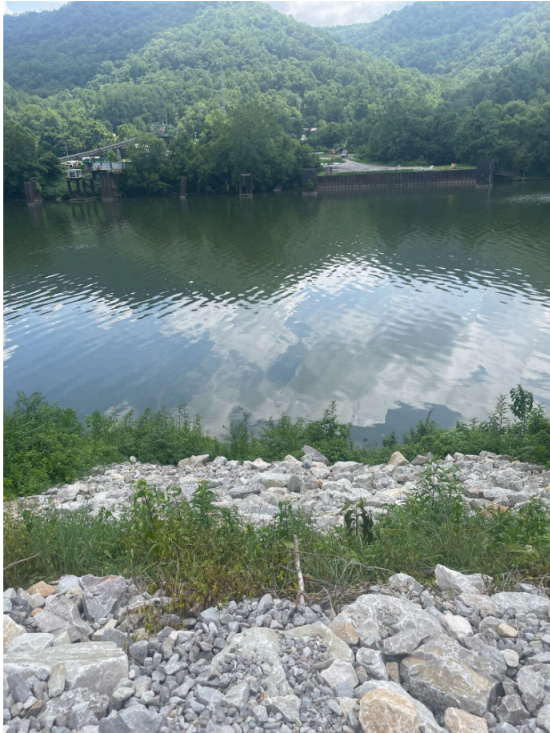
Media 13: Southern slope of EFA along the Kanawha River showing erosion repair that was backfilled with geotextile and riprap

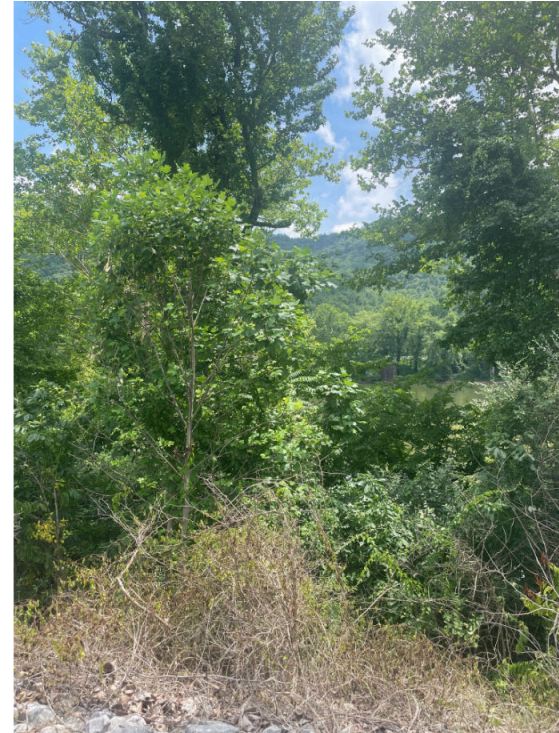
Media 14: Southeast corner of EFA from top of access road (top of dike) looking towards the Kanawha River

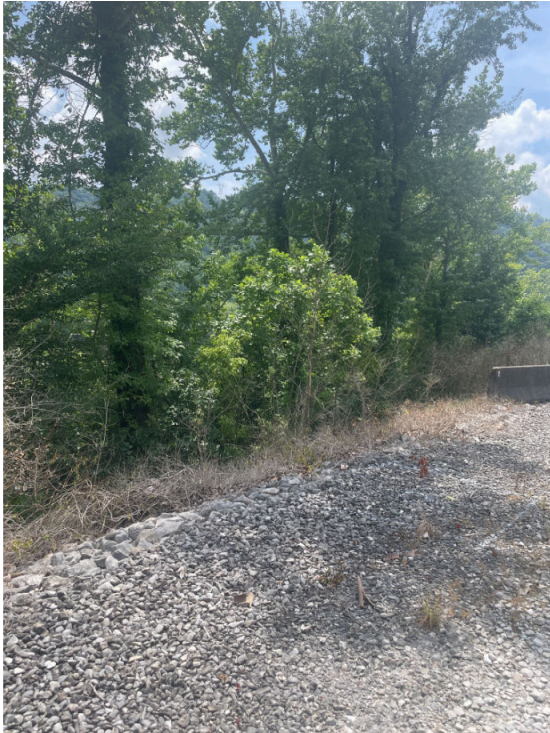
Media 15: Southeast corner of EFA from top of access road (top of dike) looking west at crest of dike

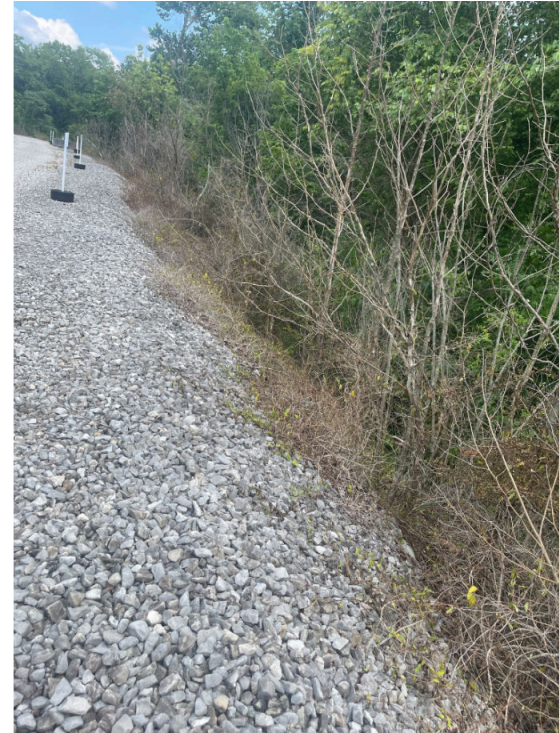
The EPA has vacated the requirement that vegetative cover on surface impoundment dikes be maintained at no more than six inches. However, the heavy tree growth on the exterior slopes of the dike, specifically on the south end of the ash pond are not consistent with good engineering practices. These areas should be cleared such that appropriate monitoring of the perimeter dike can be performed.

Media 16: Southern slope of EFA along dike crest showing stone base for access road and heavily vegetated area on slope

Vegetation management activities should be performed in accordance with an appropriate work plan following applicable regulatory requirements, which may include development of a Stormwater Pollution Prevention Plan (SWPPP), compliance with seasonal environmental constraints (e.g., bat roosting windows), and coordination with applicable permitting agencies, if required. Clearing activities should be conducted in a manner that does not adversely impact embankment stability, with careful consideration given to whether tree stumps and root systems are left in place to avoid potential instability or removed and backfilled.

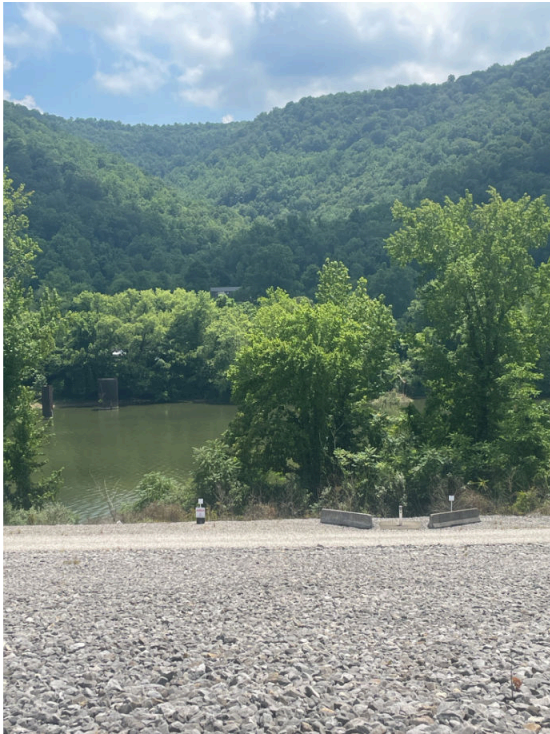
Media 17: Top of EFA cover looking south towards the Kanawha River. Showing surge stone on top of the geosynthetic cover system

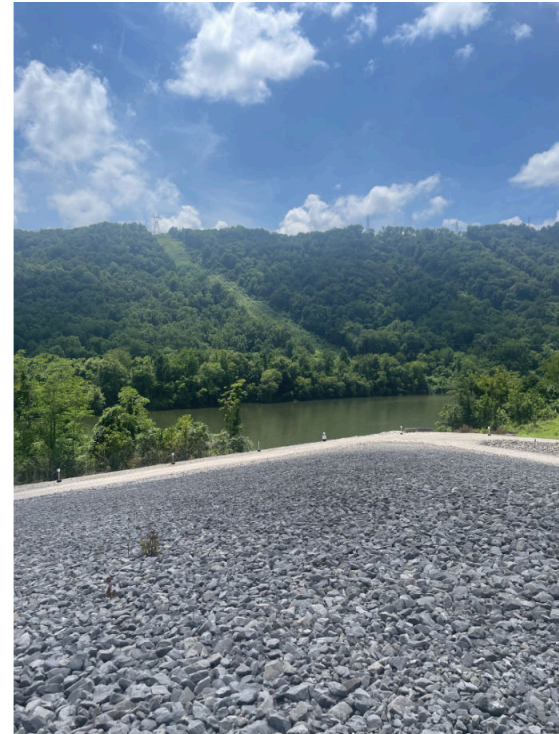
Media 18: Top of EFA looking southwest towards the Kanawha River (surge stone cover material)
