INITIAL STRUCTURAL STABILITY ASSESSMENT

Fly Ash Pond

Philo Site

Philo Legacy CCR Impoundment
Periodic Structural Stability Assessment
Philo Power Plant
Philo, Ohio
S&ME Project No. 25170079

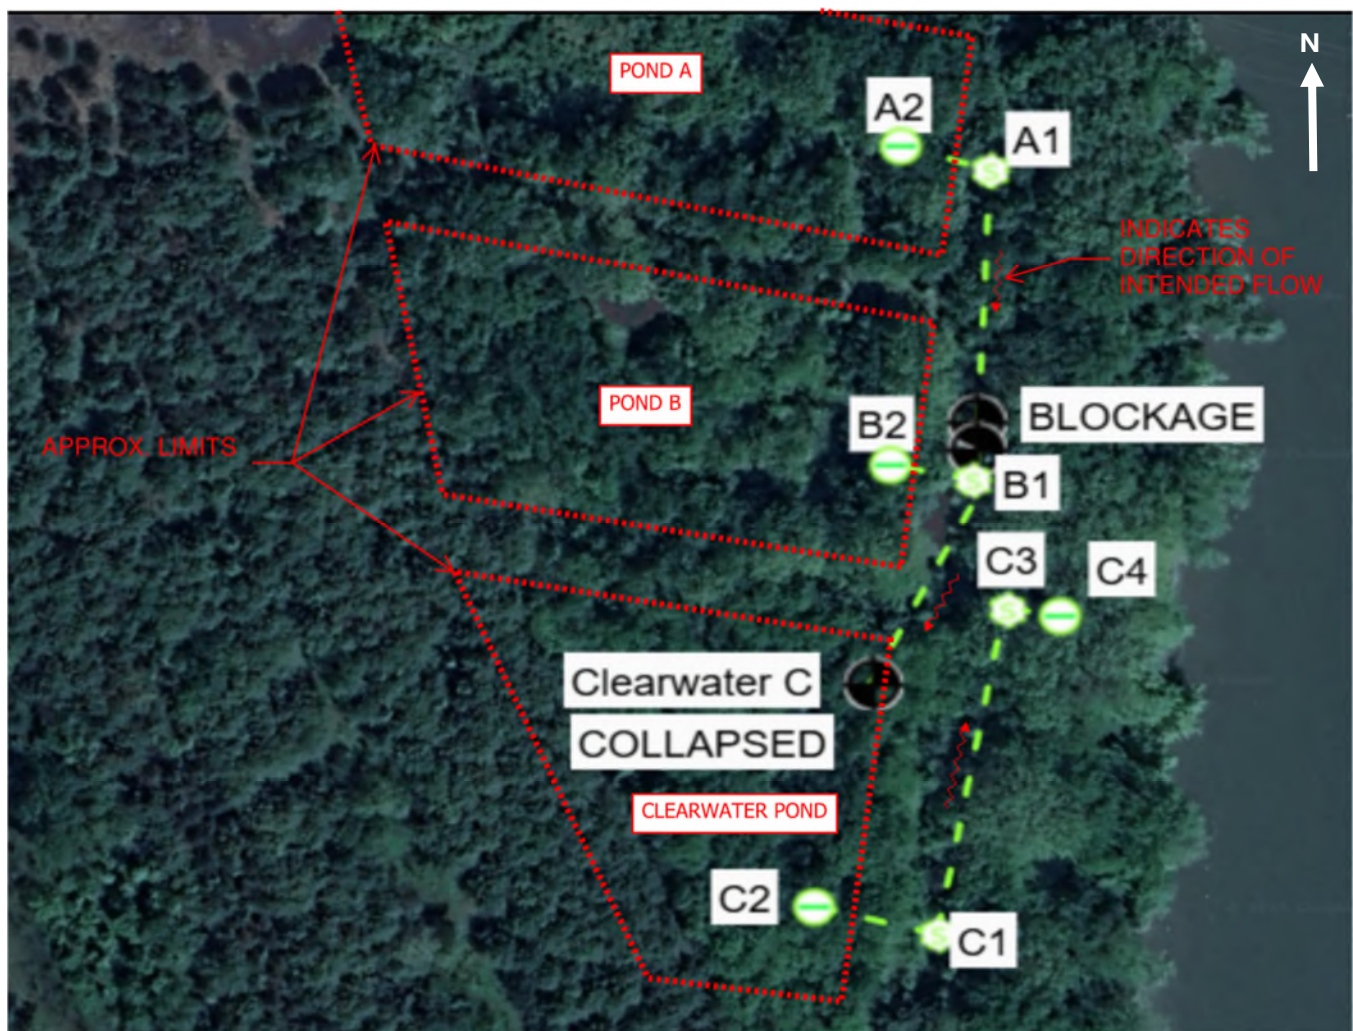
Figure 1-2 – Bottom Ash Impoundment Configuration

Muskingum River (approximate invert El. 679.0 feet according to record drawings). Figure 1-2 shows a conceptual depiction of the configuration of the culvert system, prepared by BloodHound, LLC, the camera inspection subcontractor. The condition of the culverts is further discussed in Sections 4.5 and 4.6.

Based on the current configuration of the drainage system between the ponds, the original system appears to consist of the following: the drainpipe from Pond A meets the drainpipe from Pond B, and the drainpipe from Pond B drains into the Clear Water Pond. Based on the recent camera inspection, the drainpipe between Pond A and Pond B had filled-in and/or collapsed and the drainpipe from Pond B to the Clear Water Pond had collapsed. The discharge end of the drainpipe between Pond B and the Clear Water Pond was not located and is suspected to have been either capped or damaged during the final stages of construction of the Clear Water Pond.

In summary, Ponds A and B do not have functioning drain pipes, and the condition of the middle segment of the spillway for the Clear Water Pond is currently unknown. As such, these pipes are considered unsatisfactory to manage flow between ponds and to the discharge end at this time. Further inspection or testing of the spillway may indicate an adequate spillway capacity for the Clear Water Pond. However, ponding of stormwater within the three basins compromising the Bottom Ash Impoundment does not appear to pose an unstable condition to the

As indicated in Section 4.5, the drainpipe between Pond A and Pond B, and the drainpipe between Pond B and the Clear Water Pond within the Bottom Ash Impoundment have become blocked (either crushed or filled-in). At this time, it is unknown whether these pipes were partially abandoned during construction or if the blockage occurred after construction. Aside from these obstructions, the camera inspection indicated intact pipes with no obvious loss of pipe section with some delamination of the bituminous coating within the flow path at the inlets. Rust was occasionally observed along the inside surface of a portion of the drainpipe between Ponds A and B. Indications of sinkholes or settlement within the vicinity of these pipes were not observed during our site visits.

The H&H evaluation performed by AECOM (April 17, 2026) recommends that the existing pipe networks be abandoned in-place. If the topography of the existing bottom ash impoundment area is to remain post-closure, we recommend that the sub-basins be hydraulically connected by either breaching the dividing embankments or providing a functioning pipe network (such as repairing the existing network or installation of new culverts within the dividing embankments).
