# STRUCTURAL STABILITY ASSESSMENT

**40 CFR 257.73 (d)**

Ash Pond

Cabin Creek Site

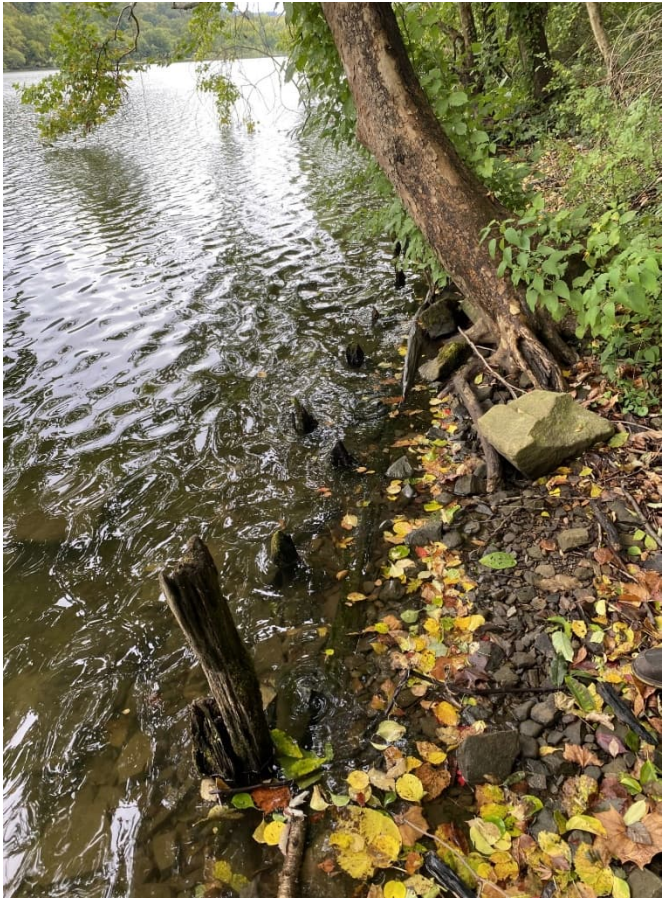
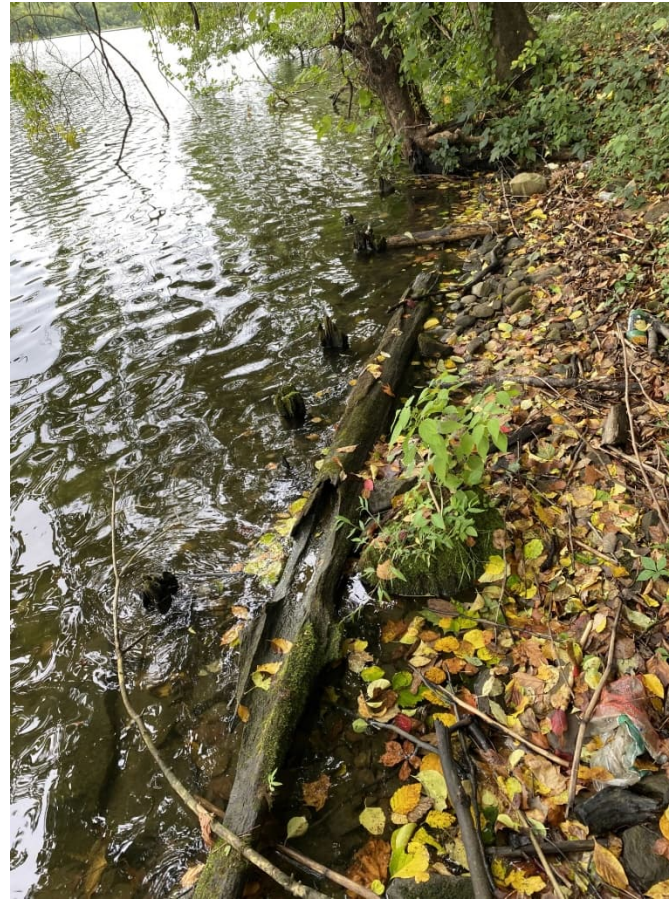
Image 1a

Available records for the Cabin Creek Ash Pond indicate timber piling was installed along the normal pool shoreline of the Kanawha River for at least a portion of the dikes overall length. Remnants of the timber pile system were observed during previous annual inspections. An engineering assessment on the timber pilings was performed in June 2026 by Wood Research and Development. The timber pile system provides stability to slope failure surface along the critical failure section of the perimeter dike. However, sections of the Cabin Creek Ash Pond dike do not appear to have been constructed with timber piles along the shoreline. The sections of the embankment dam without timber piling does not meet the required factors of safety for slope stability. AEP is evaluating options to address the inadequate factor of safety deficiency.

**Images 1a and 1b: Timber piles along the shoreline in the western half of the ash pond's northern dike**

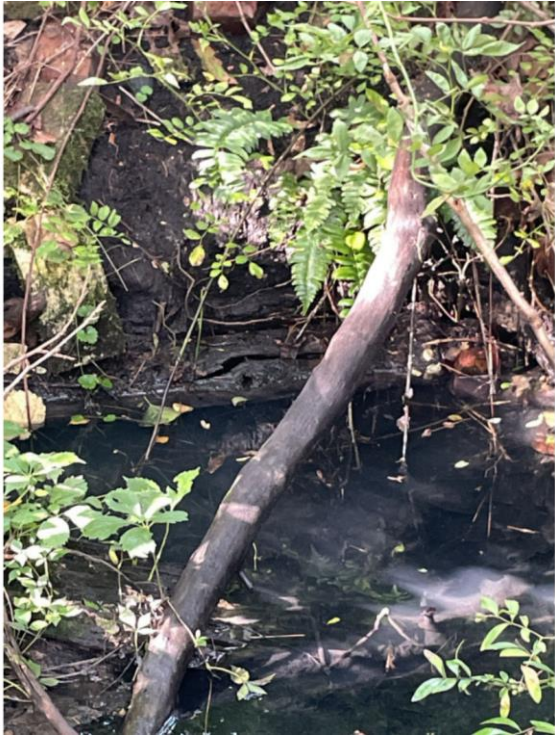
Media 3: Potential drainage outlet pipe at the downstream toe of the perimeter dike

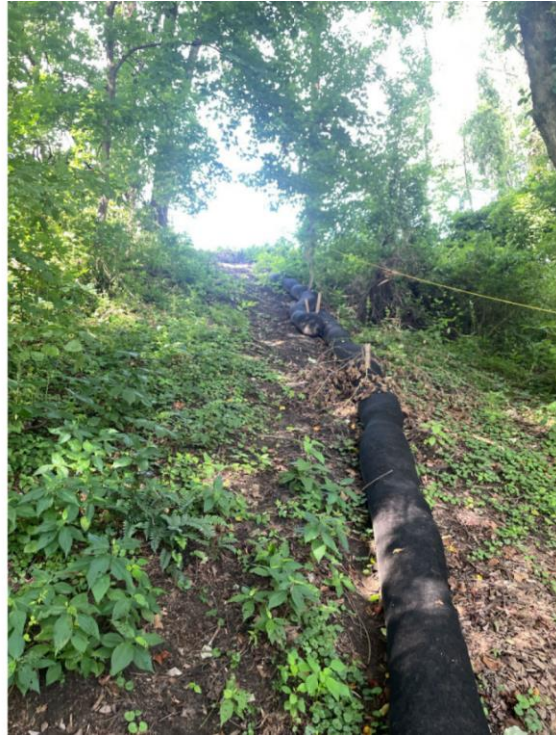
Media 8: Erosion control measures on perimeter dike

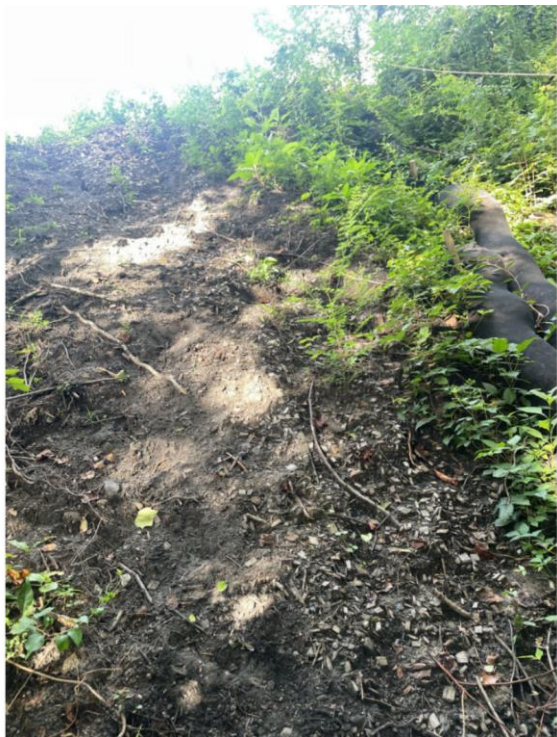
Media 9: Erosion control measures on perimeter dike

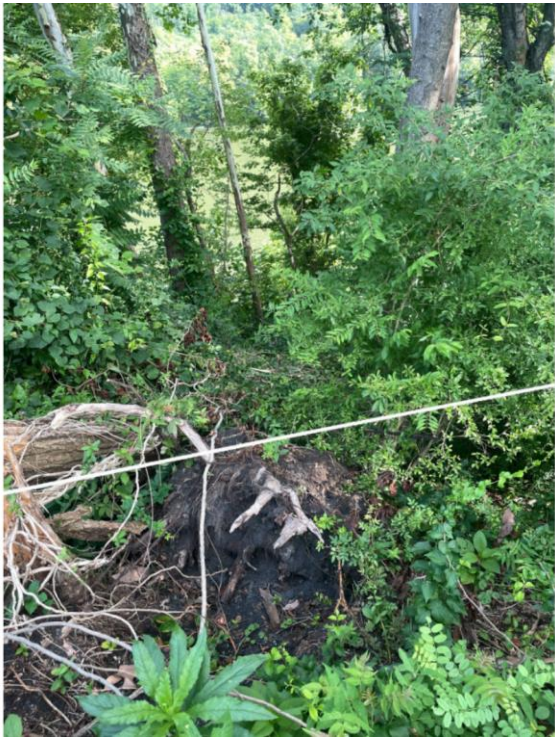
Media 15: Looking north towards the Kanawha River down the perimeter dike (heavy vegetation)

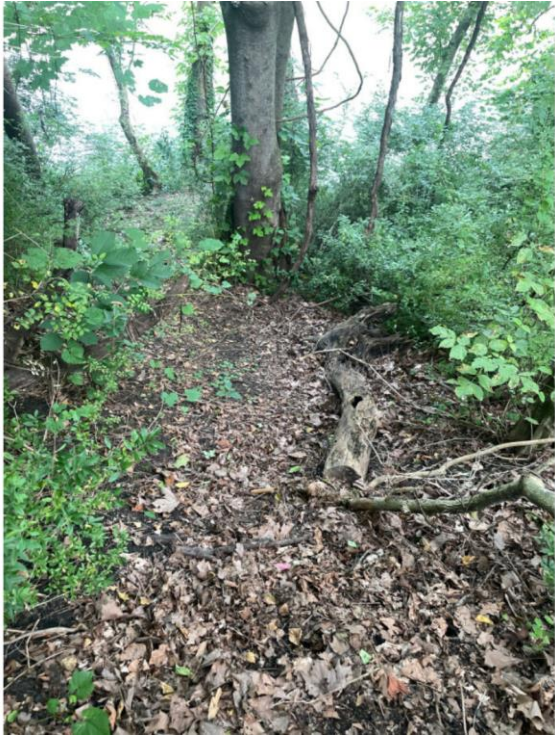
Media 17: Looking north towards the Kanawha River down the perimeter dike (heavy vegetation)

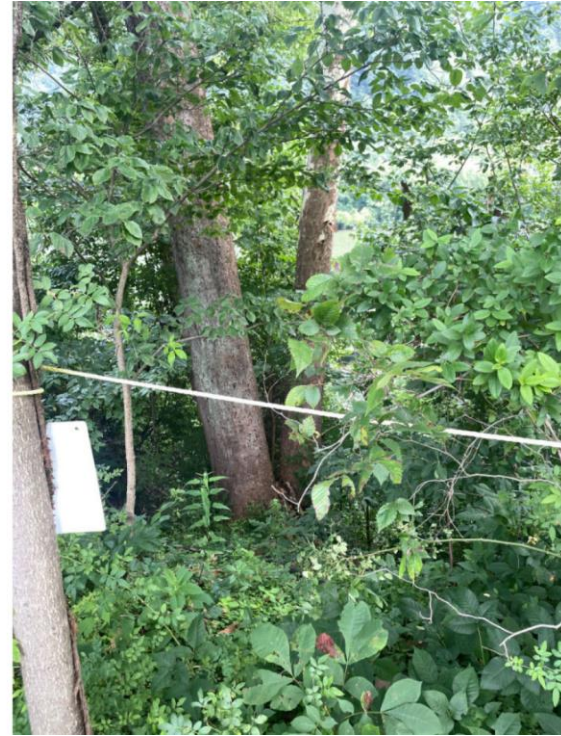
Media 18: Looking north towards the Kanawha River down the perimeter dike (heavy vegetation)

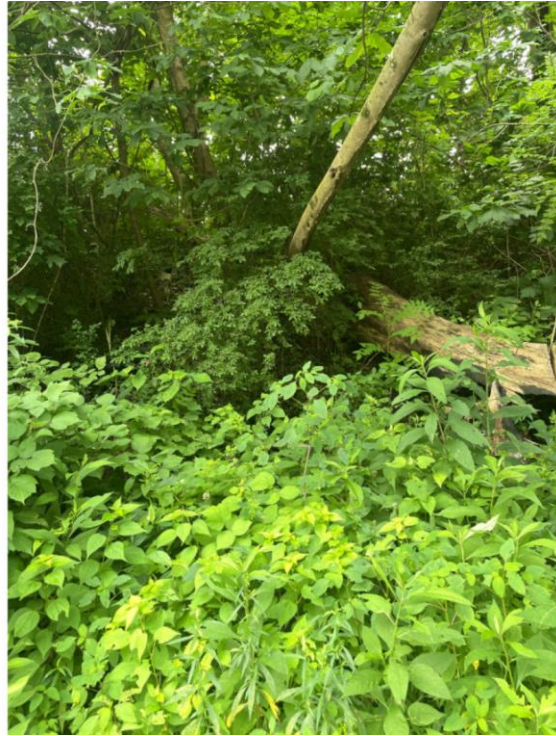
Media 22: Looking up the perimeter dike slope from the Kanawha River (heavy vegetation)

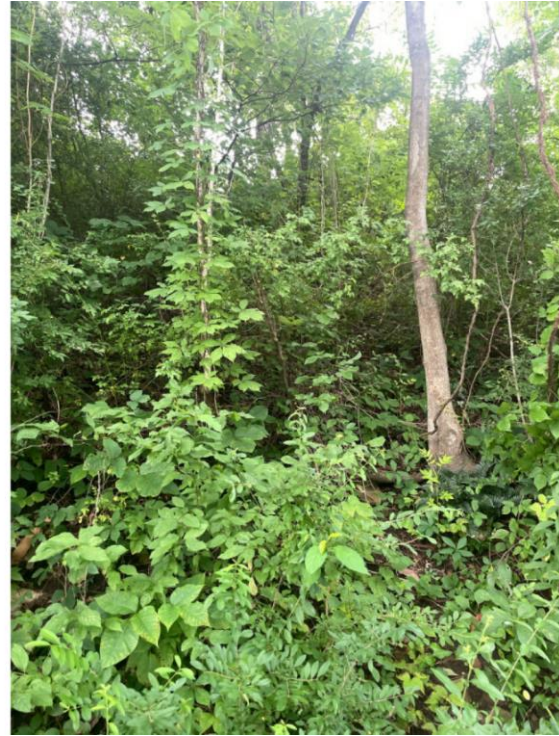
Media 24: Heavy vegetation is shown on the perimeter dike at the northwest end of the ash pond adjacent to the Kanawha River

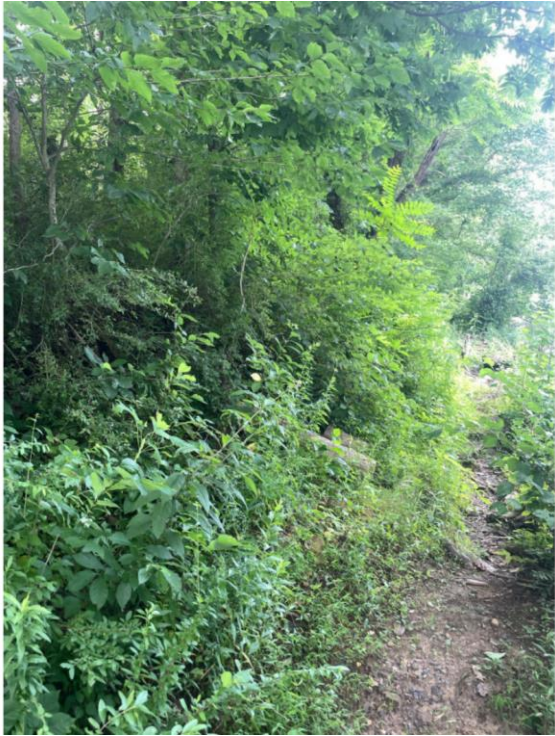
Media 25: Heavy vegetation shown on the perimeter dike at the northwest end of the ash pond adjacent to the Kanawha River

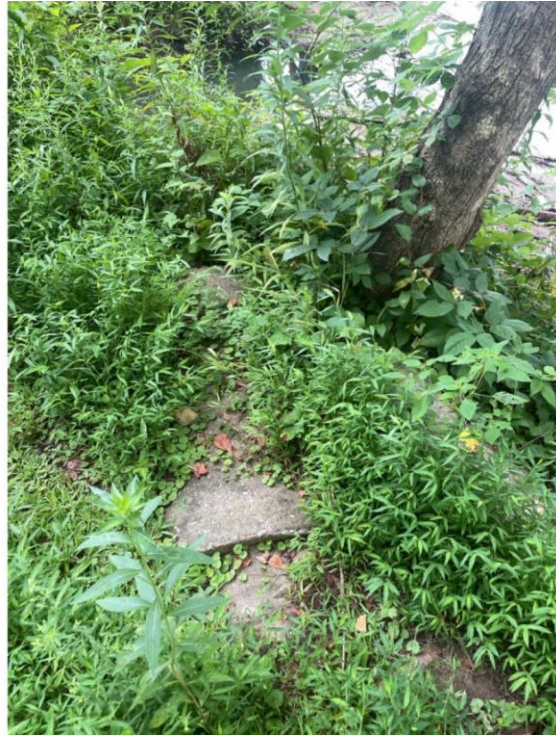
Media 28: Concrete spillway outlet pipe

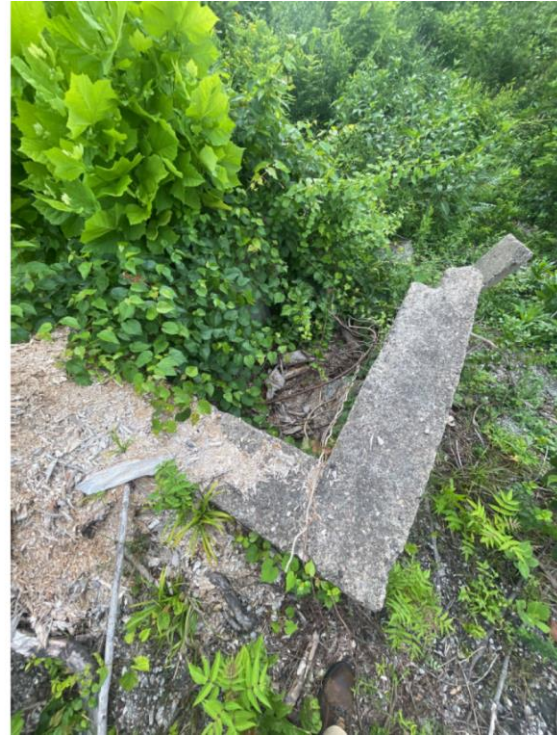
Media 34: Remnants of old concrete outlet structure used when the ash pond was active

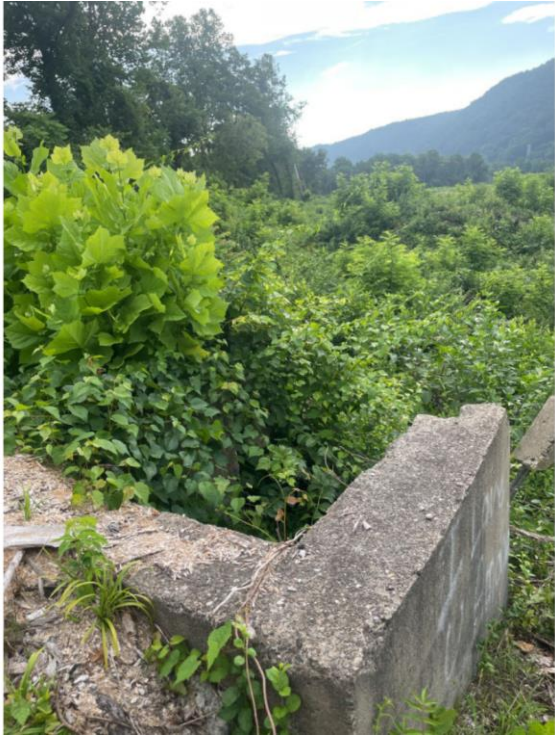
Media 35: Remnants of an old concrete outlet structure used when the ash pond was active

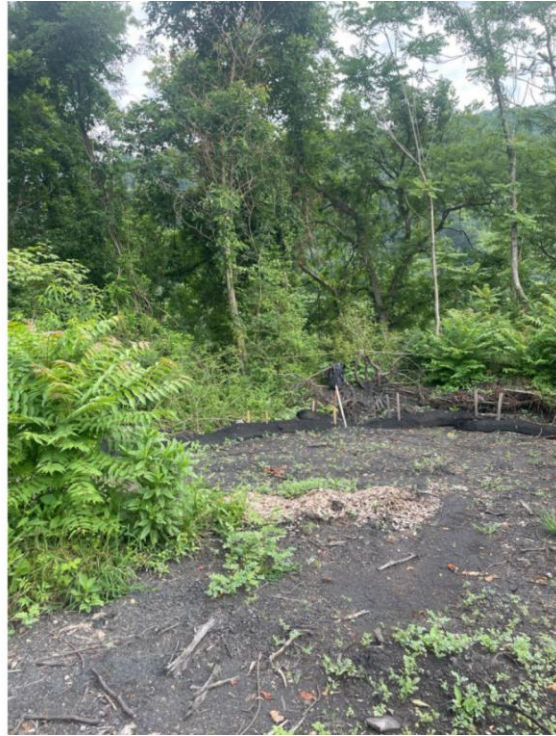
Media 36: Cleared area on the top of the ash pond with in-place erosion control measures (recently cleared)

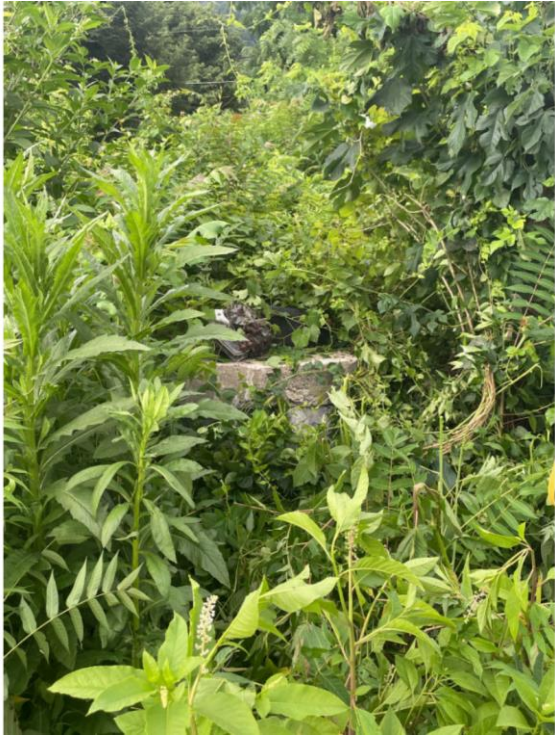
Media 43: Top of concrete stormwater manhole. Access point for stormwater drainage pipes that traverse the ash pond

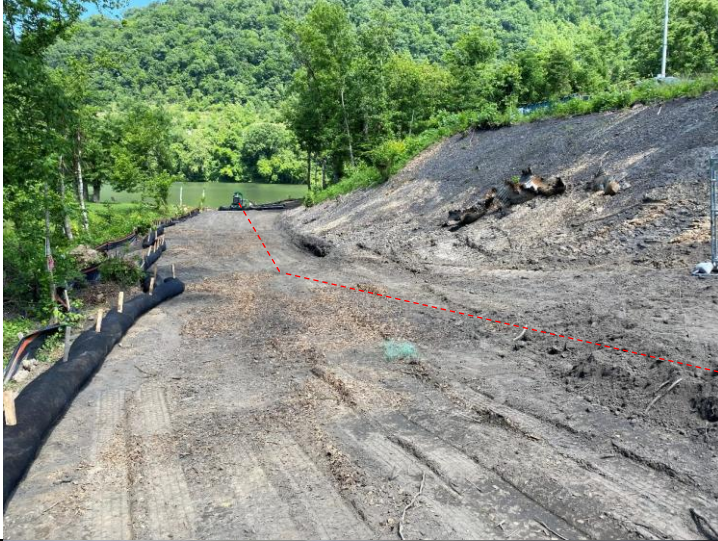
Photograph 8.  
Showing the backfilled trench  
with the red line approximating  
the replaced storm drain  
alignment.

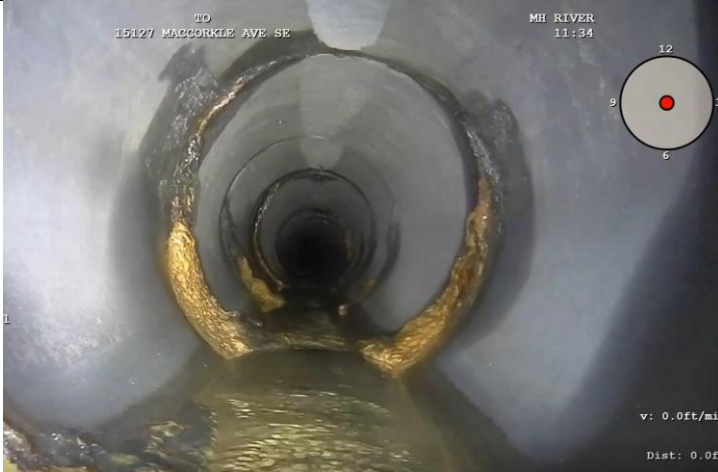
Photograph 9.  
Screenshot taken from video  
pipe inspection, showing  
condition of the storm drainpipe  
before hydro jetting.

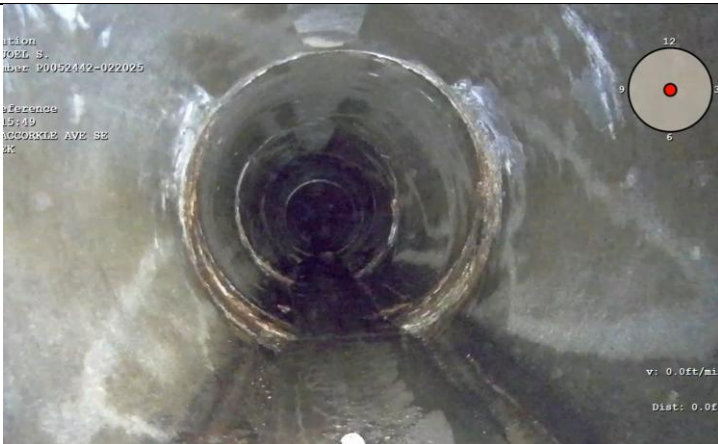
The remaining concrete storm drain beneath the CCR unit from the newly installed manhole to the existing manhole near the intersection of Grady Street and Appalachian Street was hydro-jetted to remove accumulated sediment and subsequently inspected using closed-circuit television (CCTV). The post-cleaning CCTV inspection confirmed that sediment accumulation had been successfully removed and that the storm drain is unobstructed and in generally good functional condition. The CCTV inspection identified no significant structural deficiencies

Photograph 10.  
Screenshot taken from video  
pipe inspection showing the  
condition of the storm drainpipe  
after cleaning.

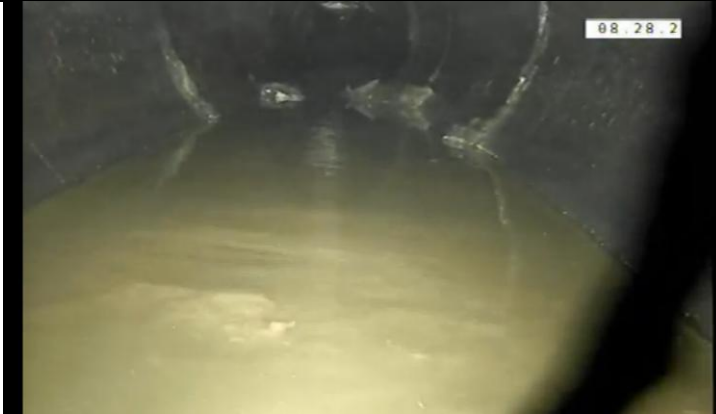
Photograph 11.  
Screenshot taken from video  
pipe inspection, showing  
condition of the storm drainpipe  
before hydro jetting.

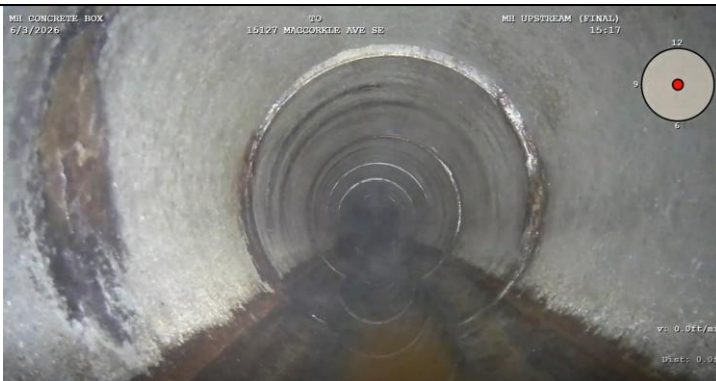
Photograph 12.  
Screenshot taken from video  
pipe inspection showing the  
condition of the storm drainpipe  
after cleaning.

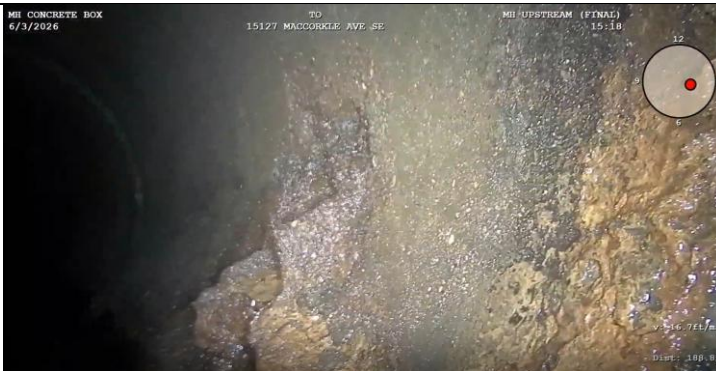
Photograph 13. View of the 4"  
diameter sanitary sewer tie into  
the 24" concrete pipe.
