INITIAL STRUCTURAL STABILITY ASSESSMENT

40 CFR 257.73 (d)

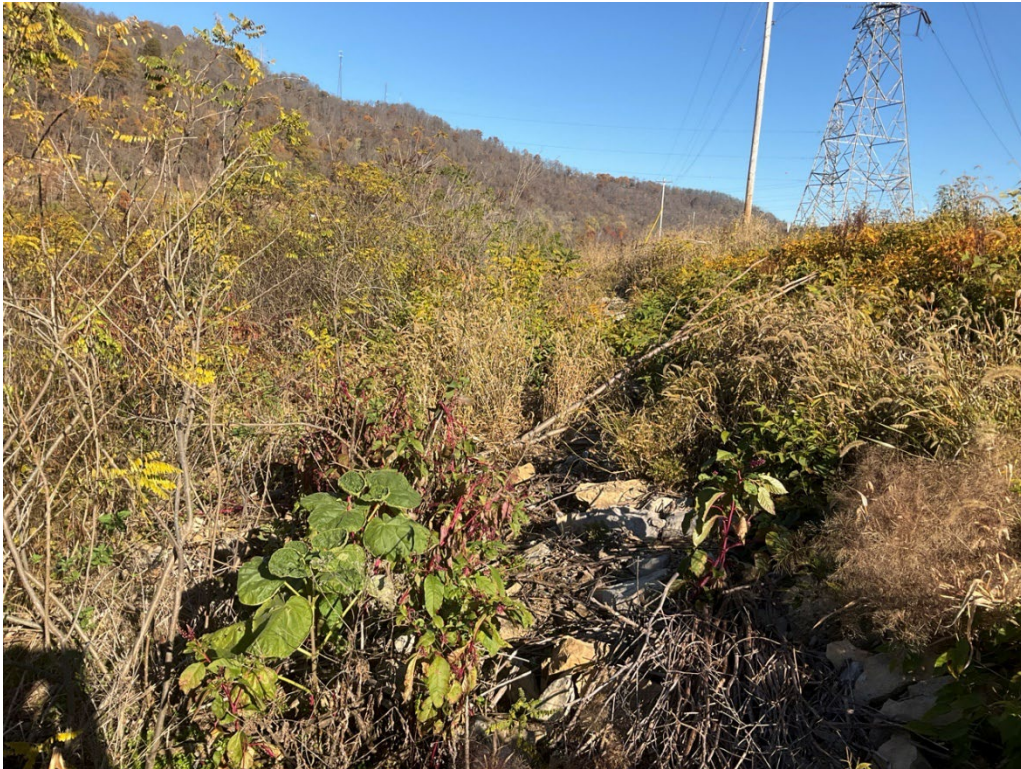
Photograph 1: View of the exterior dike slope looking north. Note rip rap observed along slope.

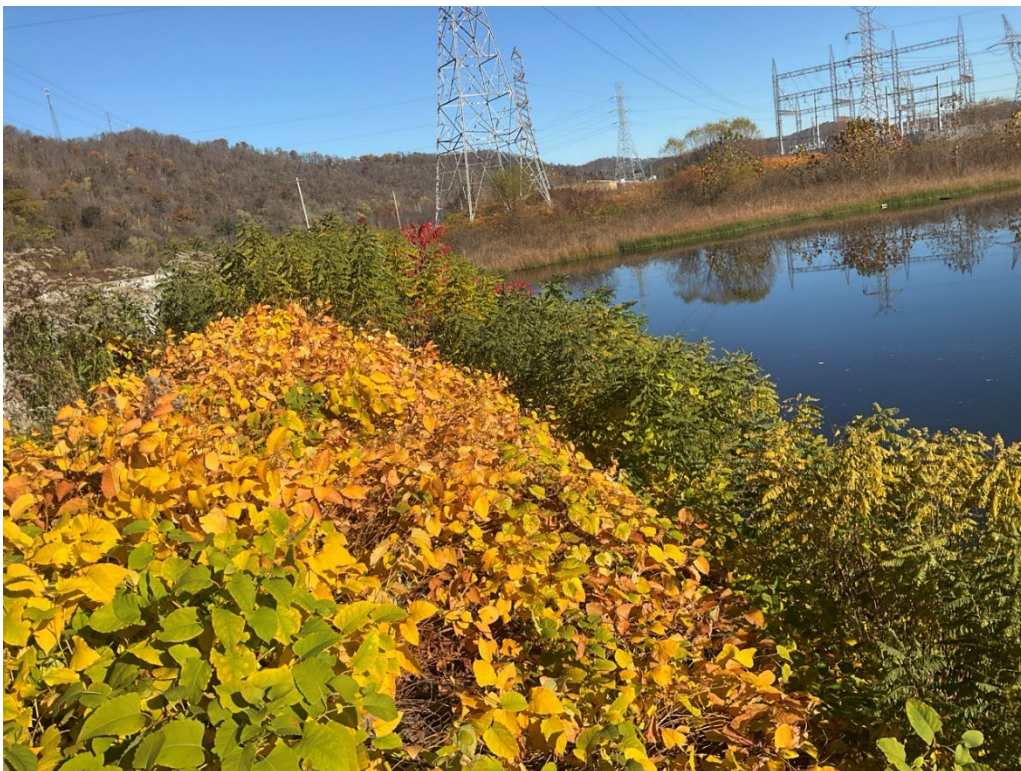
Photograph 2: View of the interior dike slope looking north.

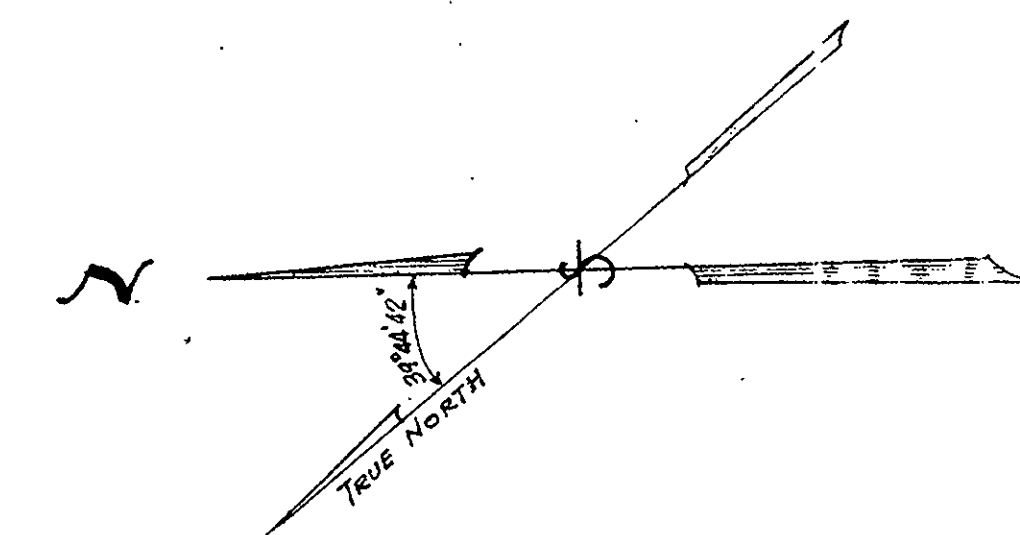
GENERAL NOTES
 High Water (1936) = EL 651.0
 Modified High Water = EL 646.0
 Normal Pool = EL 600.0
 Design Low Water = EL 607.5
 Tidal Grade at Flood = EL 609.0 (Varies)
 Flood Road Elevation for EL 699.0
 For Removal of soft material and replacement of this material, locate on Dwg 12-3005
 For location of OBSERVATION WELLS, see Dwg 12-3005
