**ALTERNATIVE SOURCE
DEMONSTRATION REPORT
FEDERAL CCR RULE**

**H.W. Pirkey Power Plant
West Bottom Ash Pond
Hallsville, Texas**

December 2020

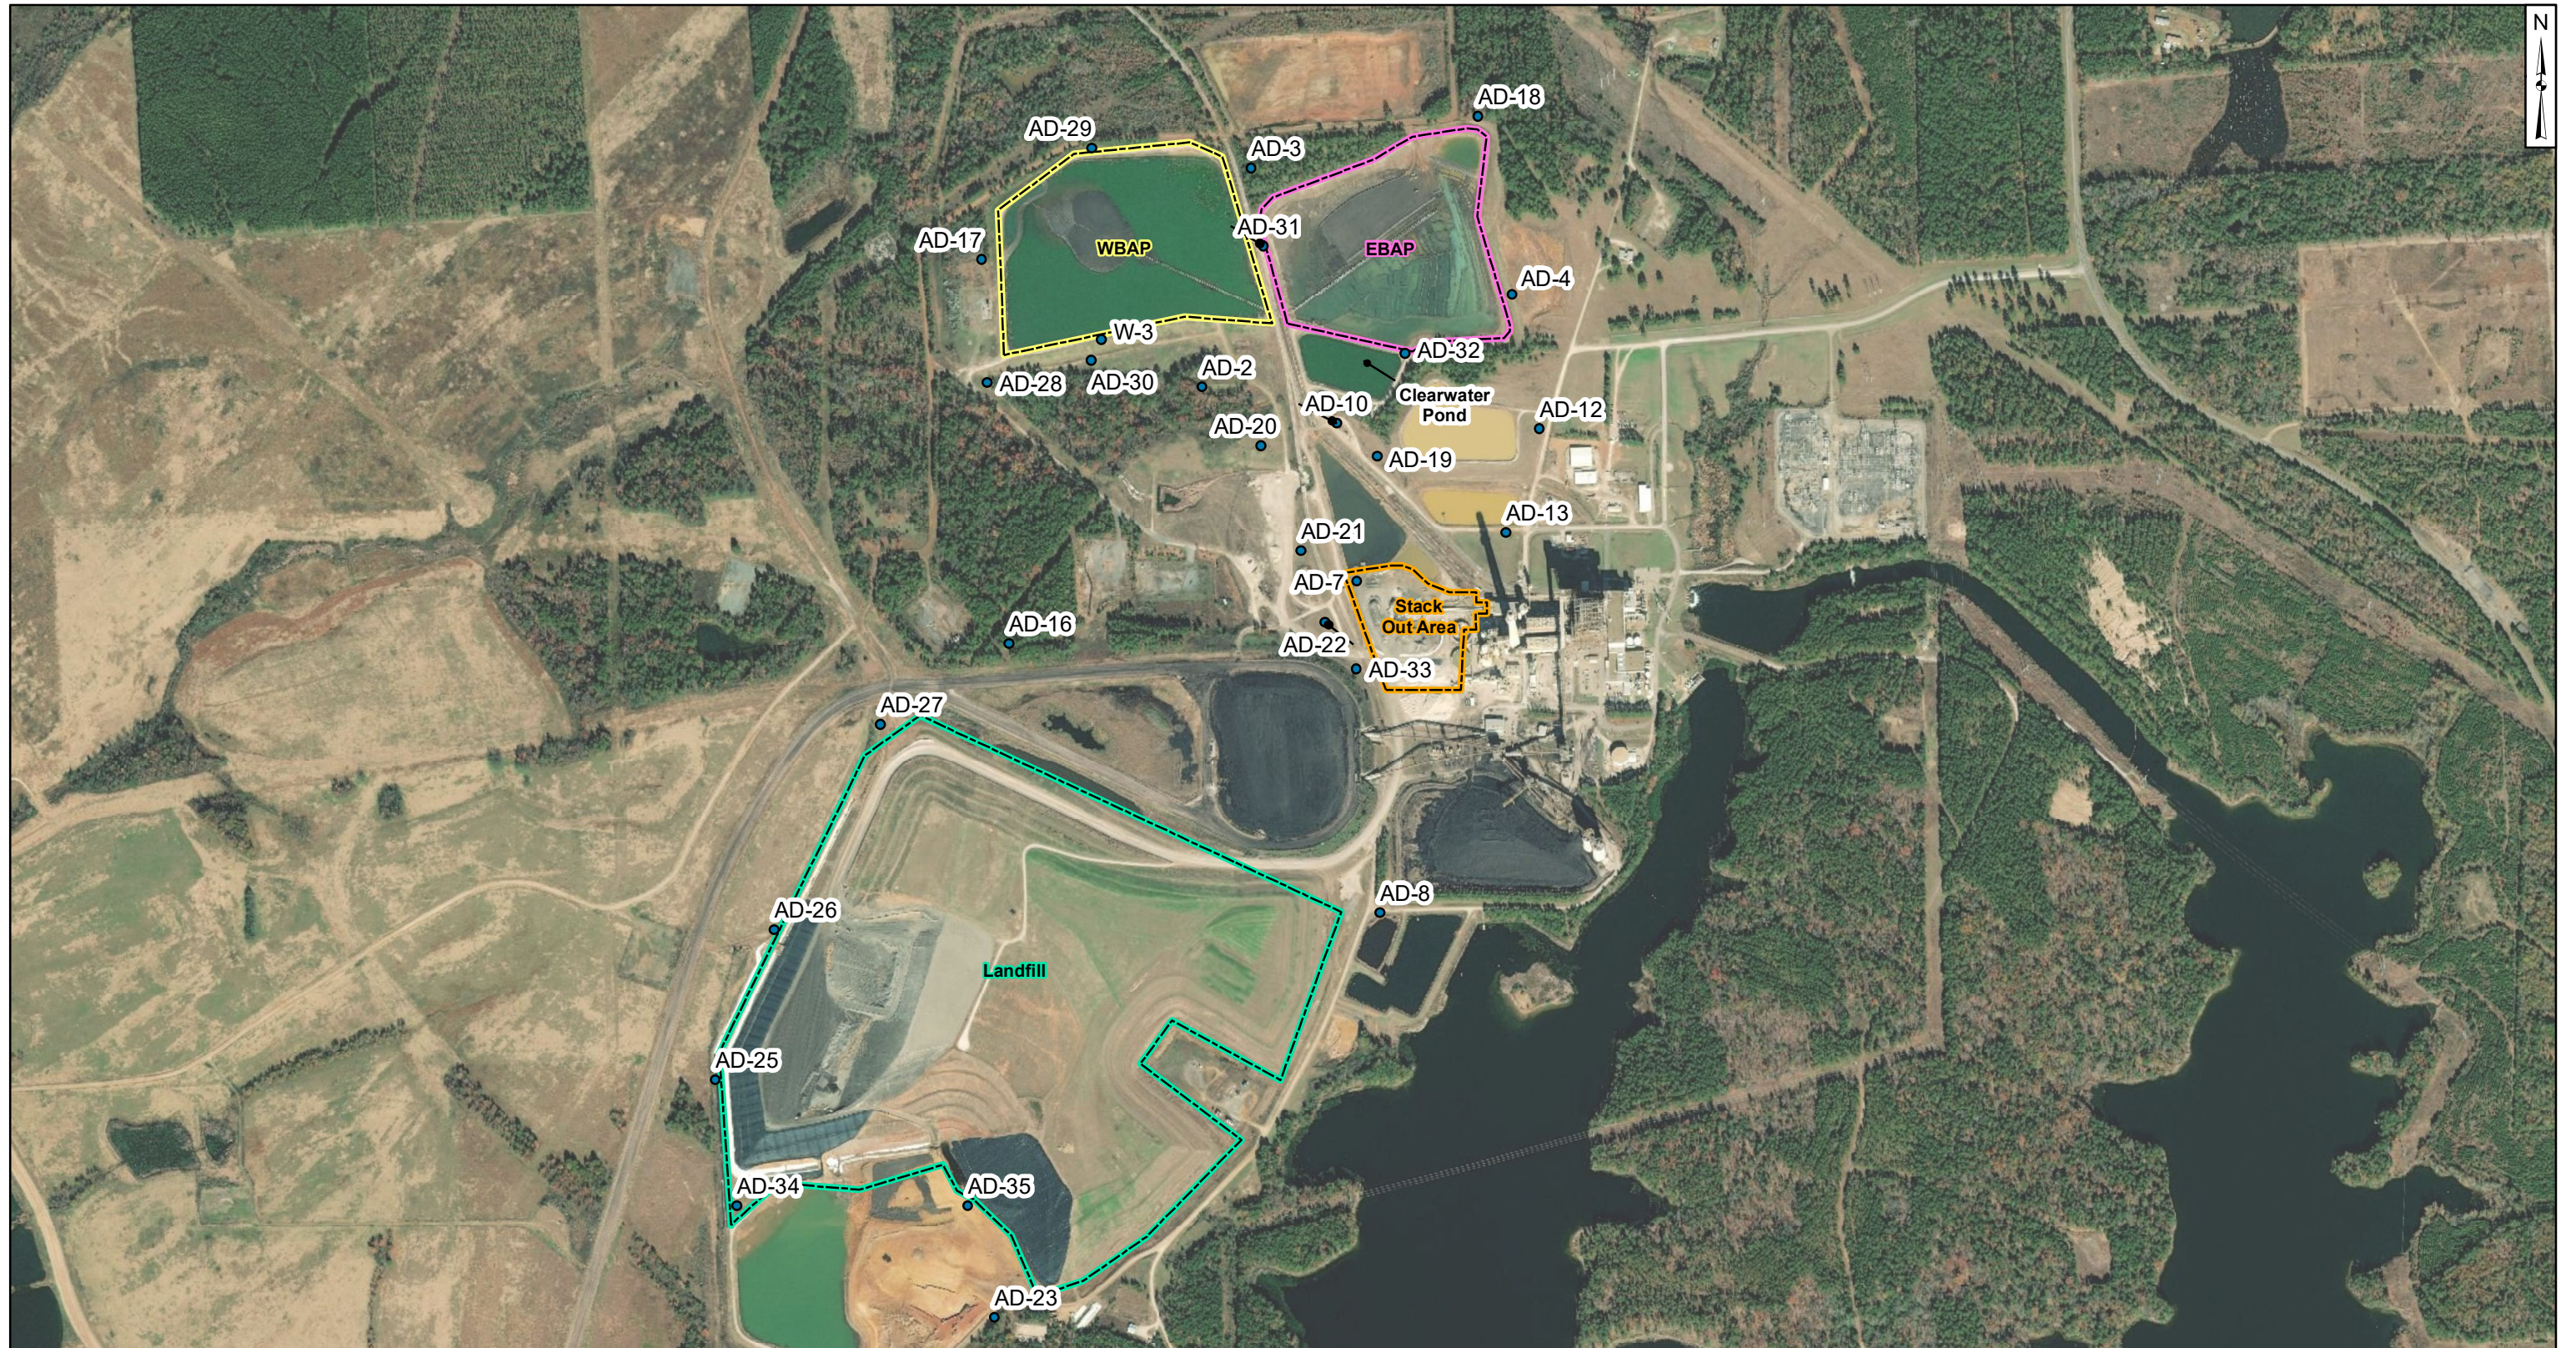
1

Site Layout

The H.W. Pirkey Plant, located in Hallsville, Texas, has four regulated coal combustion residuals (CCR) storage units, including the West Bottom Ash Pond (**Figure 1**). In June 2020, a semi-annual assessment monitoring event was conducted at the WBAP in accordance with 40 CFR 257.95(d)(1). The monitoring data were submitted to Groundwater Stats Consulting, LLC (GSC) for statistical analysis. Groundwater protection standards (GWPSs) were established for each Appendix IV parameter in accordance with the statistical analysis plan developed for the facility (AEP, 2017) and United States Environmental Protection Agency's (USEPA) *Statistical Analysis of Groundwater Monitoring Data at RCRA Facilities – Unified Guidance* (Unified Guidance; USEPA, 2009). The GWPS for each parameter was established as the greater of the background concentration and the maximum contaminant level (MCL) or, for constituents without an MCL, the risk-based level specified in 40 CFR 257.95(h)(2). To determine background concentrations, an upper tolerance limit (UTL) was calculated using pooled data from the background wells collected during the background monitoring and assessment monitoring events.

Monitoring well AD-28 is located near the southwest corner of the WBAP, as shown in **Figure 1**. Previous ASDs for cobalt at the WBAP provided evidence to show that cobalt is present in the aquifer media at the site and that the observed cobalt concentrations were due to natural variation (Geosyntec, 2019a; Geosyntec, 2019b; Geosyntec, 2020b). The previous ASDs discussed how the WBAP itself did not appear to be a source for cobalt in downgradient groundwater, based on observed concentrations of cobalt both in the ash material and in leachate from Synthetic Precipitation Leaching Procedure (SPLP) analysis (SW-864 Test Method 1312, [USEPA, 1994]) of the ash material. Cobalt was not detected in the SPLP leachate above the reporting limit of 0.01 mg/L (**Table 1**).

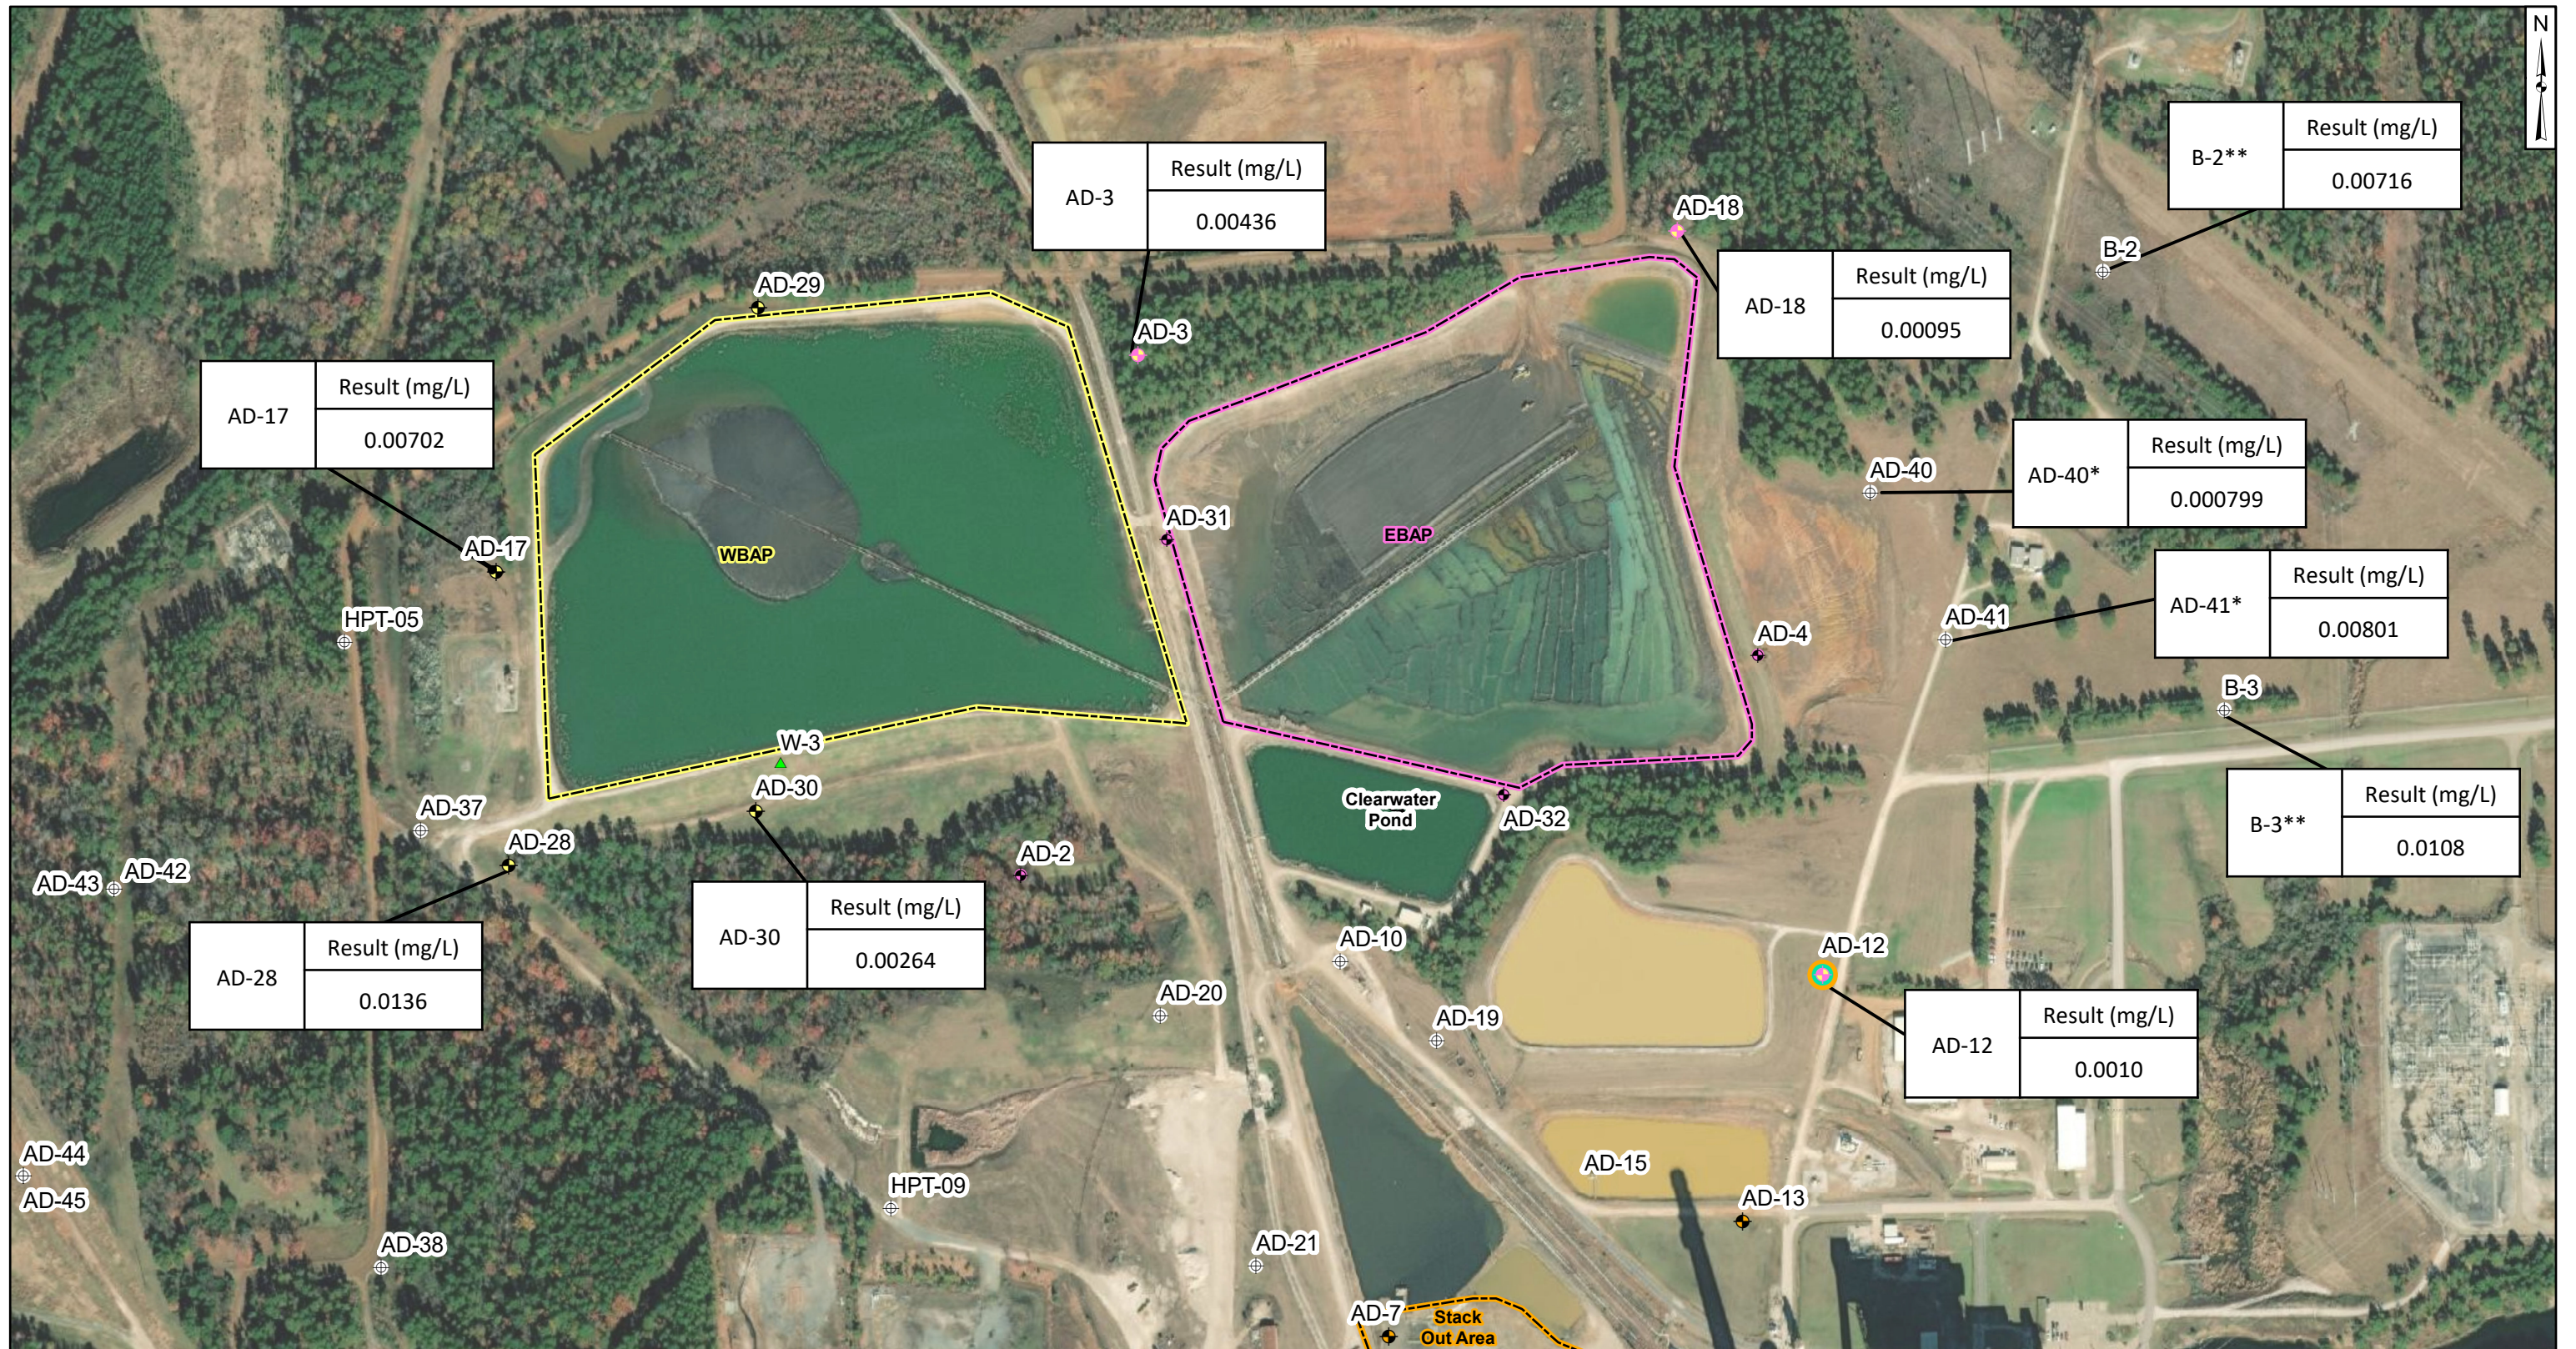
Cobalt Distribution in Groundwater	
AEP Pirkey Power Plant Hallsville, Texas	
Geosyntec consultants	
Columbus, Ohio	2020/12/22
Figure 2

- Monitoring well coordinates, site features, and data provided by AEP.
- AD-15 location is approximated
- Samples collected in June 2020
- * - Well most recently sampled August 2019
- ** - Well most recently sampled November 2020
- AD-29 included in the well network for water level measurements only

To support this ASD determination, a grab sample of the pond water was collected from the WBAP on November 4, 2020. Cobalt was detected at a concentration of 0.000501 mg/L in the WBAP sample (**Table 1**). This concentration is lower than all reported cobalt concentrations for in network wells from the most recent sampling event, and over an order of magnitude lower than the average concentration observed at AD-28 (**Figure 2; Table 1**). Thus, the WBAP is not the likely source of cobalt at AD-28.

Groundwater cobalt concentrations at the Site vary considerably, even within upgradient monitoring wells. The most recent cobalt concentrations from upgradient wells vary from 0.000799 mg/L at AD-40 to 0.0108 mg/L at B-3 (**Figure 2**). The reported cobalt concentration at downgradient well AD-28, which was identified as an exceedance, was only slightly above the value reported at B-3. The range of cobalt concentrations provides evidence for natural variation of cobalt at the Site, particularly as the concentration at upgradient well B-3 exceeds the GWPS for the WBAP.

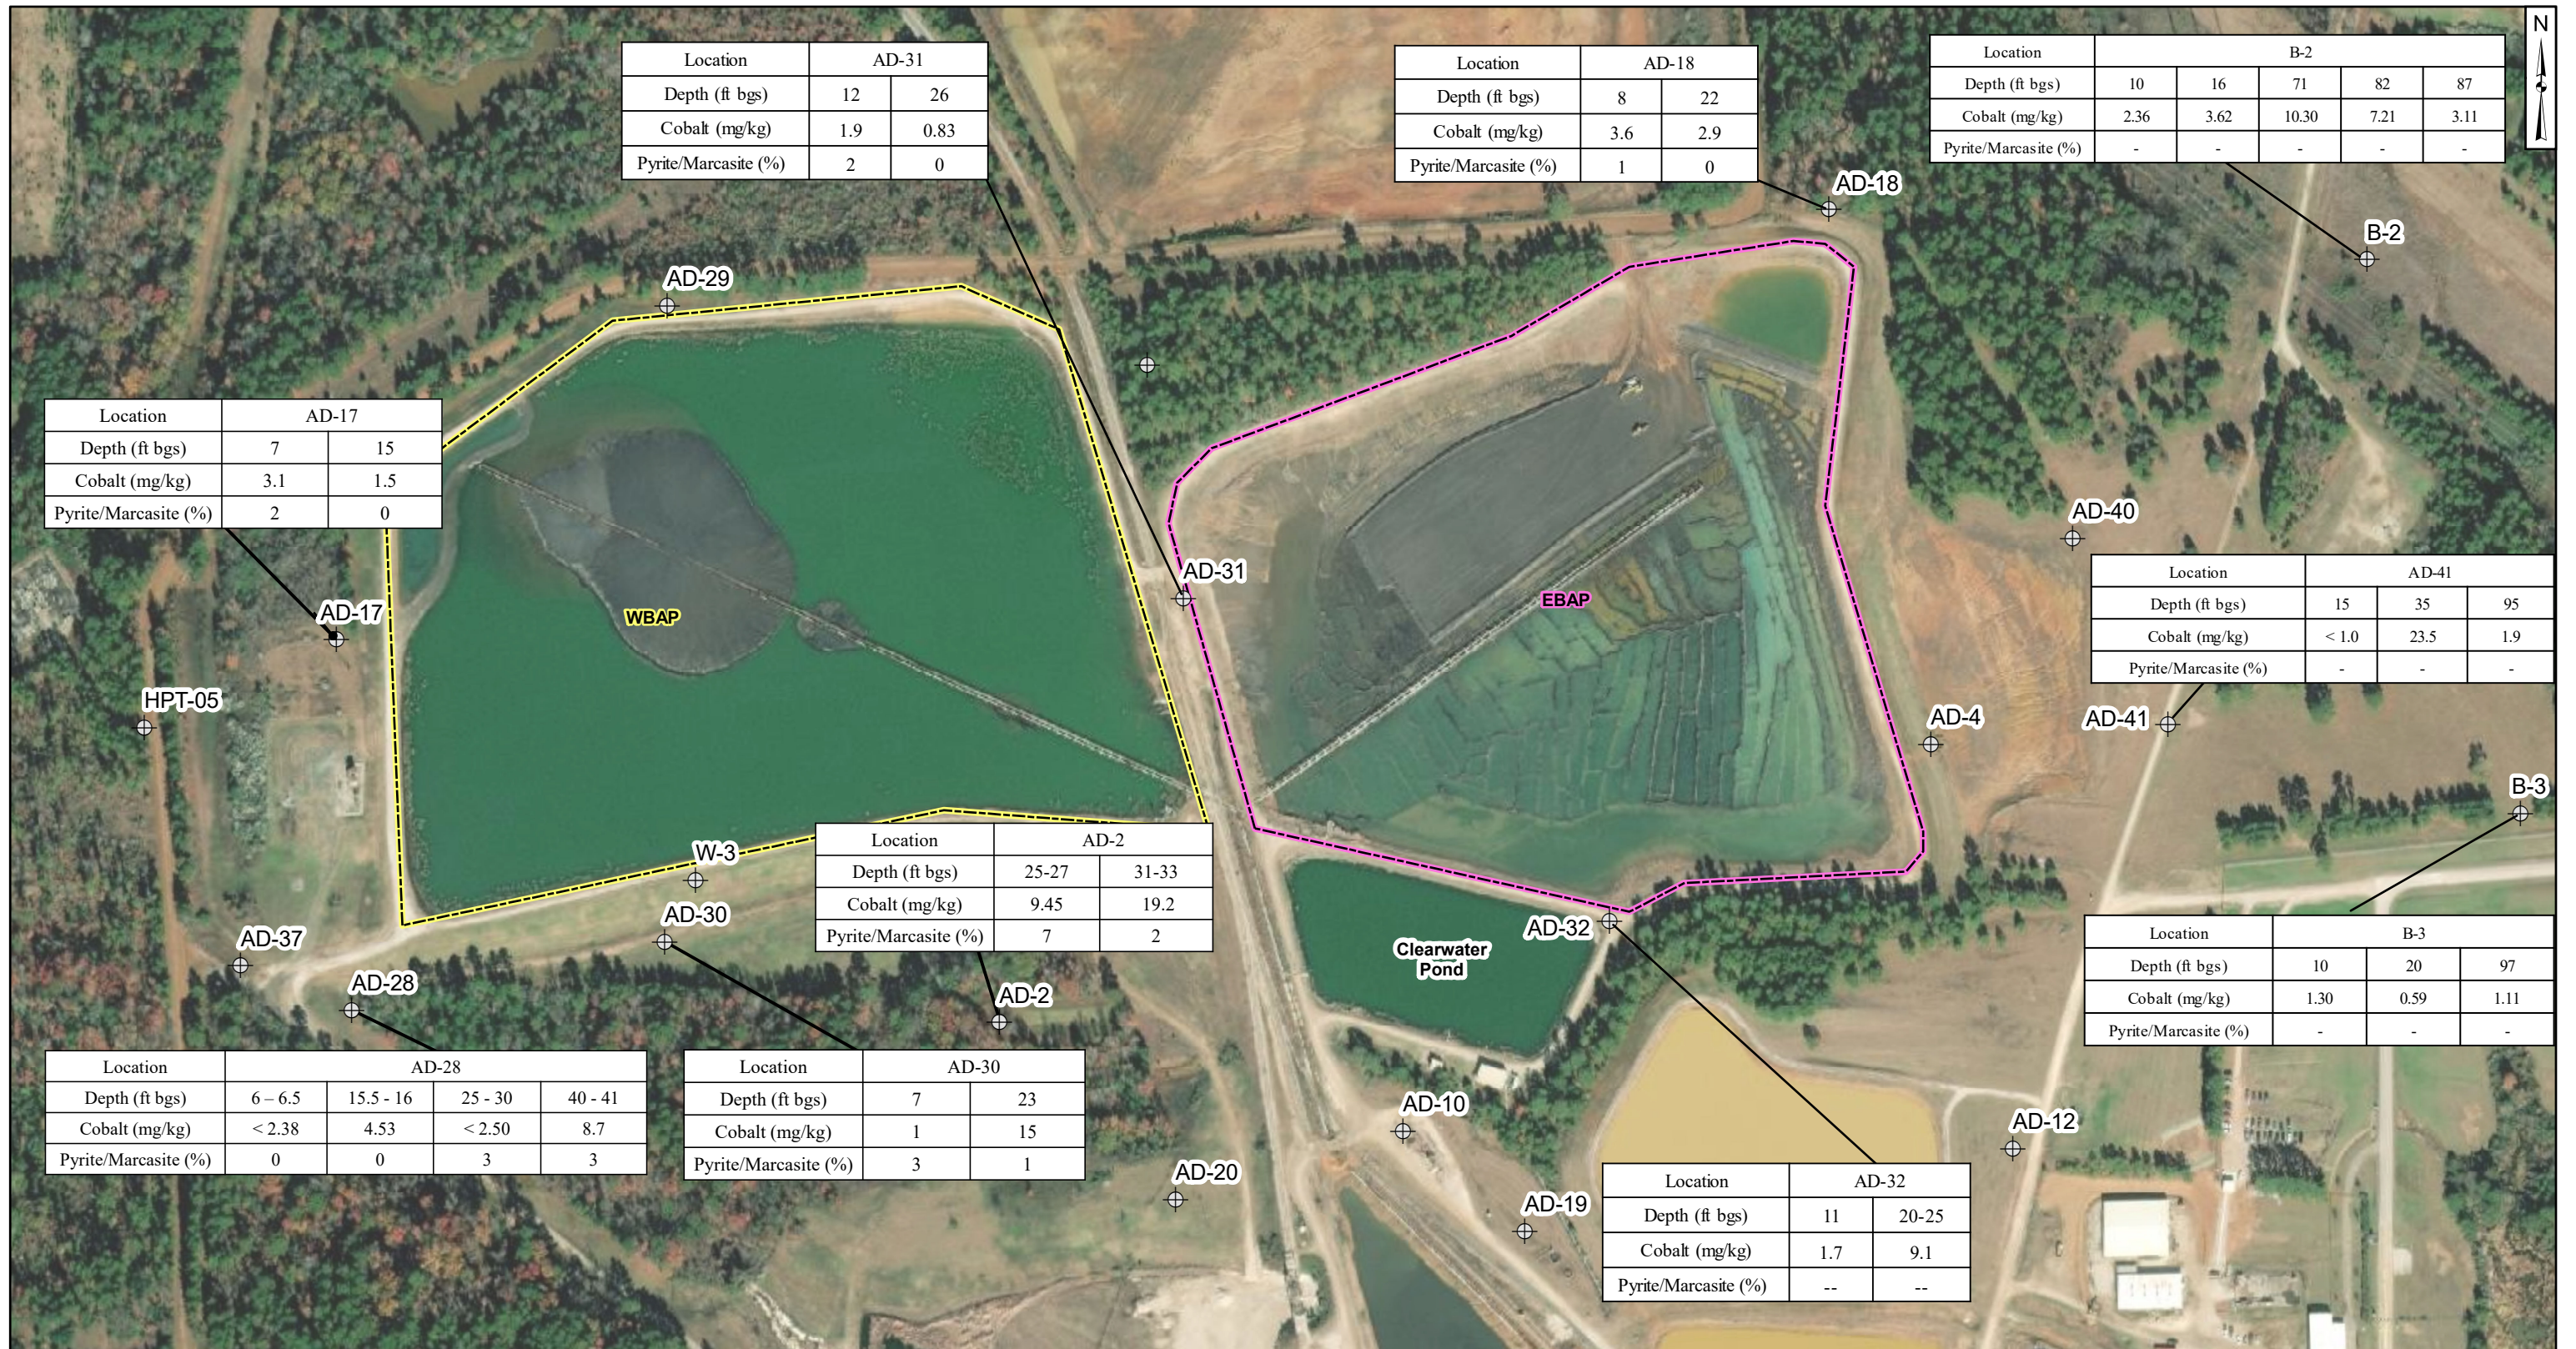
Figure
3

- Monitoring well coordinates provided by AEP.
- AD-2 and AD-28 samples collected on April 20, 2020
- All other data provided by AEP, 2019.
- ft bgs: feet below ground surface.
- mg/kg: milligrams per kilogram.
- -- not analyzed.

Cobalt Distribution in Soil

As noted in the previous ASDs, soil samples collected across the site, including from locations near the WBAP, identified cobalt in the aquifer solids at varying concentrations. SB-28 was advanced in the vicinity of AD-28 in April 2020 to re-log the geology at AD-28 and collect samples for laboratory analysis of total metals and mineralogy. The SB-28 field boring log, generated by Auckland Consulting LLC, is provided as **Attachment A**. Cobalt was identified at SB-28 at concentrations of 4.53 milligrams per kilogram (mg/kg) at 15.5-16 feet below ground surface (bgs) and 8.70 mg/kg at 40-41 feet bgs (**Table 2**). The 15.5-16 feet bgs interval at SB-28 correlates to the depth of the monitoring well screen of AD-28 (15-35 feet bgs), indicating that cobalt is present in aquifer solids within the AD-28 screened interval. Cobalt was also identified in the aquifer solids at varying concentrations at other locations throughout the site, with the highest value of 23.5 mg/kg reported at AD-41, which is upgradient of the WBAP (**Figure 3**).

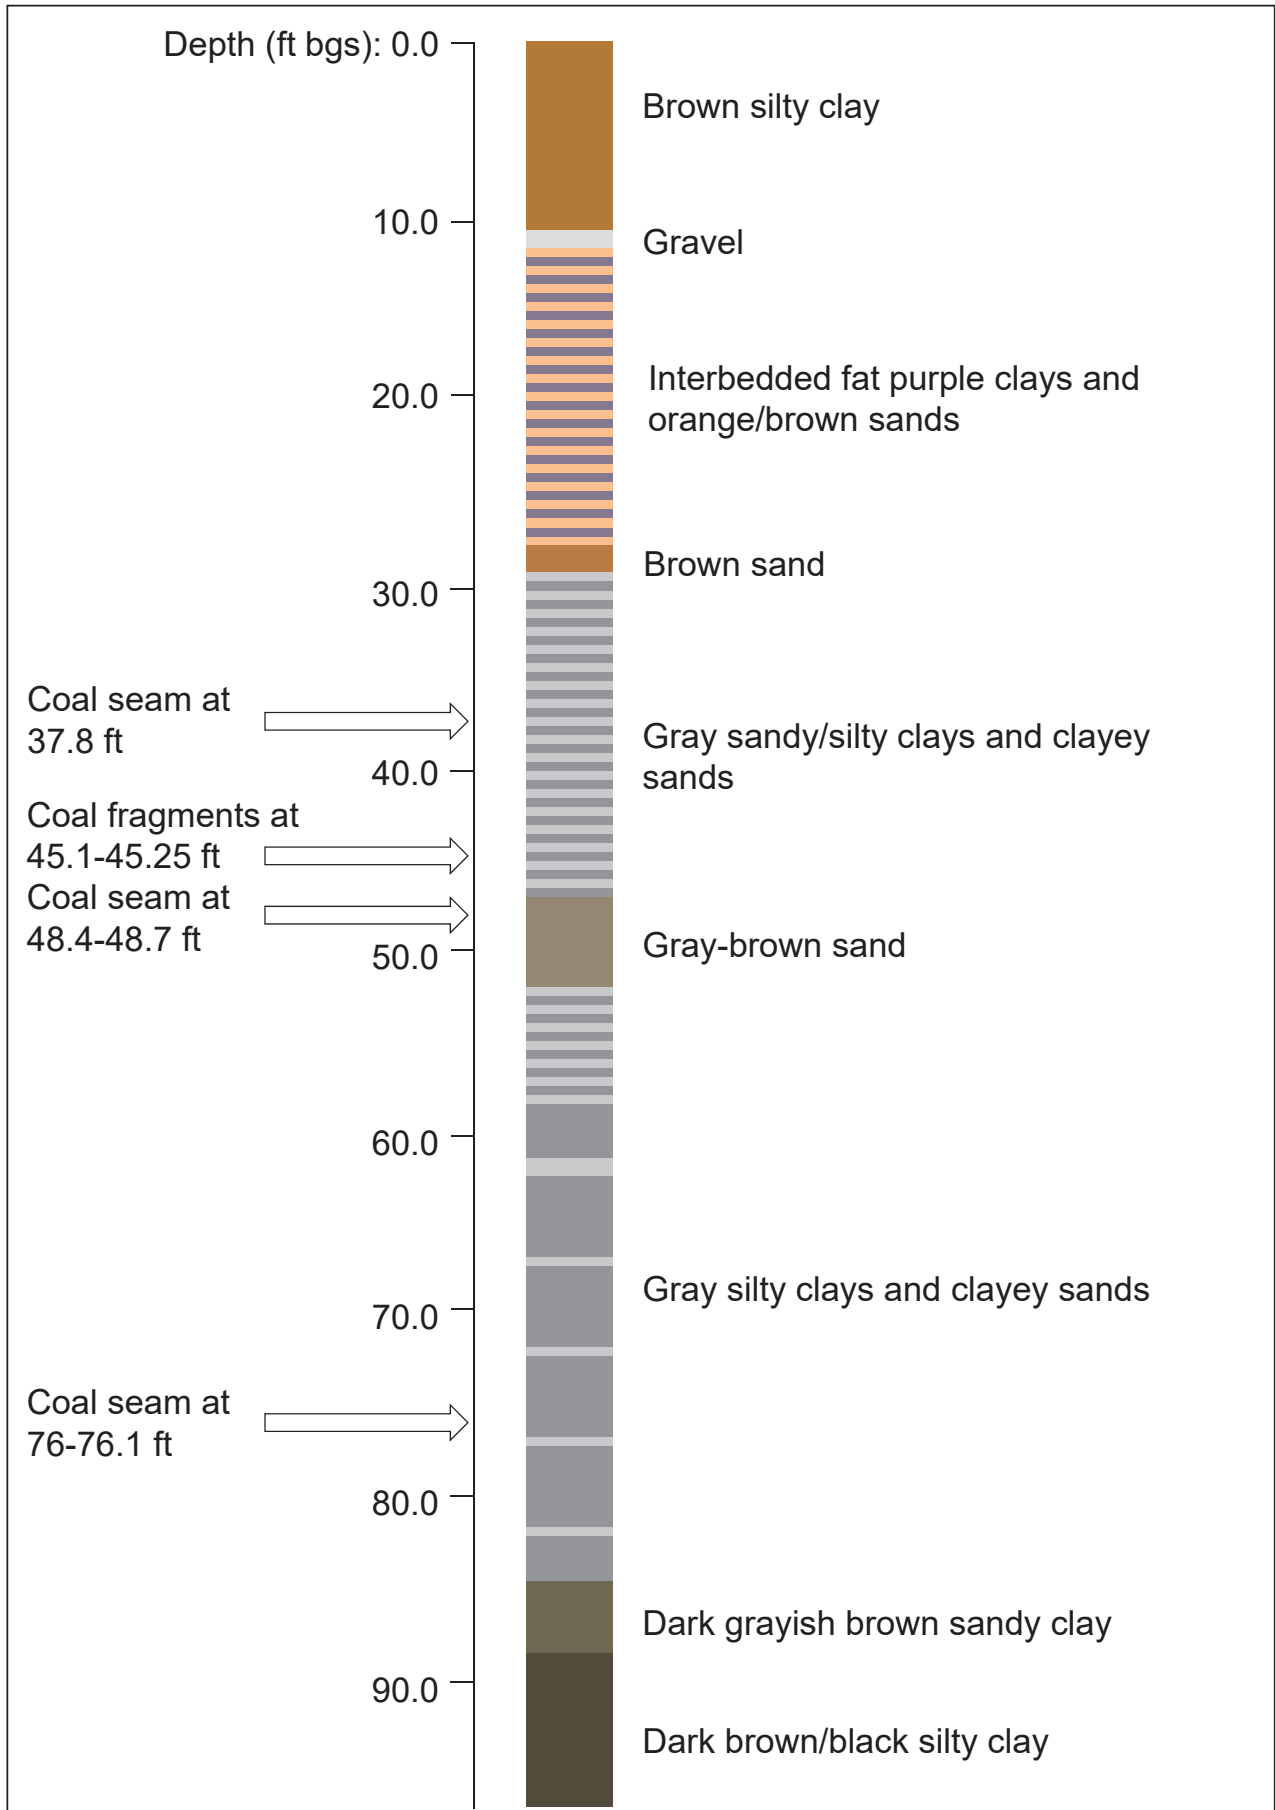
4

- Notes:
- Ft = feet
 - Bgs = below ground surface
 - Boring completed May 2019
 - Total depth of 97.5 ft bgs
 - Well installed in offset boring screened at 29-34 ft bgs

B-3 Visual Boring Log

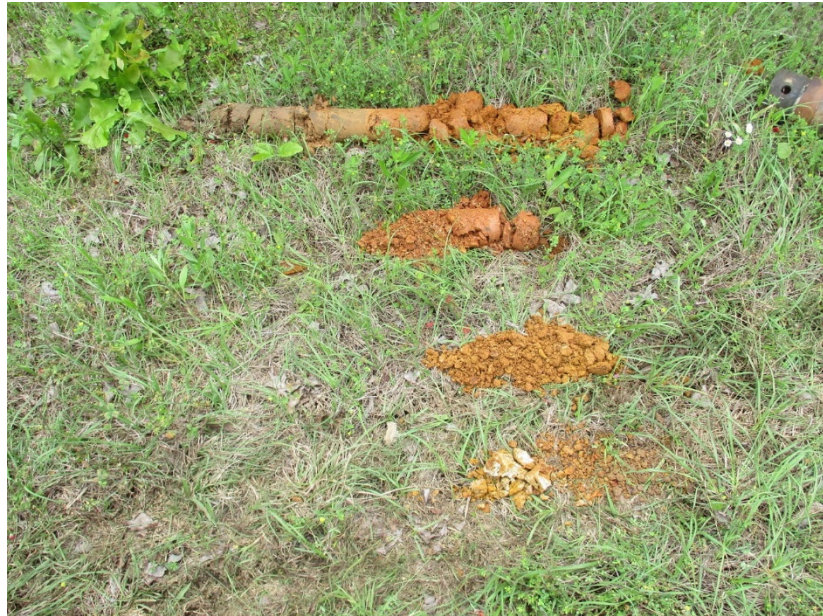
Photograph 1

Comments:
Multiple sections of core from soil boring SB-28 advanced near downgradient monitoring well AD-28 within the Western Bottom Ash Pond (WBAP) CCR unit. 5-foot pushes were used. Note the reddish color indicating the presence of oxidized iron-bearing minerals.

The aquifer solids at SB-28 are distinctly red in color at shallow depths, as illustrated in the photolog of soil cores provided in **Attachment B**. Red color in soils is often associated with the presence of oxidized iron-bearing minerals such as hematite and goethite. Goethite, an iron oxide mineral (FeOOH), was present at depths up to 16 ft bgs at SB-28 at up to 37% of the total aquifer solids (**Table 3**). The weathering of pyrite to goethite under oxidizing conditions is also a well-understood phenomenon, including in formations in east Texas (Senkayi et al., 1986; Dixon et al., 1982). It is likely that the pyrite weathering process is resulting in the release of isomorphically substituted cobalt from the pyrite crystal structure as it undergoes oxidative transformation to iron oxide minerals.

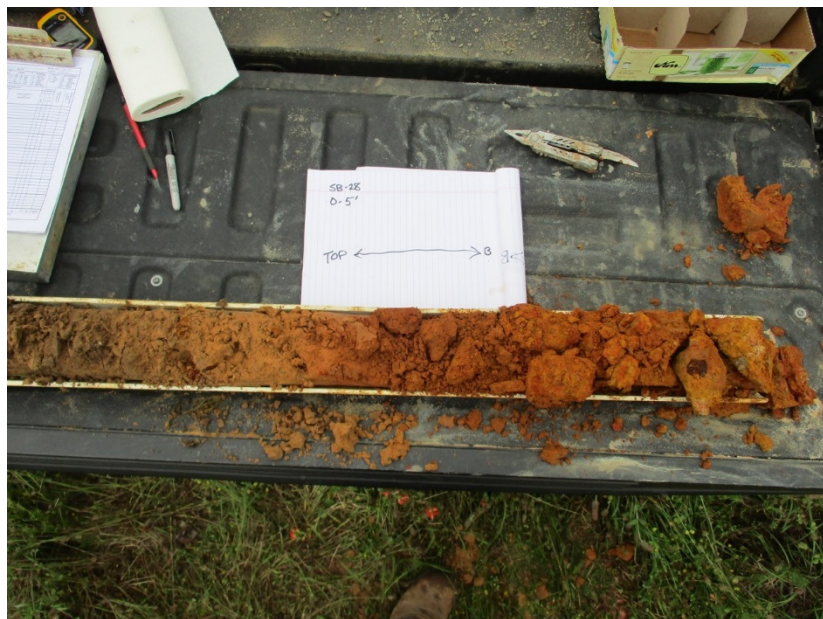
Photograph 2

Comments:
0-5 foot interval of SB-28.

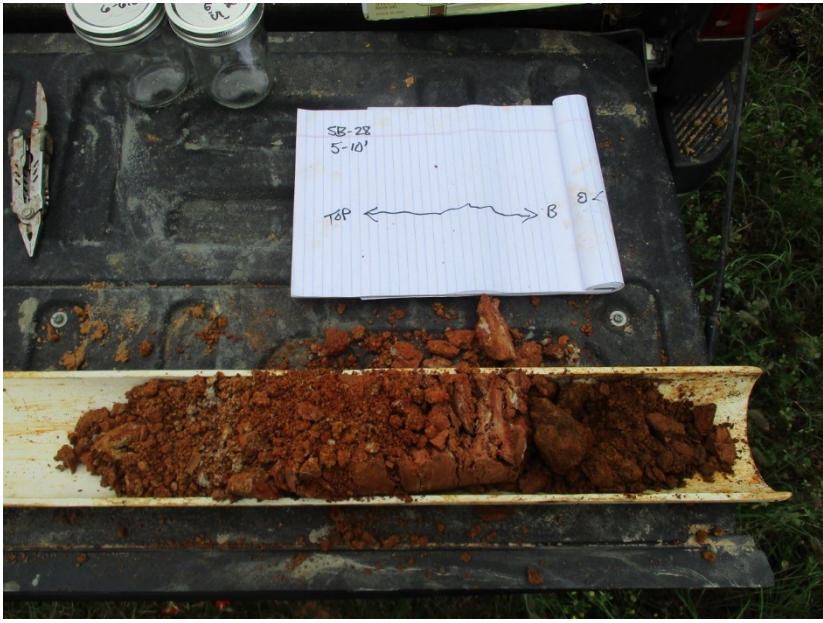
Photograph 3

Comments:
5-10 foot interval of SB-28. Recovery of this interval was limited. A sample was collected from this interval from 6-6.5 ft. below ground surface (bgs).

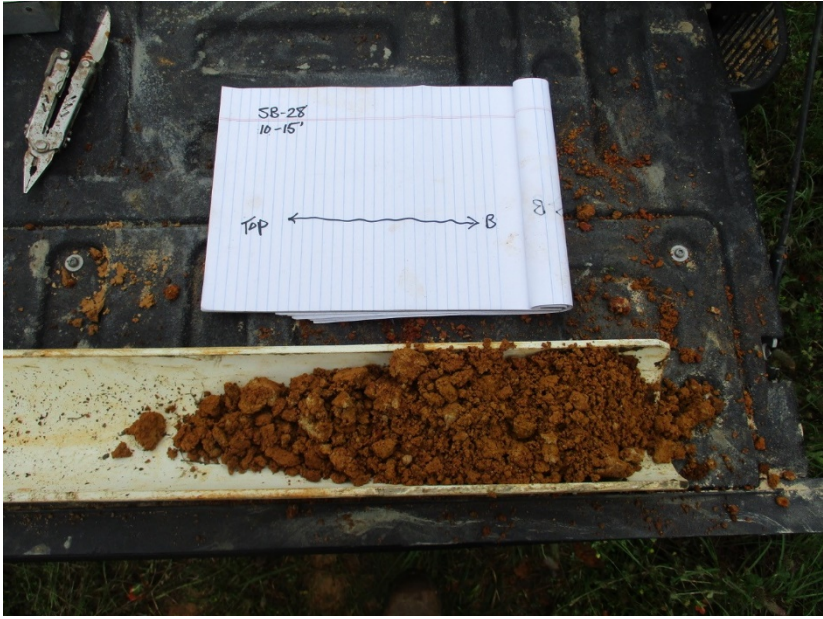
Photograph 4

Comments:
10-15 foot interval of SB-28. Recovery of this interval was limited.

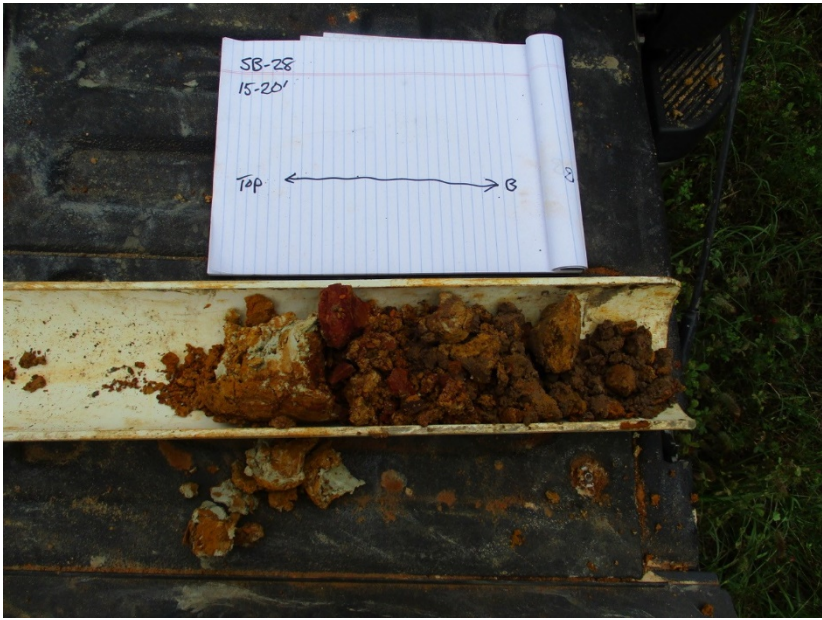
Photograph 5

Comments:
 15-20 foot interval of SB-28. Recovery of this interval was limited. A sample was collected from this interval from 15.5-16 ft. bgs.

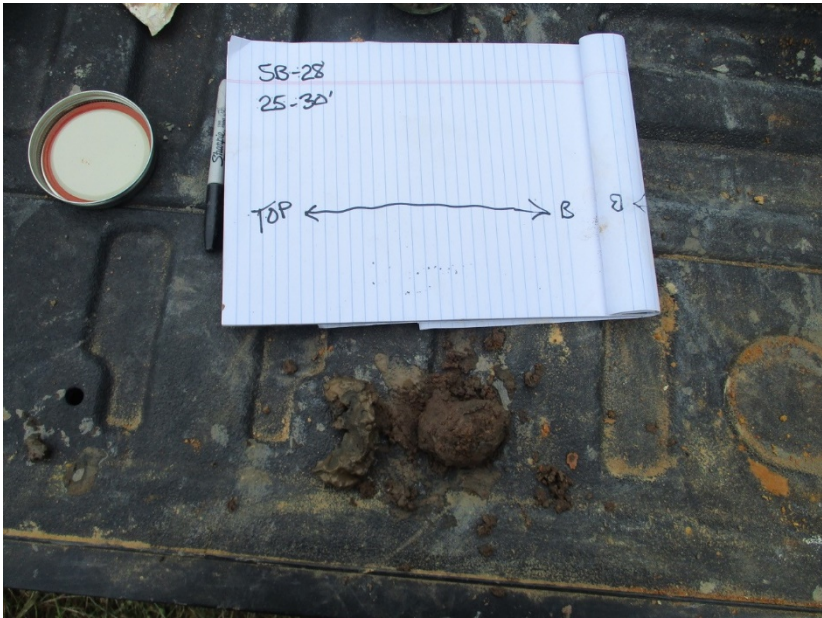
Photograph 7

Comments:
25-30 foot interval of SB-28. Very little of this interval was recovered. Note the color change of the soil from red to dark brown/black. A sample was collected from this interval.

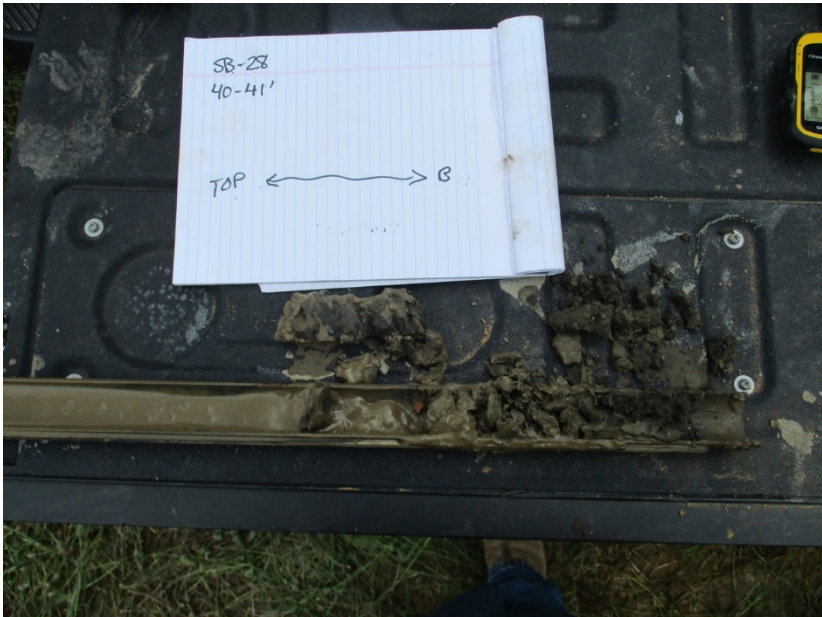
Photograph 8

Comments:
Bottom of SB-28. The boring log indicates no recovery of soil from the 30-40 foot interval. A sample was collected from this interval.

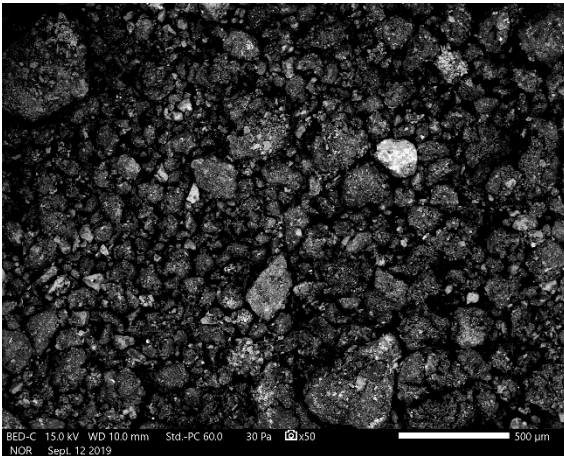
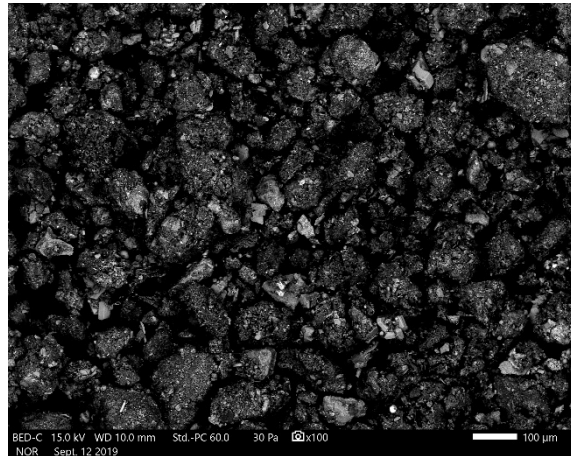
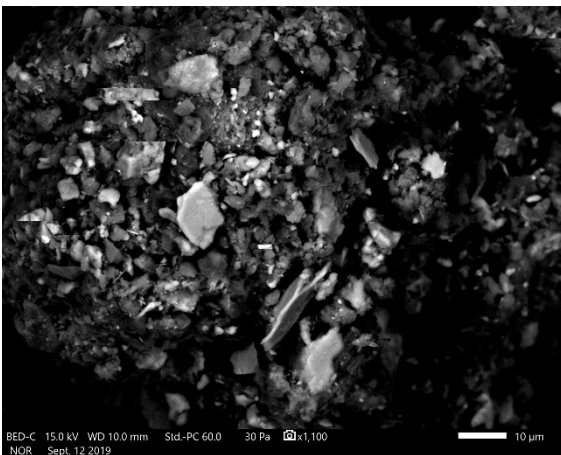
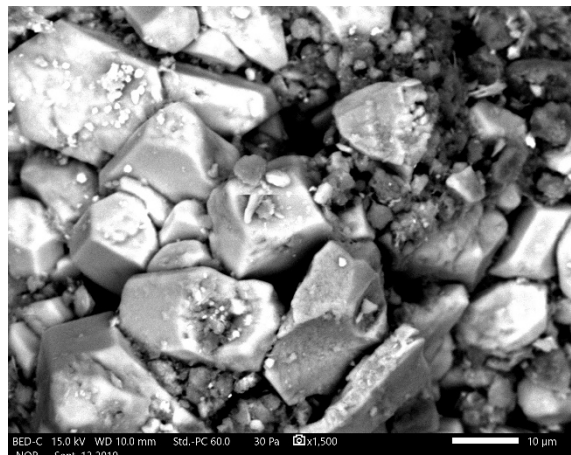
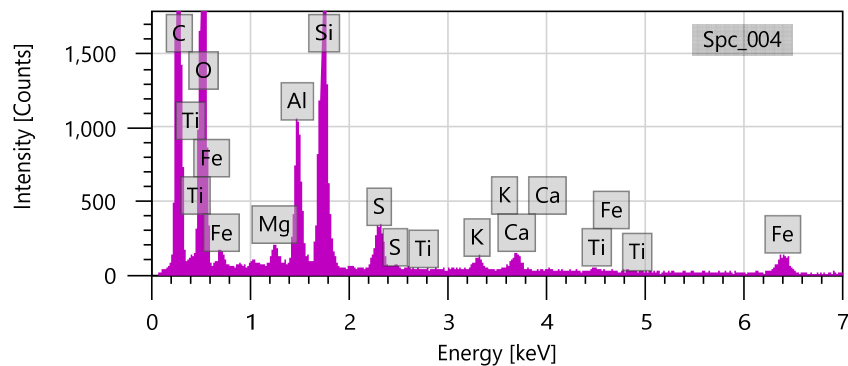
Lignite. Backscattered electron micrographs show the sample at 100X, 1,100X, and 1,500X. EDS spectrum at bottom is an area scan of the region shown in top right micrograph. Bright particles are mostly quartz and feldspar. Major peaks for carbon, oxygen, silicon, and aluminum suggest coal and clay.

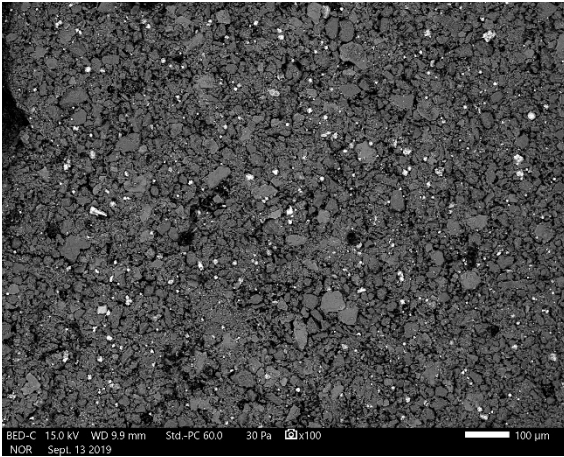
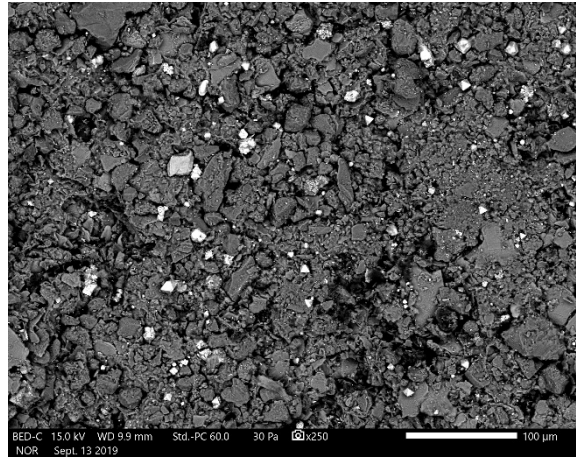
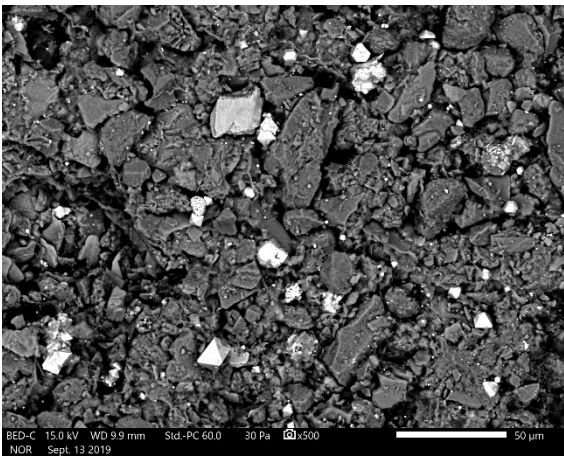
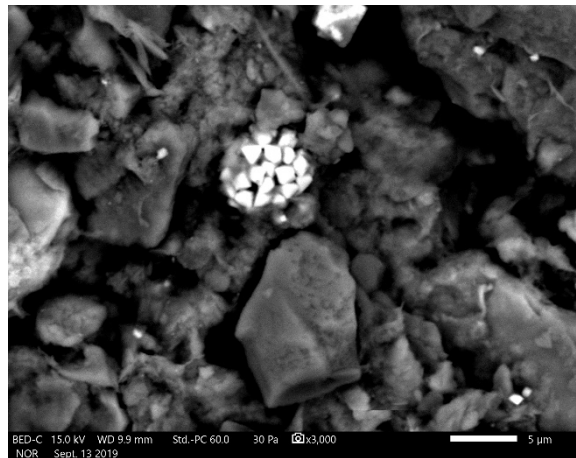
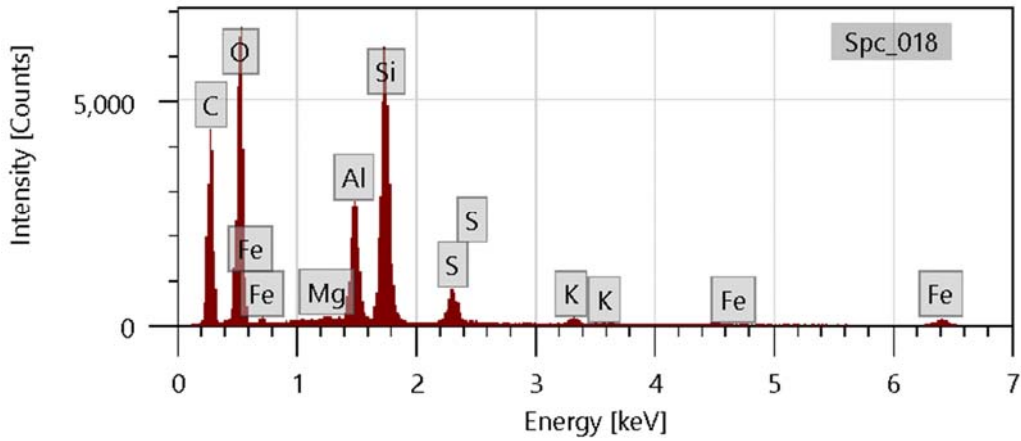
Sample VAP B3 40-45. Backscattered electron micrographs show the sample at 100X, 250X, 500X, and 3000X. EDS spectrum at bottom is an area scan of the region shown at 500X. Bright particles are pyrite (framboid in bottom right micrograph). Major peaks for carbon, oxygen, silicon, and aluminum suggest coal and clay.

The solid sample [VAP-B3-(40-45)] was submitted for mineralogical analysis via XRD and scanning electron microscopy (SEM) using an energy dispersive spectroscopic analyzer (EDS). The XRD results identified pyrite as approximately 3% of the solid phase (**Table 4**). Pyrite was identified during SEM/EDS analysis of lignite which is mined immediately adjacent to the site. Logging completed while the VAP boring was advanced identified coal at several intervals, including 45 and 48 ft bgs (**Figure 4**). Furthermore, SEM/EDS of both centrifuged solid samples [VAP-B3-(40-45) and VAP-B3-(50-55)] identified pyrite in backscattered electron micrographs by the distinctive framboidal morphology (Harris et al., 1981; Sawlowicz, 2000). Major peaks involving iron and sulfur were identified in the EDS spectrum, which further support the identification of pyrite (**Attachment C**). While cobalt was not identified in the EDS spectrum, it is likely present at concentrations below the detection limit.

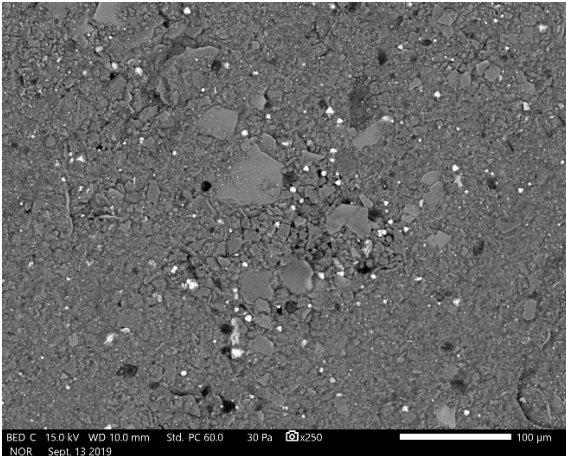
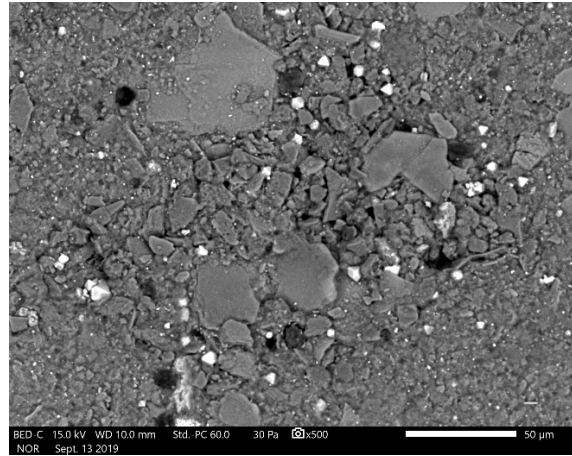
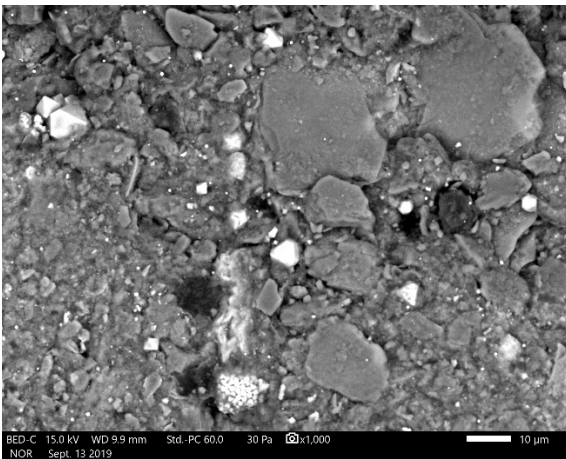
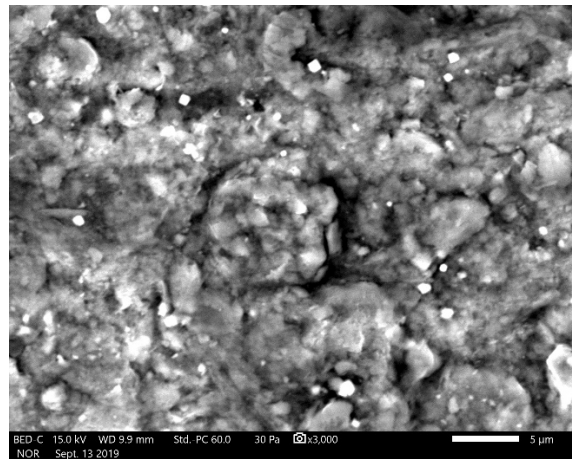
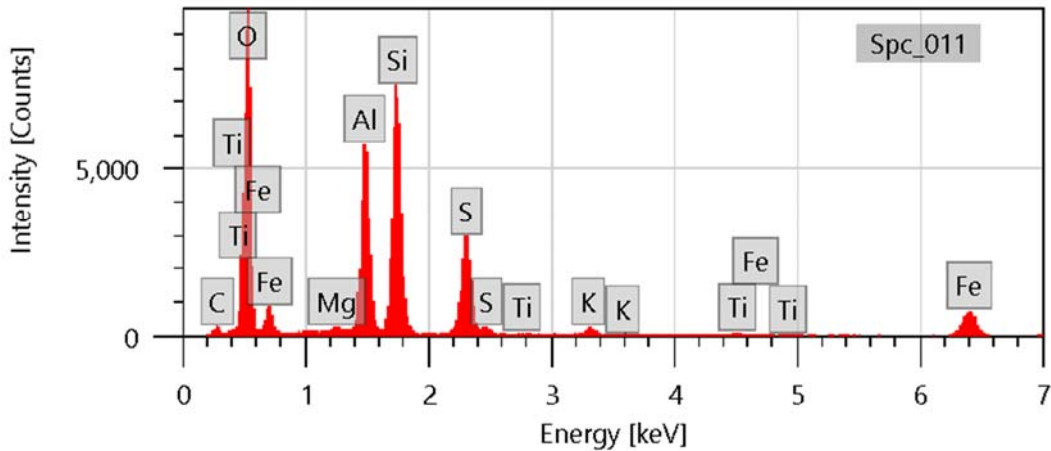
Sample VAP B3 50-55. Backscattered electron micrographs show the sample at 250X, 500X, 1000X, and 3000X. EDS spectrum at bottom is an area scan of the region shown at 3000X. Bright particles are mostly pyrite (framboid in bottom left micrograph); occasional particles of Fe-Ti oxide are detected. Major peaks for oxygen, silicon, and aluminum suggest clay. Large blocky particles are mostly quartz, feldspar, and clay.
