SAFETY FACTOR ASSESSMENT
PERIODIC 5-YEAR REVIEW

30 TAC 352.731 (40 CFR 257.73e)

West Bottom Ash Pond

Pirkey Plant
Hallsville, Texas

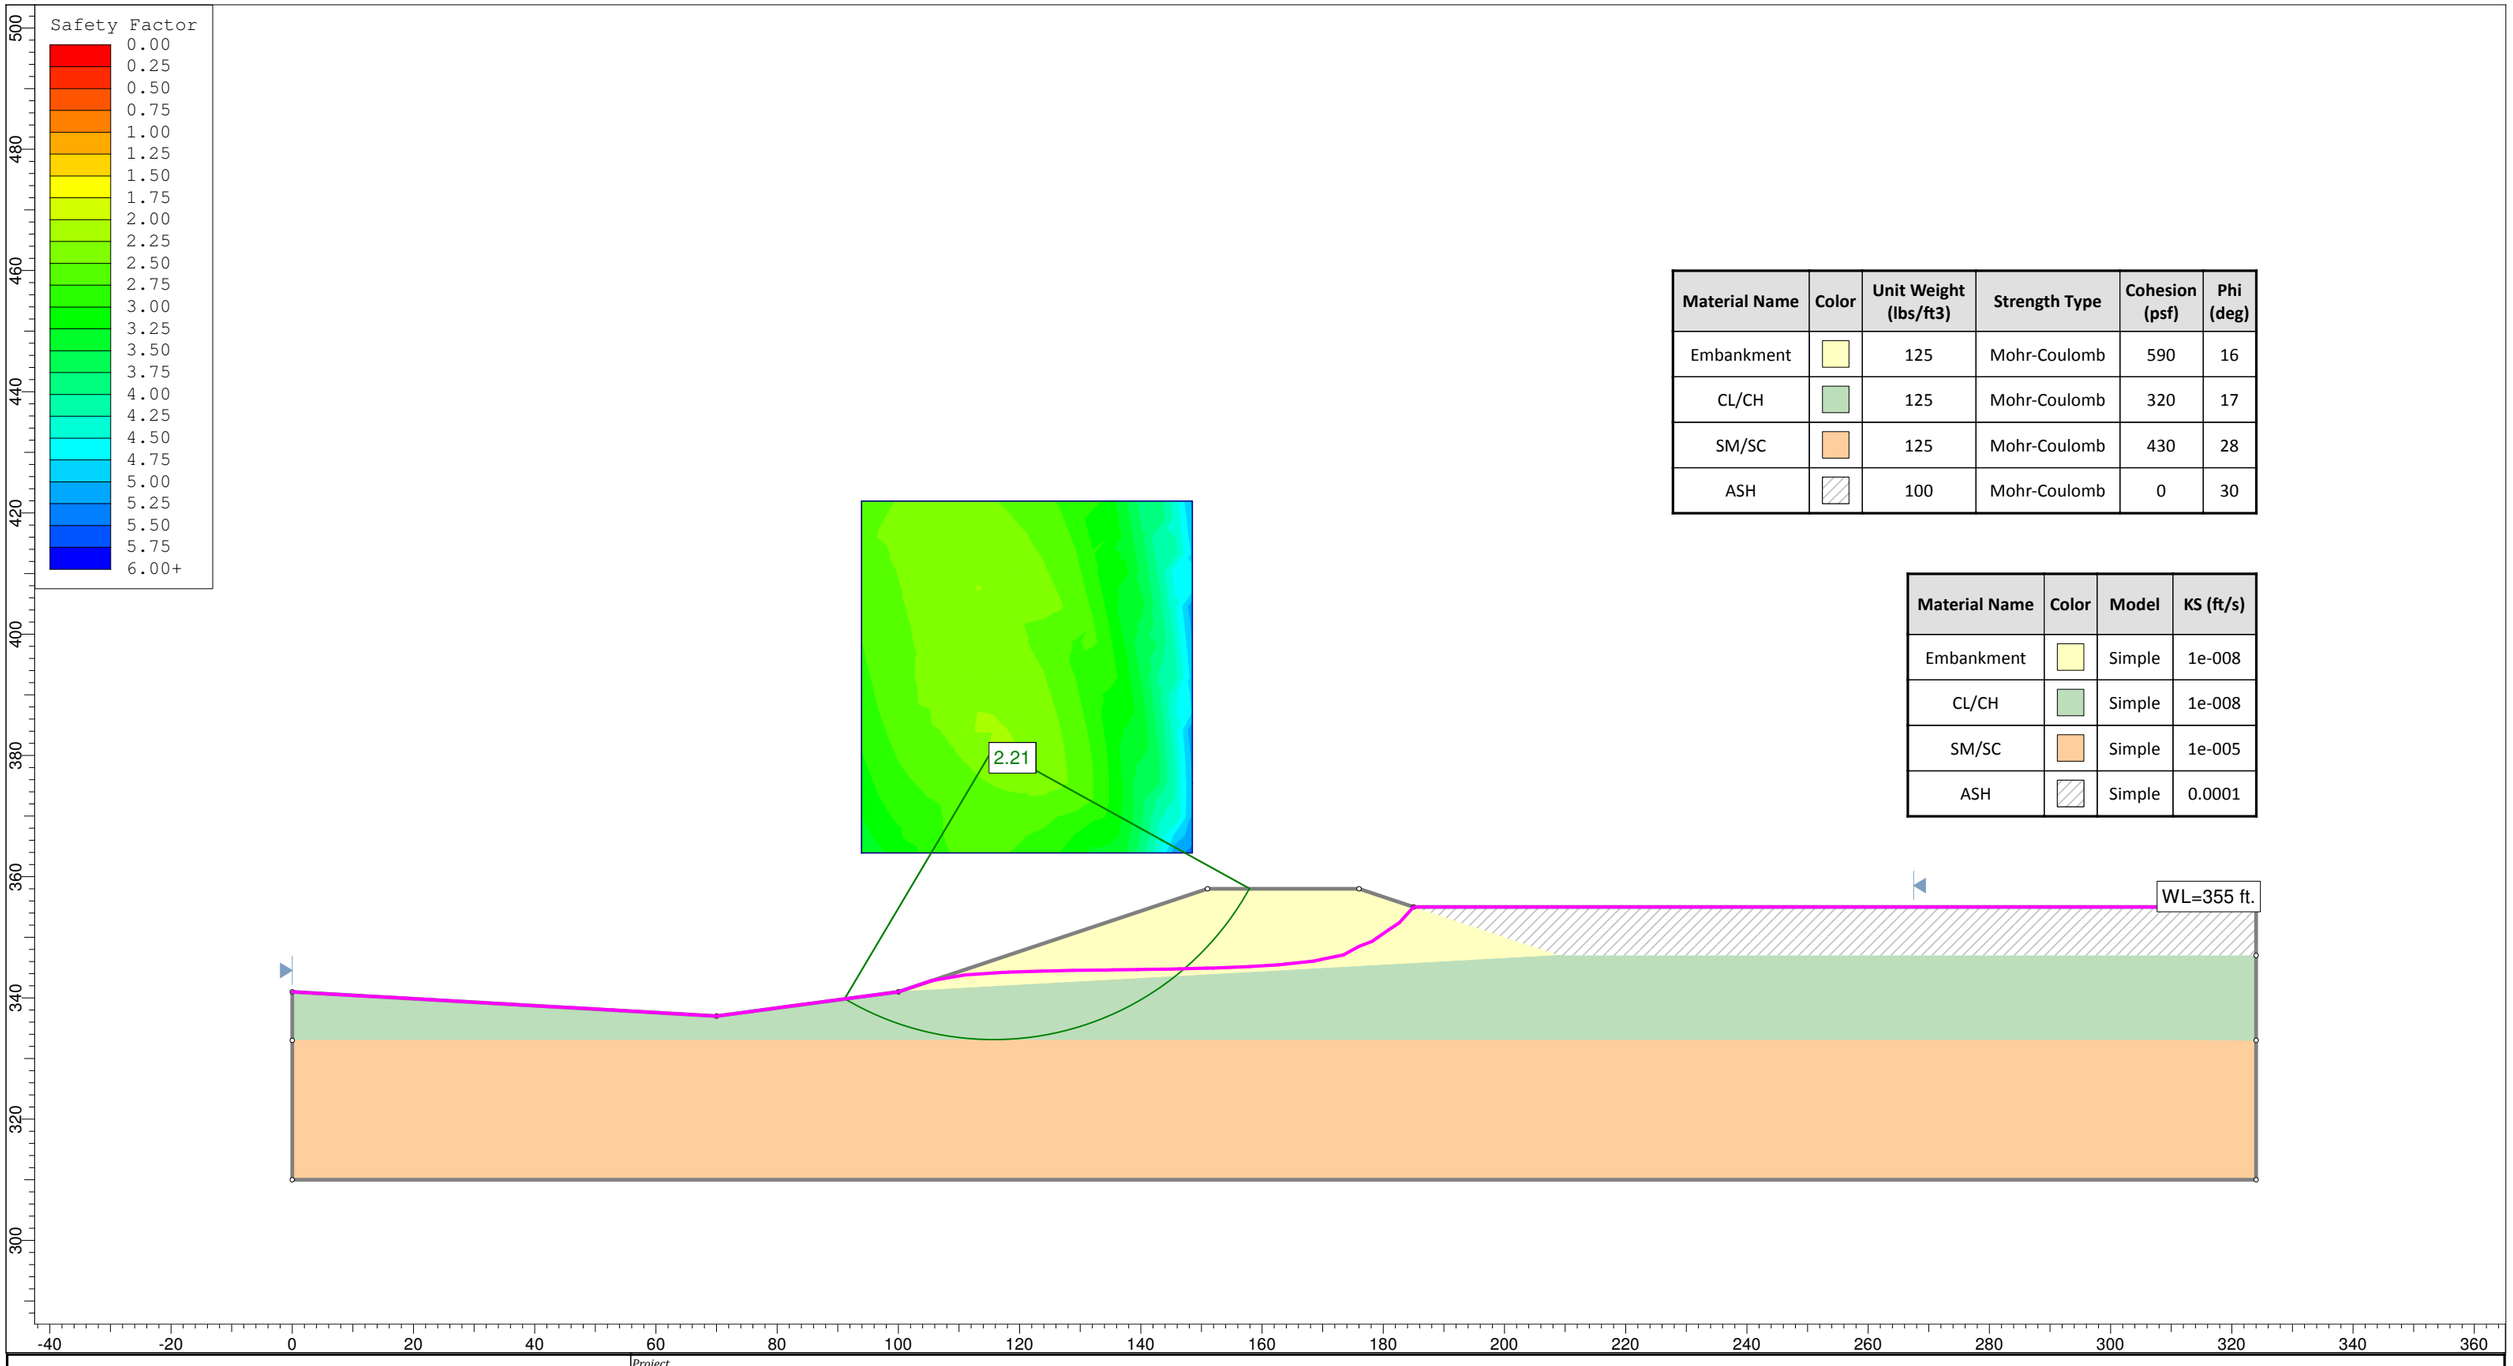
Project	Pirkey Power Station - West Ash Pond, Section No. 1		
Analysis Description	Steady State Seepage at Maximum and Surcharge Pool		
Drawn By	JJT	*Company*	
Date	12/15/2015	*File Name*	WEST ASH_Section 1_SSS_25yr.slim

Summary of Stability Analyses – Safety Factors, Section No. 1		
Modeled Condition	**Factor of Safety**	
	Actual	**Minimum**
Steady State Seepage – Maximum Pool	2.21	1.50
Steady State Seepage – Surcharge Pool	2.21	1.40
Steady State Seepage with Seismic – Maximum Pool	1.35	1.00

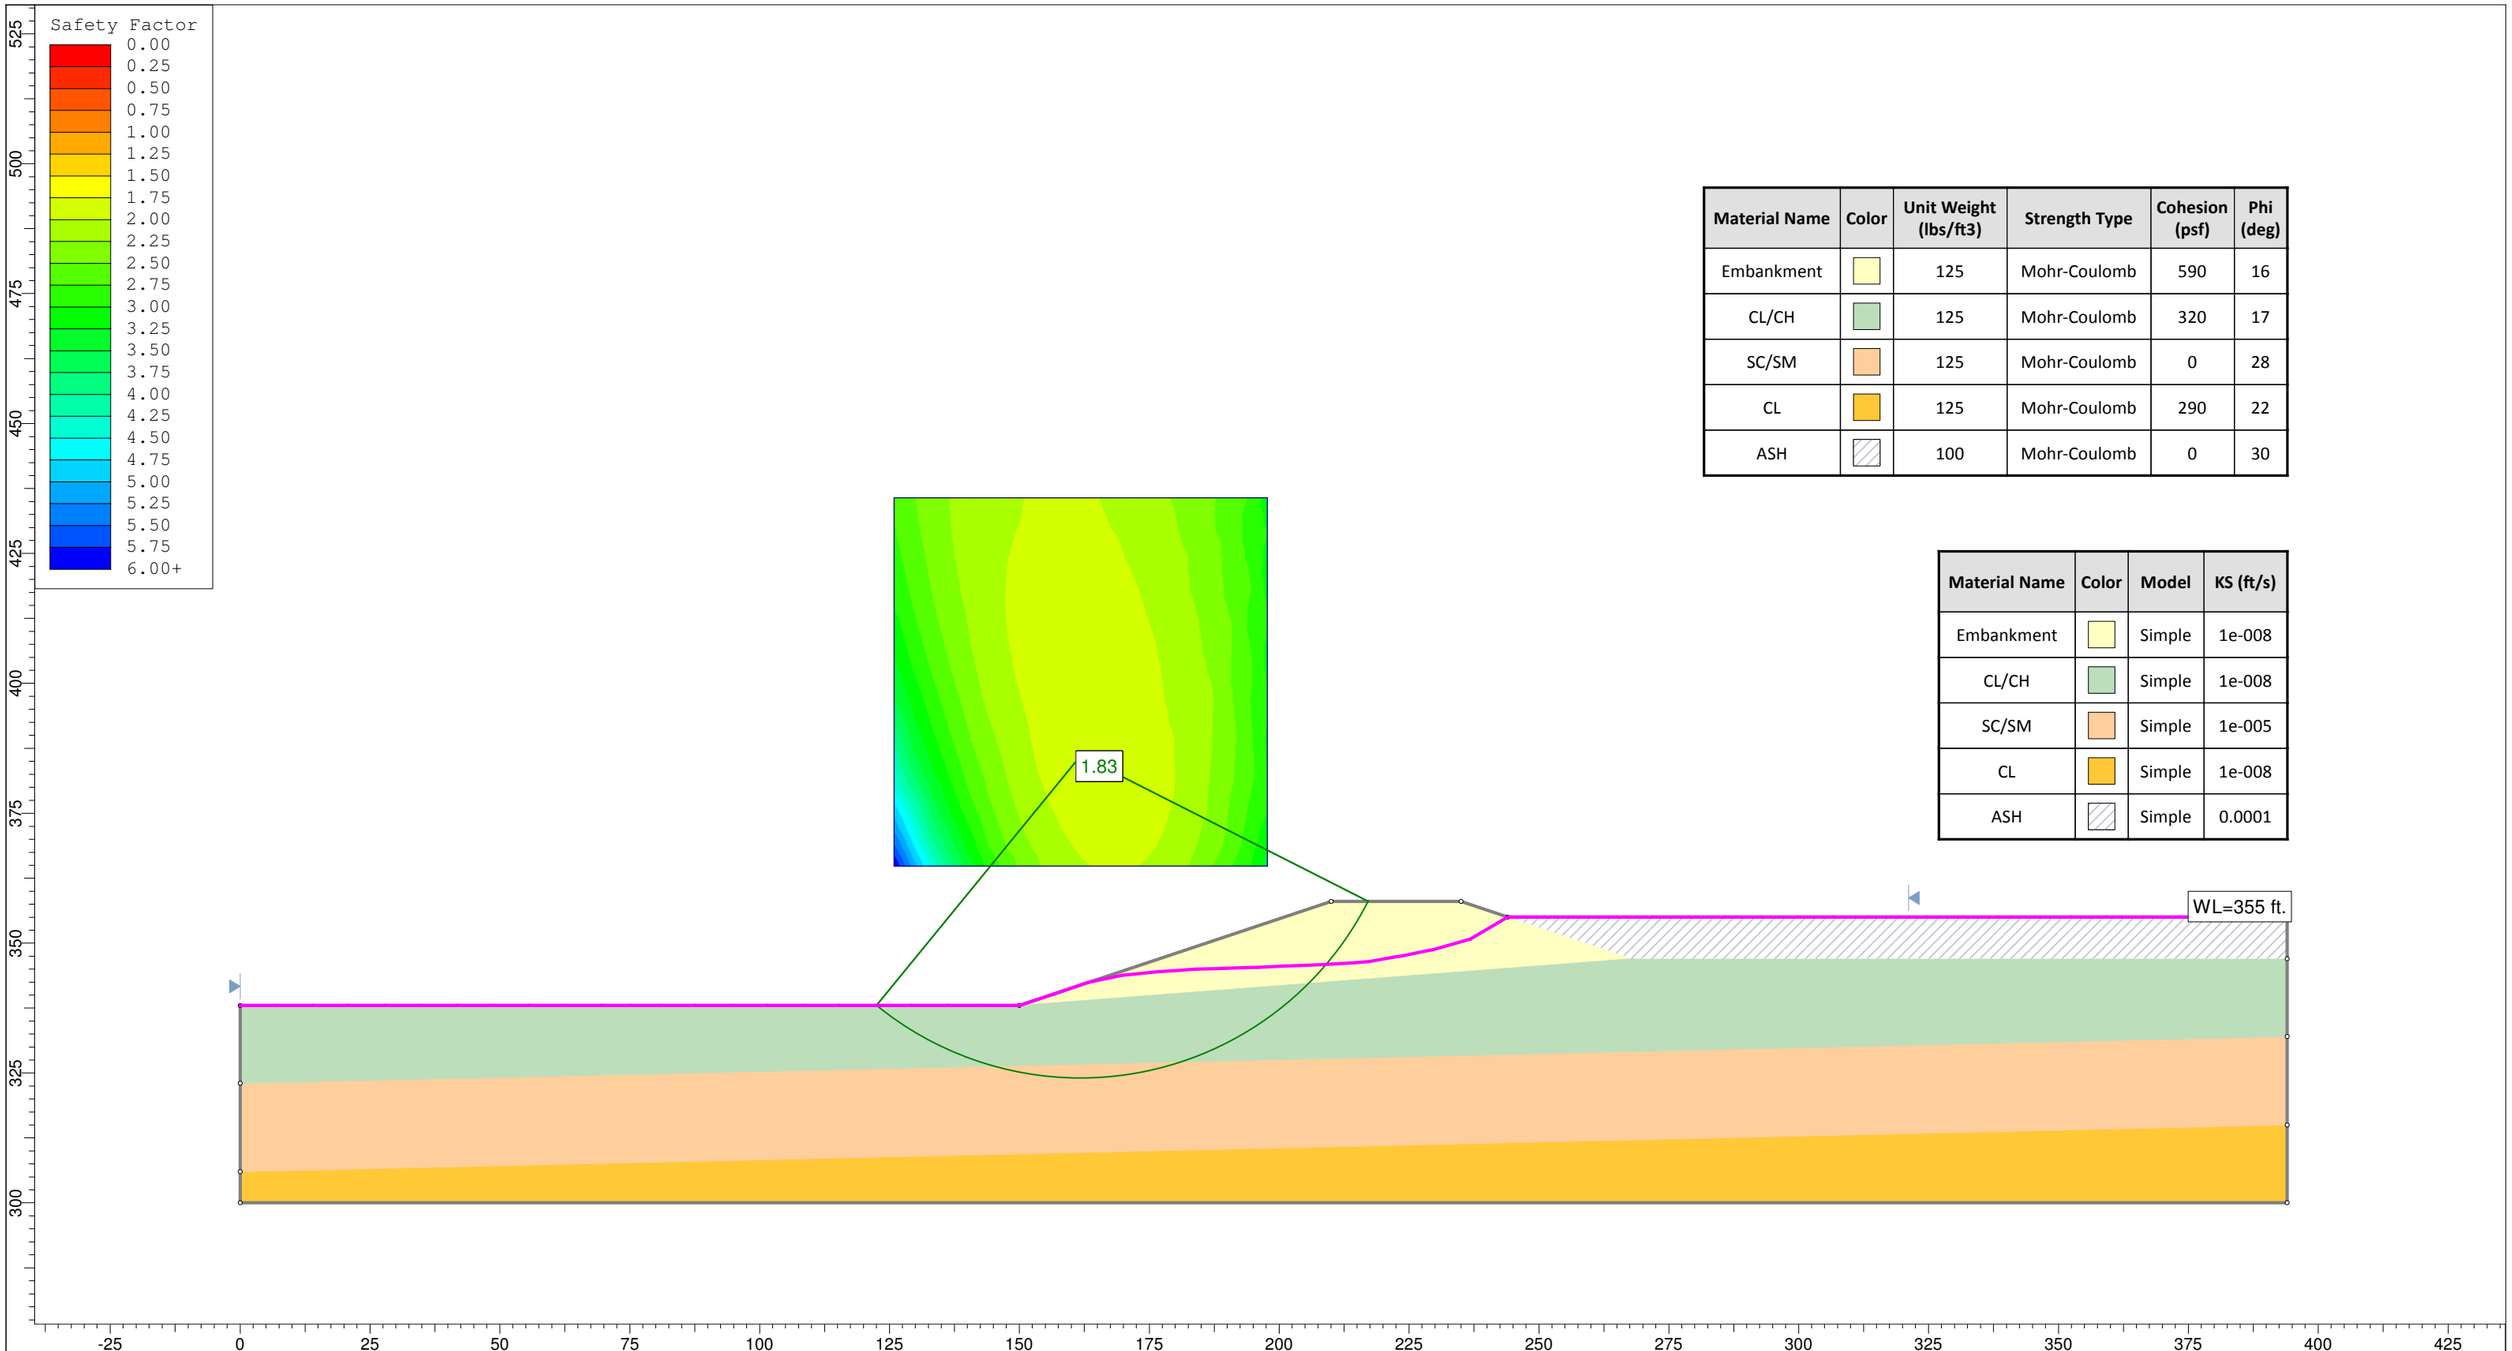
Project	Pirkey Power Station - West Ash Pond, Section No. 2		
Analysis Description	Steady State Seepage at Maximum and Surcharge Pool		
Drawn By	JJT	*Company*	
Date	12/15/2015	*File Name*	WEST ASH_Section 2_SSS_25yr.slim

Summary of Stability Analyses – Safety Factors, Section No. 2		
Modeled Condition	**Factor of Safety**	
	Actual	**Minimum**
Steady State Seepage – Maximum Pool	1.83	1.50
Steady State Seepage – Surcharge Pool	1.83	1.40
Steady State Seepage with Seismic – Maximum Pool	1.50	1.00
