October 8, 2026
Closure Completion Notification
Rockport Plant
West Bottom Ash Pond

SAFETY FACTOR ASSESSMENT
PERIODIC 5-YEAR REVIEW

West Bottom Ash Pond

Rockport Plant
Rockport, Indiana

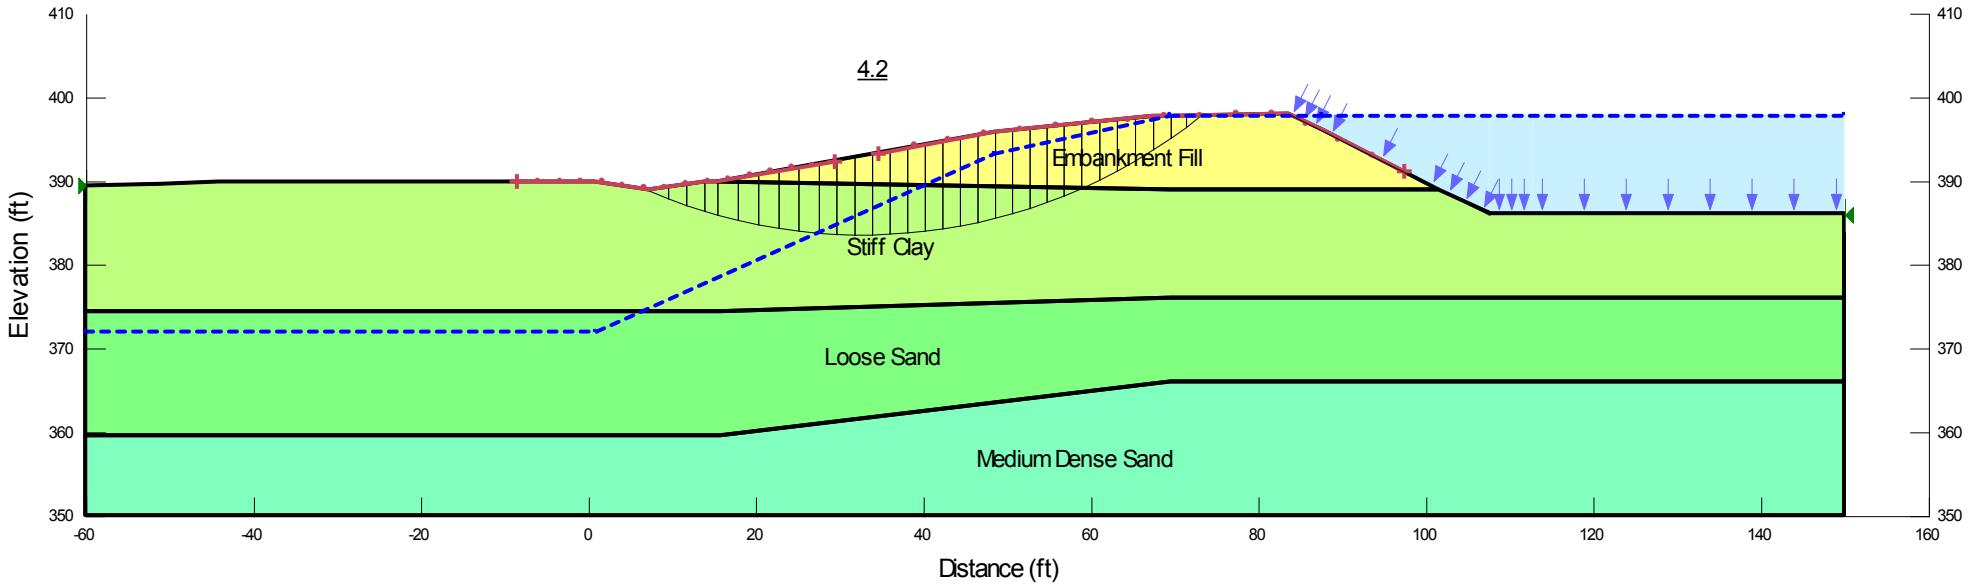
Exhibit
D-1

MAXIMUM SURCHARGE POOL WATER LEVEL: EXTERIOR

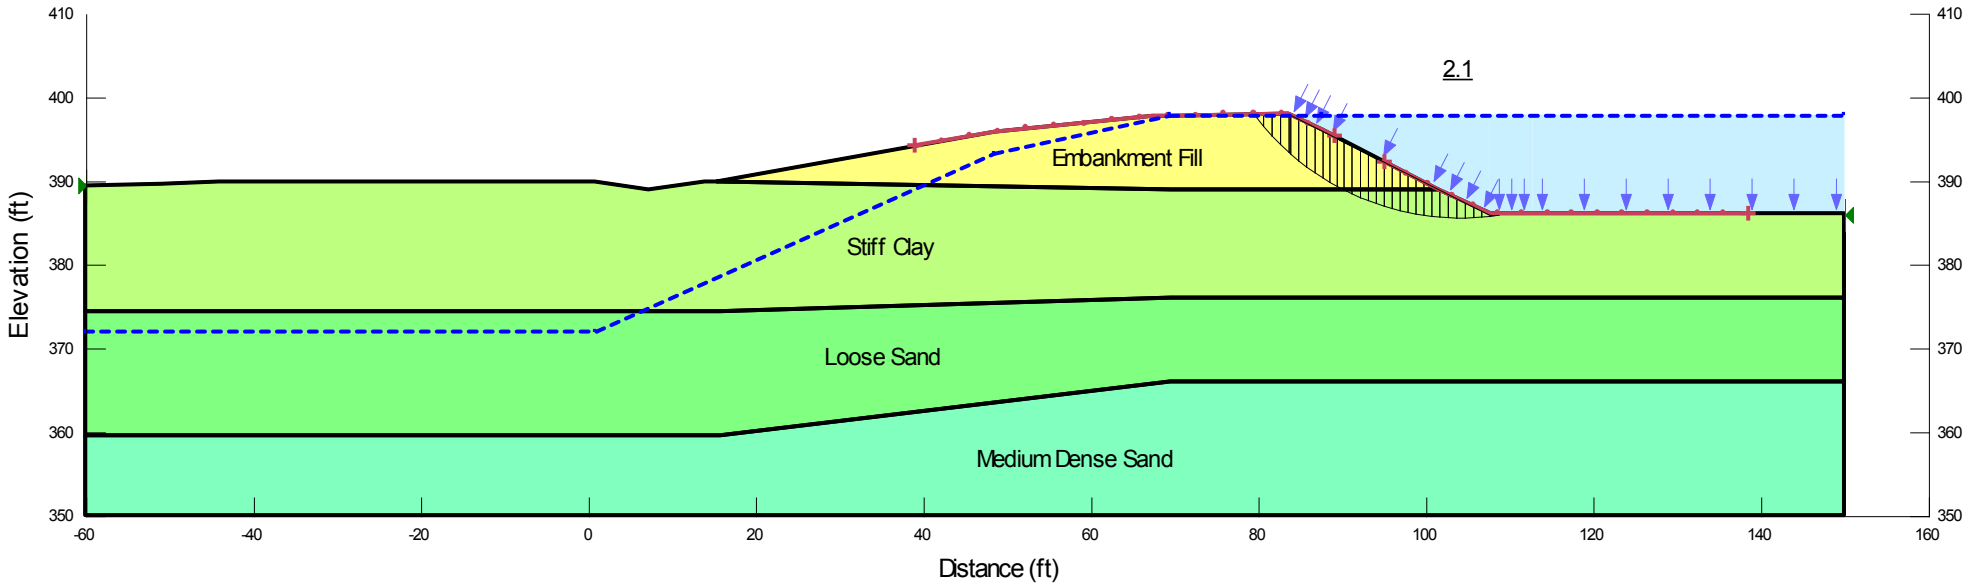
Exhibit
D-2

MAXIMUM SURCHARGE POOL WATER LEVEL: INTERIOR

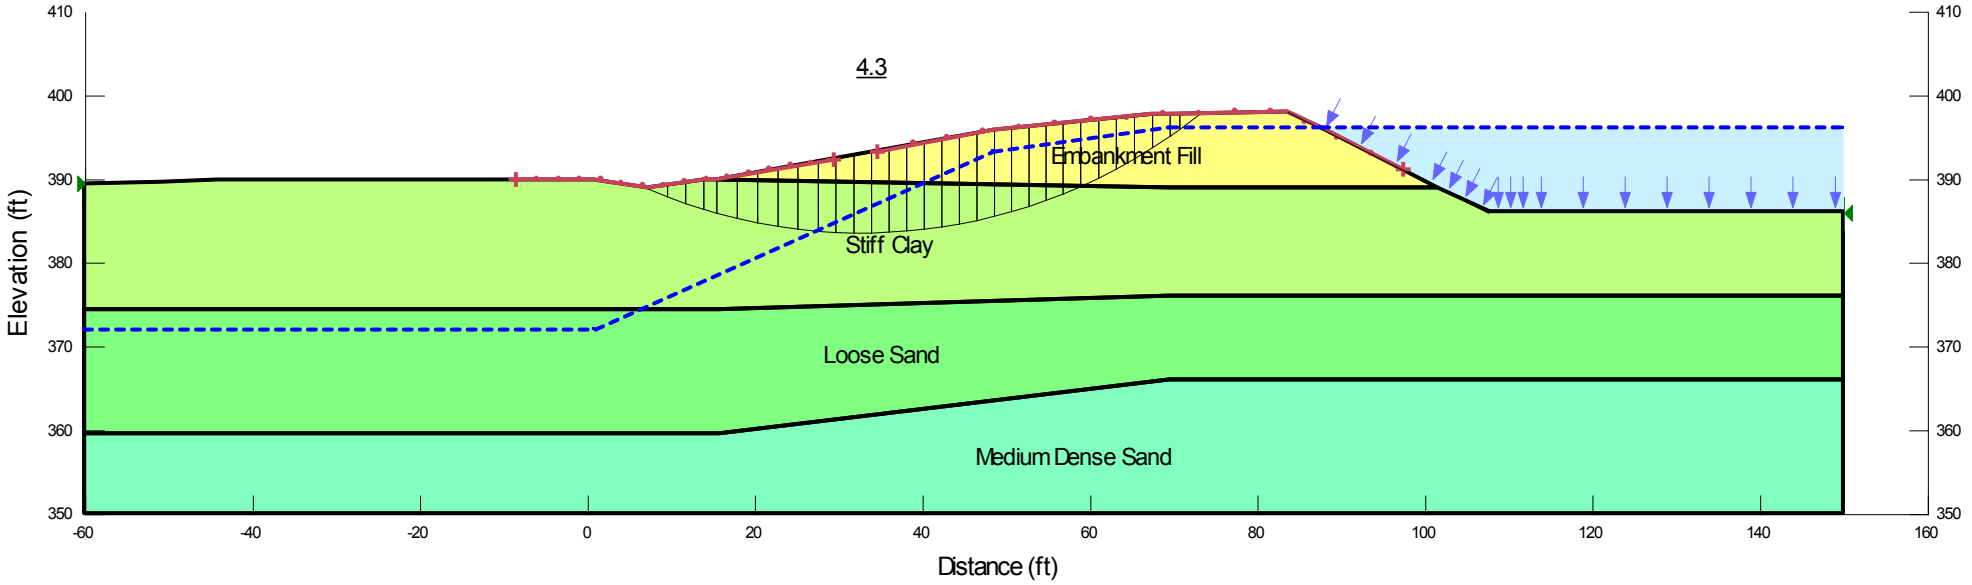
Exhibit
D-3

MAXIMUM STORAGE POOL WATER LEVEL: EXTERIOR

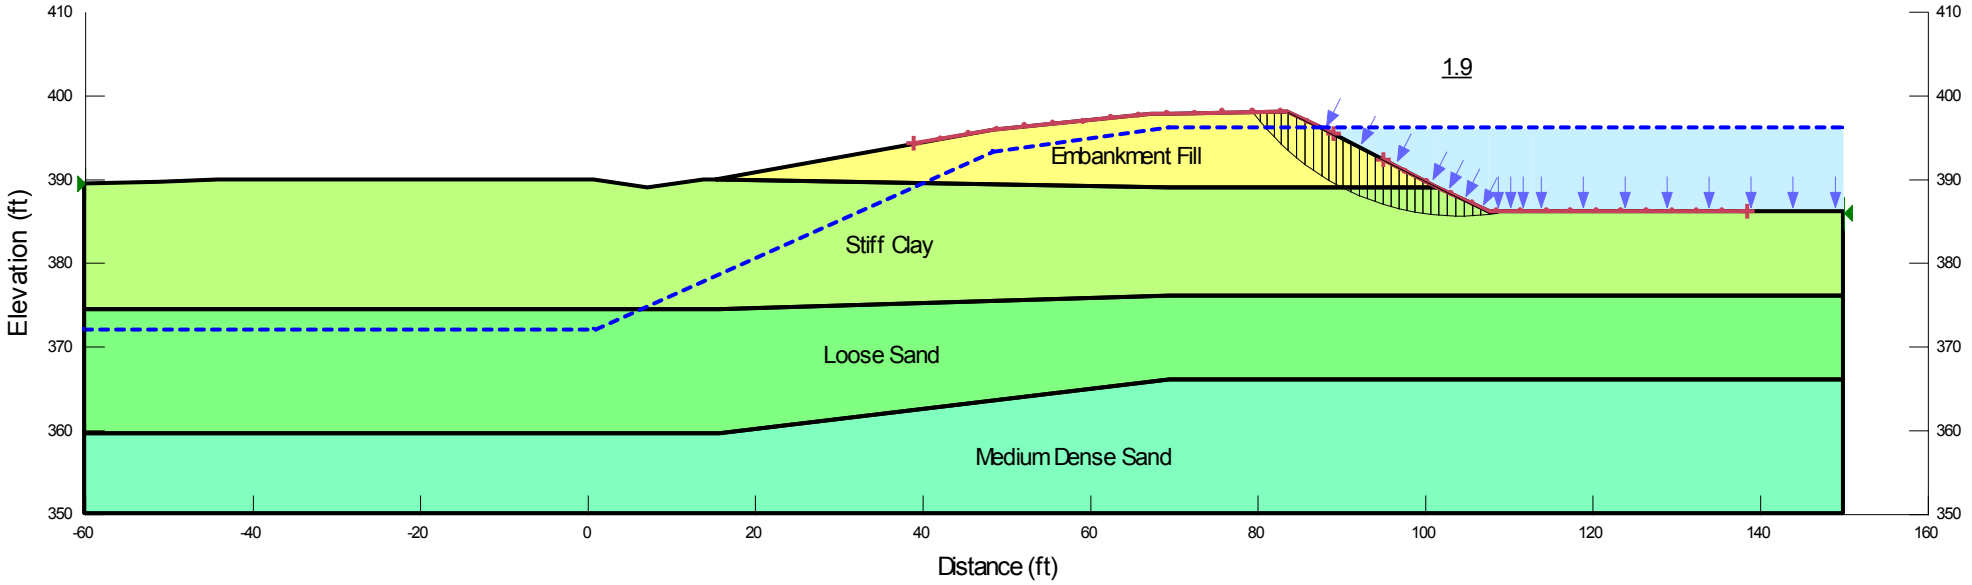
Exhibit
D-4

MAXIMUM STORAGE POOL WATER LEVEL: INTERIOR

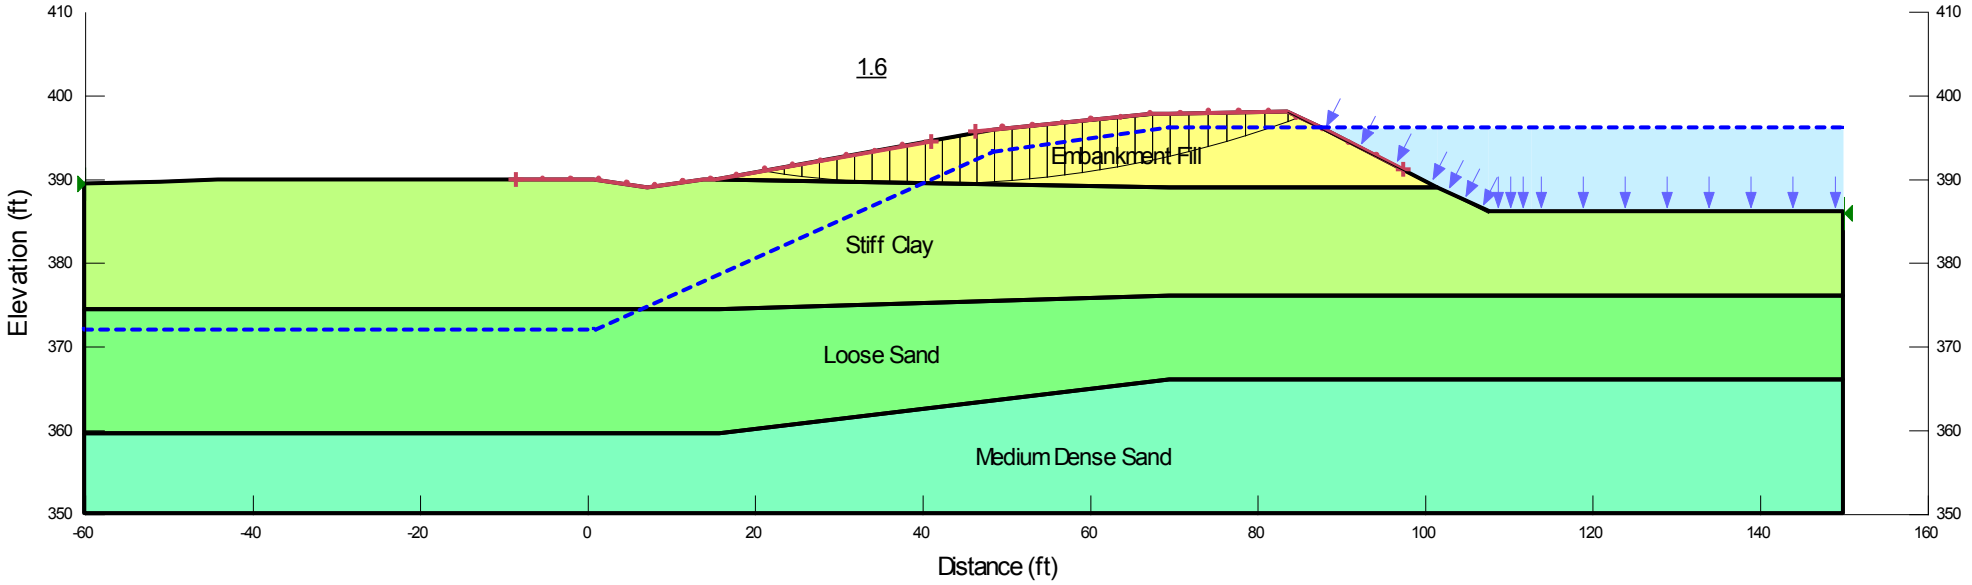
Exhibit
D-5

MAXIMUM STORAGE POOL WATER LEVEL (SEISMIC): EXTERIOR

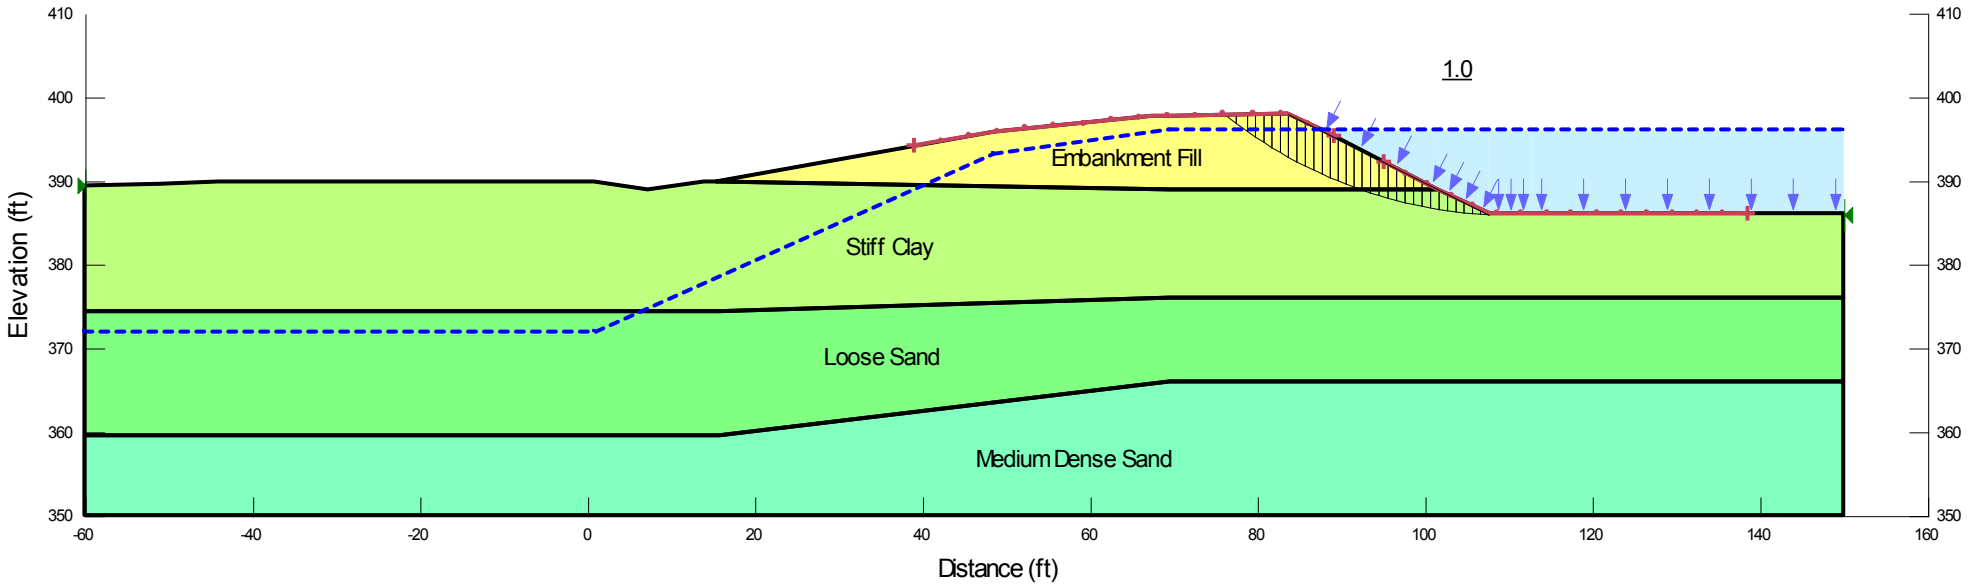
MAXIMUM STORAGE POOL WATER LEVEL (SEISMIC): INTERIOR

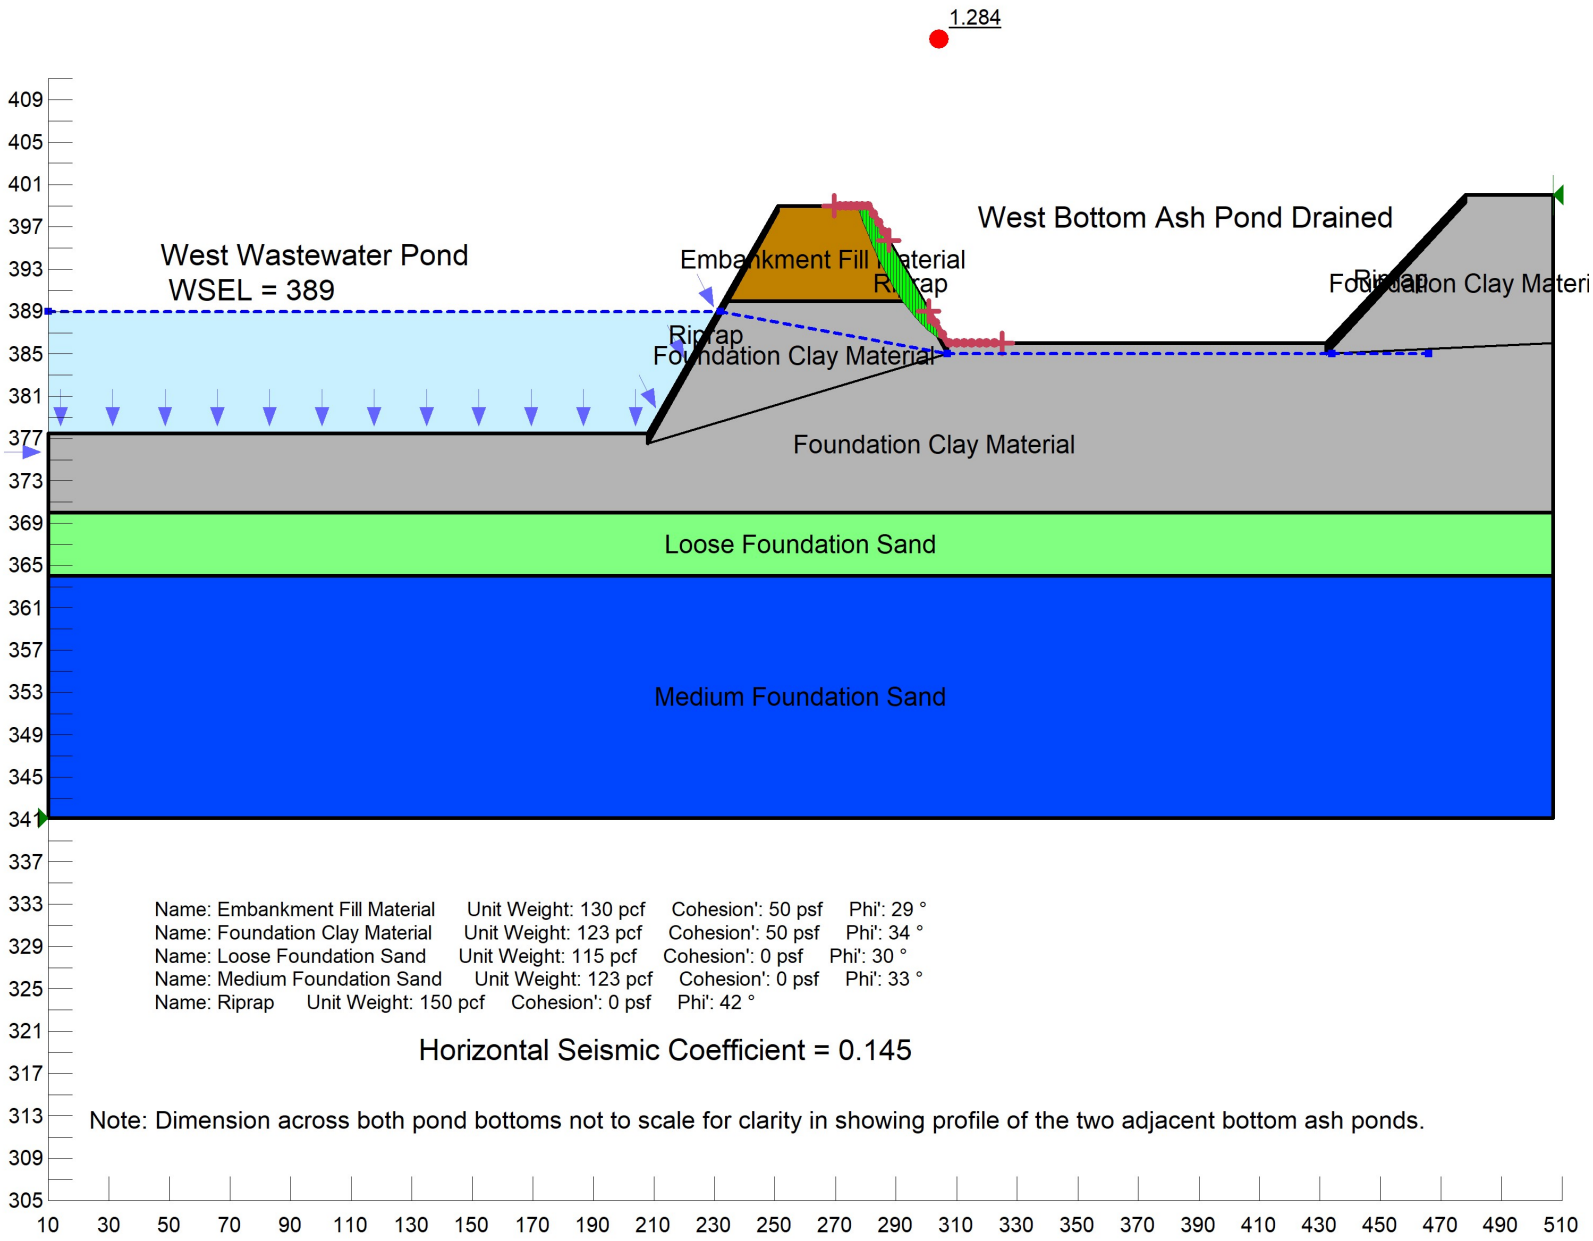
1.743
West Waste Water Pond
WSEL = 389
Embankment Fill Material
Riprap
West Bottom Ash pond drained
Riprap
Foundation Clay Material
Riprap
Foundation Clay Material
Foundation Clay Material
Loose Foundation Sand
Medium Foundation Sand
Name: Embankment Fill Material Unit Weight: 130 pcf Cohesion': 50 psf Phi': 29 °
Name: Foundation Clay Material Unit Weight: 123 pcf Cohesion': 50 psf Phi': 34 °
Name: Loose Foundation Sand Unit Weight: 115 pcf Cohesion': 0 psf Phi': 30 °
Name: Medium Foundation Sand Unit Weight: 123 pcf Cohesion': 0 psf Phi': 33 °
Name: Riprap Unit Weight: 150 pcf Cohesion': 0 psf Phi': 42 °
Note: Dimension across both pond bottoms not to scale for clarity in showing profile of the two adjacent bottom ash ponds.
409
405
401
397
393
389
385
381
377
373
369
365
361
357
353
349
345
341
337
333
329
325
321
317
313
309
305
10
30
50
70
90
110
130
150
170
190
210
230
250
270
290
310
330
350
370
390
410
430
450
470
490
510

Horizontal Seismic Coefficient = 0.145

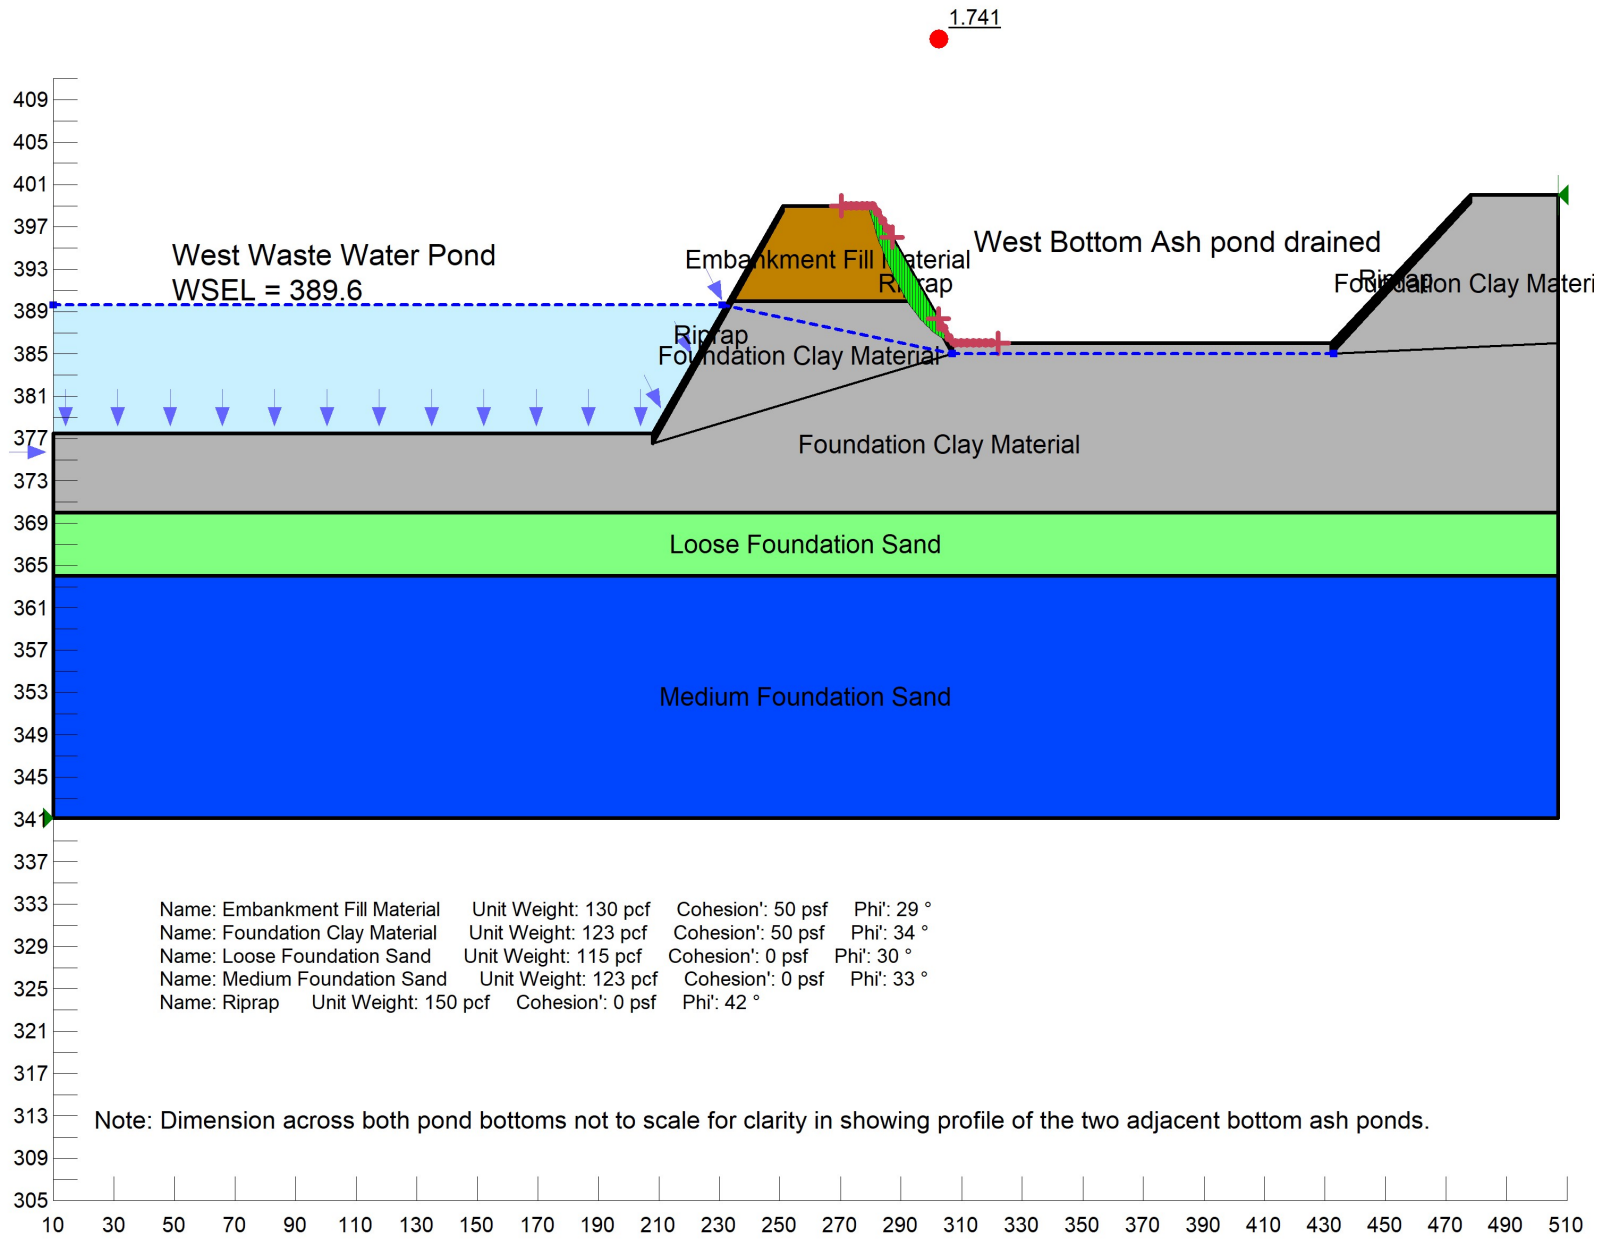
1.741
West Waste Water Pond
WSEL = 389.6
Embankment Fill Material
Riprap
West Bottom Ash pond drained
Riprap
Foundation Clay Material
Riprap
Foundation Clay Material
Foundation Clay Material
Loose Foundation Sand
Medium Foundation Sand
Name: Embankment Fill Material Unit Weight: 130 pcf Cohesion': 50 psf Phi': 29 °
Name: Foundation Clay Material Unit Weight: 123 pcf Cohesion': 50 psf Phi': 34 °
Name: Loose Foundation Sand Unit Weight: 115 pcf Cohesion': 0 psf Phi': 30 °
Name: Medium Foundation Sand Unit Weight: 123 pcf Cohesion': 0 psf Phi': 33 °
Name: Riprap Unit Weight: 150 pcf Cohesion': 0 psf Phi': 42 °
Note: Dimension across both pond bottoms not to scale for clarity in showing profile of the two adjacent bottom ash ponds.
409
405
401
397
393
389
385
381
377
373
369
365
361
357
353
349
345
341
337
333
329
325
321
317
313
309
305
10
30
50
70
90
110
130
150
170
190
210
230
250
270
290
310
330
350
370
390
410
430
450
470
490
510
