2019 Annual Dam and Dike Inspection Report

Clinch River Ash Pond 1A/1B

**Clinch River
Appalachian Power Company
Carbo, Virginia**

Document ID: GERS-19-049

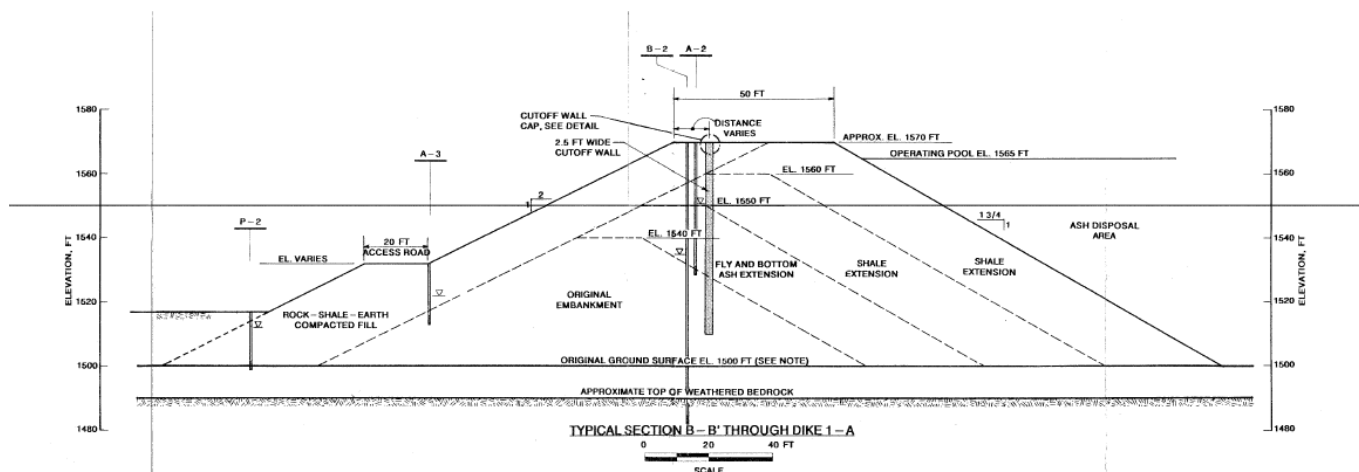
Typical cross section taken from AEP Drawing SK-CL-62290A.

3 upstream raisings. The width of the crest is roughly 35 feet wide, and portions of the embankment have a 20-foot wide bench on the downstream slope which carries an access road leading up to the crest. There is a splitter dike separating Pond 1A and 1B. A 2.5-foot wide, 65-foot deep, 2,150-foot long cement-bentonite-fly ash slurry wall was designed and constructed in 1990. The slurry wall penetrated the various materials used for the upstream raising and was keyed into the original embankment, except at the ends of the dam where it was keyed 1 to 2 feet into the shallow, fractured, bedrock. A 1,500 foot long section of Dump's Creek was re-routed during the original construction of the Ash Pond 1A/1B Dam.

The majority of the downstream slope has an inverted filter that was constructed in 2006-2009. A toe drain system with a single stage drainage media runs along the downstream toe. The toe drain system was retrofitted to drain into a seepage pump station near the center of the dam. The seepage is pumped and drains by gravity into the reclaim pond, near the southern end of the Ash Pond 1A/1B Dam.
