2019 Annual Landfill Inspection Report

CCR Landfill

**Turk Power Plant
Southwestern Electric Power Company
Fulton, Arkansas**

Document Number: GERS-19-036

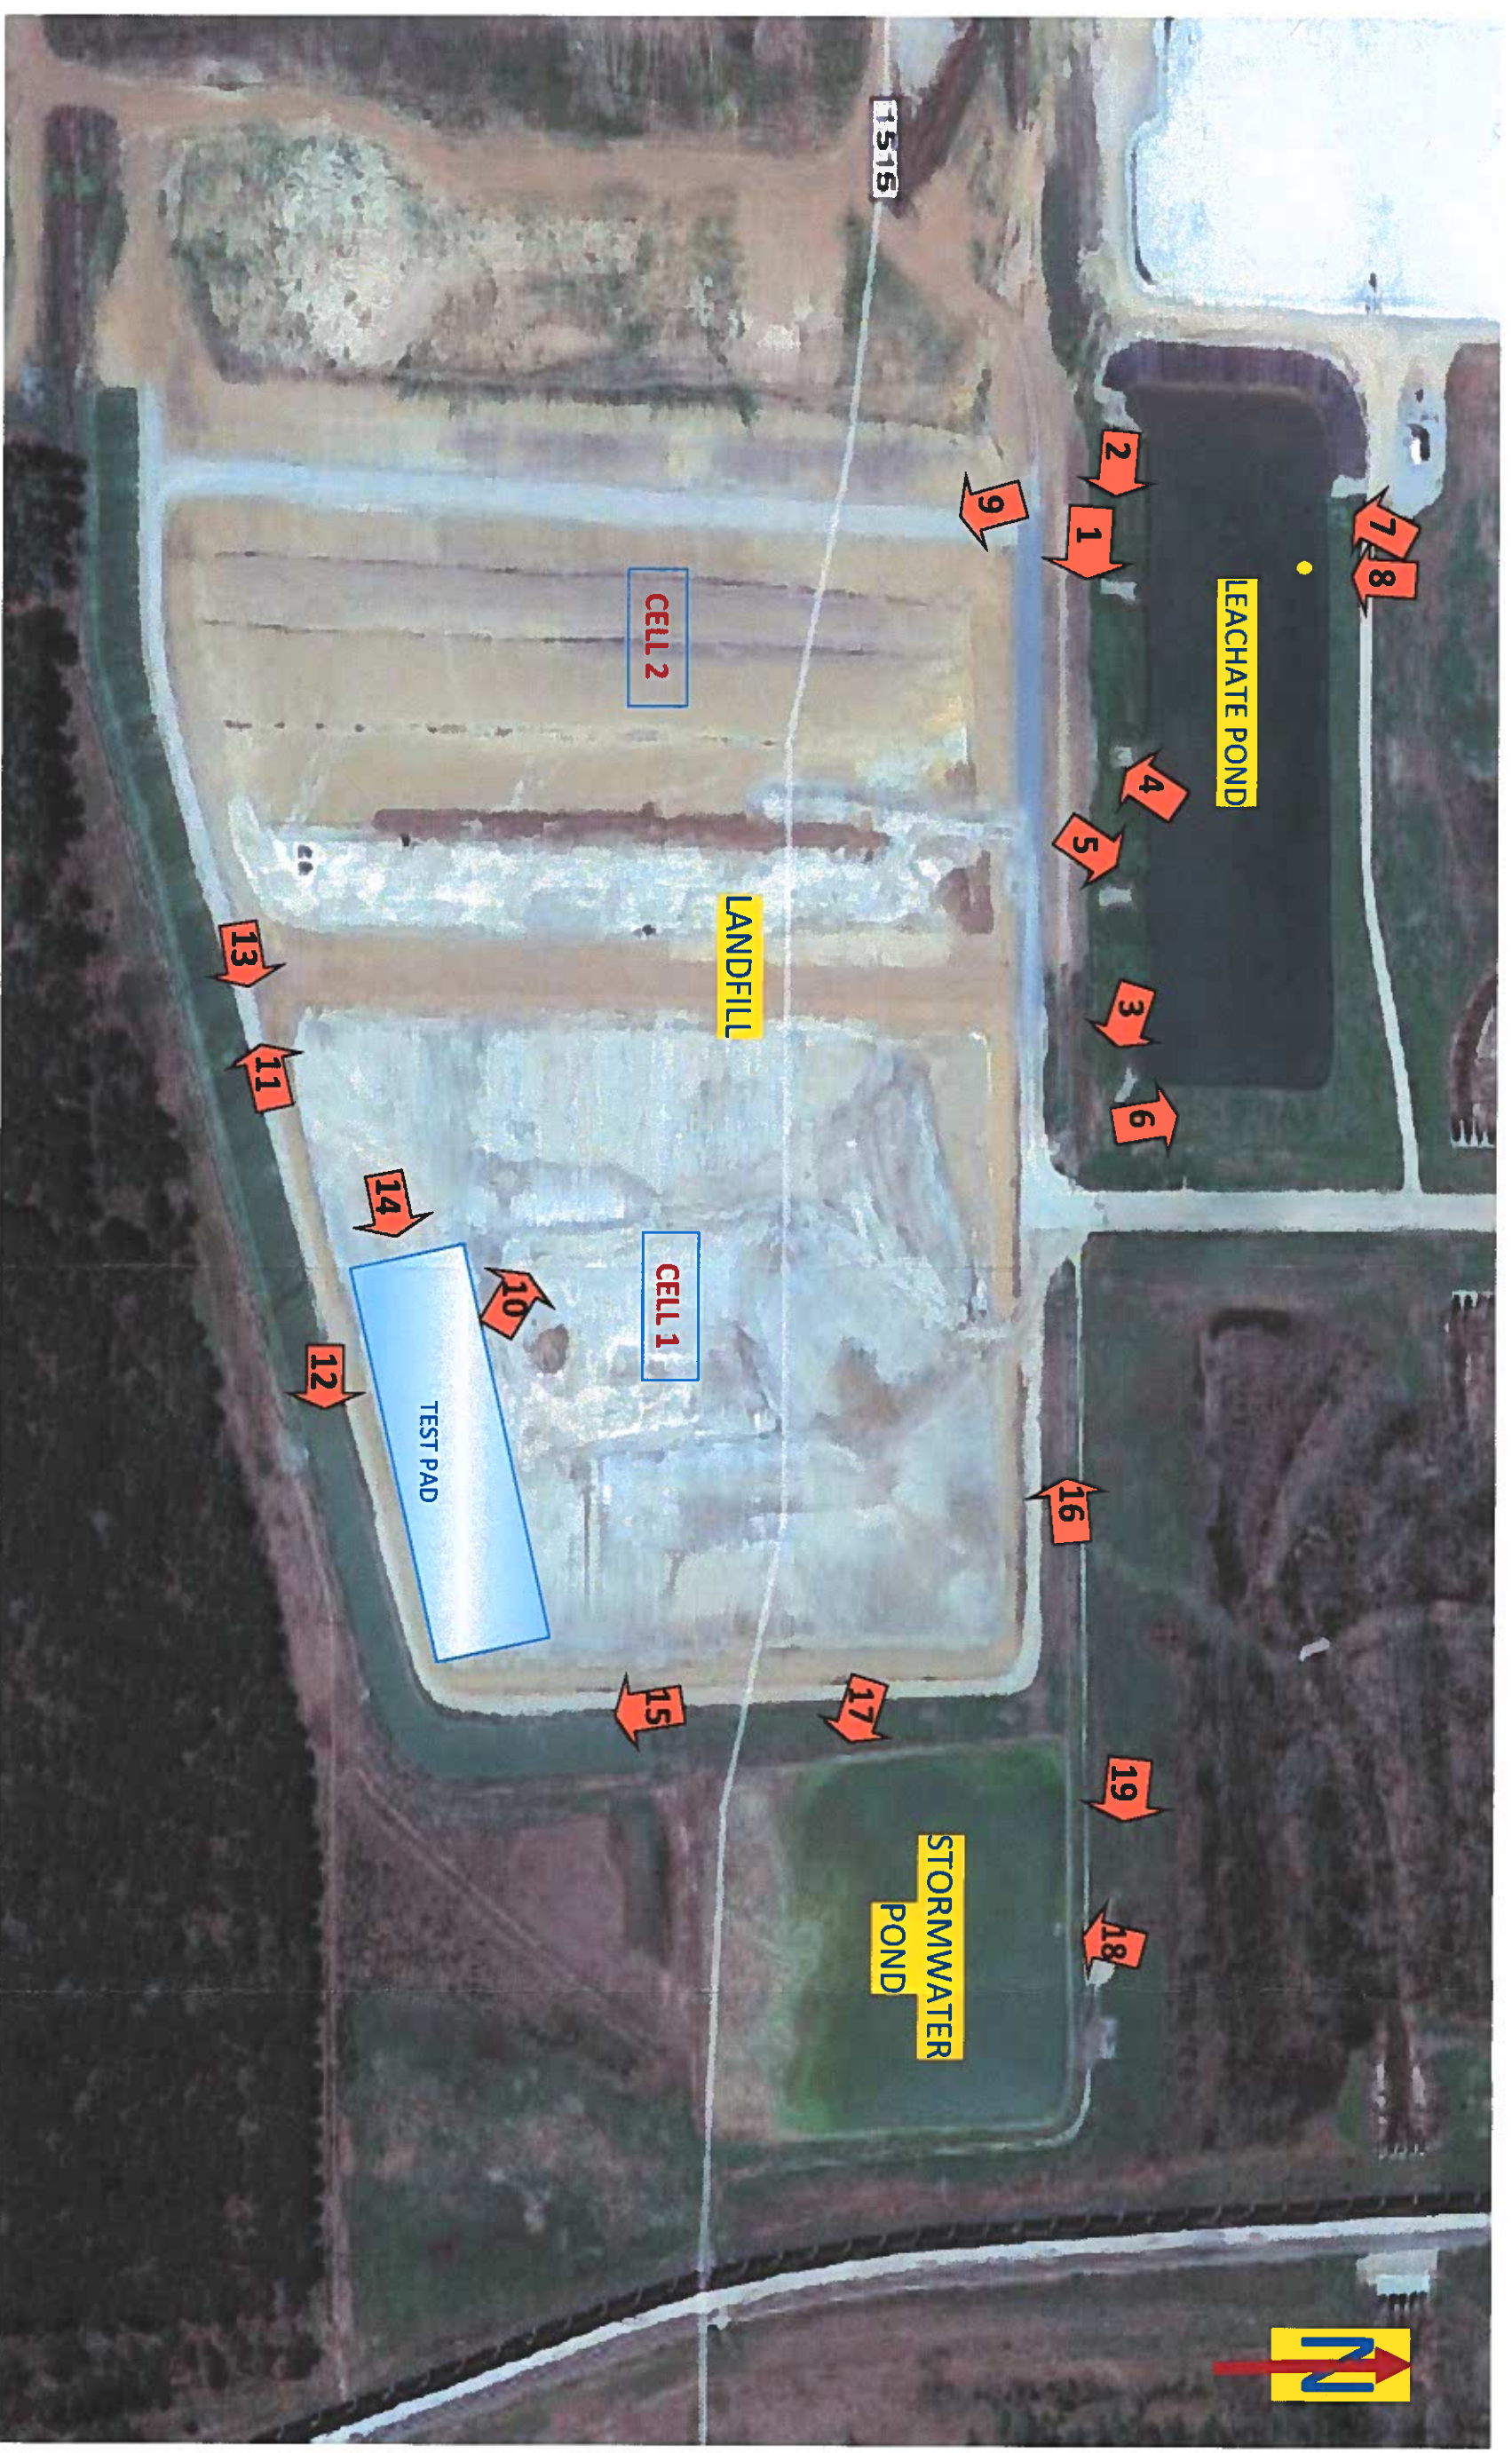
1. The south slope of the leachate pond adjacent to the landfill is shown in Photographs 1 and 2. The slope appeared in good and stable condition. Intermittent bare spots with lack of vegetation were noticed at this slope. The south perimeter ditch (Photograph No. 1) appeared in functional condition with positive drainage.

<p>Photo #1 North perimeter diversion ditch at the south slope (looking east).</p>	  A wide-angle photograph showing a long, straight, earthen diversion ditch running through a field of dry, brownish vegetation. In the background, a large, white, domed structure, likely a landfill cover, is visible under a clear blue sky.
<p>Photo #2 South interior slope of the leachate pond (looking east).</p>	  A photograph of a grassy slope leading down to a small, shallow pond. The vegetation is sparse and dry. The sky is clear and blue.
<p>Photo #3 Typical condition of the leachate drain pipe and wing wall.</p>	  A close-up photograph of a concrete leachate drain pipe and its wing wall. The pipe is partially filled with dark, murky liquid. The surrounding area is rocky and covered with dry, scrubby vegetation.
