**2019 DAM AND DIKE INSPECTION REPORT  
BOTTOM ASH COMPLEX  
(Facility ID #05307)**

**GERS-19-017**

**APPALACHIAN POWER COMPANY  
MOUNTAINEER PLANT  
NEW HAVEN, WEST VIRGINIA**

**INSPECTION DATE: August 14, 2019**

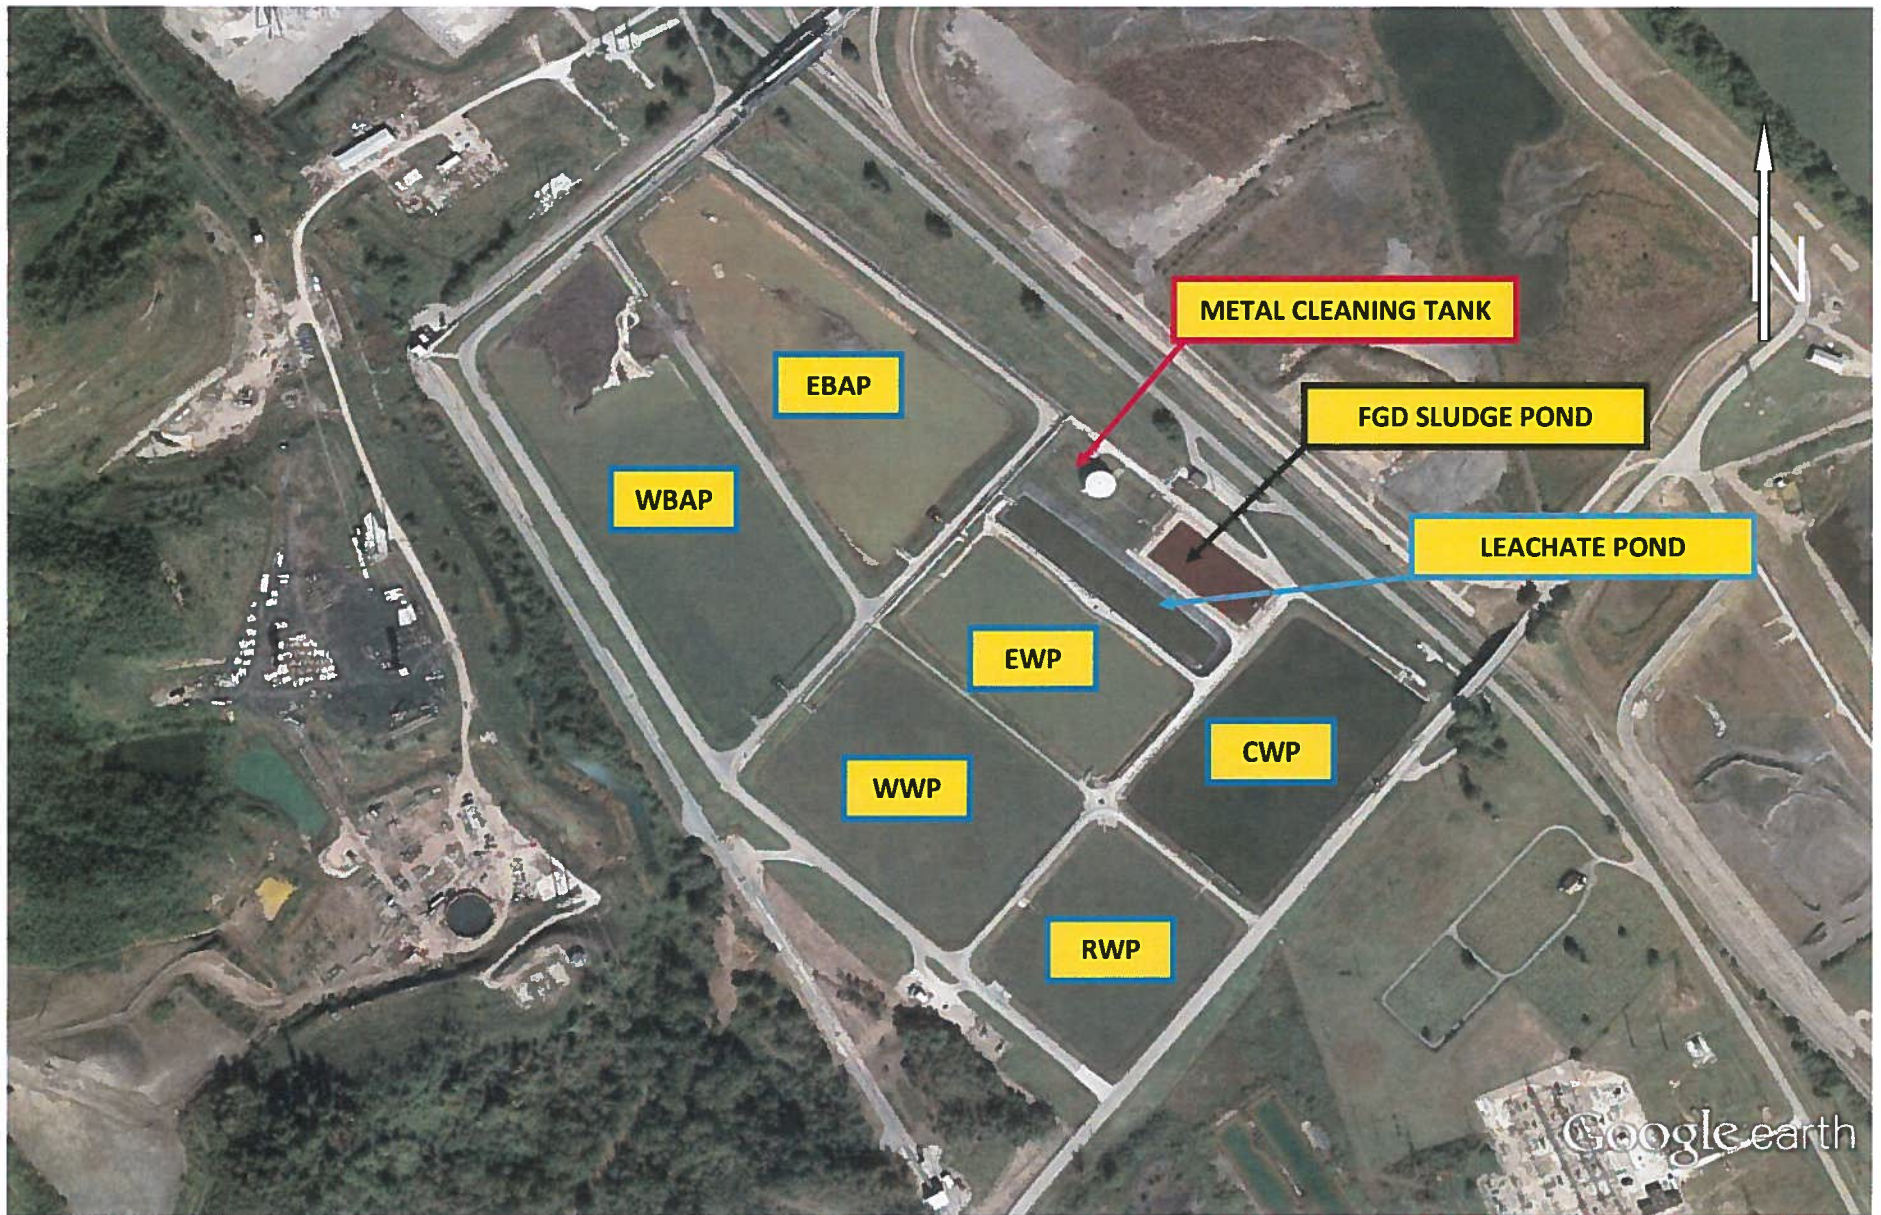
**FIGURE 2 – BOTTOM ASH POND COMPLEX**  
MOUNTAINEER PLANT, NEW HAVEN, WV

The pond embankments are generally small in height (i.e., < 50 ft.) and have design slopes of 3 Horizontal to 1 Vertical (3H to 1V) for both the interior and exterior slopes. The Bottom Ash Ponds normal pool elevation are at 612 feet, the Waste Water Ponds normal pool elevations are at 609 feet, and the Reclaim and Clear Water Ponds normal pool elevations are at 603 feet. The East Bottom Ash and the East Wastewater Ponds were out of service at the time of this inspection, but could be used in alternate sequences with the West Bottom Ash and the West Wastewater Ponds during routine maintenance, repair, ash removal or other operating activity. Figure 2 included in Appendix A illustrate various ponds arrangement at the Bottom Ash Complex.

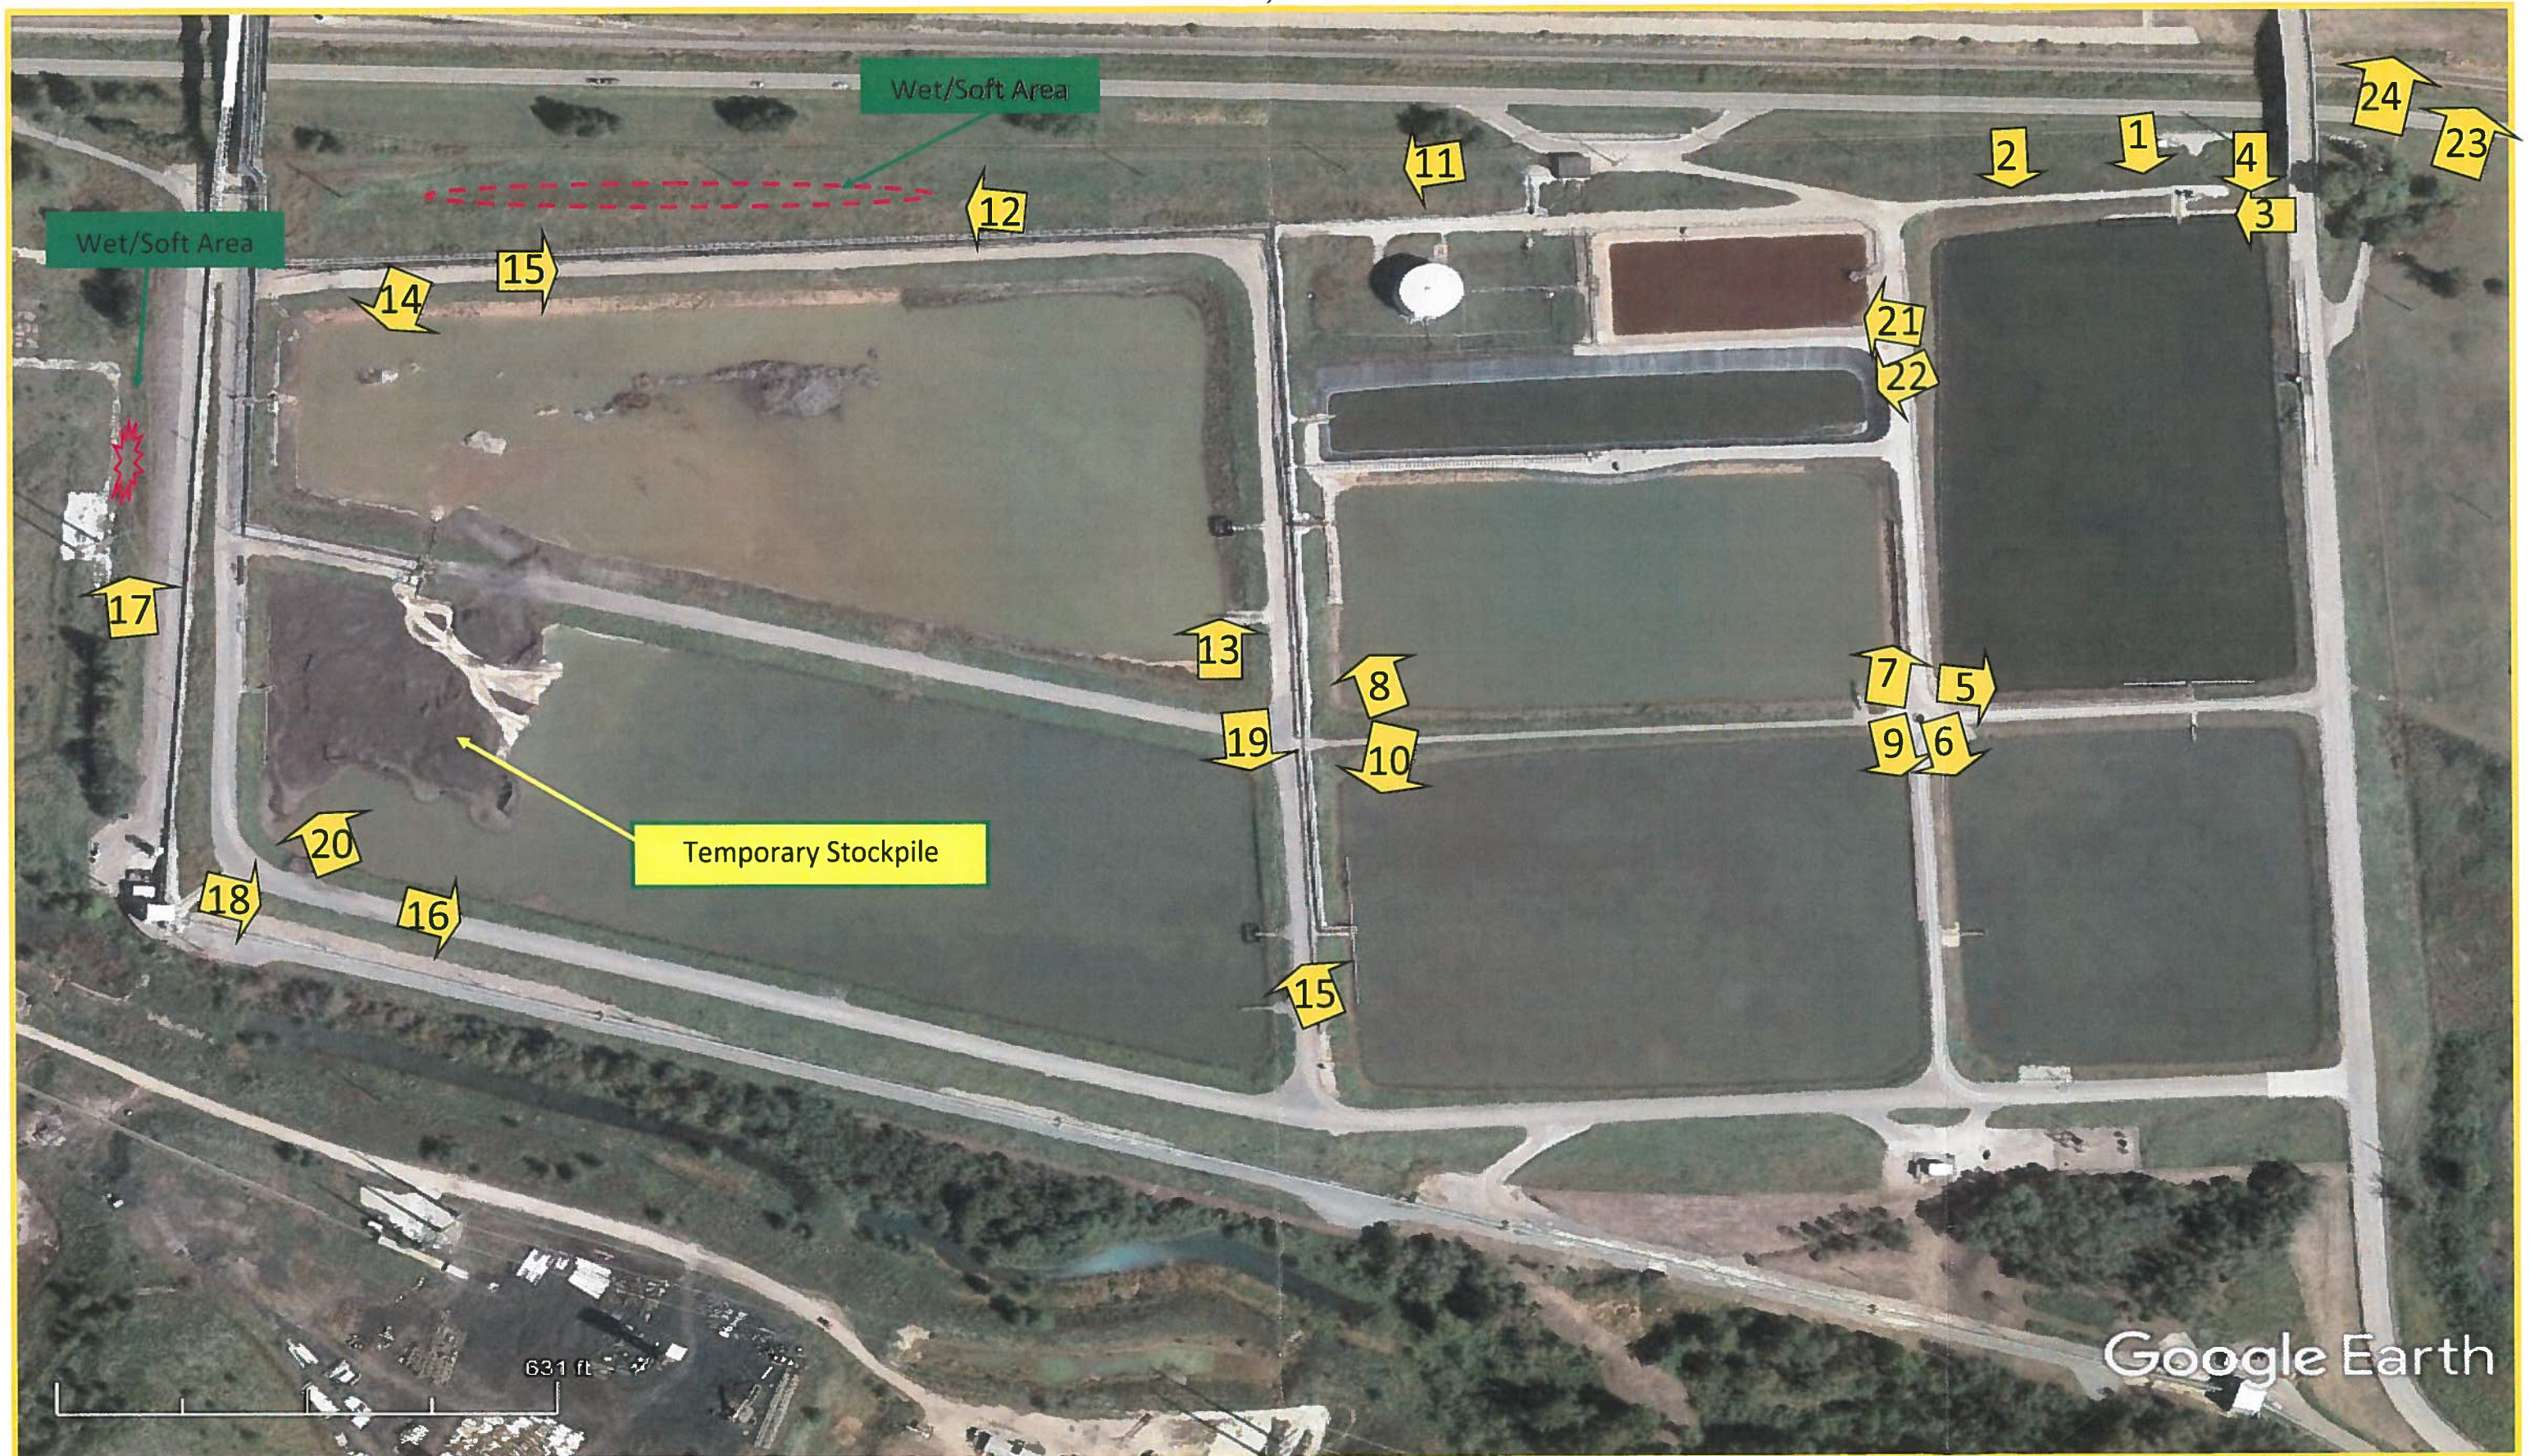
**FIGURE 3 – PHOTOGRAPH LOCATION MAP**  
**BOTTOM ASH COMPLEX, MOUNTAINEER PLANT**

The Bottom Ash Pond Complex is comprised of diked embankments to the north, east, and west sides of the complex. The south side of the complex is incised and also consists of a haul road providing access to this area. There are six main ponds (EBAP, WBAP, EWP, WWP, RWP, and CWP) within the complex. The Bottom Ash Ponds and Wastewater Ponds were designed in tandem, but one pond each is in service at a given time. At present, the WBAP and WWP are used most of the time without a need to switch to the other ponds. In addition, a metal cleaning tank pond, a FGD pond, and a leachate pond were added to the east of the EWWP. Figure 3 (Photograph Location Map) and photographs are included in Appendix B.

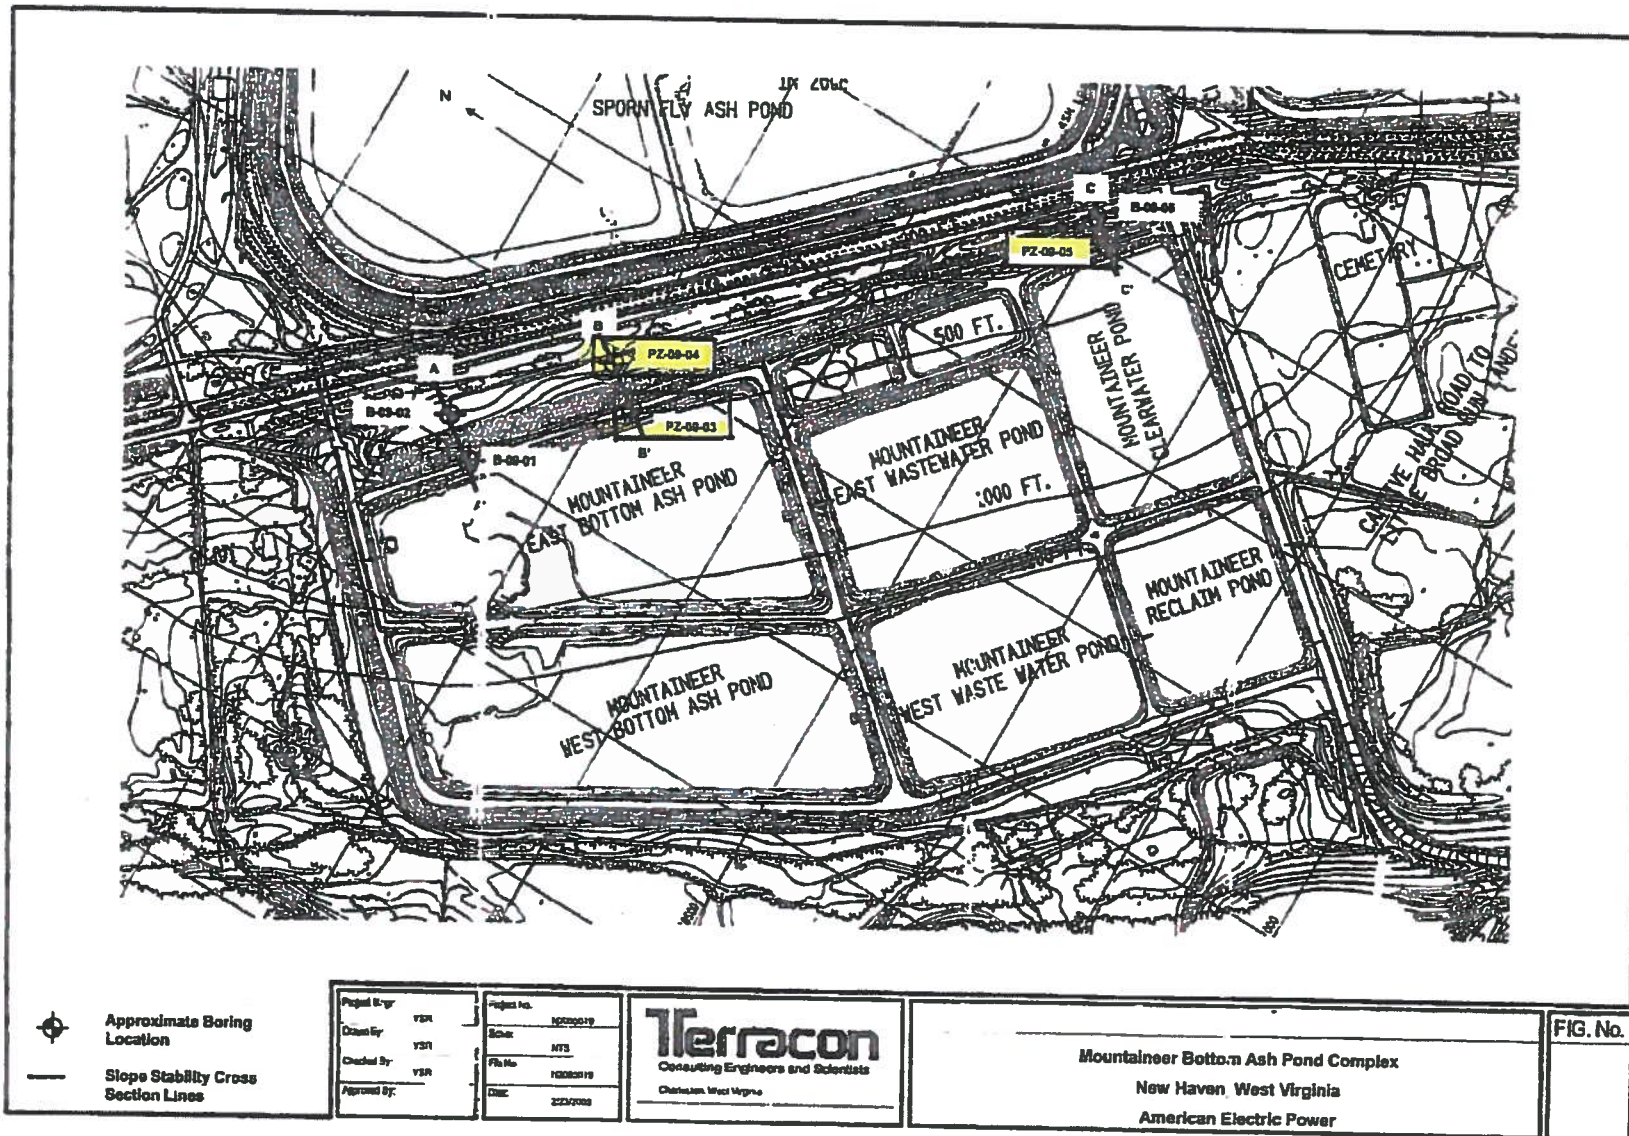
**FIGURE 4 – PIEZOMETER LOCATION MAP  
BOTTOM ASH COMPLEX, MOUNTAINEER PLANT**

Three piezometers were installed in February 2009. PZ-09-03 was installed at the crest of the EBAP. PZ-09-04 was installed at the toe, directly down the slope from PZ-09-03. PZ-09-05 was installed at the crest of the CWP. The location of all three piezometer are illustrated in Figure 4 (Piezometer Location Map) included in Appendix C. The following Table 2a illustrates the maximum reading recorded of the piezometers since the last annual inspection (October 2018). A summary of the pond levels measured during the 2019 inspection and the pool level data from previous three years are summarized below in Table 2b. The historical static water level data (2009-19) of the Bottom Ash Complex is compiled and presented in Figure 5 at Appendix C.
