**2020 DAM AND DIKE INSPECTION REPORT  
BOTTOM ASH COMPLEX  
(Facility ID #05307)**

**GERS-20-031**

**APPALACHIAN POWER COMPANY  
MOUNTAINEER PLANT  
NEW HAVEN, WEST VIRGINIA**

**INSPECTION DATE:** October 13, 2020

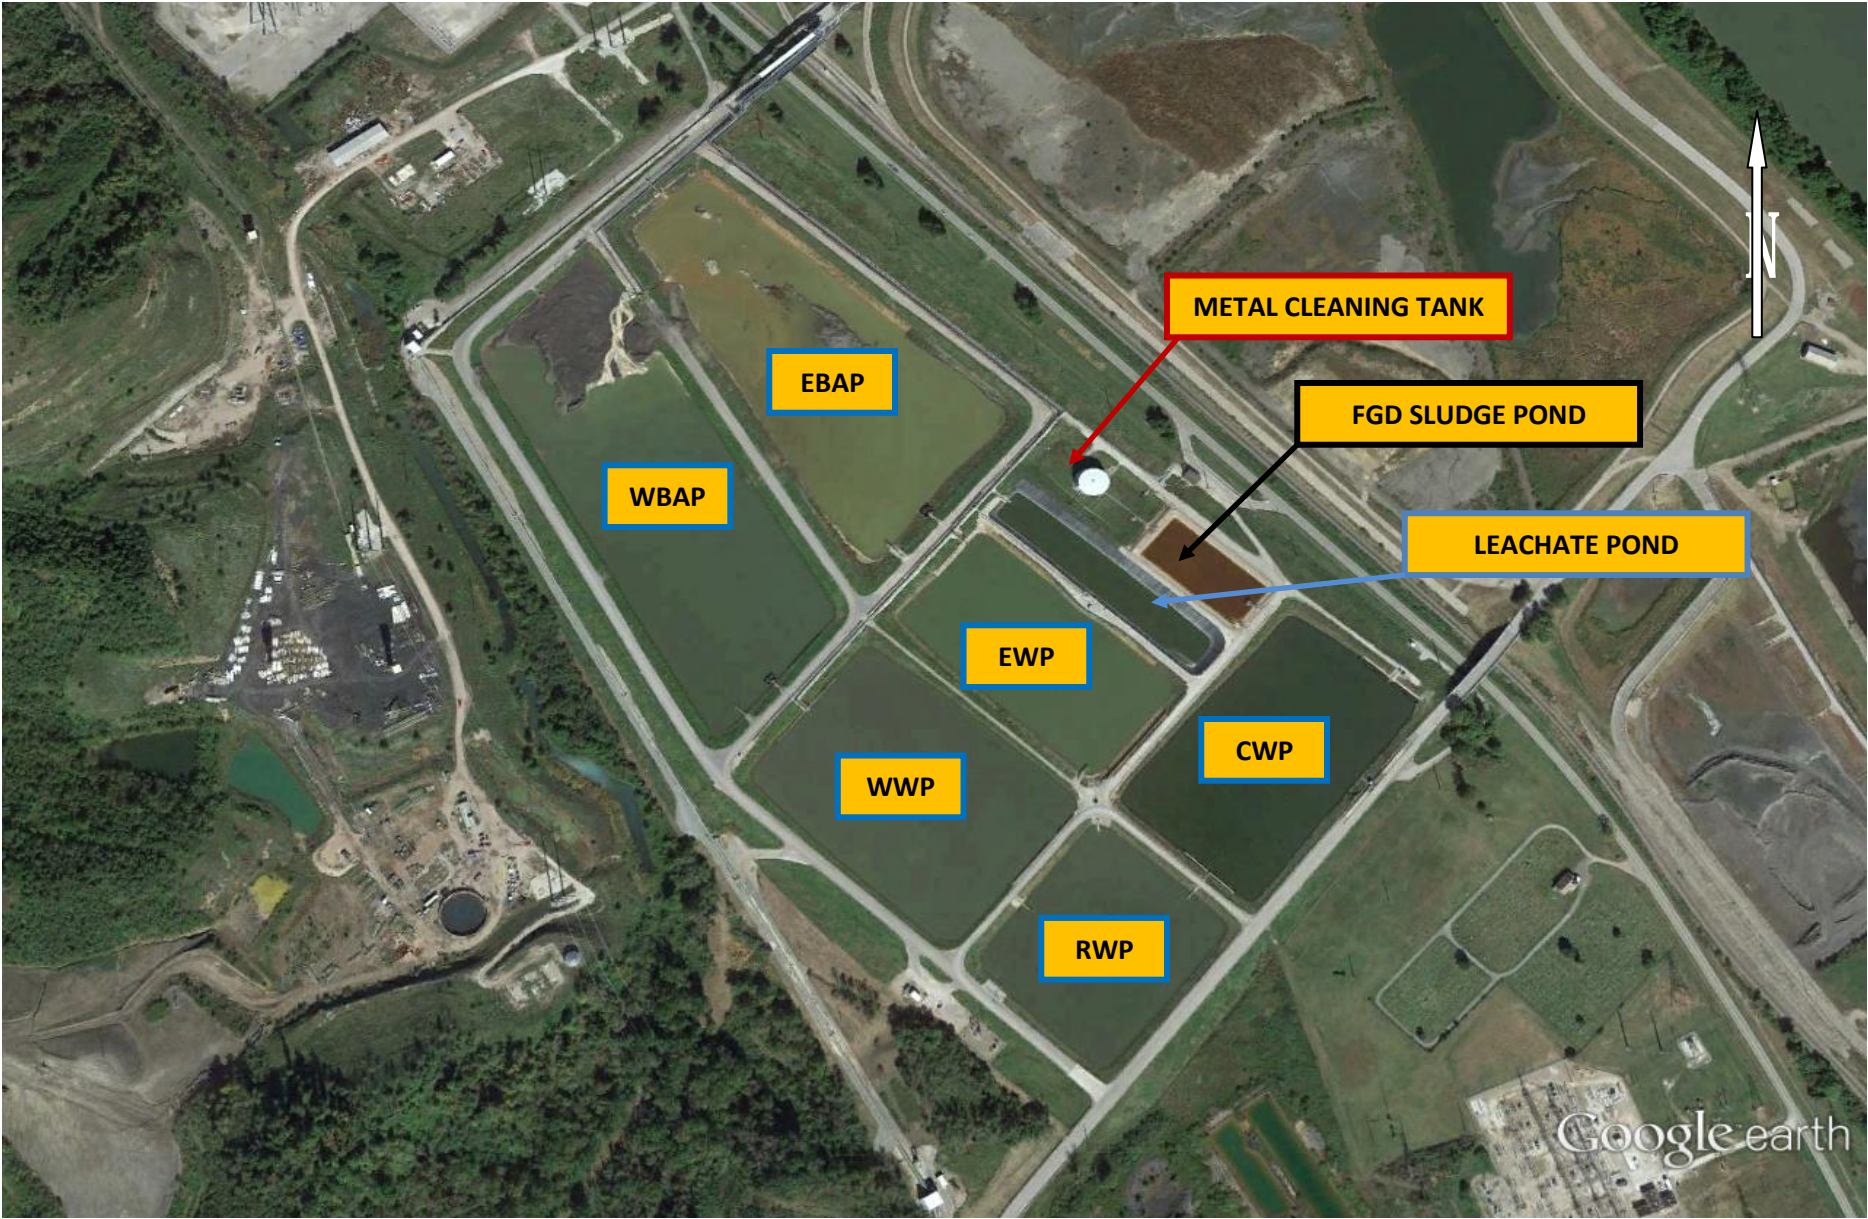
**FIGURE 2 – BOTTOM ASH POND COMPLEX**

The pond embankments are generally small in height (i.e., < 50 ft.) and have design slopes of 3 Horizontal to 1 Vertical (3H to 1V) for both the interior and exterior slopes. The Bottom Ash Ponds normal pool elevation are at 612 feet, the Waste Water Ponds normal pool elevations are at 609 feet, and the Reclaim and Clear Water Ponds normal pool elevations are at 603 feet. The East Bottom Ash and the East Wastewater Ponds were out of service at the time of this inspection, but could be used in alternate sequences with the West Bottom Ash and the West Wastewater Ponds during routine maintenance, repair, ash removal or other operating activity. Figure 2 included in Appendix A illustrate various ponds arrangement at the Bottom Ash Complex.

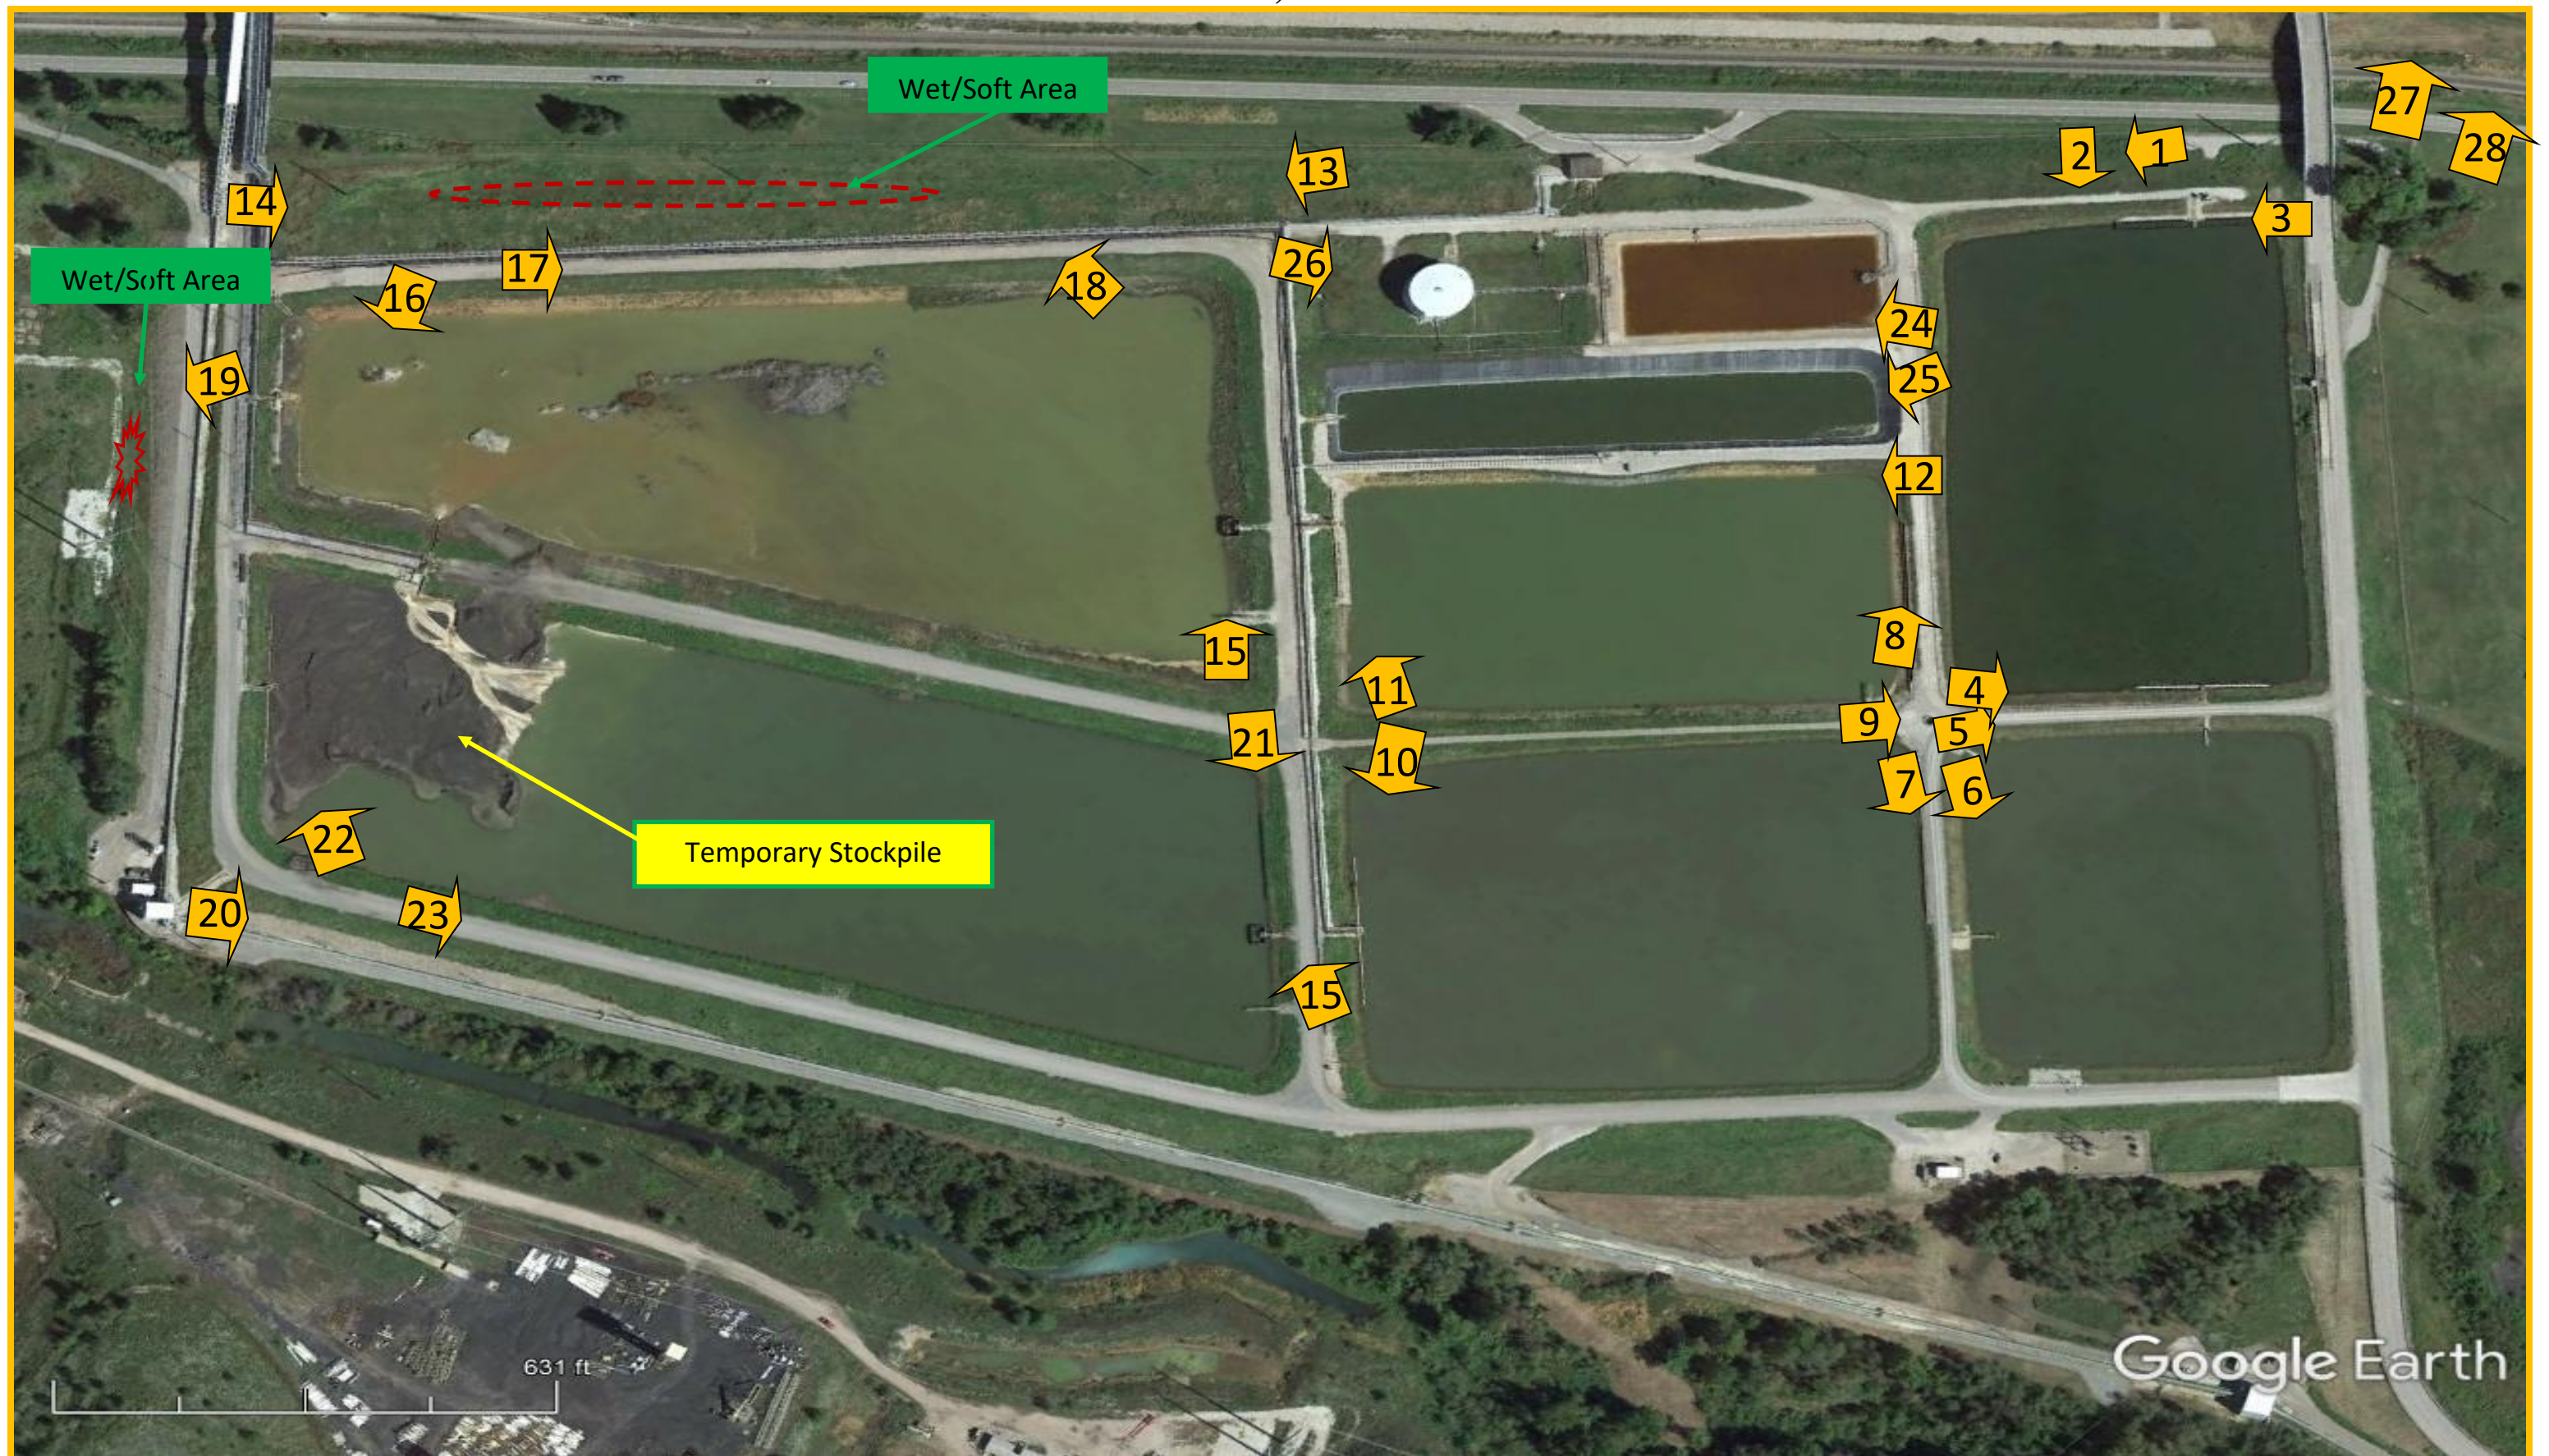
**FIGURE 3 – PHOTOGRAPH LOCATION MAP**  
**BOTTOM ASH COMPLEX, MOUNTAINEER PLANT**

The Bottom Ash Pond Complex is comprised of diked embankments to the north, east, and west sides of the complex. The south side of the complex is incised and also consists of a haul road providing access to this area. There are six main ponds (EBAP, WBAP, EWP, WWP, RWP, and CWP) within the complex. The Bottom Ash Ponds and Wastewater Ponds were designed in tandem, but one pond each is in service at a given time. At present, the WBAP and WWP are used most of the time without a need to switch to the other ponds. In addition, a metal cleaning tank pond, a FGD pond, and a leachate pond were added to the east of the EWWP. Figure 3 (Photograph Location Map) and photographs are included in Appendix B.

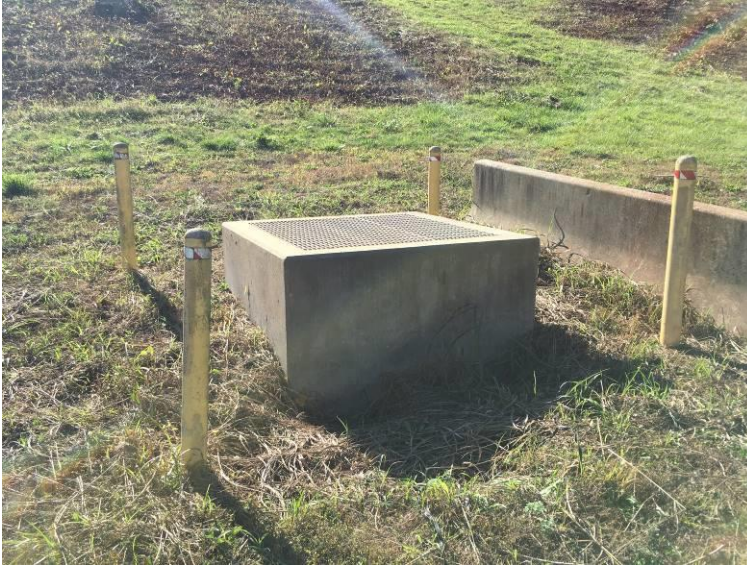
**Photo No. 28**

Bottom Ash Complex

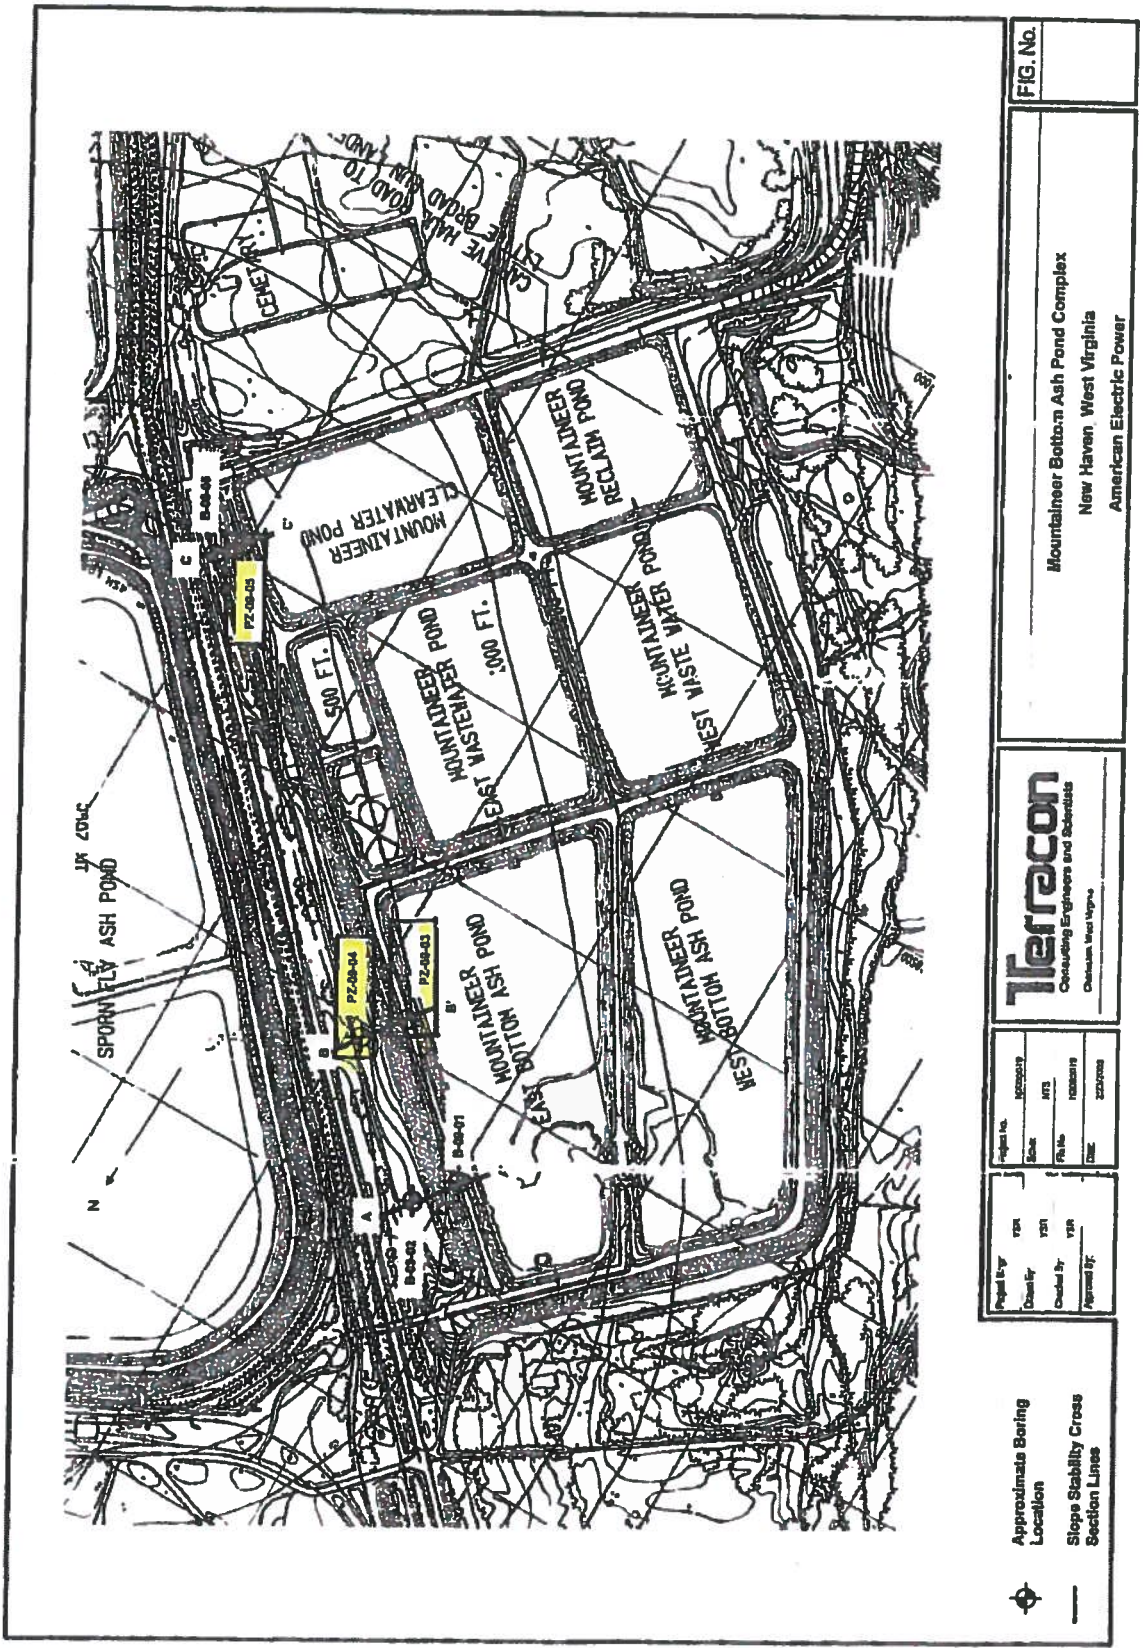
**FIGURE 4 - PIEZOMETER LOCATION MAP  
BOTTOM ASH COMPLEX, MOUNTAINEER PLANT**

Three piezometers were installed in February 2009. PZ-09-03 was installed at the crest of the EBAP. PZ-09-04 was installed at the toe, directly down the slope from PZ-09-03. PZ-09-05 was installed at the crest of the CWP. The location of all three piezometer are illustrated in Figure 4 (Piezometer Location Map) included in Appendix C. The following Table 2a illustrates the maximum reading recorded of the piezometers since the last annual inspection (August 2019). A summary of the pond levels measured during the 2020 inspection and the pool level data from previous three years are summarized below in Table 2b. The historical static water level data (2018-2020) of the Bottom Ash Complex is compiled and presented in Figure 5 at Appendix C.
