**Rockport Fly Ash Landfill Deficiency Corrective  
Measure Report  
For  
Intermediate Berm Leachate Seepage**

**Indiana Michigan Power Company  
Rockport Plant  
Rockport, Indiana**

**November 2021**

**Document ID: GERS-21-070**

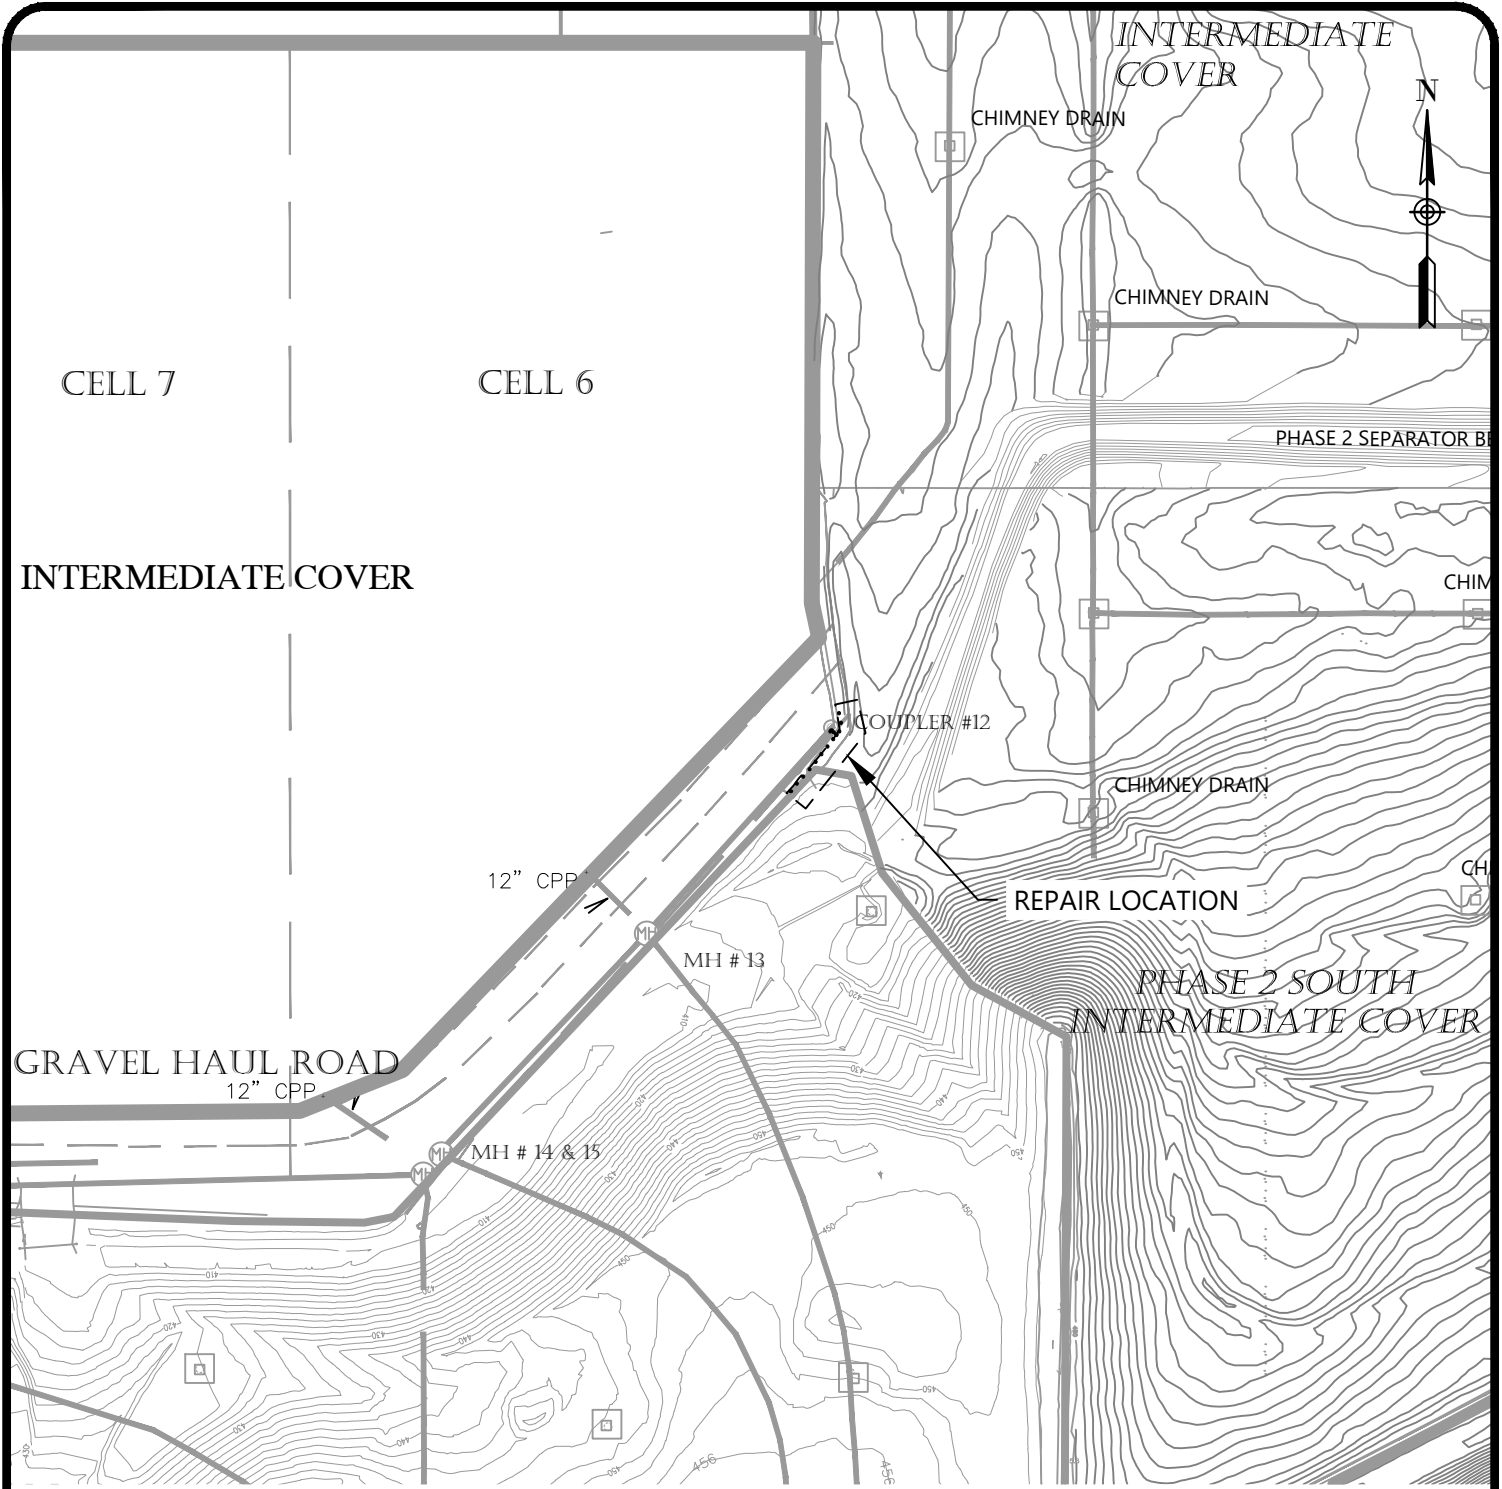
<b>REPAIR LOCATION</b>	SCALE:	FIGURE NO.
	LANDFILL SEEPAGE REPAIR ROCKPORT FLY ASH LANDFILL ROCKPORT, IN	GRAPHIC	<b>2</b>
		DATE:	
		PROJECT NUMBER	
	217736

The cover soil portion of the existing intermediate berm was removed to facilitate construction prior to S&ME's arrival on-site. At the beginning of our observations on August 30, 2021, the existing geomembrane was cut on the landfill side of the floor liner/rain flap seam that was identified by AEP to be defective.

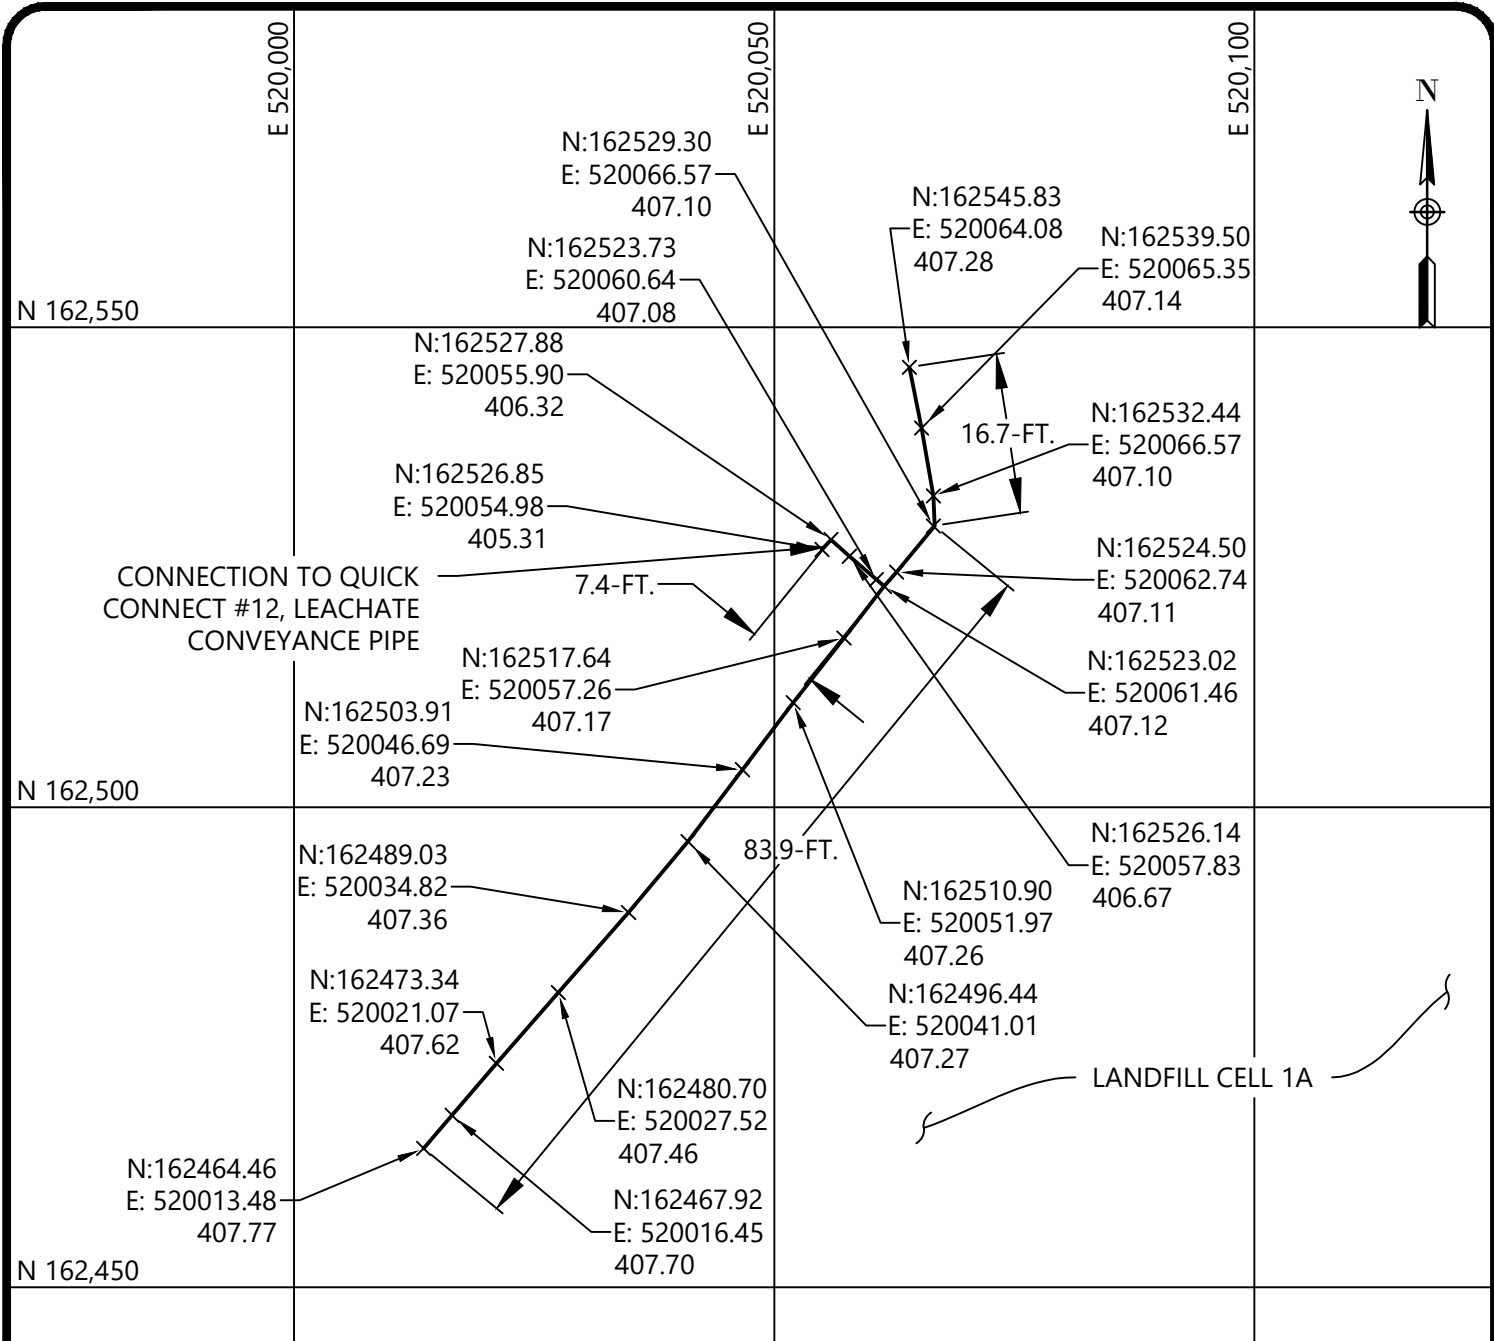
<b>UNDERDRAIN</b>	SCALE:	FIGURE NO.
	LANDFILL SEEPAGE REPAIR ROCKPORT FLY ASH LANDFILL ROCKPORT, IN	GRAPHIC	<b>4</b>
		DATE:	
		PROJECT NUMBER	
		10/29/2021

As shown in the as-built details in Appendix I, an underdrain pipe was installed at the toe of the intermediate berm, above the in-place floor liner. The underdrain pipe was a 4-inch IPS DR 17 PE 4710 HDPE pipe and was manufactured by WL Plastics. The perforated pipe traversed approximately 100 feet along the repair area and the pipe was connected to a 'tee' connection approximately 20 feet south of the north end of the perforated pipe. The pipe was non-perforated where it exited the berm approximately 20 feet south of the north end of the repair area, as depicted in the as-built pipe locations provided in Appendix I. The pipe traversed perpendicular to the final berm geometry at its outlet and terminated at existing Quick Connect #12 where the leachate is conveyed to the existing leachate conveyance line on the west side of the Cell.

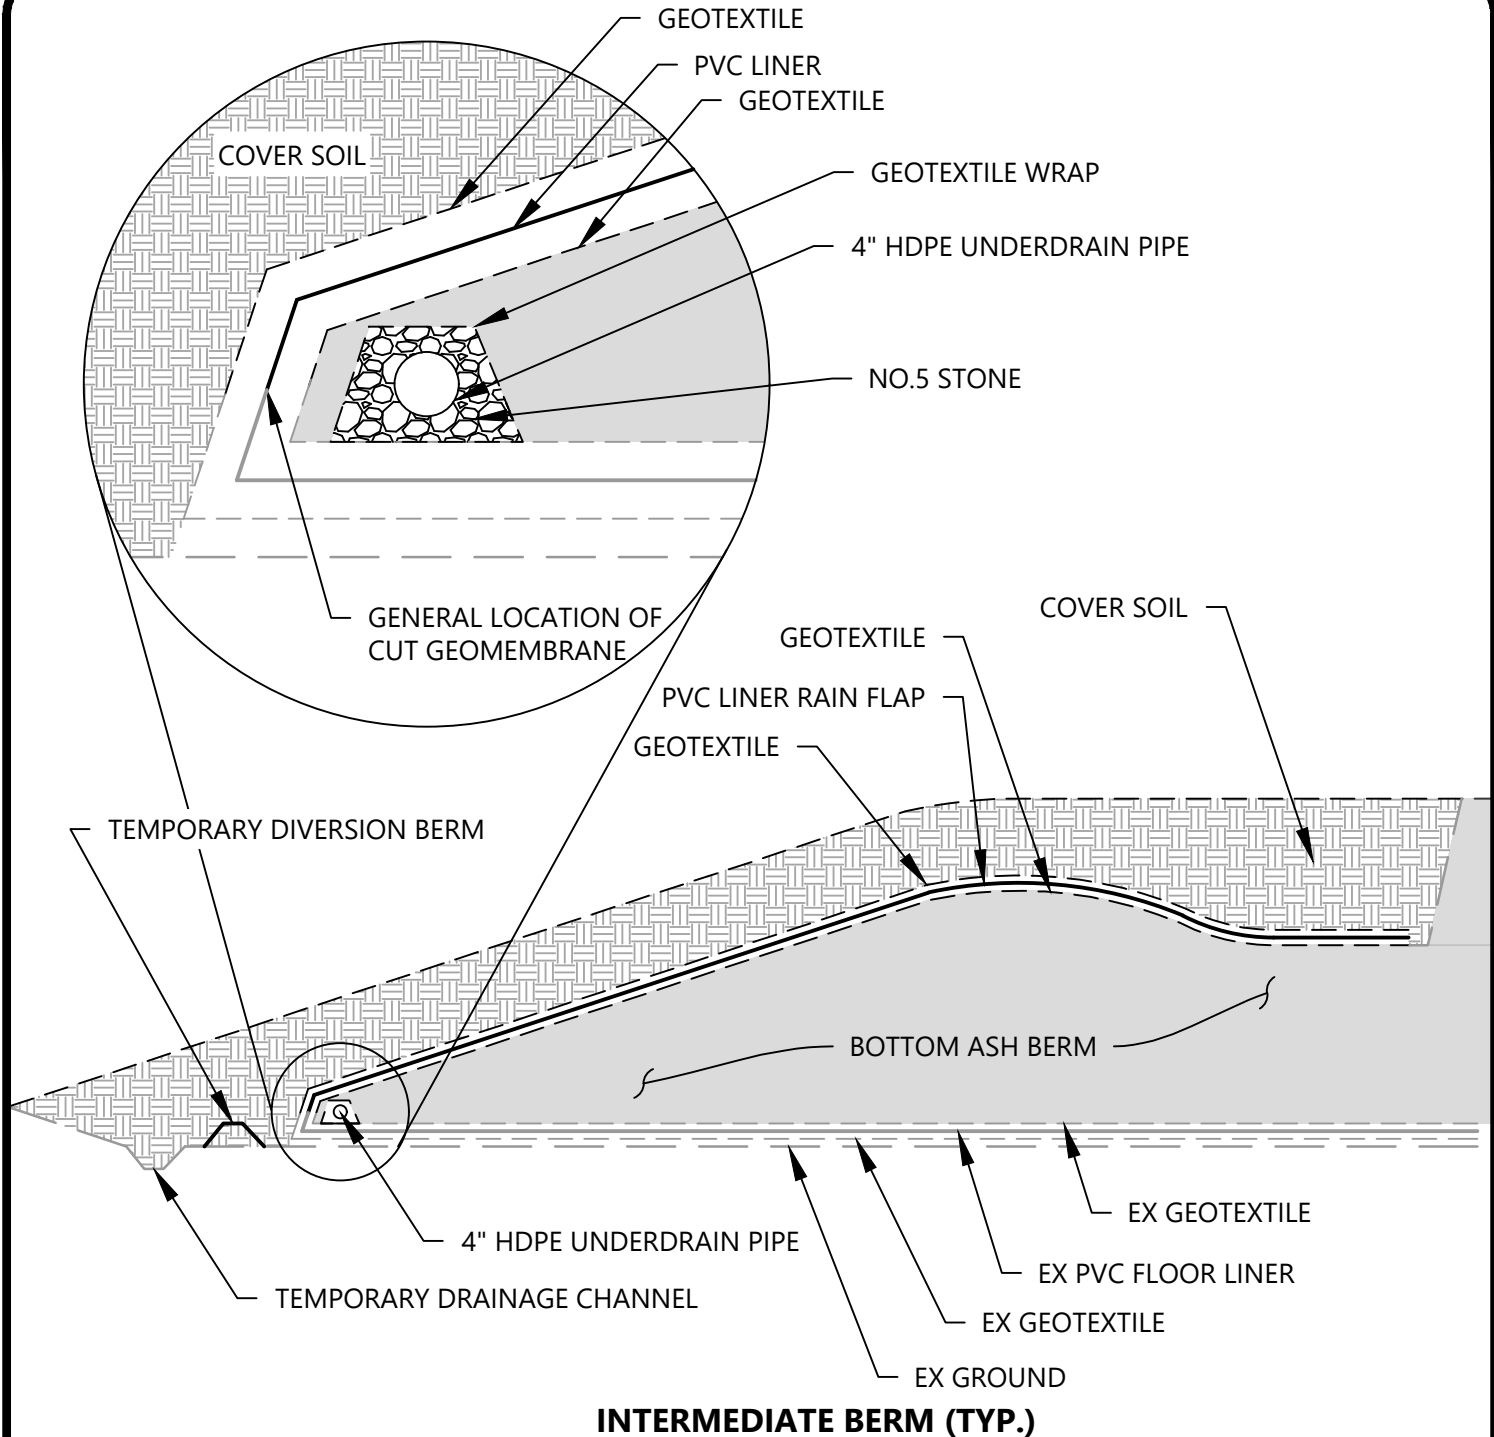
The intermediate berm was reconstructed with granular bottom ash where necessary. The majority of the existing berm was left intact and just the inside edge and area above the underdrain pipe required replacement.

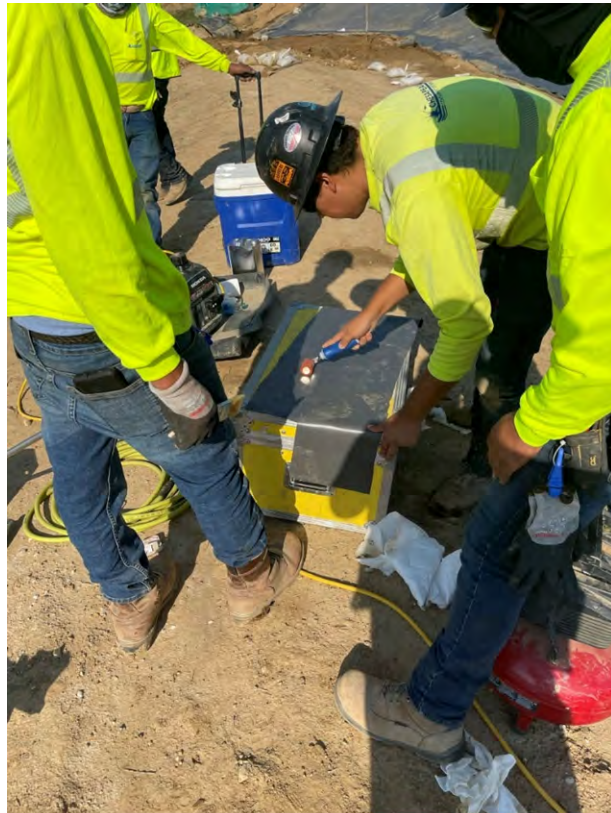
Photo 1: CCS using adhesive on the PVC liner to produce a trial weld.
