2022 Annual Dam and Dike Inspection Report

Bottom Ash Pond Complex

Mitchell Plant

Document ID: GERS-22-012

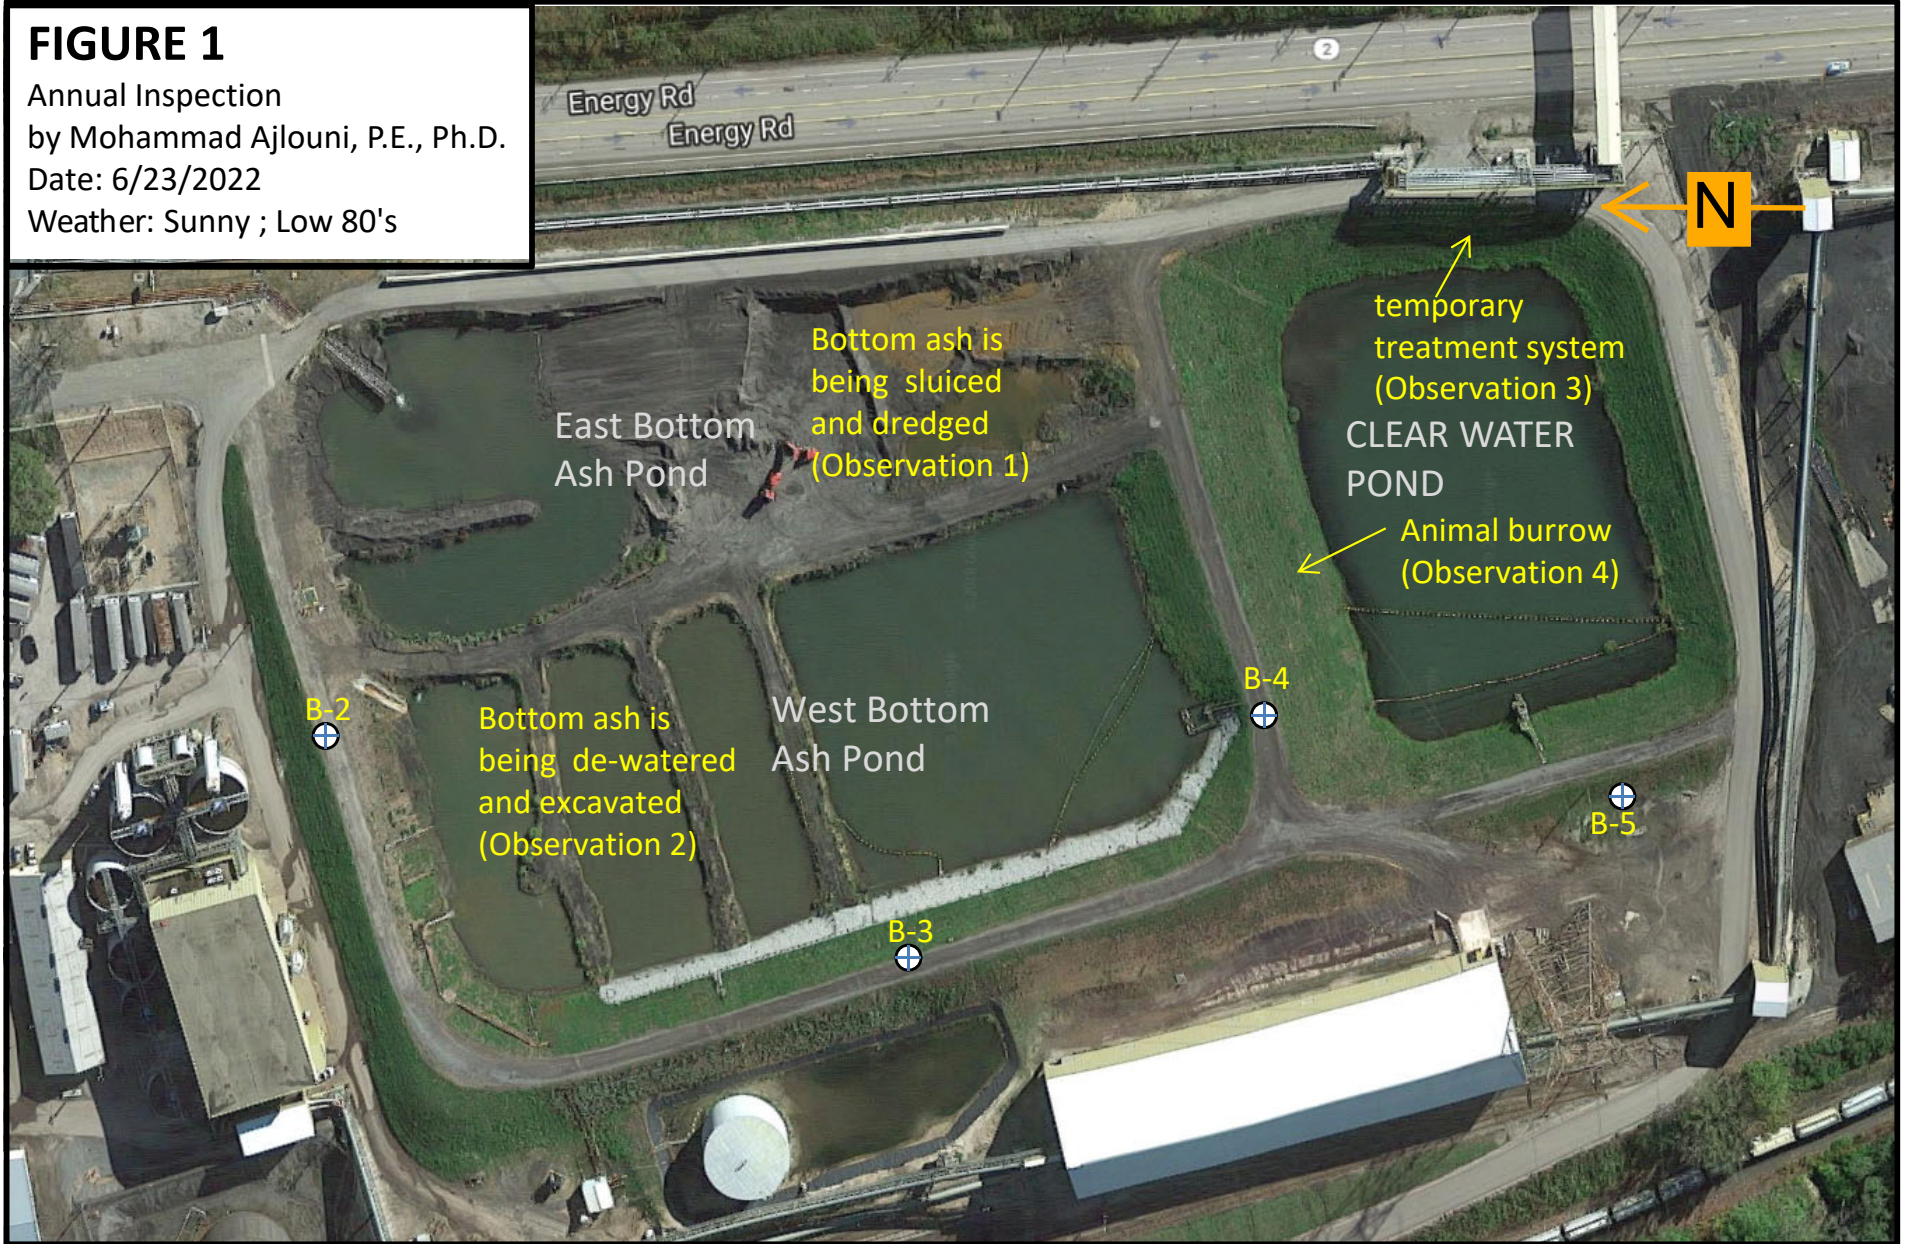
FIGURE 1

Annual Inspection
by Mohammad Ajlouni, P.E., Ph.D.
Date: 6/23/2022
Weather: Sunny ; Low 80's

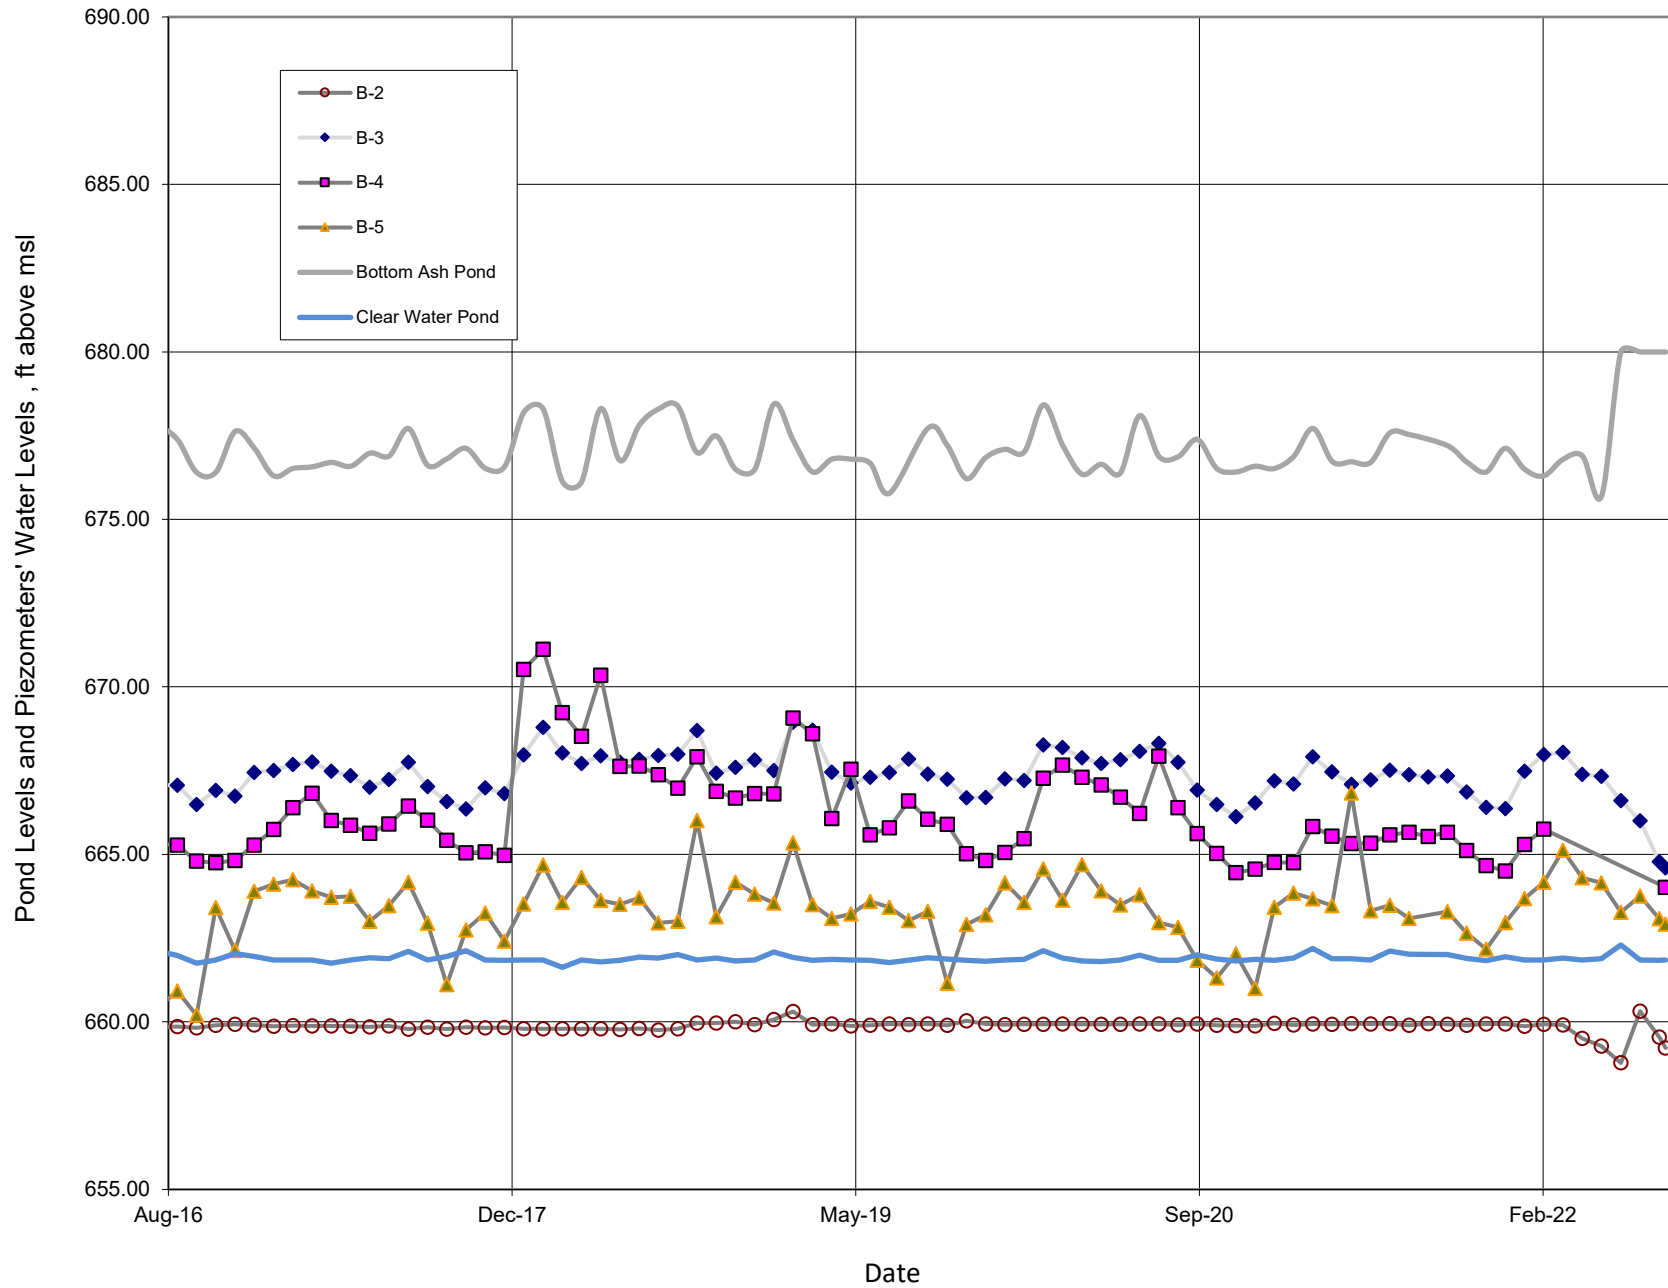
Figure 2 Bottom Ash Pond Complex Piezometers' & Ponds Level

Figure 2 presents the pond water levels as well as the piezometers water levels. Changes in piezometers levels does not appear to be affected by the bottom ash pond level because of the presence of the PVC liner.
