2023 ANNUAL DAM AND DIKE INSPECTION REPORT

BOTTOM ASH PONDS

**PIRKEY POWER PLANT
HALLSVILLE, TEXAS**

Dam & Dike Inspection Report (CCR - Bottom Ash Ponds)

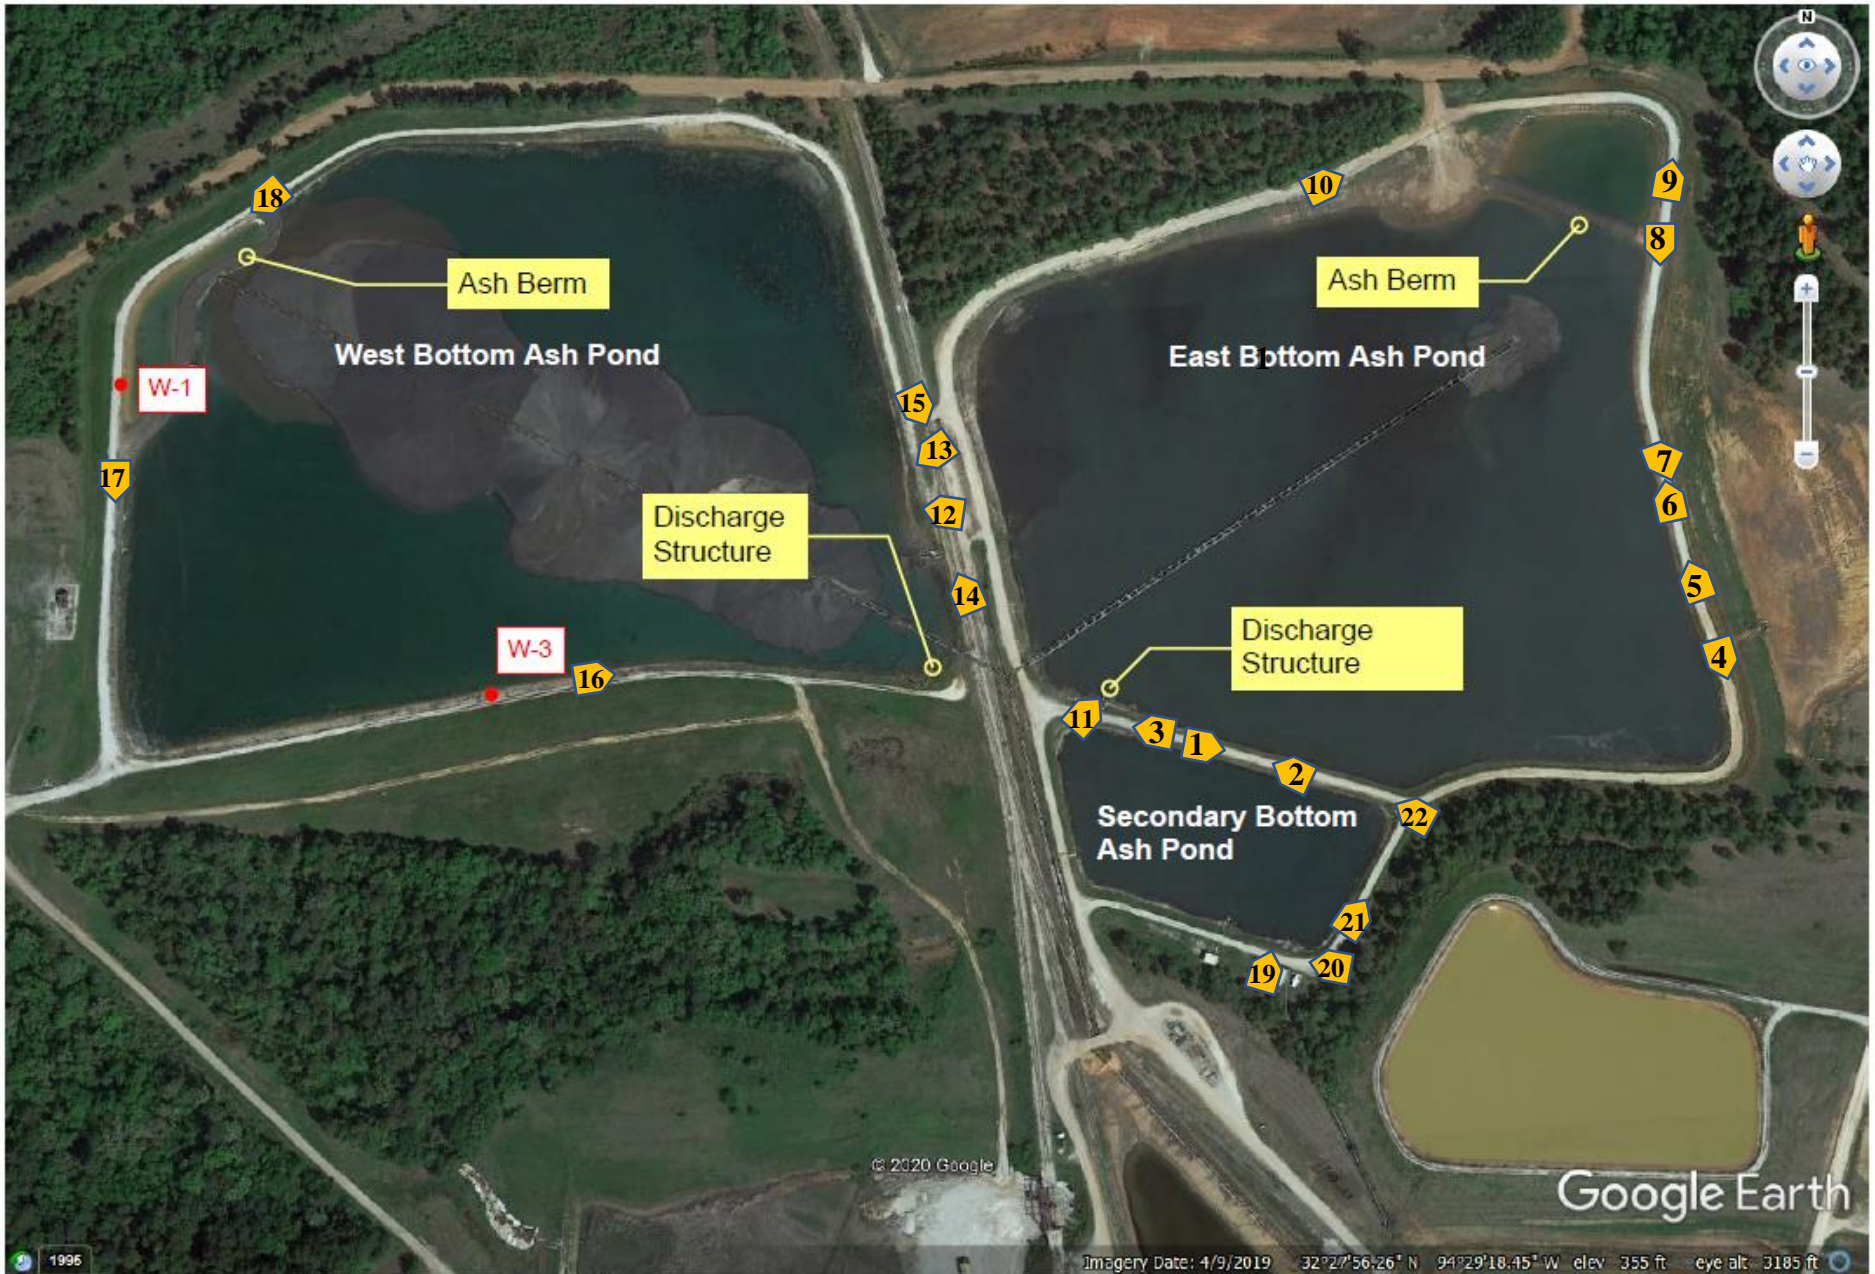
FIGURE 3 – INSPECTION PHOTOGRAPH LOCATION MAP
Pirkey Plant, Hallsville, Texas

A visual inspection of the CCR Ponds Complex was conducted to identify any signs of distress or malfunction of the impoundment and appurtenant structures. Specific items inspected included all structural elements of the dam such as upstream and downstream slopes, crest, and toe. Figure 3 illustrate the location of inspection photographs and selected photographs taken during the inspection and used to illustrate the visual observations are included at Appendix B. Additional inspection photos can be made available to the Plant upon request.
