Little Broad Run Landfill 2024 Landfill Inspection

Mountaineer Plant, Letart, West Virginia

AEP Document ID: GEVR-24-032

2024 Annual Inspection Report

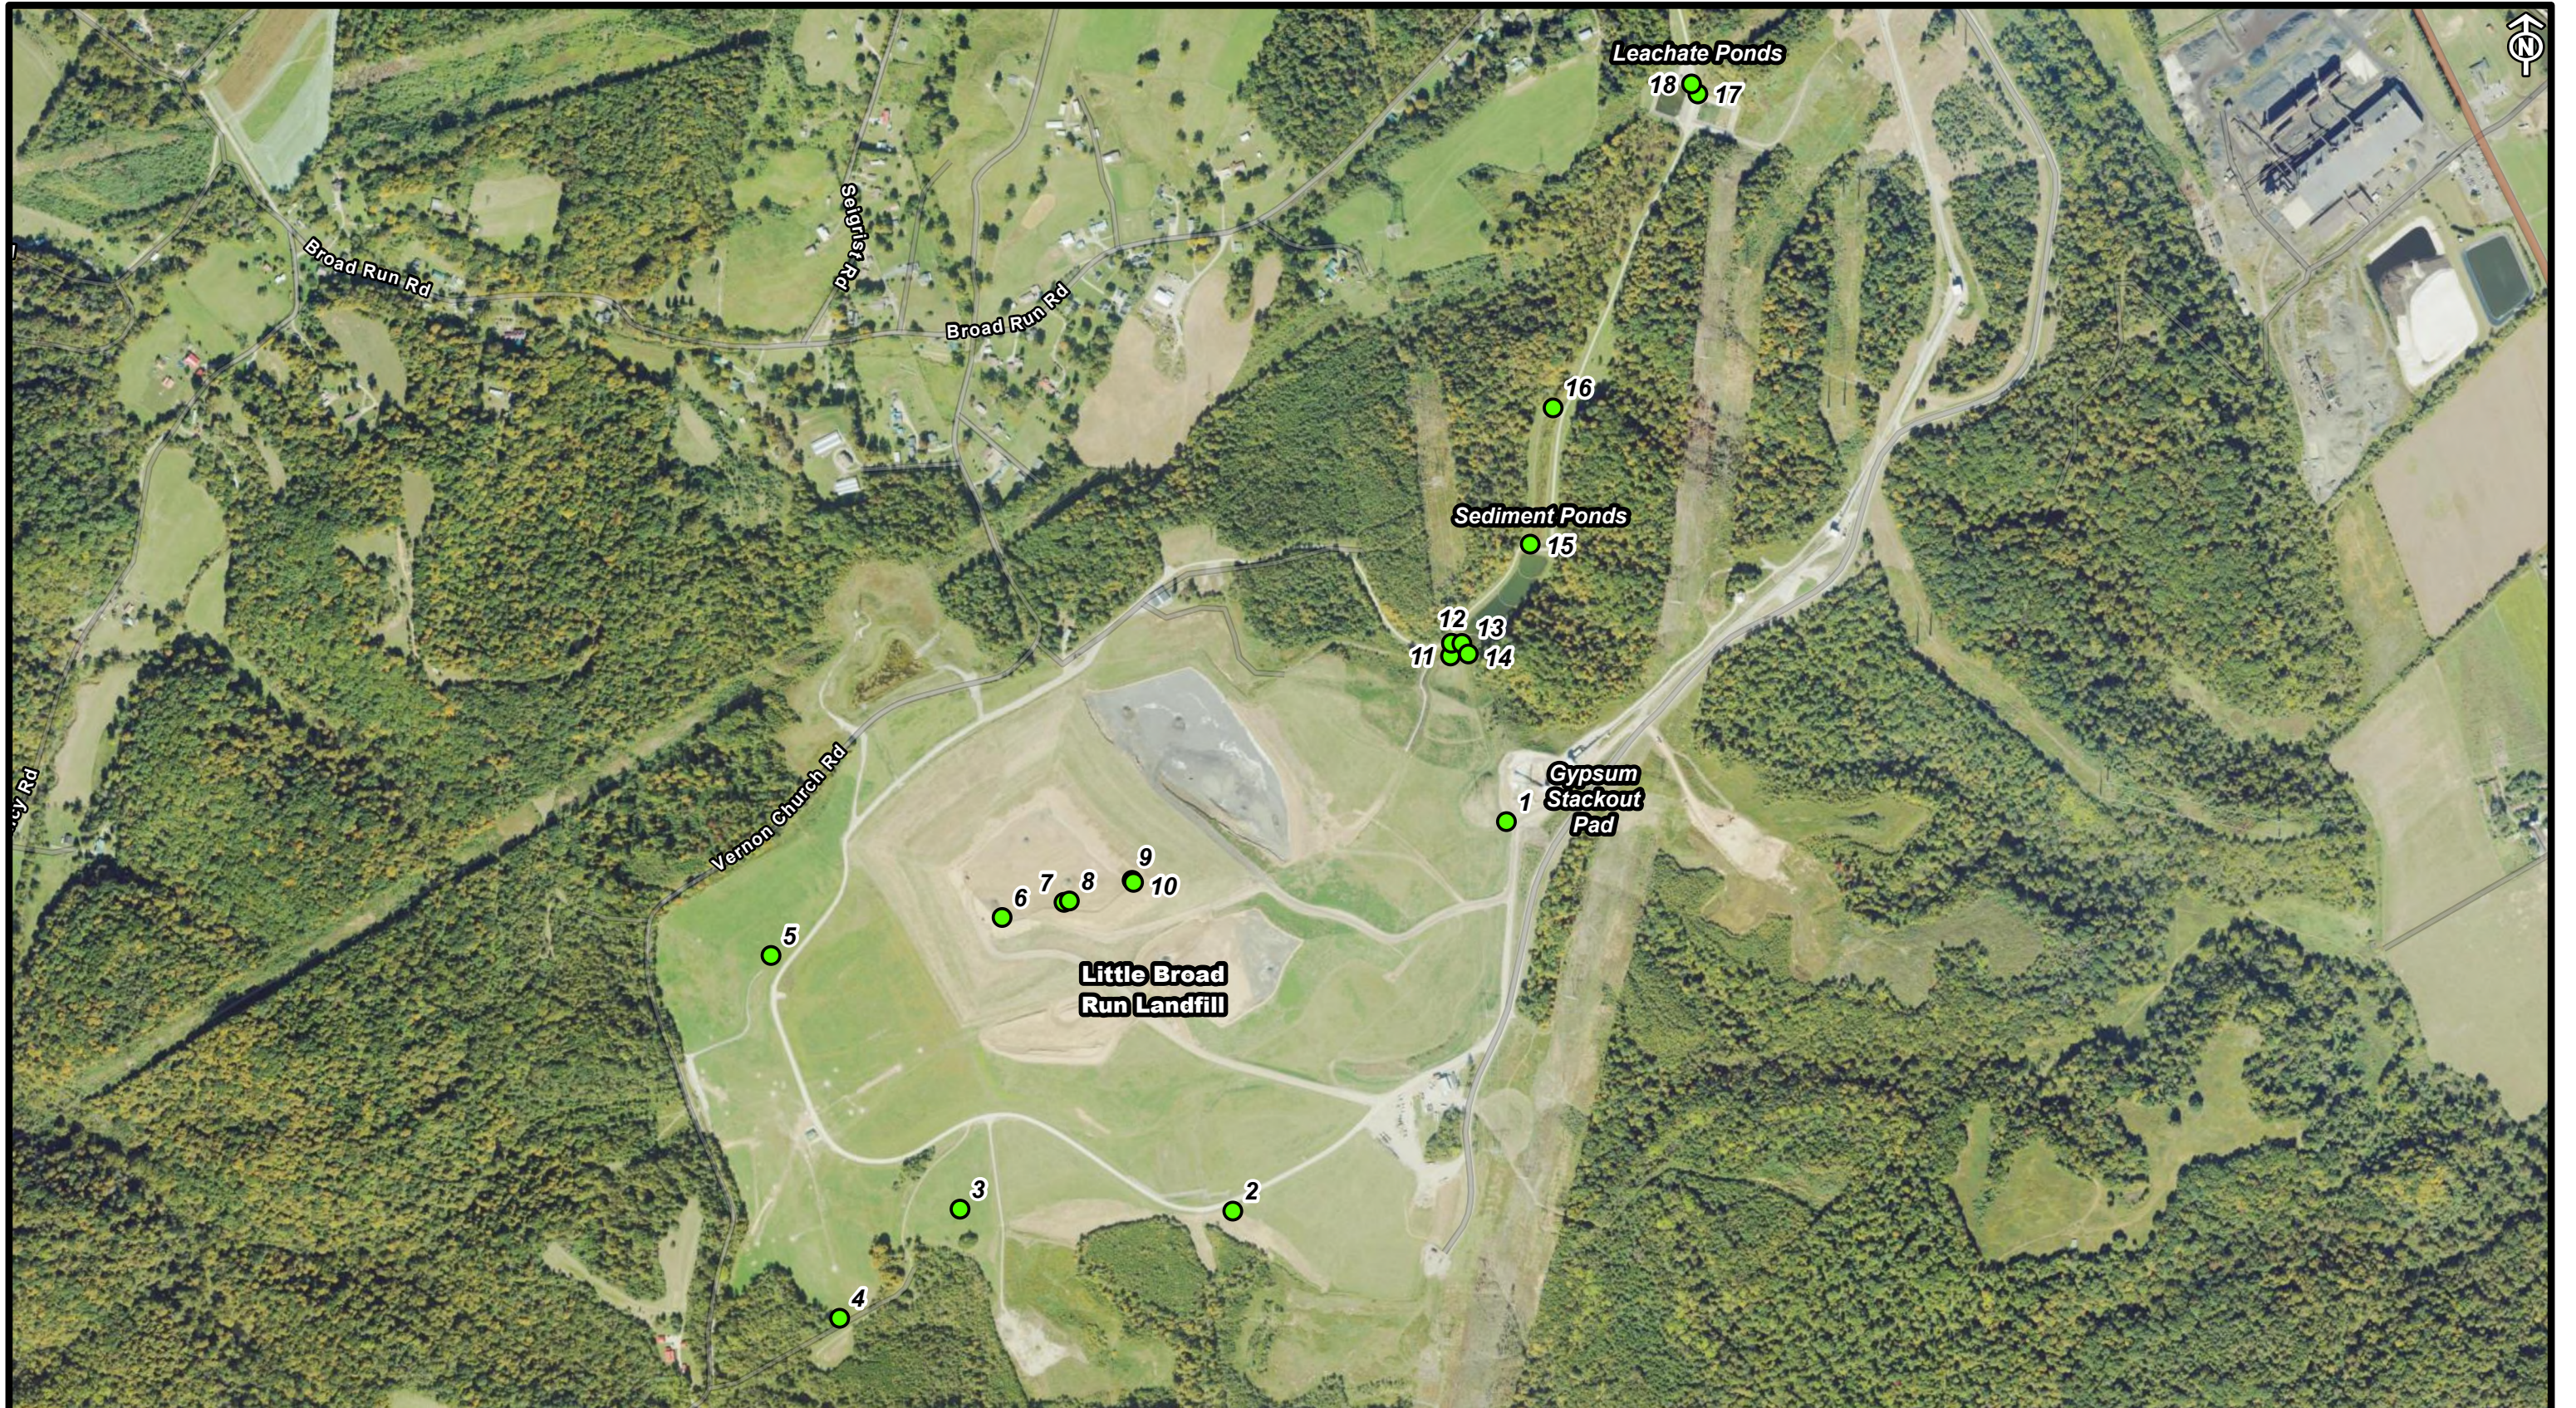
The Landfill is permitted for nine disposal areas (Area 1 through Area 9) and a vertical expansion that is designed over the existing landfill area of approximately 209 acres. Areas 1-7 of the landfill are filled to the permitted grades. Areas 8 and 9 are permitted but not constructed. The vertical expansion is currently divided into four development phases (Phase 1-4) and could be adjusted in acreages based on the operational needs. Figure 3 – Site Plan identifies the landfill, leachate collection ponds, and gypsum stacker pad.

Overall, the facility is in satisfactory condition. The landfill is functioning as intended with no new signs of potential structural weakness or conditions which are disrupting to the safe operation of the landfill. A summary of the observations are provided below. Inspection photos are included in Appendix A and their locations are provided on Figures 3 – Site Plan.
