Bottom Ash Pond 2024 Annual Dam and Dike Inspection Report

Northeastern Plant, Oologah, Oklahoma

Project 2305686

AEP Document ID: GEVR-24-036

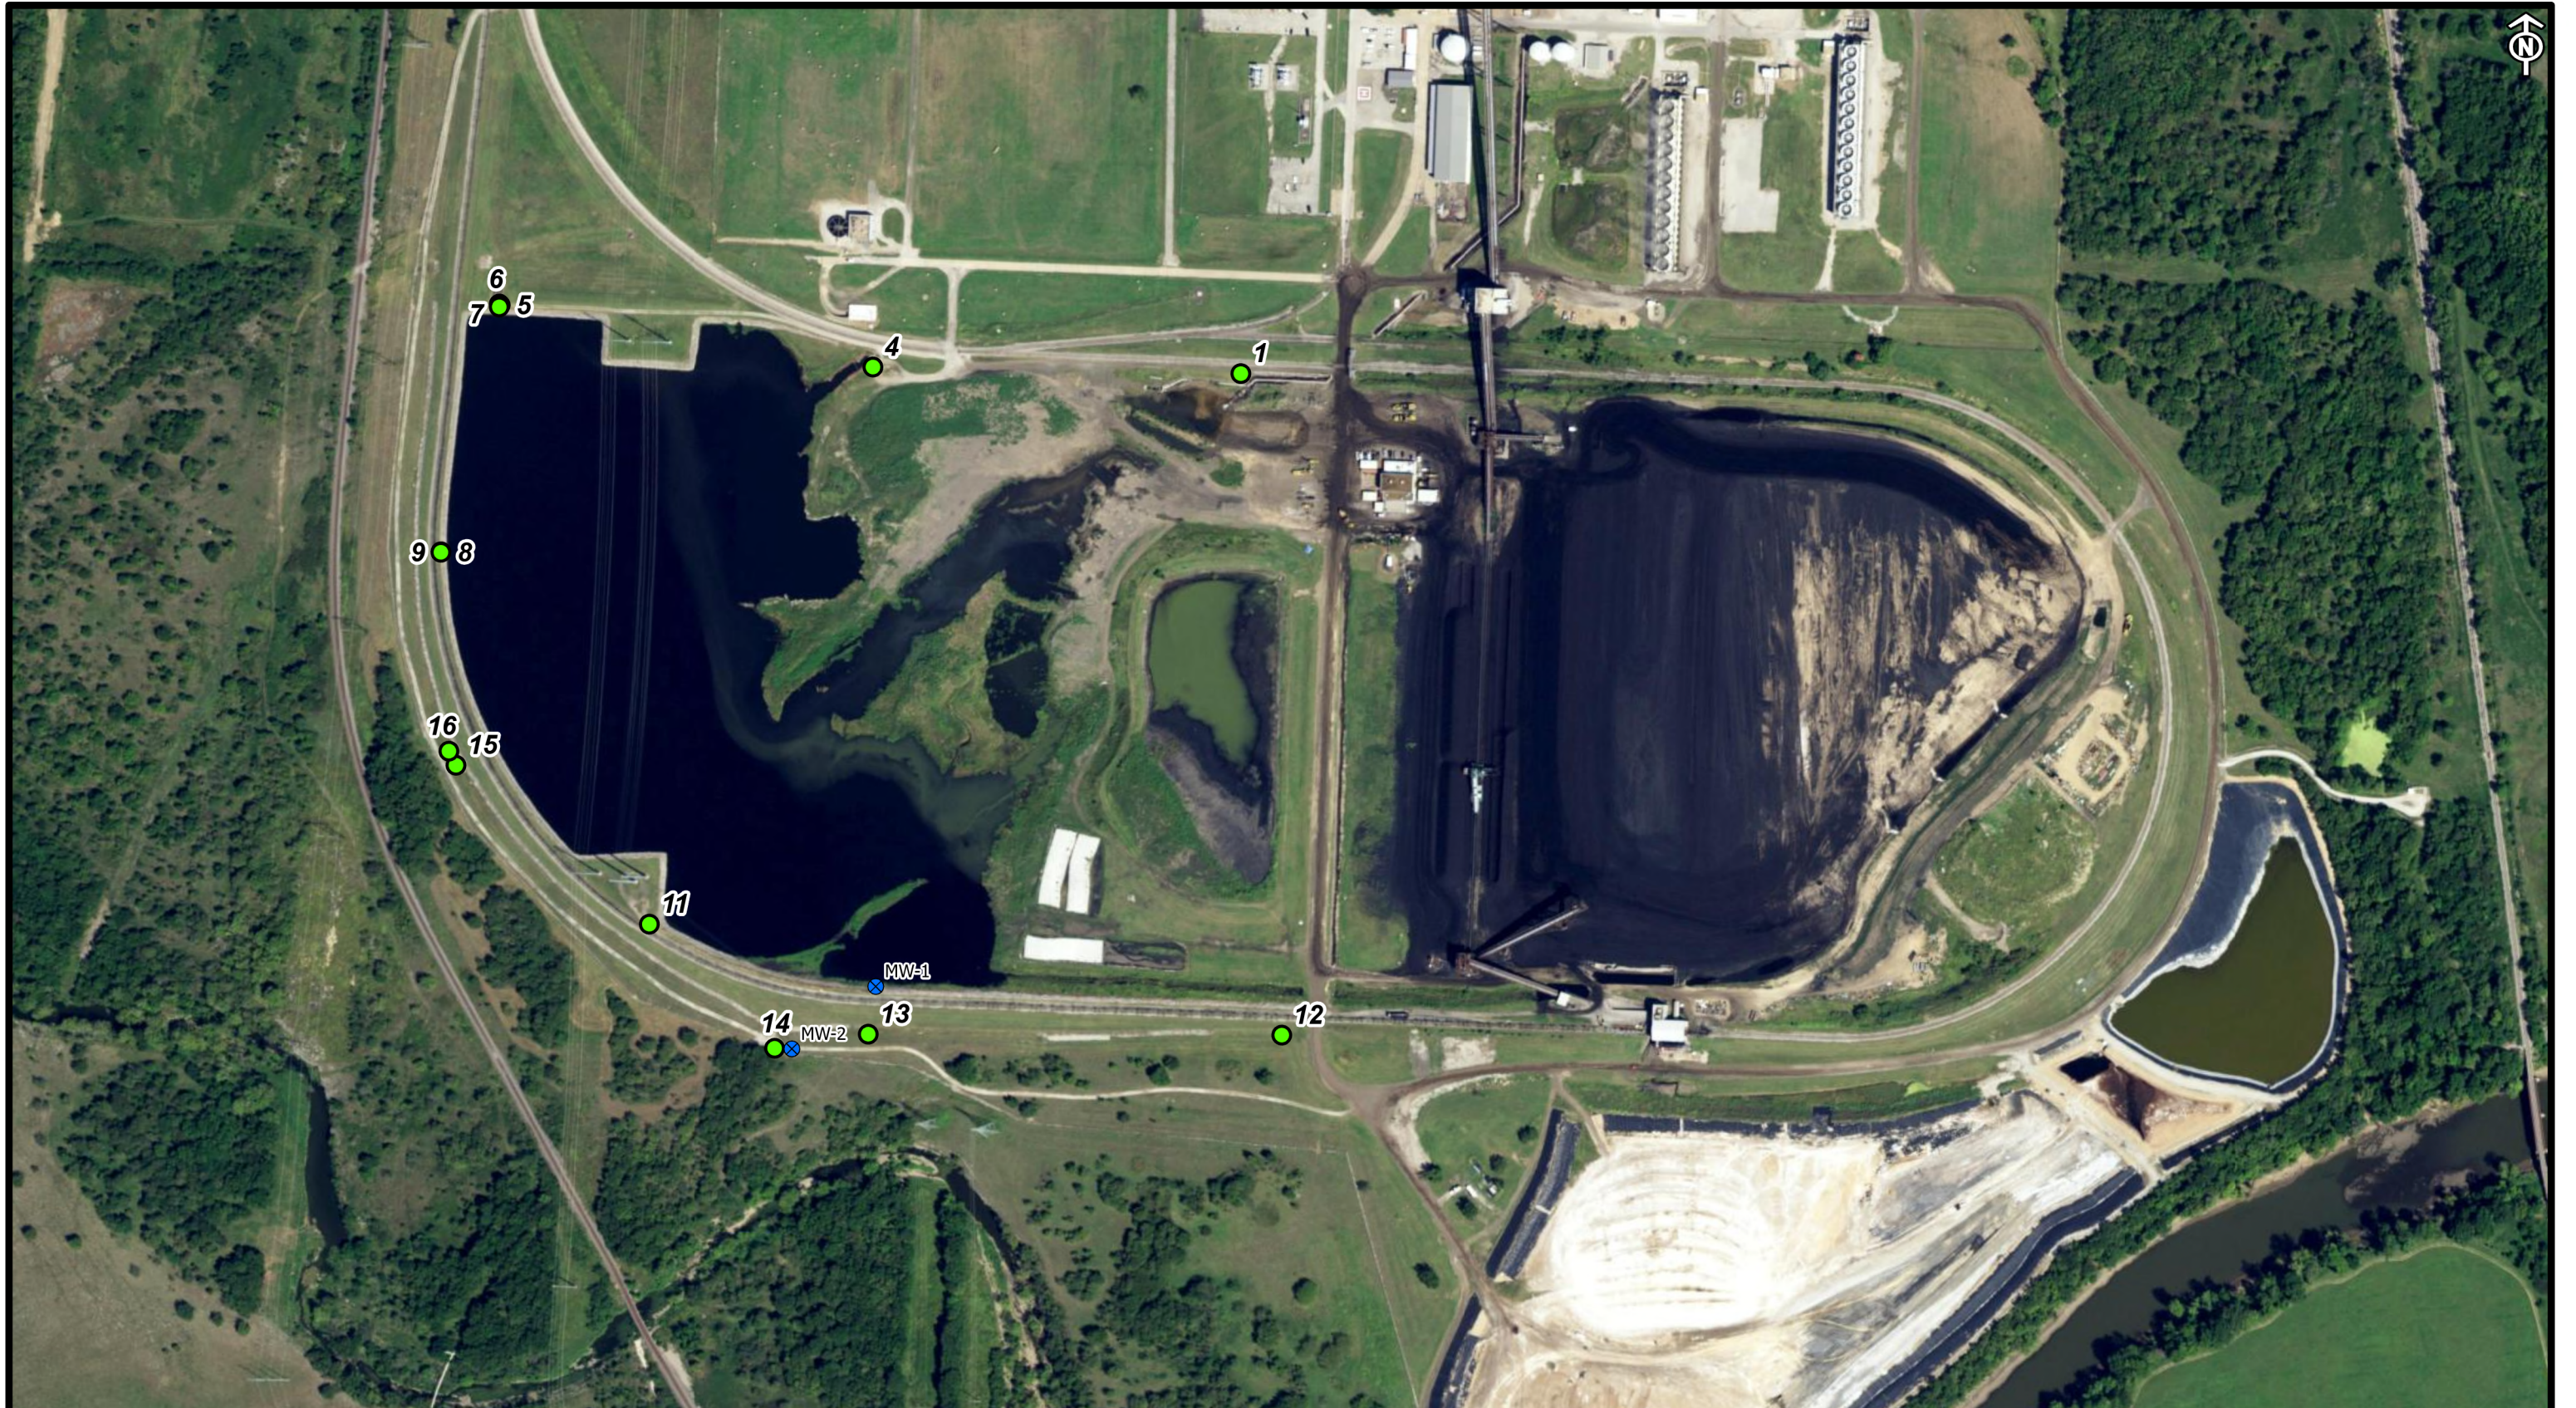
Figure 3 – Site Plan

The instrumentation for the Bottom Ash Pond consists of two piezometers which are shown on Figure 3 – Site Plan. The minimum maximum recorded readings of each piezometer since the previous annual inspection is shown in Table 1 below. The readings collected since the last inspection were all within their normal operating ranges as shown on the graph provided in Appendix A – Instrumentation Data.
