Bottom Ash Ponds 2024 Annual Dam and Dike Inspection Report

H.W. Pirkey Power Plant, Hallsville, Texas

July 8, 2024

AEP Document ID: GEVR-24-001

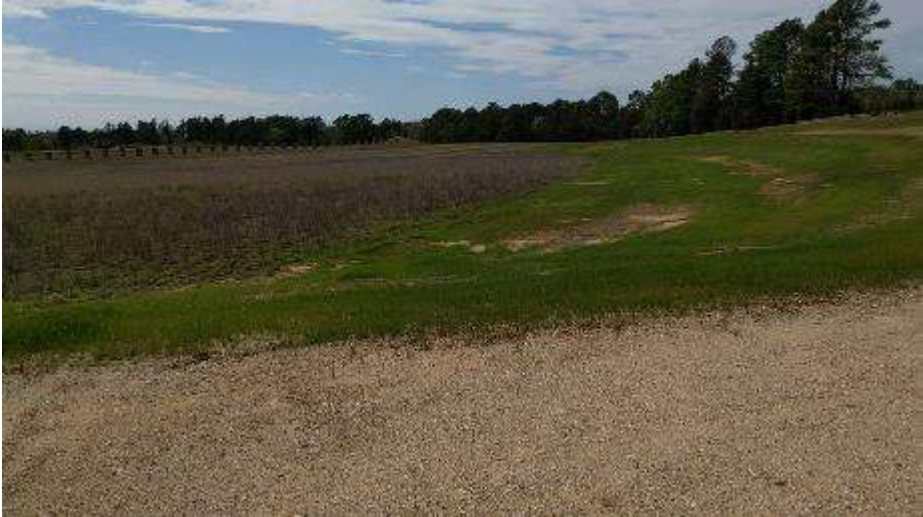
PHOTOGRAPH NO: 1	DATE: March 20, 2024 2:53 PM	LATITUDE: 32.46853639	LONGITUDE: -94.48989668
SITE LOCATION: HALLSVILLE, TEXAS			
DESCRIPTION: West area, Upstream Slope of Original Dam. Looking West. Typical Conditions.

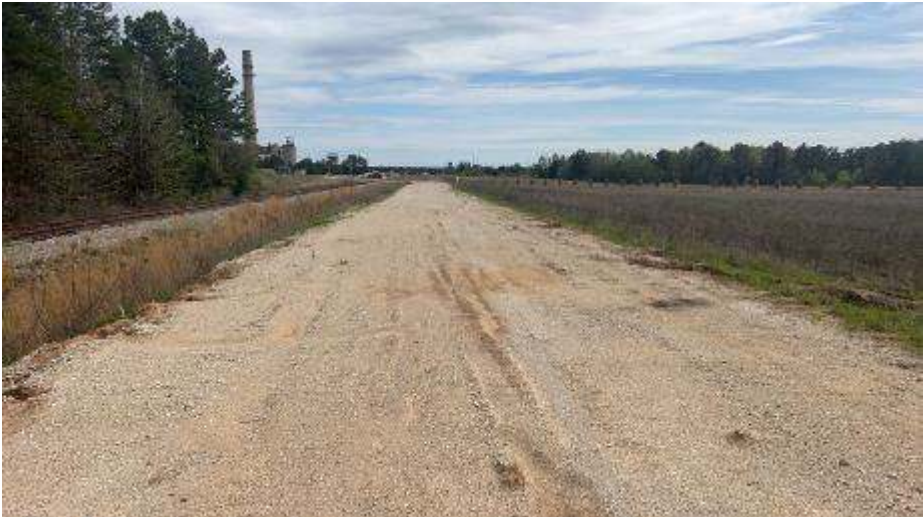
PHOTO BY: GEI CONSULTANTS, INC.			
PHOTOGRAPH NO: 2	DATE: March 20, 2024 2:55 PM	LATITUDE: 32.4685917236073	LONGITUDE: -94.4897559709474
SITE LOCATION: HALLSVILLE, TEXAS			
DESCRIPTION: East area, Crest. Looking South. General Photo, Typical Conditions.

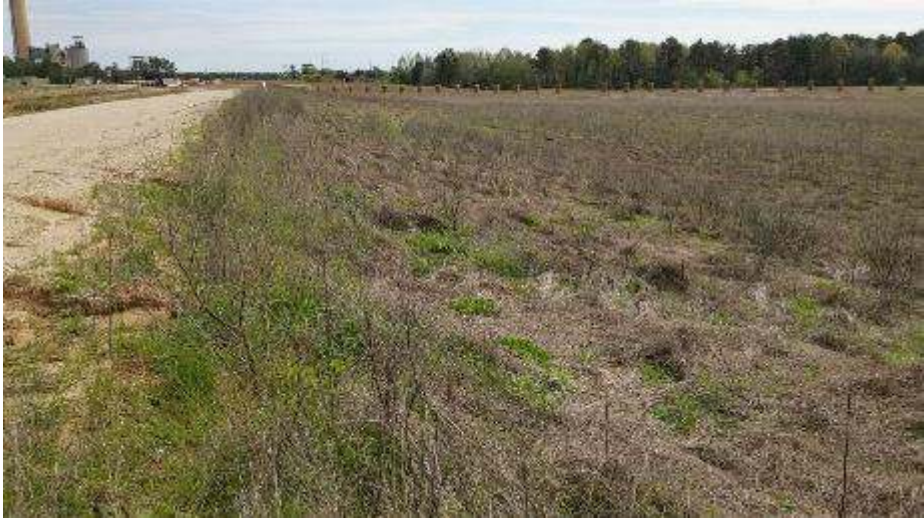
PHOTO BY: GEI CONSULTANTS, INC.			
PHOTOGRAPH NO: 4	DATE: March 20, 2024 2:57 PM	LATITUDE: 32.46843704	LONGITUDE: -94.48978109
SITE LOCATION: HALLSVILLE, TEXAS			
DESCRIPTION: East area, Upstream Slope of Original Dam. Looking South. Typical Conditions.

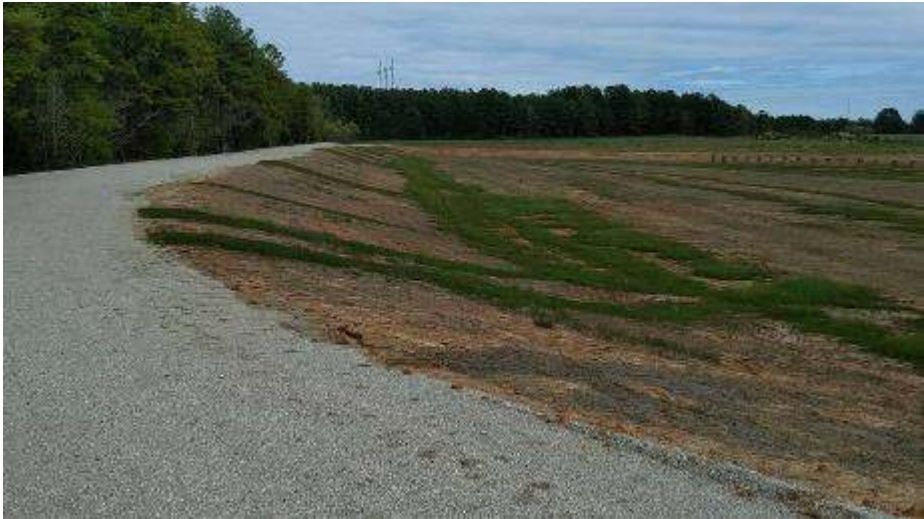
PHOTOGRAPH NO: 5	DATE: March 20, 2024 2:36 PM	LATITUDE: 32.46796794	LONGITUDE: -94.48913187
SITE LOCATION: HALLSVILLE, TEXAS			
DESCRIPTION: North area, Upstream Slope of Original Dam. Looking Northeast. Typical Conditions.

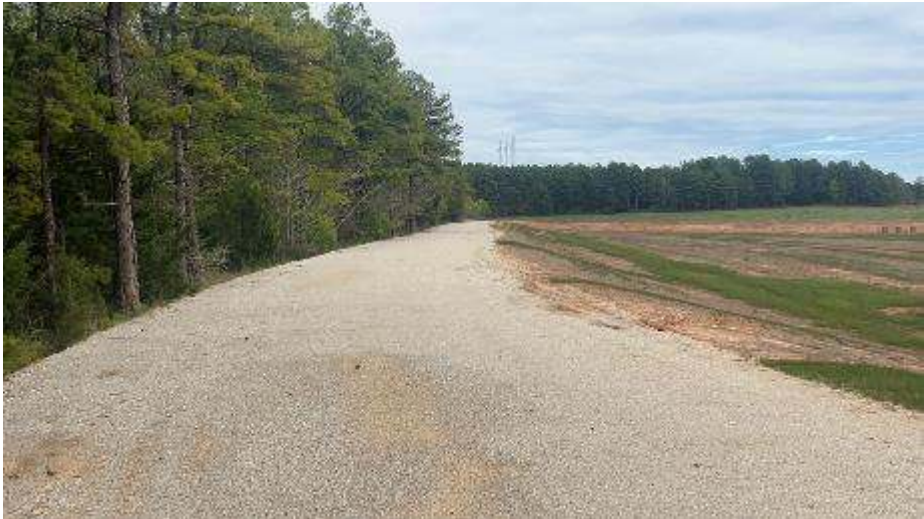
PHOTO BY: GEI CONSULTANTS, INC.			
PHOTOGRAPH NO: 6	DATE: March 20, 2024 2:36 PM	LATITUDE: 32.4680095619327	LONGITUDE: -94.489083981754
SITE LOCATION: HALLSVILLE, TEXAS			
DESCRIPTION: North area, Crest. Looking East. Typical Conditions.

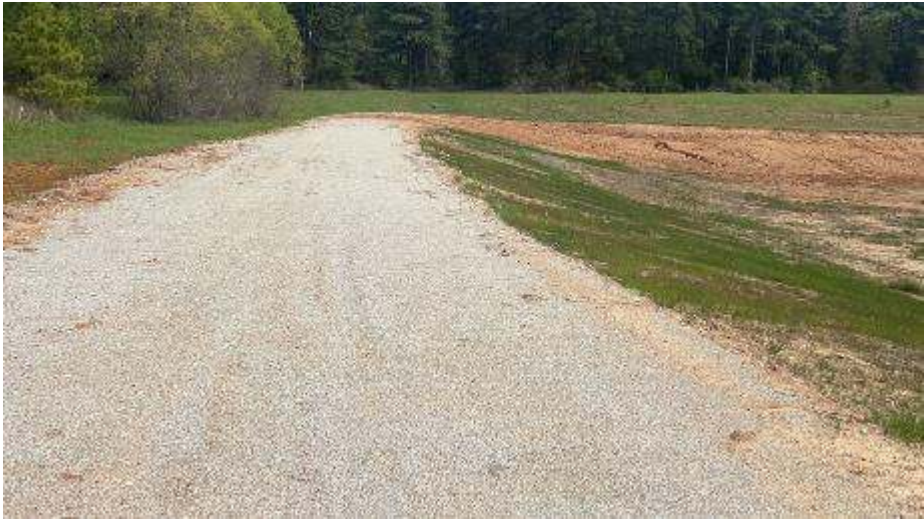
PHOTOGRAPH NO: 7	DATE: March 20, 2024 2:43 PM	LATITUDE: 32.4690148608949	LONGITUDE: -94.4862108492012
SITE LOCATION: HALLSVILLE, TEXAS			
DESCRIPTION: North area, Crest. Looking East. Typical Conditions.

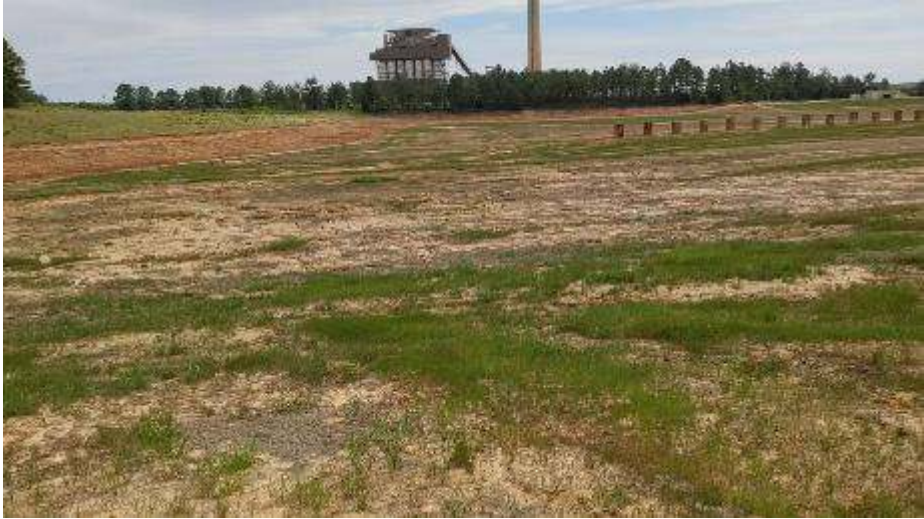
PHOTO BY: GEI CONSULTANTS, INC.			
PHOTOGRAPH NO: 8	DATE: March 20, 2024 2:43 PM	LATITUDE: 32.46897117	LONGITUDE: -94.48598182
SITE LOCATION: HALLSVILLE, TEXAS			
DESCRIPTION: North area, Upstream Slope of Original Dam. Looking South. Typical Conditions.

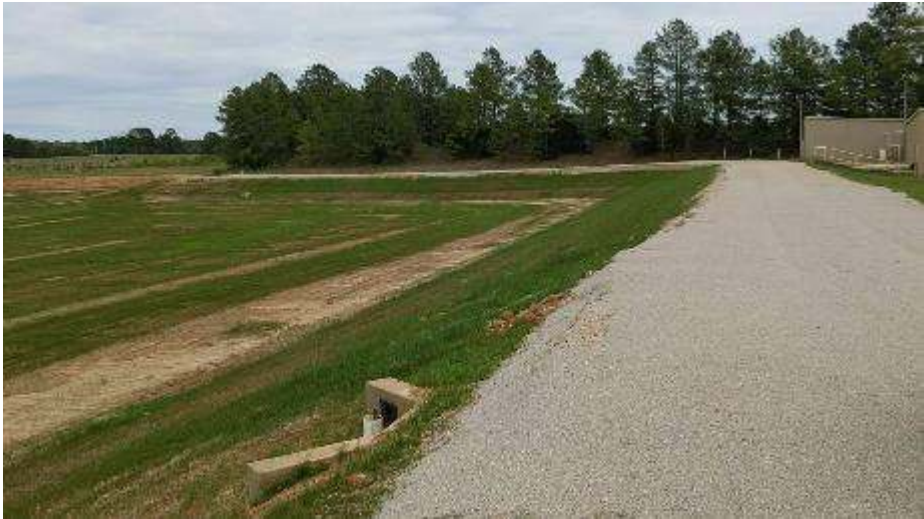
PHOTOGRAPH NO: 9	DATE: March 20, 2024 2:19 PM	LATITUDE: 32.46517519	LONGITUDE: -94.48834739
SITE LOCATION: HALLSVILLE, TEXAS			
DESCRIPTION: South area, Upstream Slope of Original Dam. Looking East. Typical Conditions.

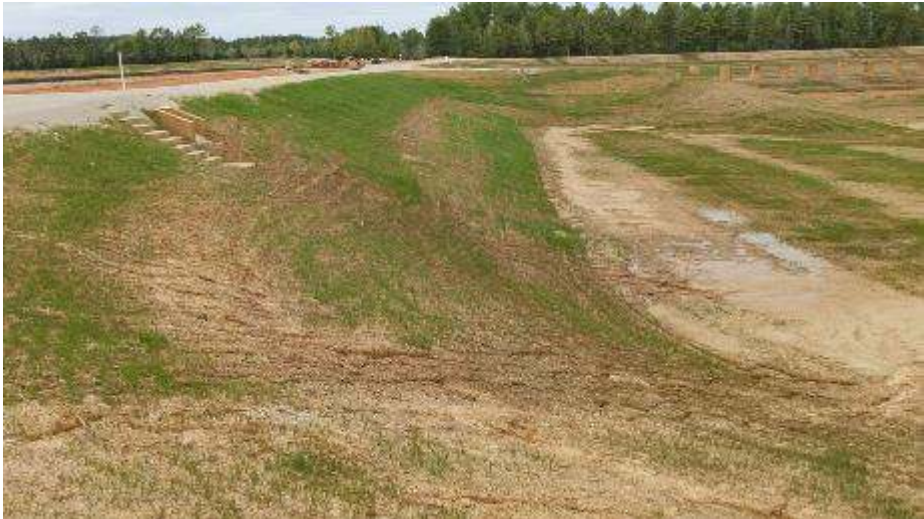
PHOTO BY: GEI CONSULTANTS, INC.			
PHOTOGRAPH NO: 10	DATE: March 20, 2024 2:22 PM	LATITUDE: 32.46518685	LONGITUDE: -94.48833106
SITE LOCATION: HALLSVILLE, TEXAS			
DESCRIPTION: South area, Upstream Slope of Original Dam. Looking North. Typical Conditions.

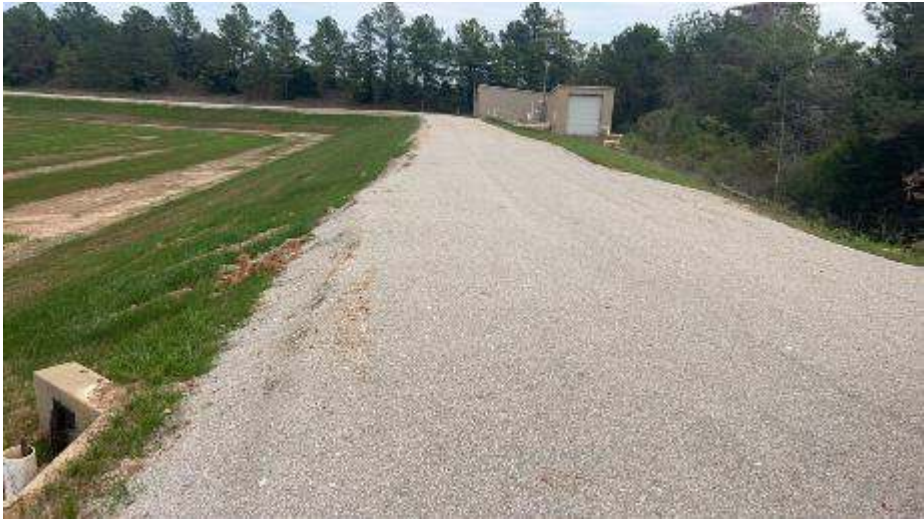
PHOTOGRAPH No: 11	DATE: March 20, 2024 2:20 PM	LATITUDE: 32.4651991318294	LONGITUDE: -94.4883320689739
SITE LOCATION: HALLSVILLE, TEXAS			
DESCRIPTION: South area, Crest. Looking East. General Photo, Typical Conditions.

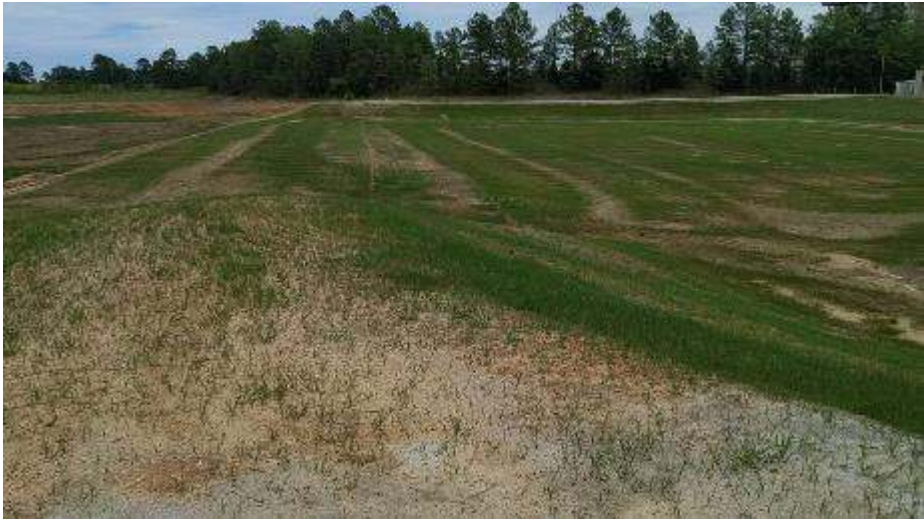
PHOTOGRAPH No: 13	DATE: March 20, 2024 2:25 PM	LATITUDE: 32.46608953	LONGITUDE: -94.48850923
SITE LOCATION: HALLSVILLE, TEXAS			
DESCRIPTION: North area, Upstream Slope of Original Dam. Looking Southeast. Typical Conditions.

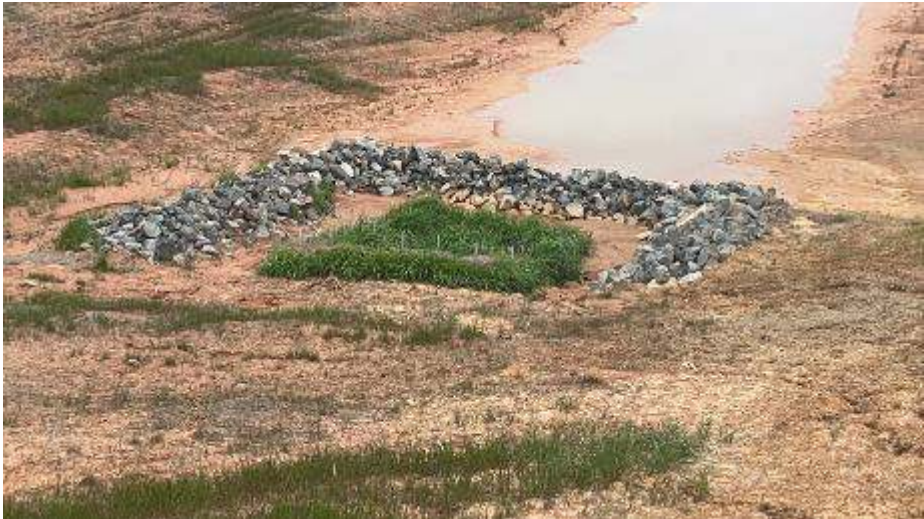
PHOTO BY: GEI CONSULTANTS, INC.			
PHOTOGRAPH No: 14	DATE: March 20, 2024 2:25 PM	LATITUDE: 32.4661104151935	LONGITUDE: -94.4885549540004
SITE LOCATION: HALLSVILLE, TEXAS			
DESCRIPTION: Toe, Drain. Looking North. Typical Conditions.

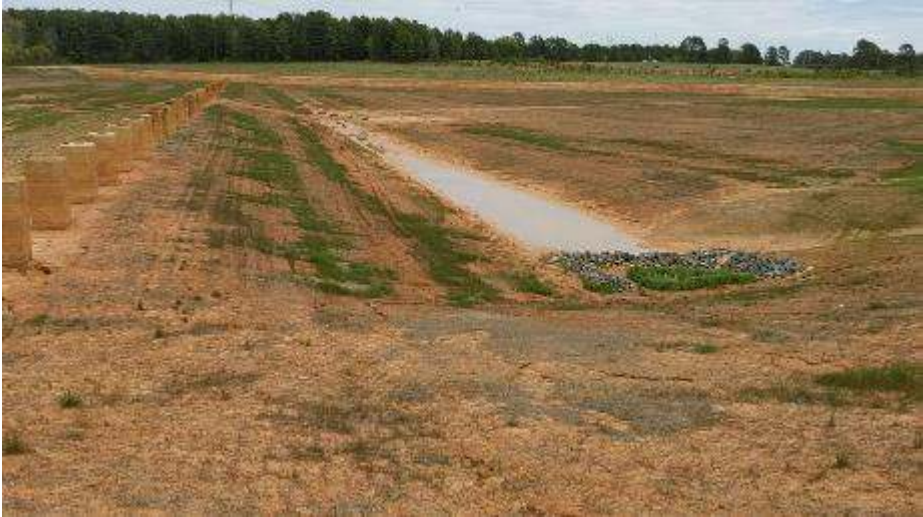
PHOTOGRAPH No: 15	DATE: March 20, 2024 2:31 PM	LATITUDE: 32.46625803	LONGITUDE: -94.48872931
SITE LOCATION: HALLSVILLE, TEXAS			
DESCRIPTION: South area, Other of Original Dam. Looking East. Ground Cover, Typical Conditions.

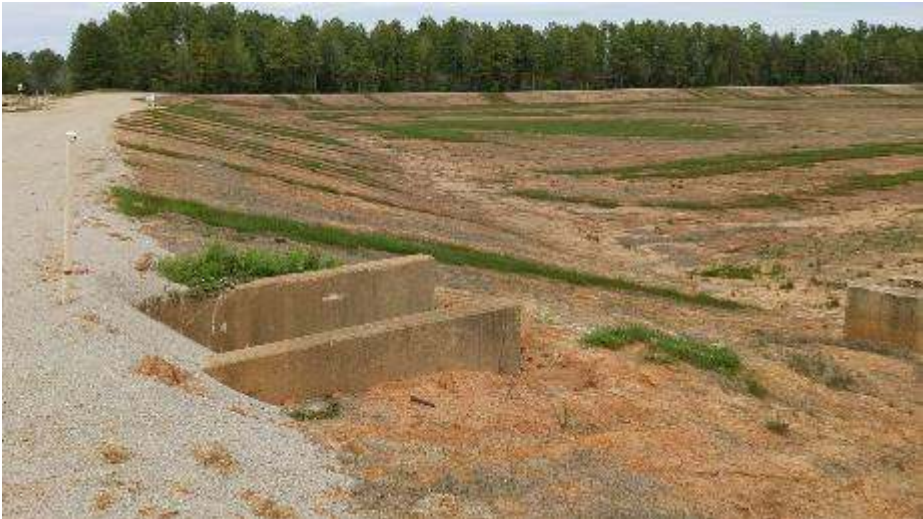
PHOTO BY: GEI CONSULTANTS, INC.			
PHOTOGRAPH No: 16	DATE: March 20, 2024 2:30 PM	LATITUDE: 32.46629069	LONGITUDE: -94.48870753
SITE LOCATION: HALLSVILLE, TEXAS			
DESCRIPTION: South area, Upstream Slope of Original Dam. Looking North. Typical Conditions.

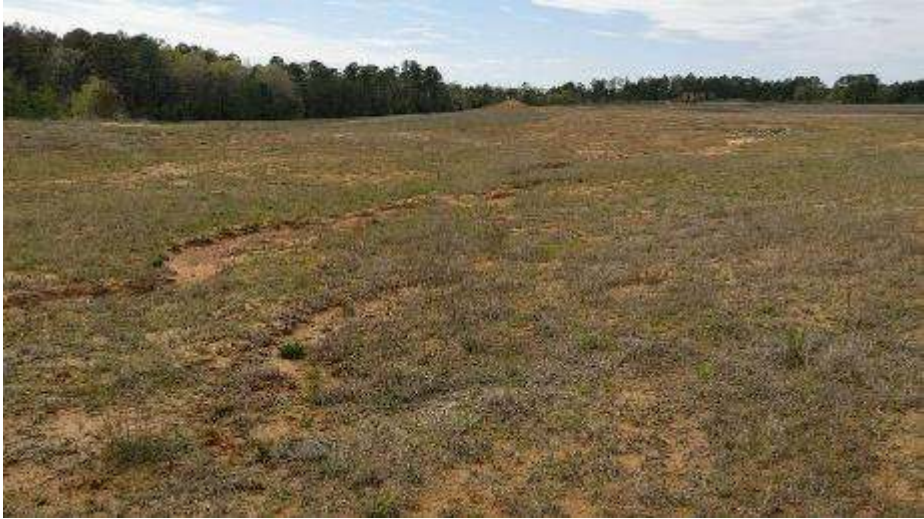
PHOTO BY: GEI CONSULTANTS, INC.			
PHOTOGRAPH No: 20	DATE: March 20, 2024 3:03 PM	LATITUDE: 32.46653643	LONGITUDE: -94.4894371
SITE LOCATION: HALLSVILLE, TEXAS			
DESCRIPTION: South area, Upstream Slope of Original Dam. Looking Southwest. Typical Conditions.

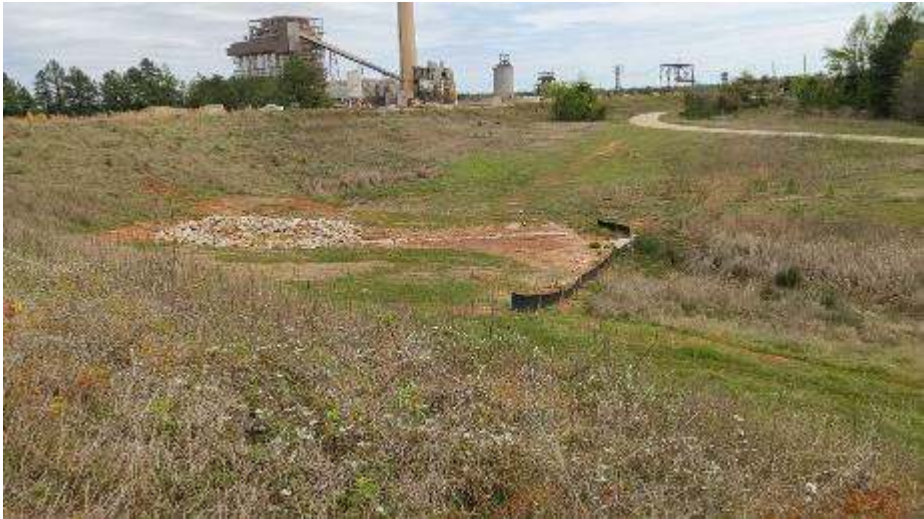
PHOTOGRAPH No: 21	DATE: March 20, 2024 3:05 PM	LATITUDE: 32.46612862	LONGITUDE: -94.48962013
SITE LOCATION: HALLSVILLE, TEXAS			
DESCRIPTION: West area, Downstream Slope of Original Dam. Looking North. Drain Feature.

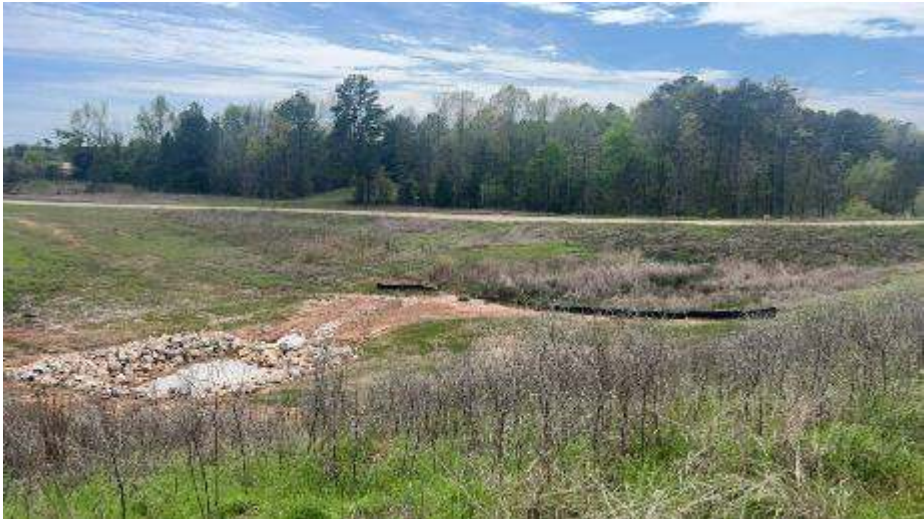
PHOTO BY: GEI CONSULTANTS, INC.			
PHOTOGRAPH No: 22	DATE: March 20, 2024 3:05 PM	LATITUDE: 32.466183205173	LONGITUDE: -94.4896219570911
SITE LOCATION: HALLSVILLE, TEXAS			
DESCRIPTION: West area, Downstream Slope of Drainage Feature. Looking Southwest. General Photo, Typical Conditions.
