## CCR Landfill and Leachate Collection 2024 Annual Inspection Report

Rockport Plant, Rockport, Indiana

September 3, 2024

AEP Document ID: GEVR-24-013

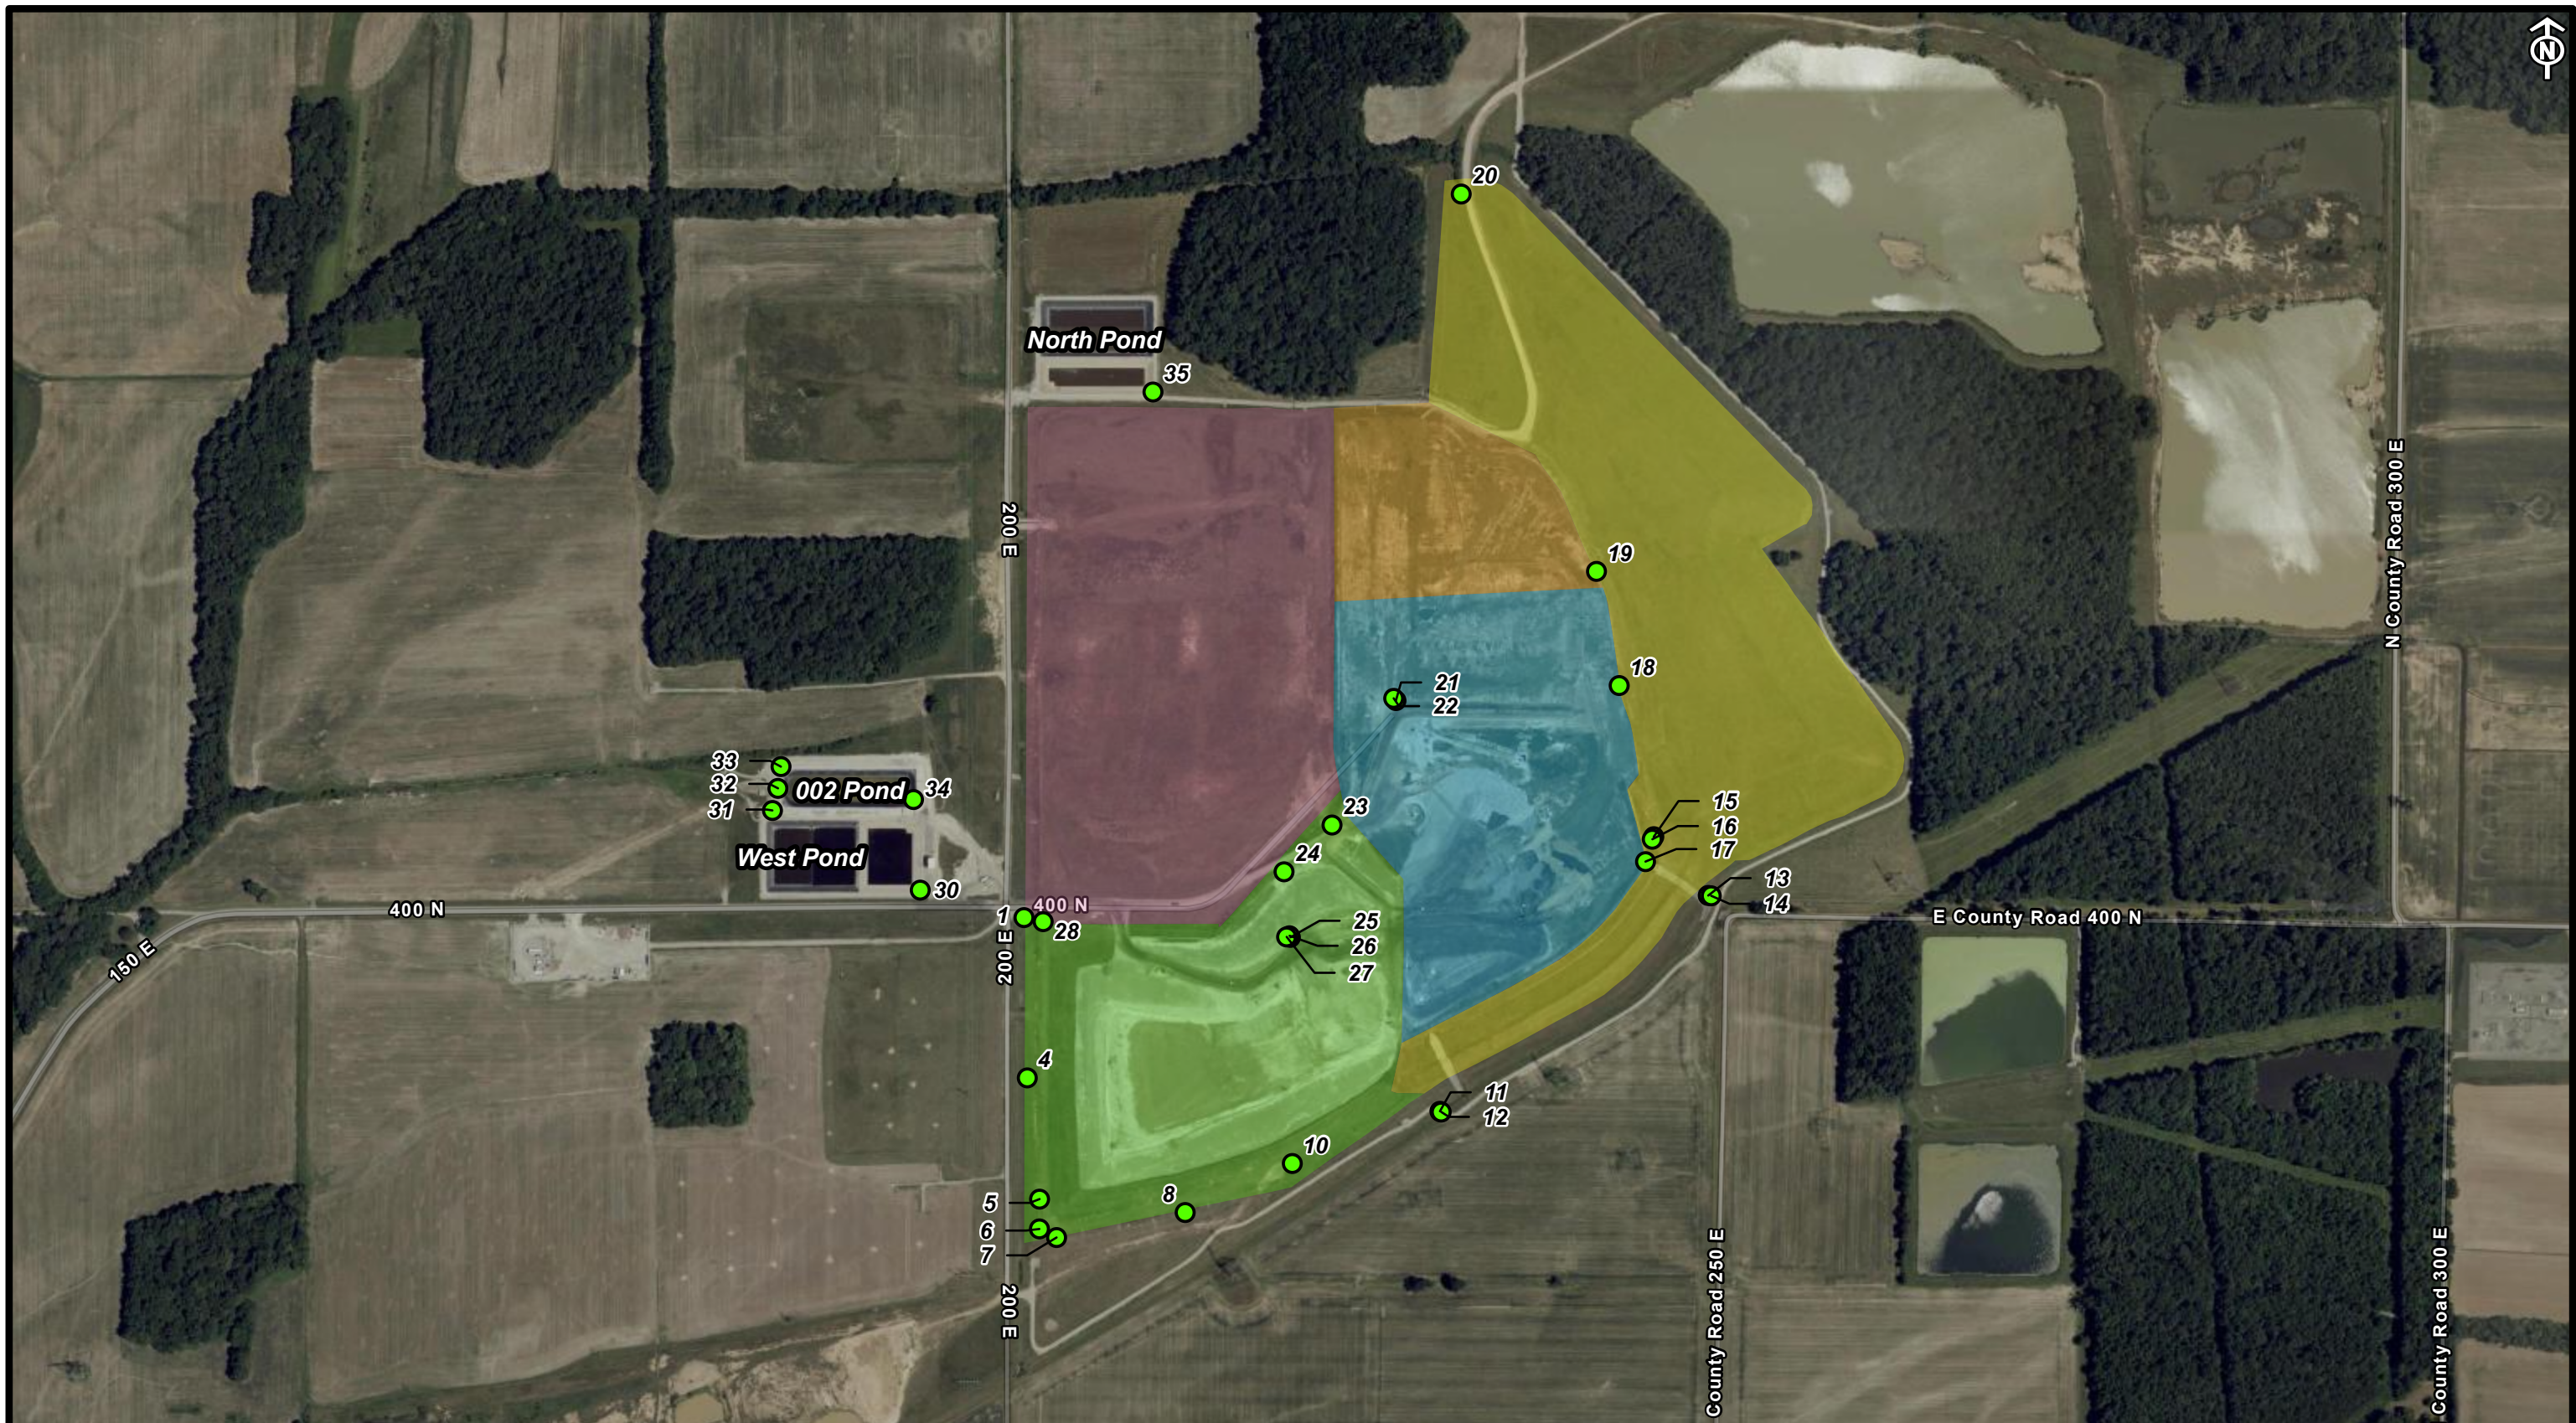
## Figure 3 – Site Plan

monitored, or as an item to be addressed. The site observations are presented on Figure 3 – Site Plan, Figure 4 – Items to be Monitored, and Figure 5 – Items to be Addressed.
