## Landfill

# 2024 Annual Inspection Report

H.W. Pirkey Power Plant, Hallsville, Texas

AEP Document ID: GEVR-24-004

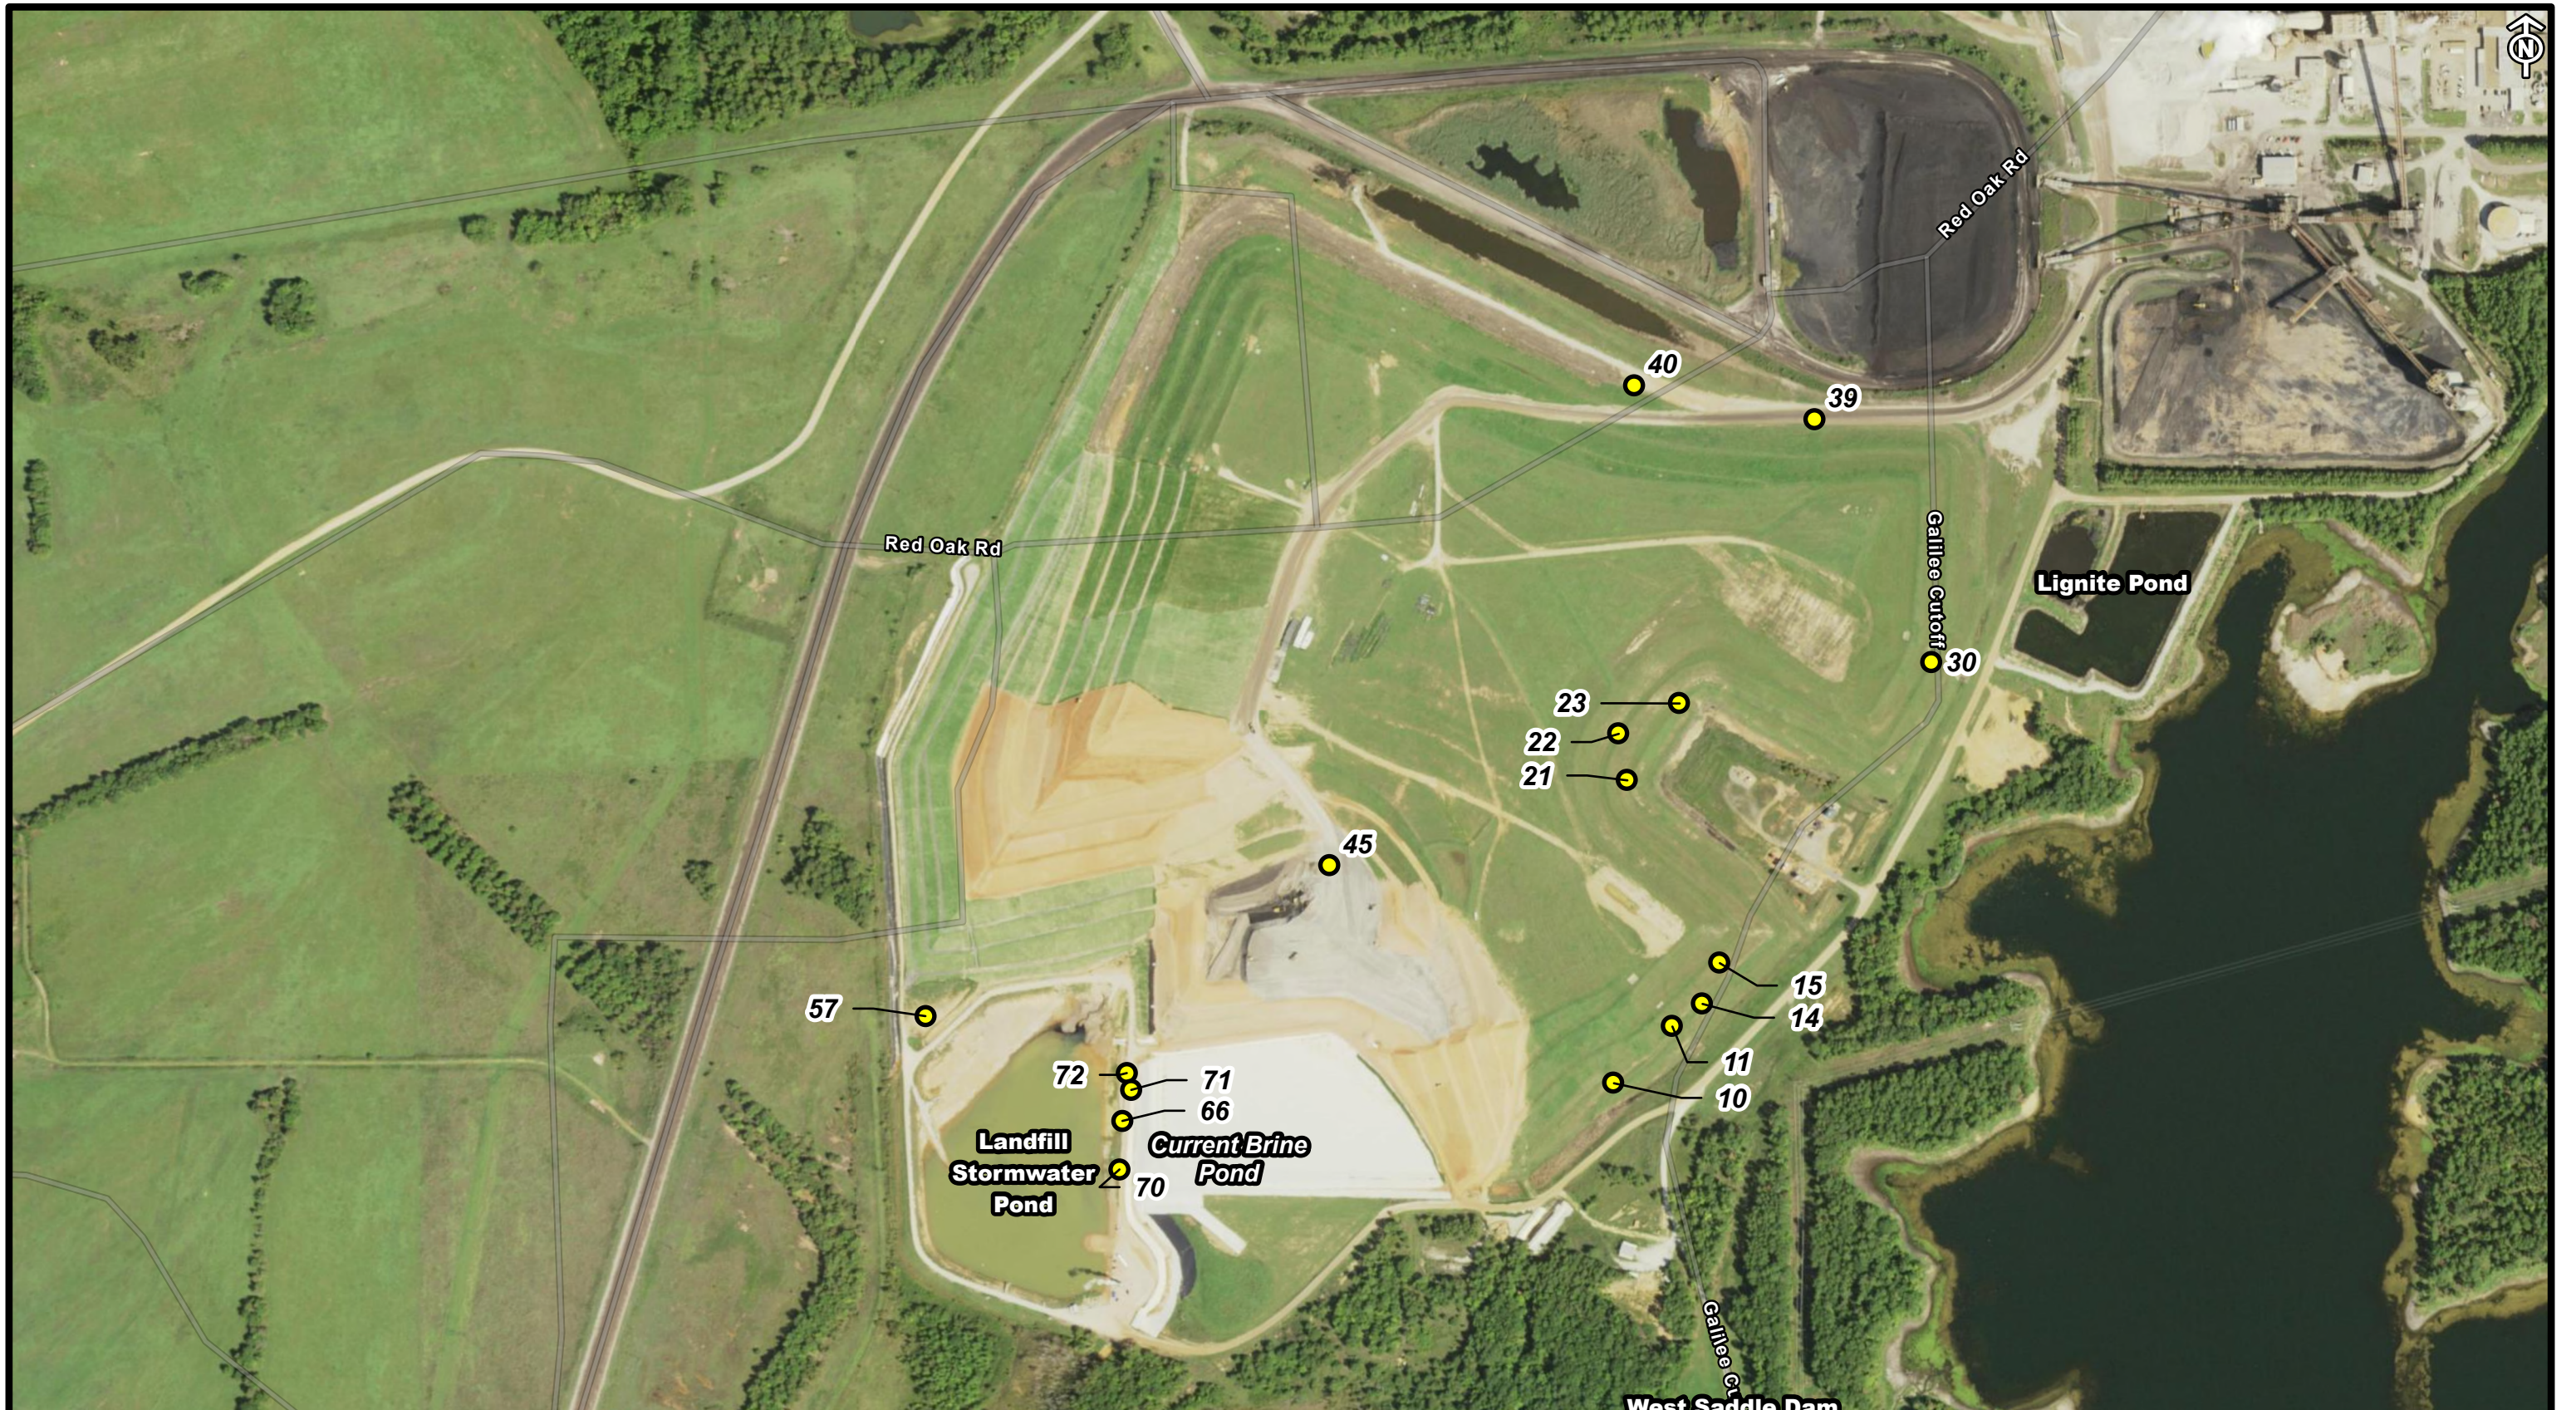
## **Figure 4 – Items to be Monitored**

Sixteen items were identified during the visual inspection as items to be monitored. The locations are provided on Figure 4 – Items to be Monitored. Photographs of the items are provided in Appendix A – Photolog.

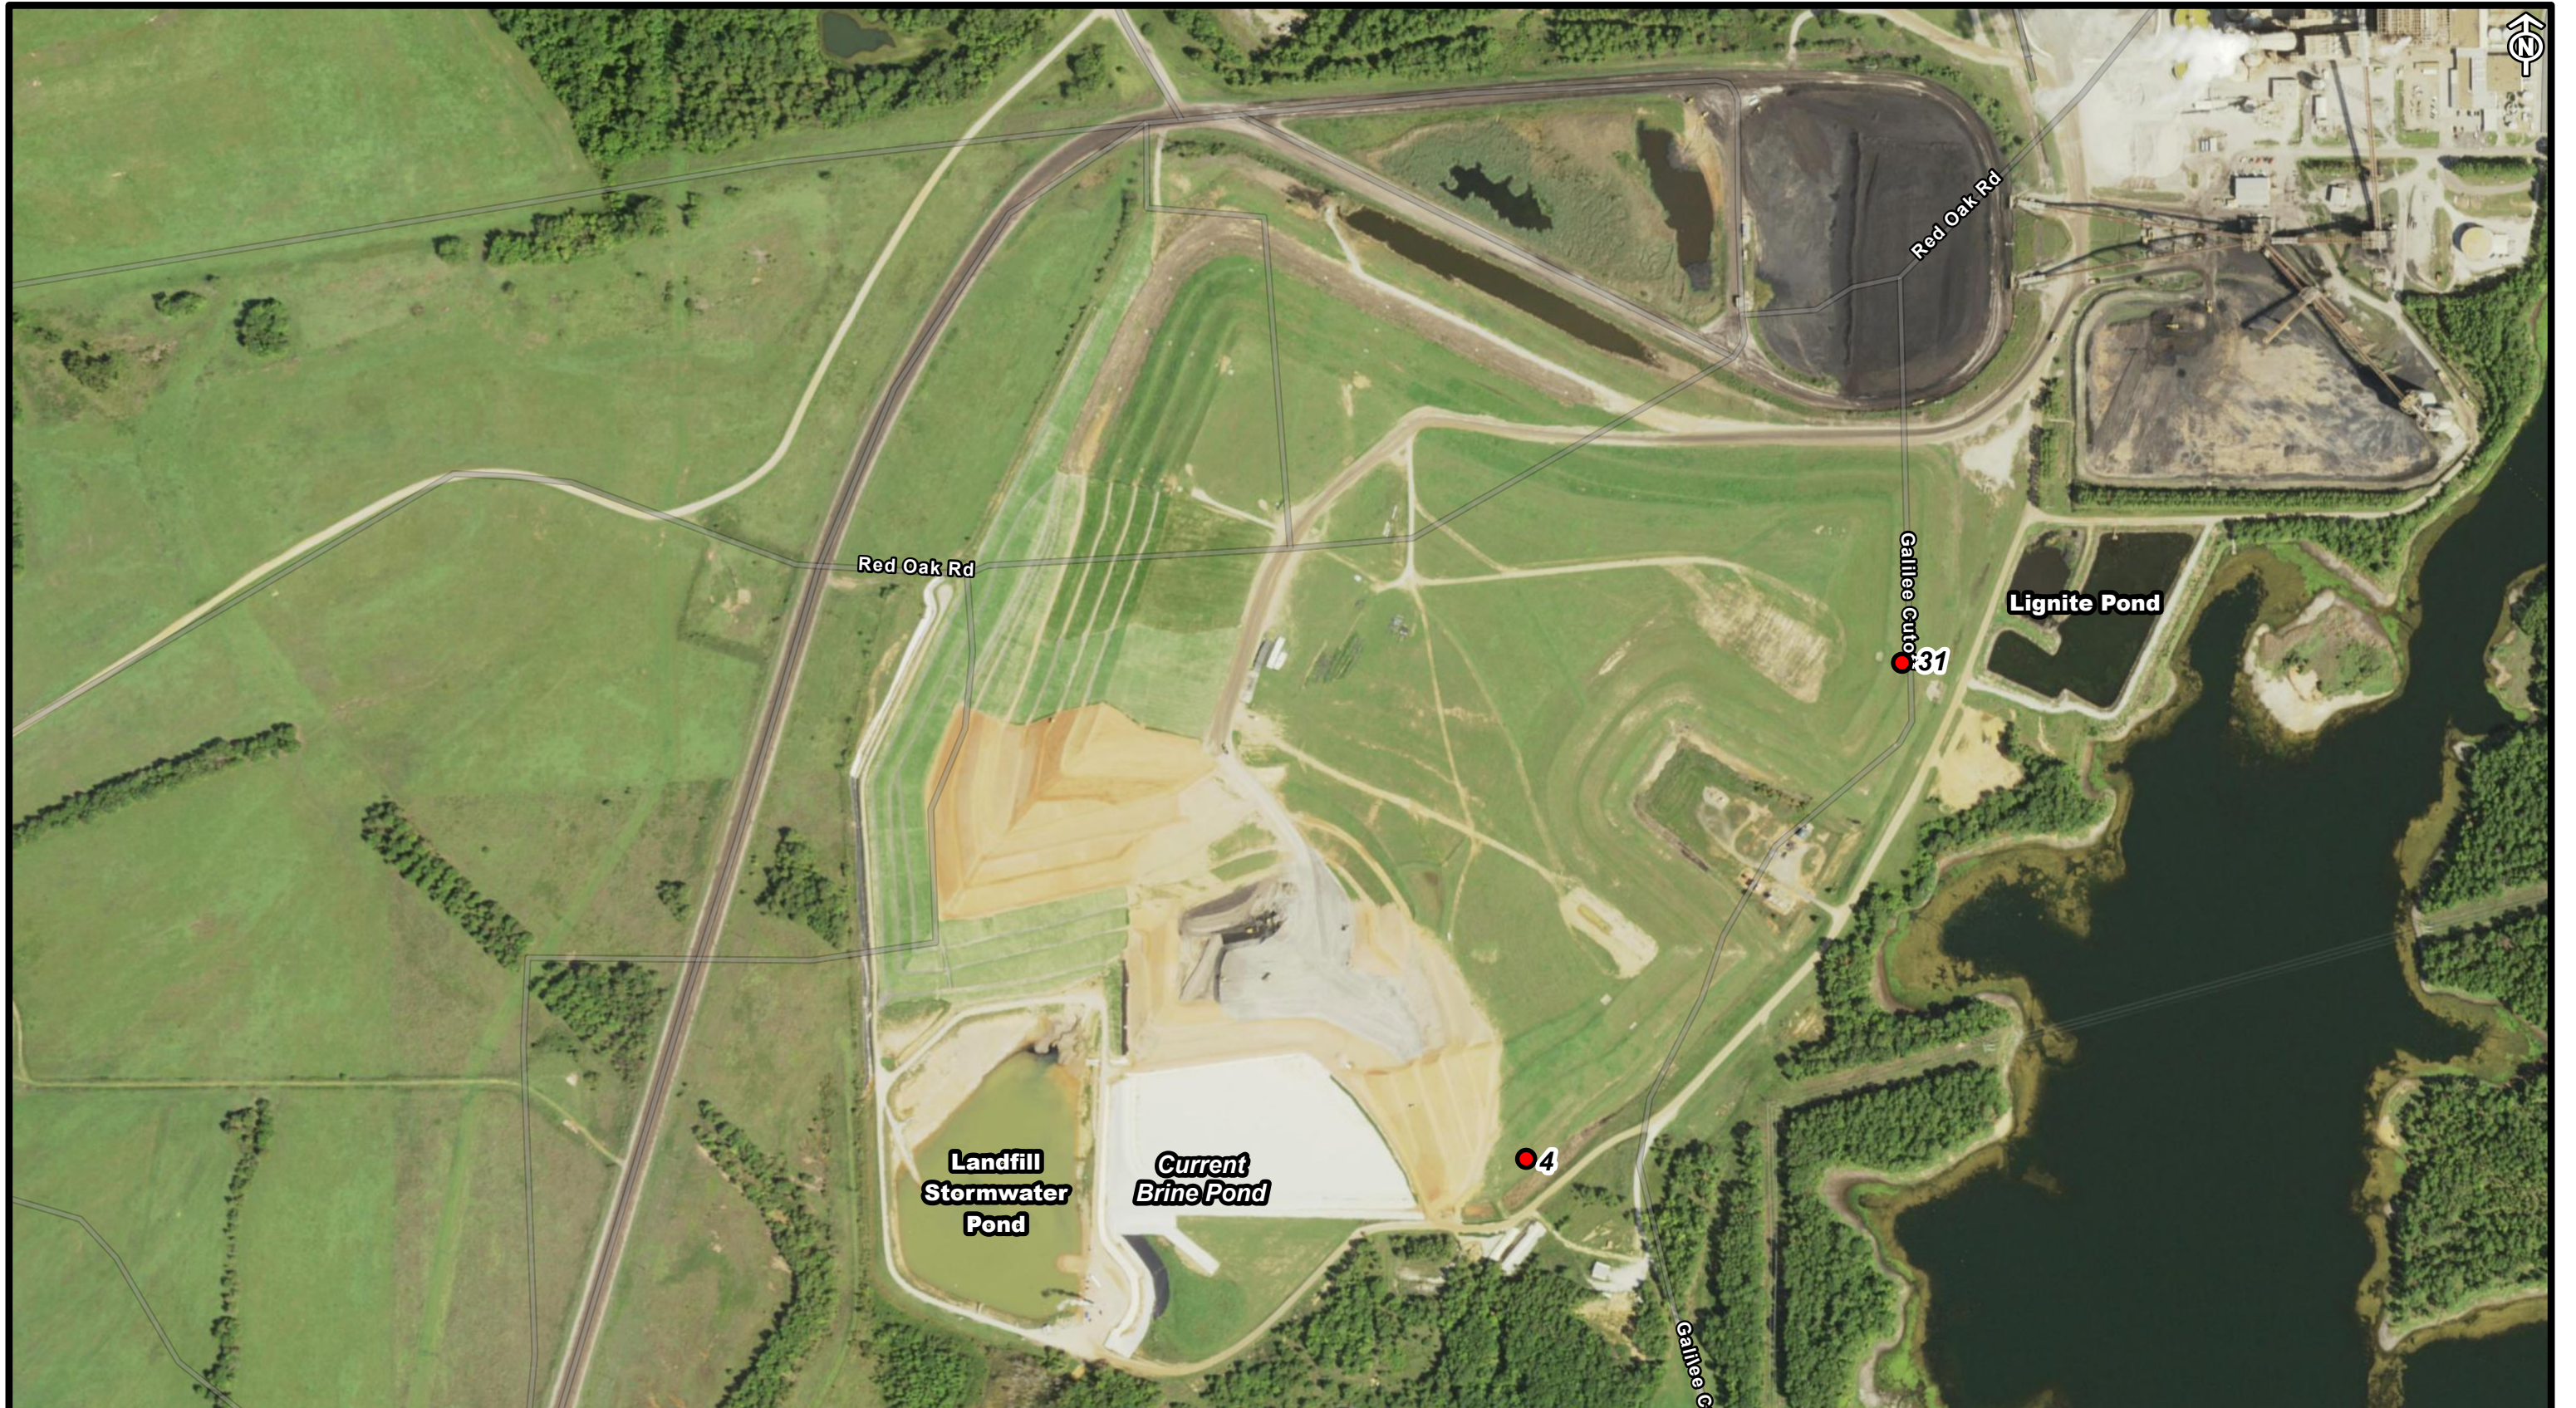
## **Figure 5 – Items to be Addressed**

These locations are provided on Figure 5 – Items to be Addressed. Photographs of the items are provided in Appendix A – Photolog.
