**Ash Pond  
Initial Dam and Dike Inspection  
Report**

Cabin Creek Power Plant Cabin Creek, West Virginia

# 2024 Annual Inspection Report

## Ash Pond Cabin Creek Power Plant

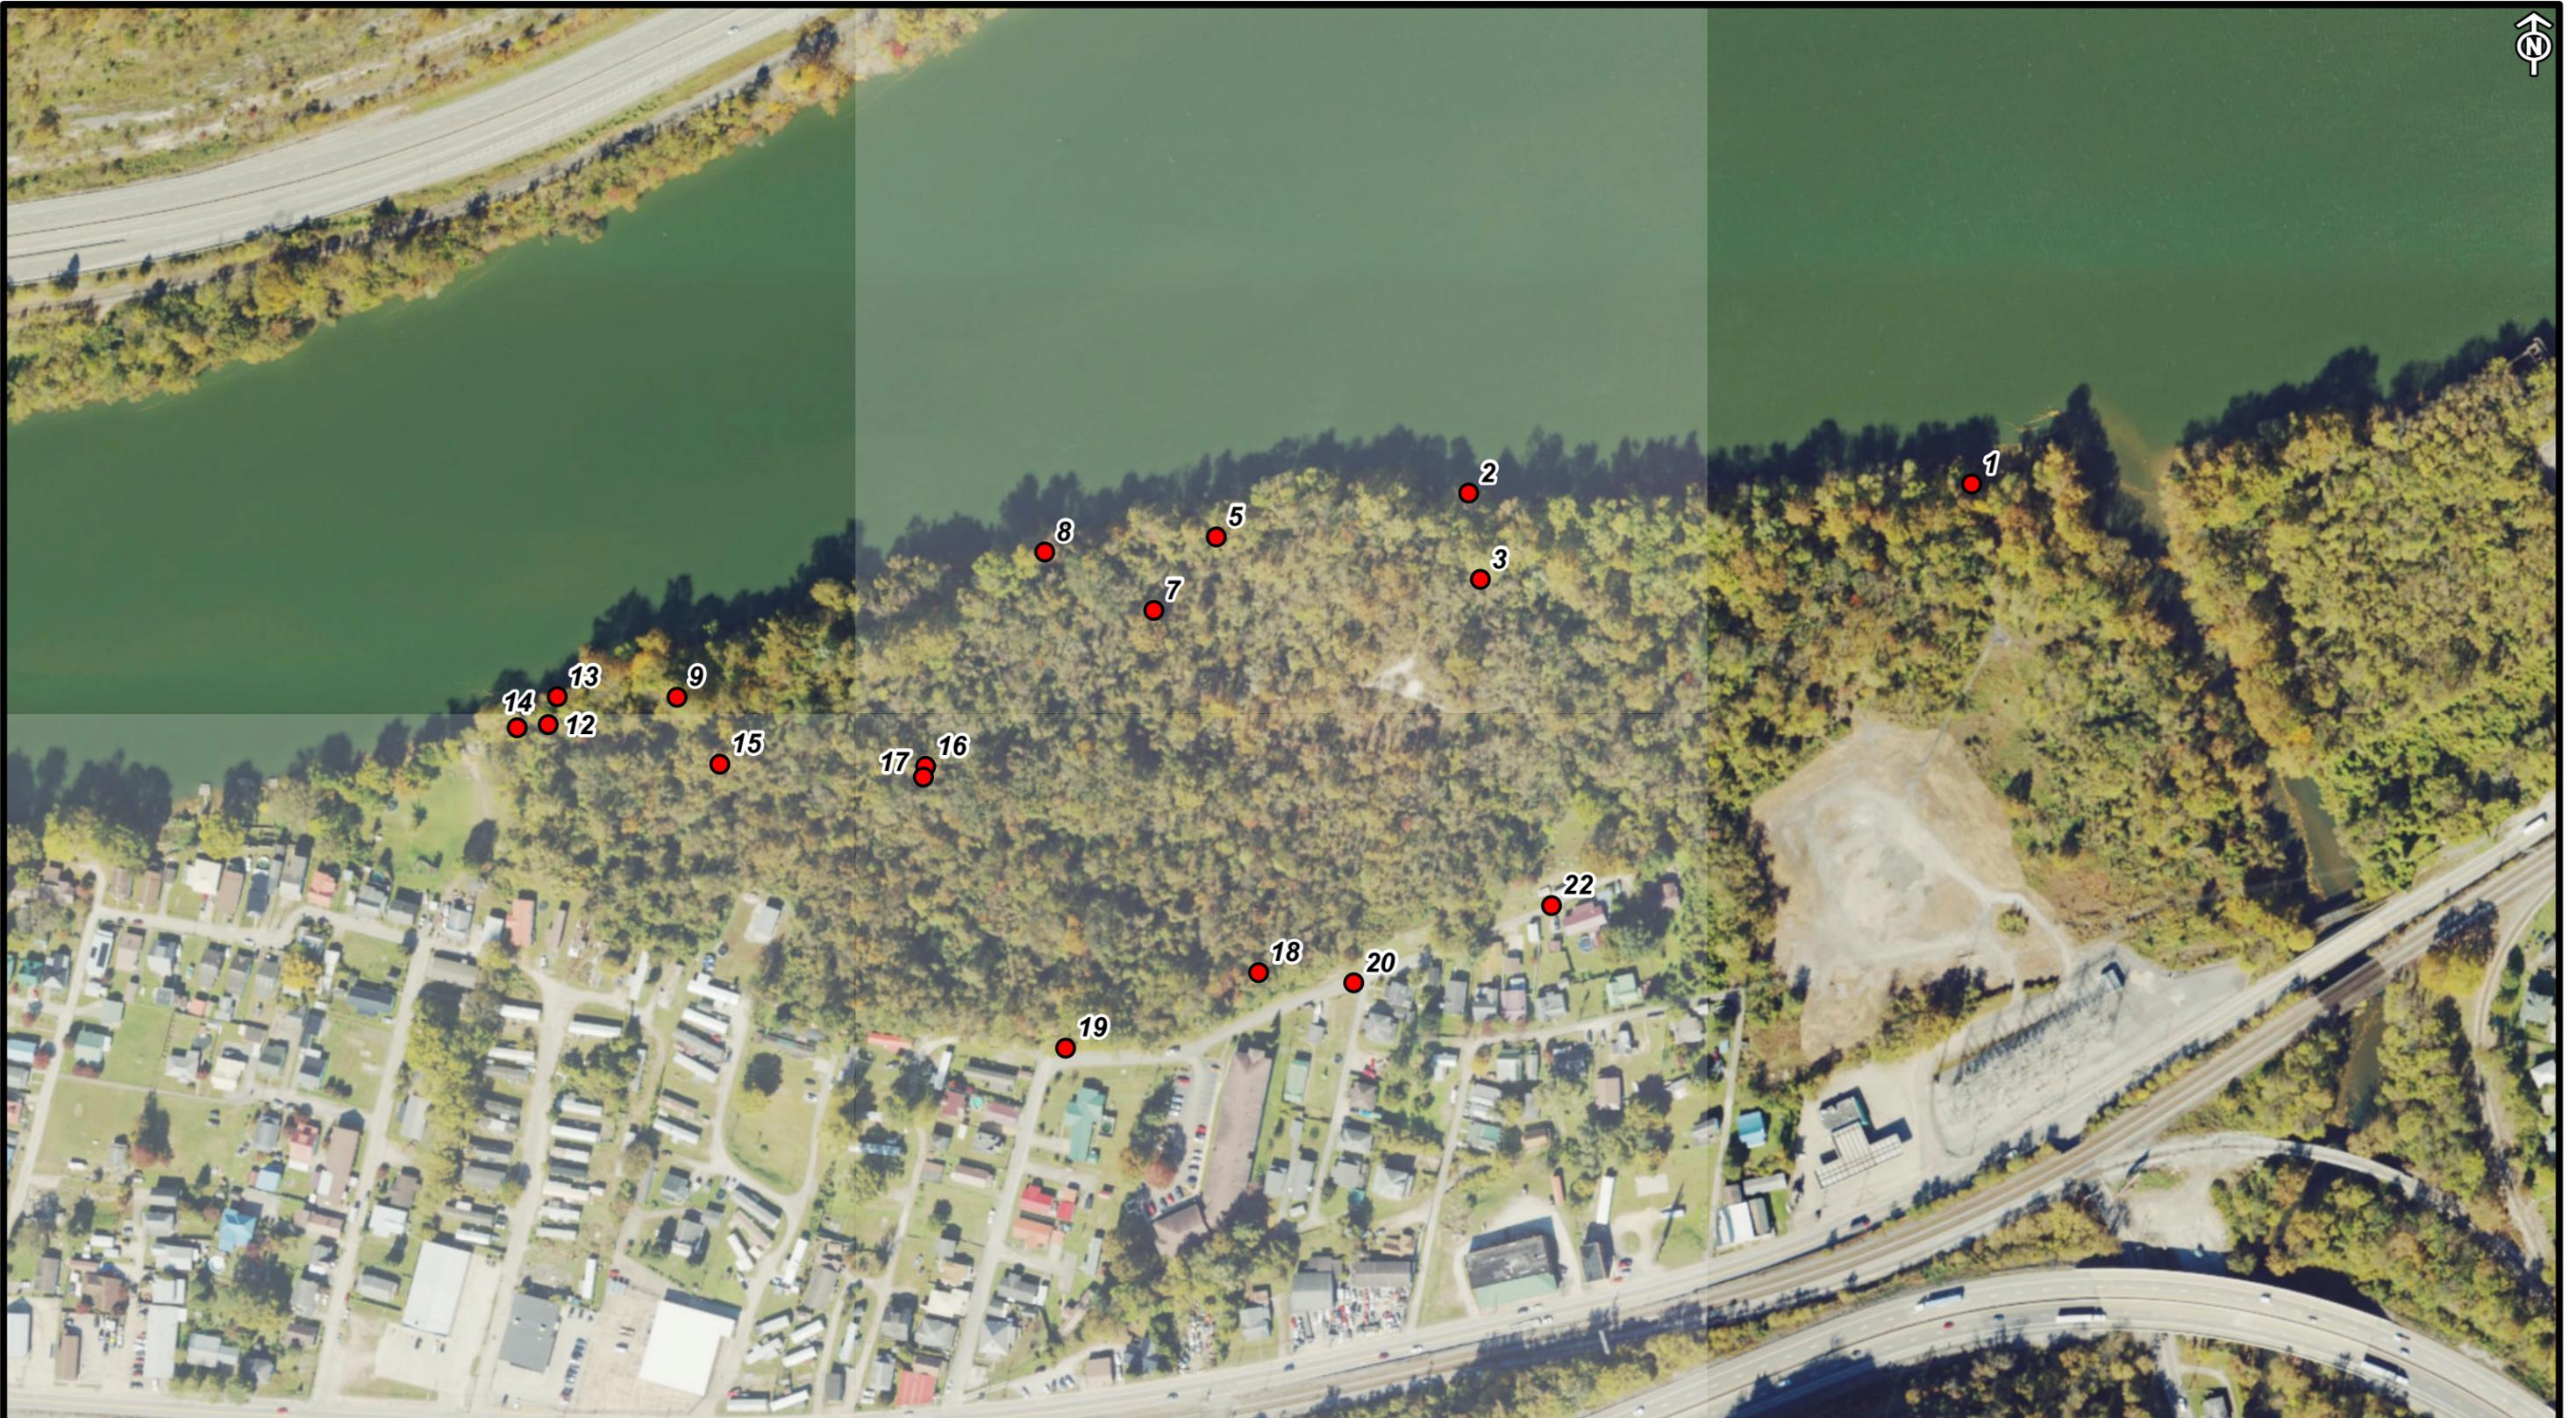
## **Figure 4 – Items to be Addressed**

The Cabin Creek Power Plant is located in Cabin Creek, West Virginia as shown on Figure 1 – Site Location Map. The facility arrangement is provided on Figure 2 – Facility Plan. The Ash Pond and its appurtenances are shown on Figure 3 – Site Plan. Locations of items to be addressed are provided on Figure 4 – Items to be Addressed.

The downstream slope of the dam is in fair condition. The slope is overgrown with woody vegetation. AEP should consider identifying the unit boundary so vegetation on the downstream slope can be addressed/maintained to 12-inches or less as shown in Photograph No. 1, 2, 3, 5, 7, 8, 9, 12, 13, 14, 18, 19, 20, and 22.

The interior of the site is in fair condition. It is heavily vegetated as shown in Photograph No. 4, 6, 15, 16, and 17. AEP should consider addressing/maintaining the vegetation to 12-inches or less in the pond's interior in preparation to comply with upcoming Legacy CCR Surface Impoundment requirements.
