Closure Completion Notification for Closure by Removal

Mitchell Plant

Bottom Ash Pond

Bottom Ash Complex 2024 Annual Dam and Dike Inspection Report

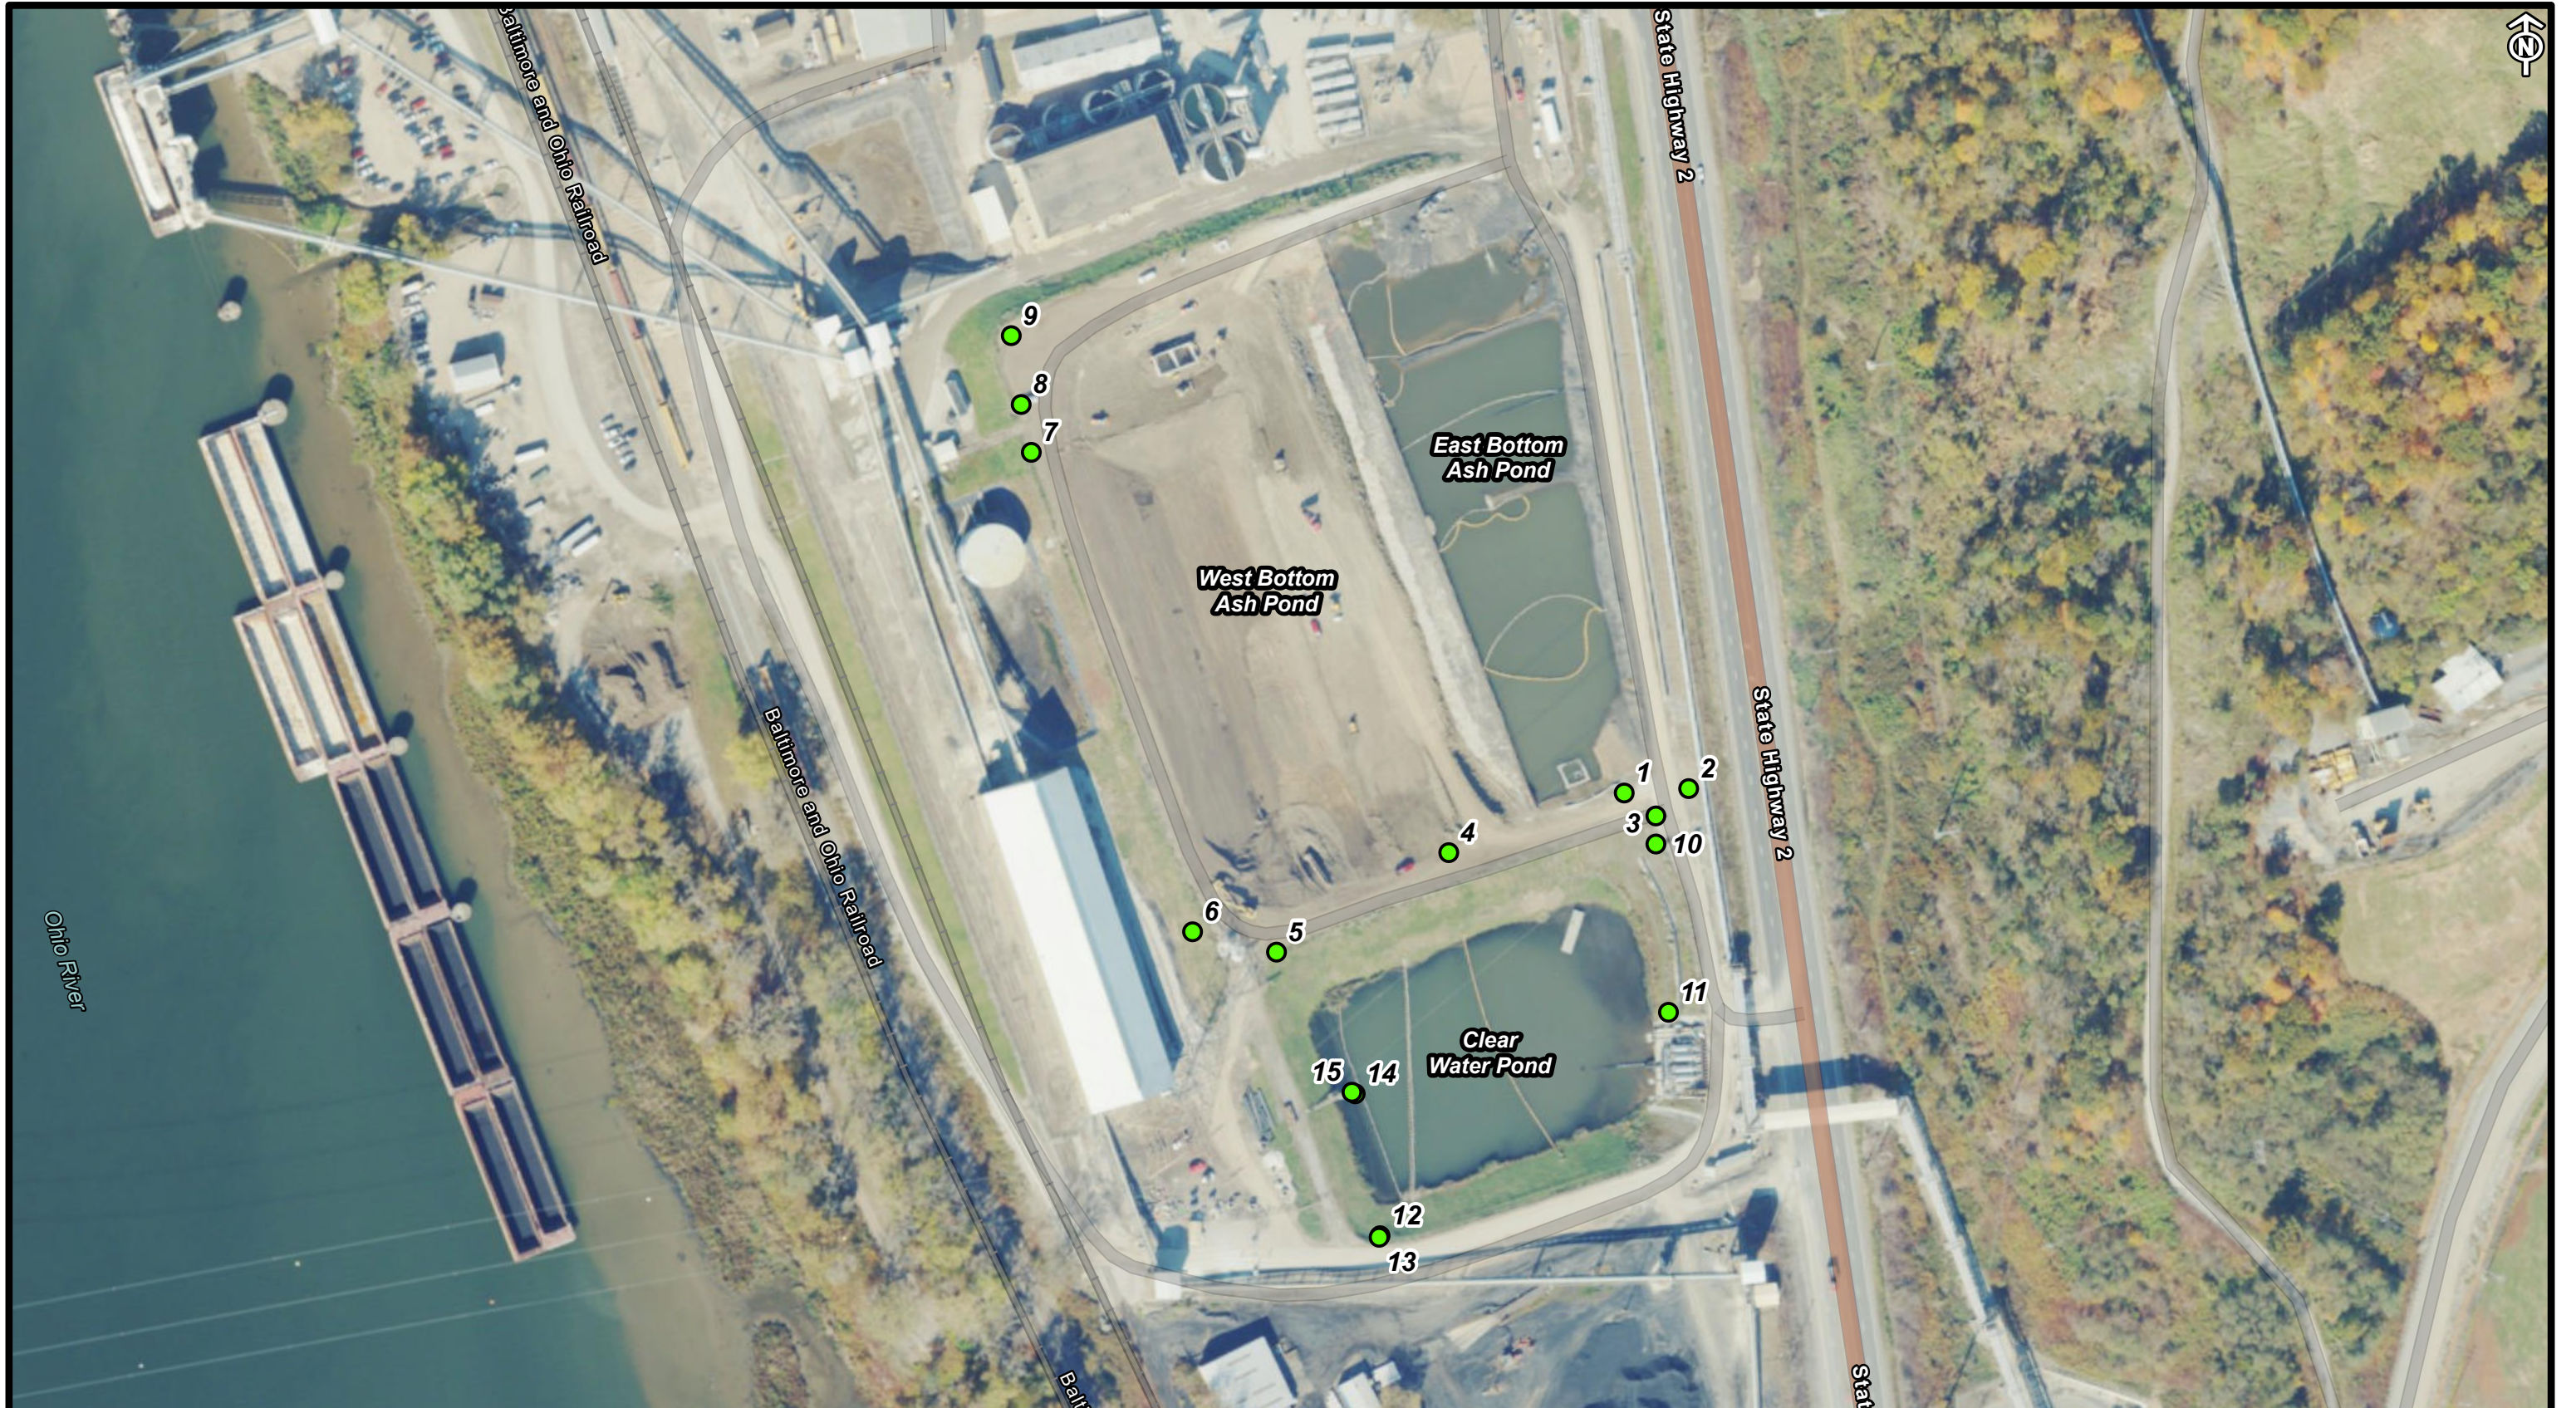
Figure 3 – Site Plan

the impoundment. Inspection photos are included in Appendix A. The locations of the inspection photos are included on Figure 3 – Site Plan.

Four standpipe piezometers exist around the Bottom Ash Complex as shown on Figure 3. Regular readings are recorded for each piezometer at a minimum 30-day interval. The piezometer readings exhibited minor fluctuations month to month during 2024 but were 0.1 to 1.7 feet higher than elevations record in 2023 – which can be attributed to the temporary conditions that were presented as the ponds were being modified. A graph of the piezometer readings is provided in Appendix B – Instrumentation Data.
